FLORIDA DEPARTMENT OF TRANSPORTATION AVIATION AND SPACEPORTS OFFICE

Statewide Airfield Pavement Management Program

Airport Pavement Evaluation Report November 2019

Clearwater Airpark (CLW) Reliever Airport District 7

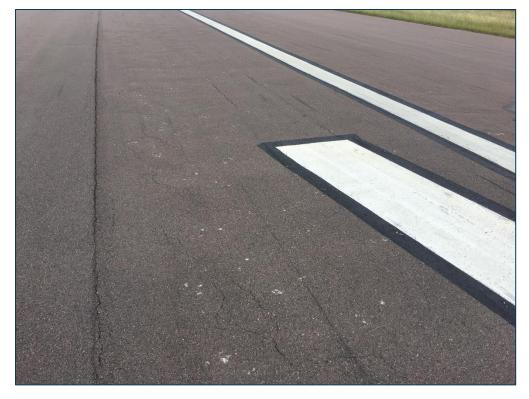
RW 16-34, Section 6110, Sample Unit 110 - Low Severity (48) Longitudinal & Transverse Cracking, Low Severity (56) Swelling, and Low Severity (57) Weathering

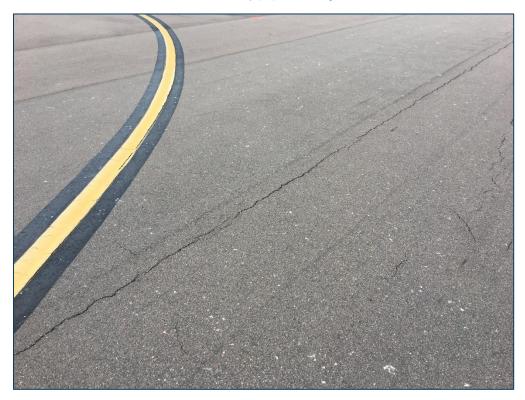
RW 16-34, Section 6110, Sample Unit 130 - Low Severity (48) Longitudinal & Transverse Cracking, Low Severity (56) Swelling, and Low Severity (57) Weathering

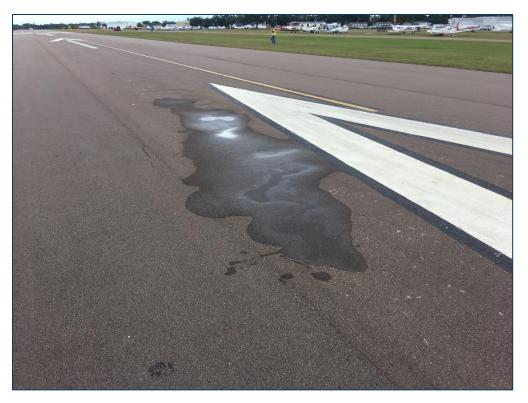
RW 16-34, Section 6110, Sample Unit 102 - Low Severity (45) Depression, Low Severity (48) Longitudinal & Transverse Cracking, Low Severity (56) Swelling, and Low Severity (57) Weathering

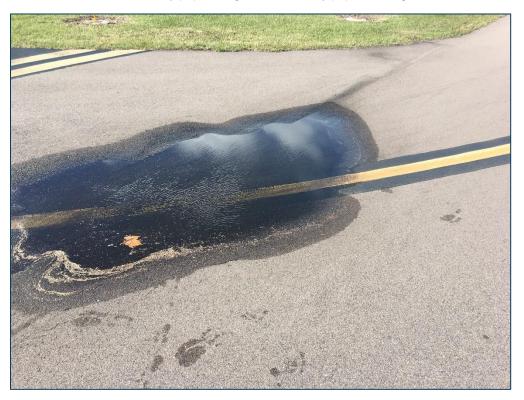
TW A, Section 105, Sample Unit 102 - Medium Severity (45) Depression, Low Severity (48) Longitudinal & Transverse Cracking, and Low Severity (57) Weathering

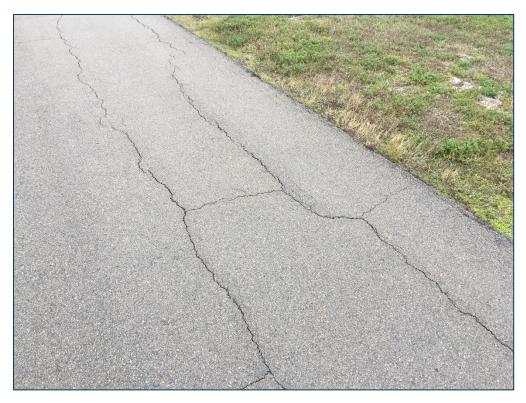
TW A, Section 135, Sample Unit 128 - Low Severity (48) Longitudinal & Transverse Cracking, Medium Severity (48) Longitudinal & Transverse Cracking, and Low Severity (57) Weathering

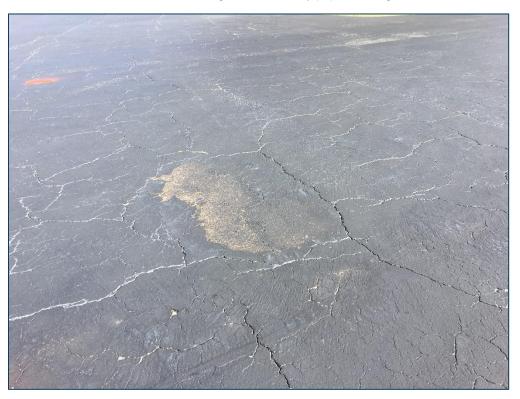
TW CONN 34, Section 5105, Sample Unit 102 - Low Severity (43) Block Cracking, Medium Severity (43) Block Cracking, Low Severity (48) Longitudinal & Transverse Cracking, and Low Severity (52) Raveling

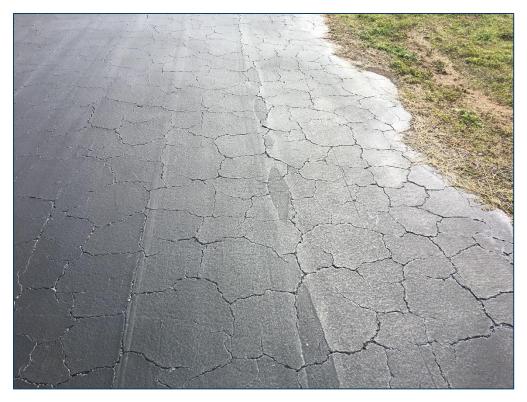
AP CENTER, Section 4410, Sample Unit 301 - Low Severity (43) Block Cracking, Medium Severity (43) Block Cracking, and Low Severity (57) Weathering

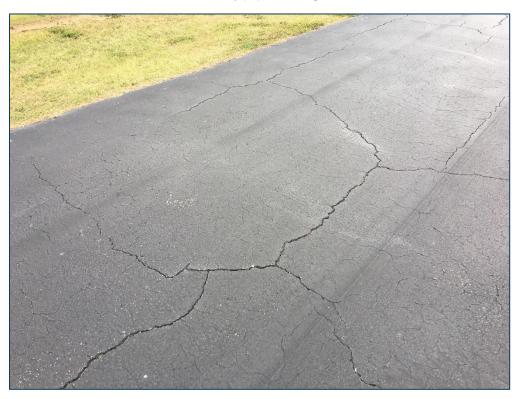
AP T-HANG, Section 4605, Sample Unit 105 - Severity (43) Block Cracking, Medium Severity (43) Block Cracking, and Low Severity (52) Raveling

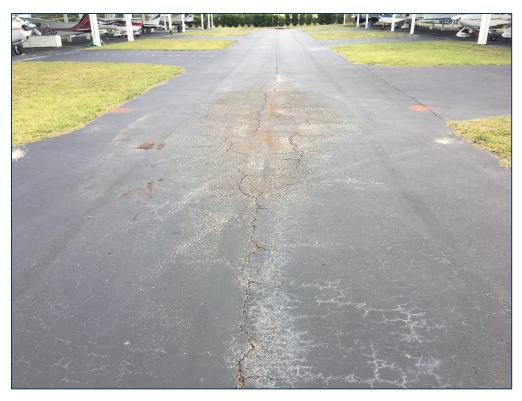
AP T-HAN 2, Section 4105, Sample Unit 400 - Low Severity (43) Block Cracking, Low Severity (45) Depression, Medium Severity (48) Longitudinal & Transverse Cracking, and Low Severity (52) Raveling
