# Statewide Airfield Pavement Management Program

## Airport Pavement Evaluation Report November 2019

**Tampa Executive  
Airport (VDF)**  
Reliever Airport  
District 7

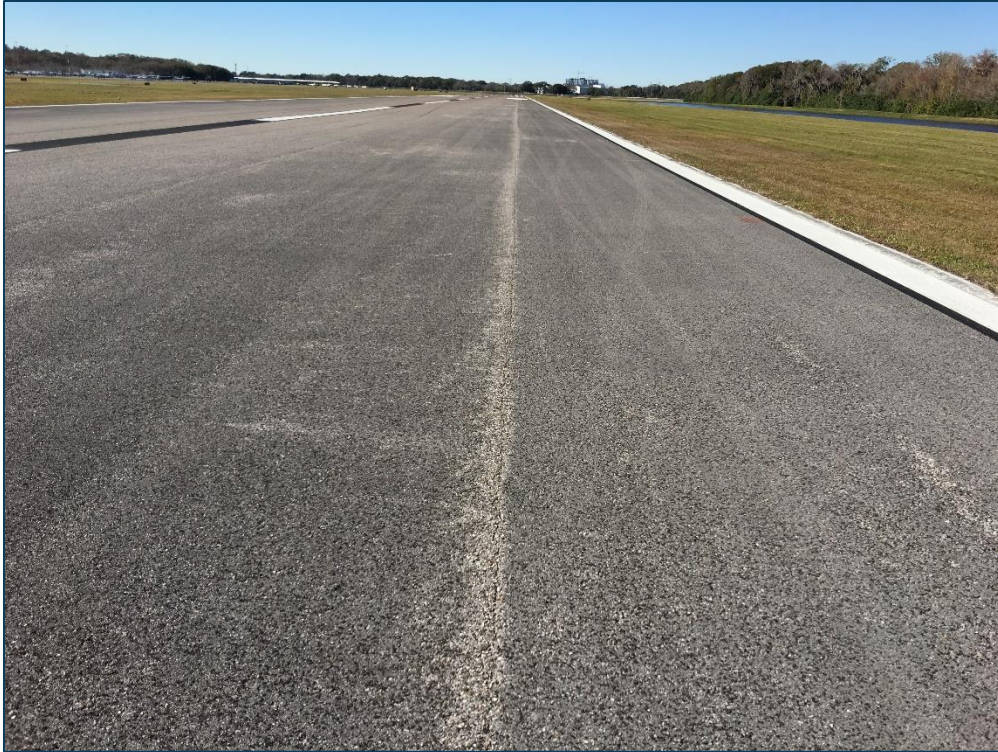
RW 5-23, Section 6205, Sample Unit 138 - Low Severity (48) Longitudinal & Transverse Cracking, Medium Severity (48) Longitudinal & Transverse Cracking, Low Severity (52) Raveling, and Medium Severity (57) Weathering

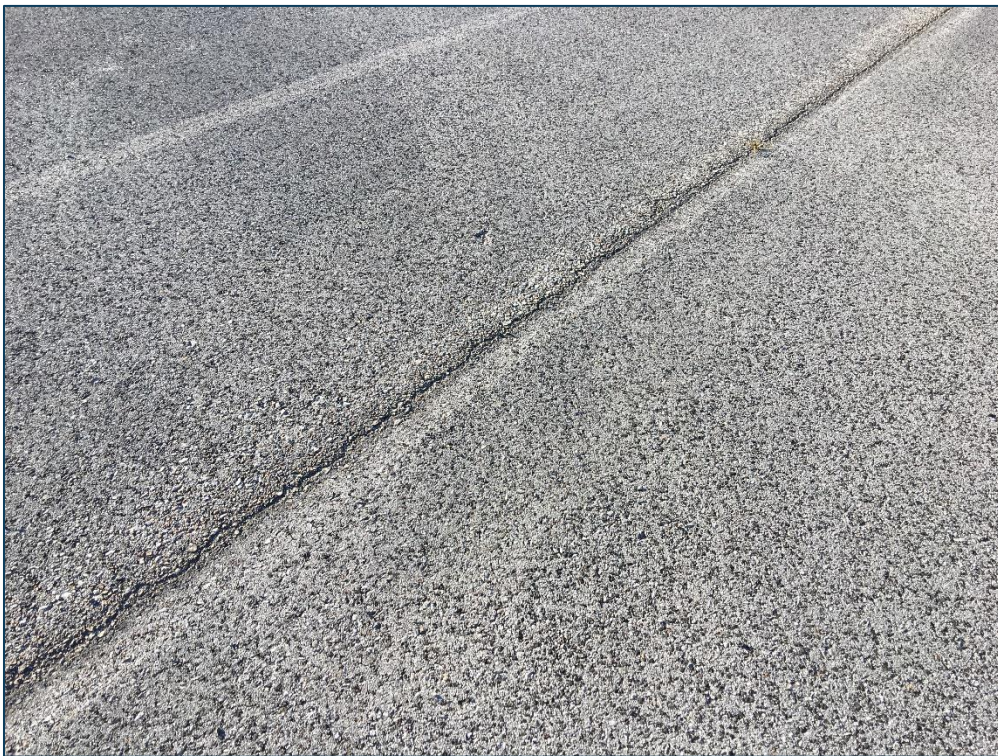
RW 5-23, Section 6205, Sample Unit 196 - Medium Severity (48) Longitudinal & Transverse Cracking, Low Severity (52) Raveling, and Medium Severity (57) Weathering

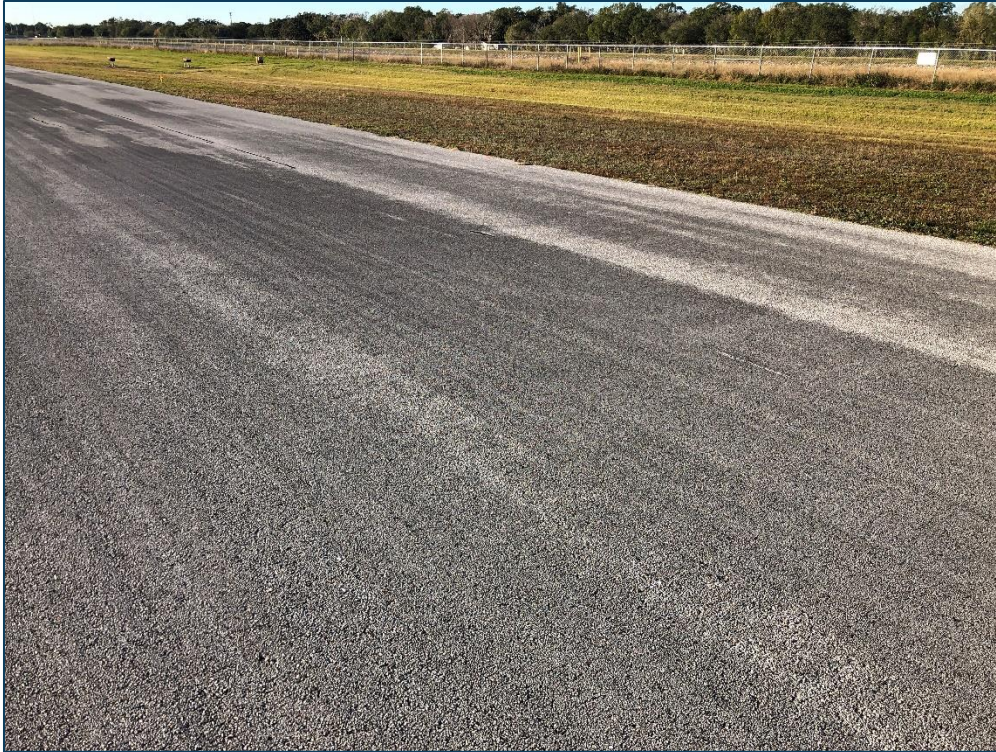
RW 18-36, Section 6105, Sample Unit 119 - Low Severity (48) Longitudinal & Transverse Cracking, Low Severity (52) Raveling, and Medium Severity (57) Weathering

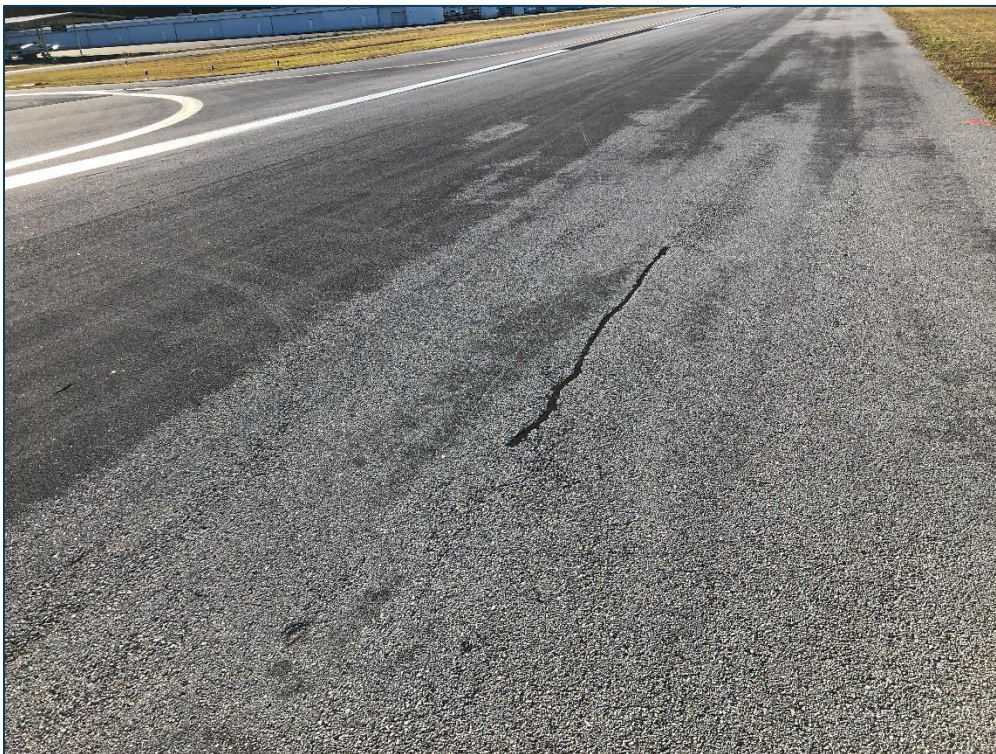
RW 18-36, Section 6105, Sample Unit 131 - Low Severity (48) Longitudinal & Transverse Cracking, Low Severity (52) Raveling, and Medium Severity (57) Weathering

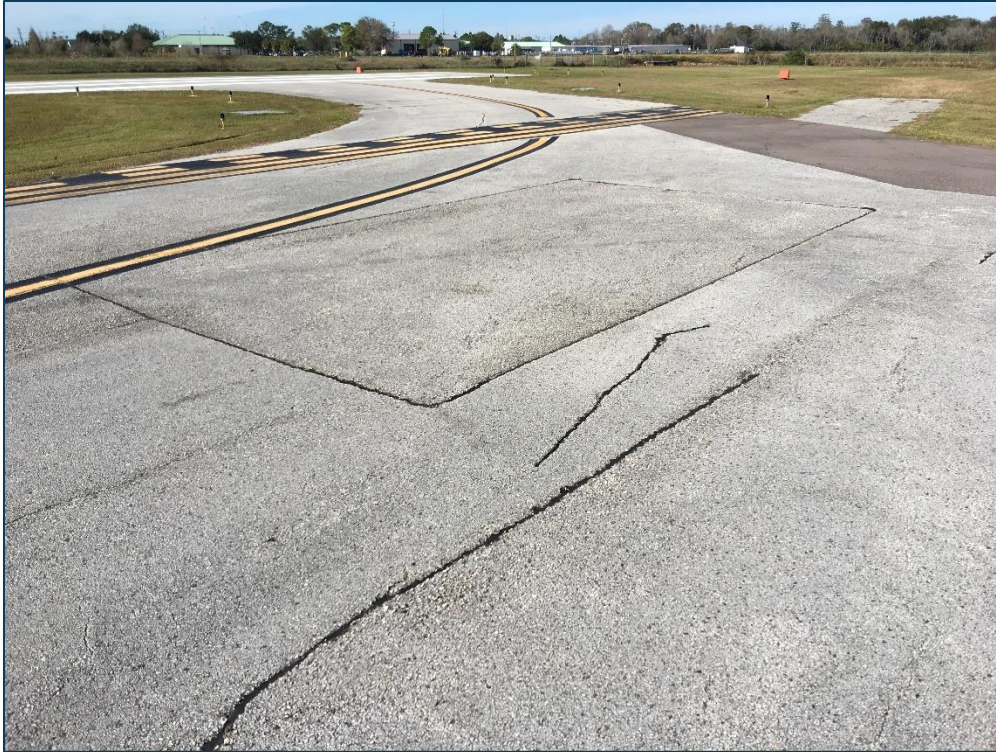
TW A, Section 105, Sample Unit 130 - Low Severity (48) Longitudinal & Transverse Cracking, Low Severity (50) Patching, Medium Severity (50) Patching, Low Severity (52) Raveling, Medium Severity (52) Raveling, and Low Severity (56) Swelling

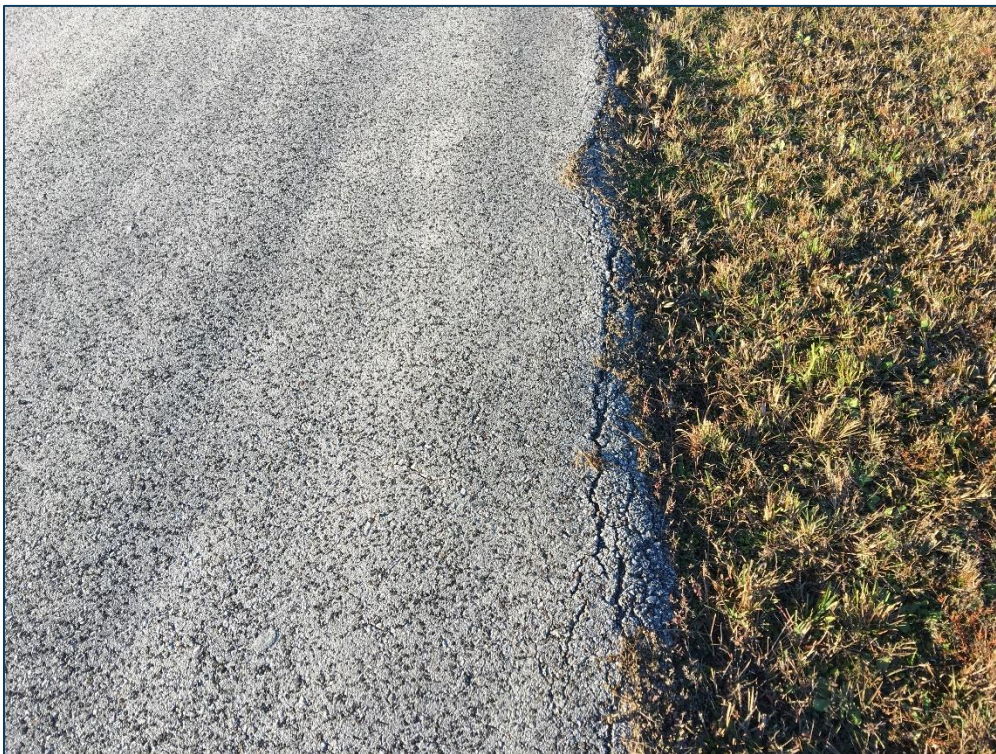
TW E, Section 505, Sample Unit 134 - Medium Severity (48) Longitudinal & Transverse Cracking, Low Severity (52) Raveling, and Medium Severity (57) Weathering

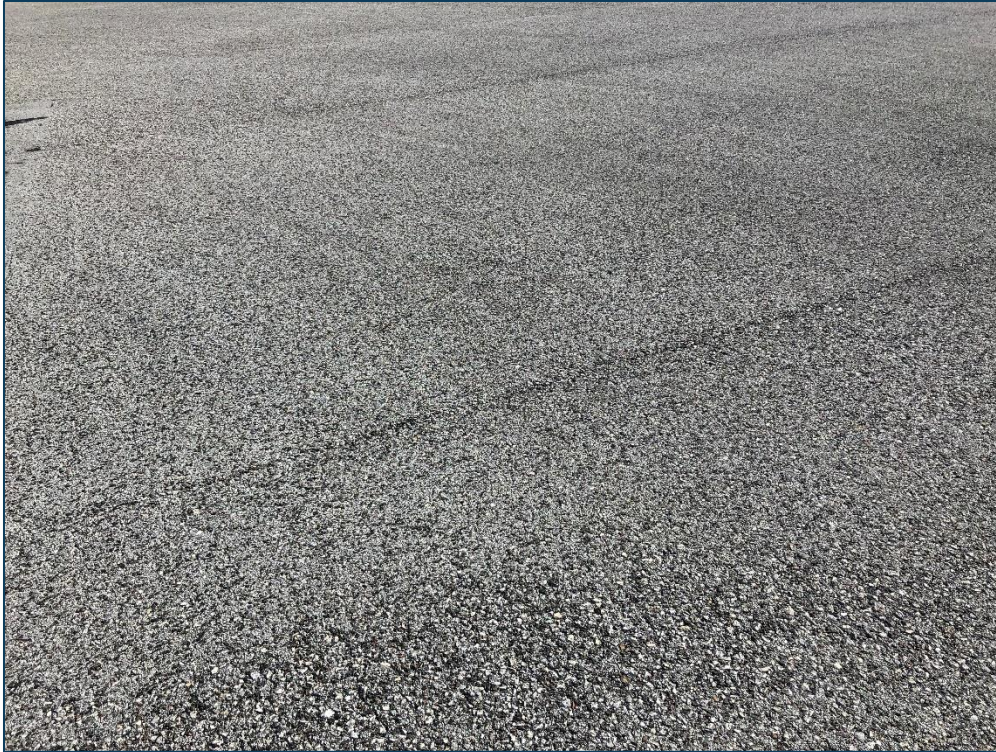
AP MAIN, Section 4410, Sample Unit 900 - Low Severity (48) Longitudinal & Transverse Cracking, Low Severity (52) Raveling, and Medium Severity (57) Weathering

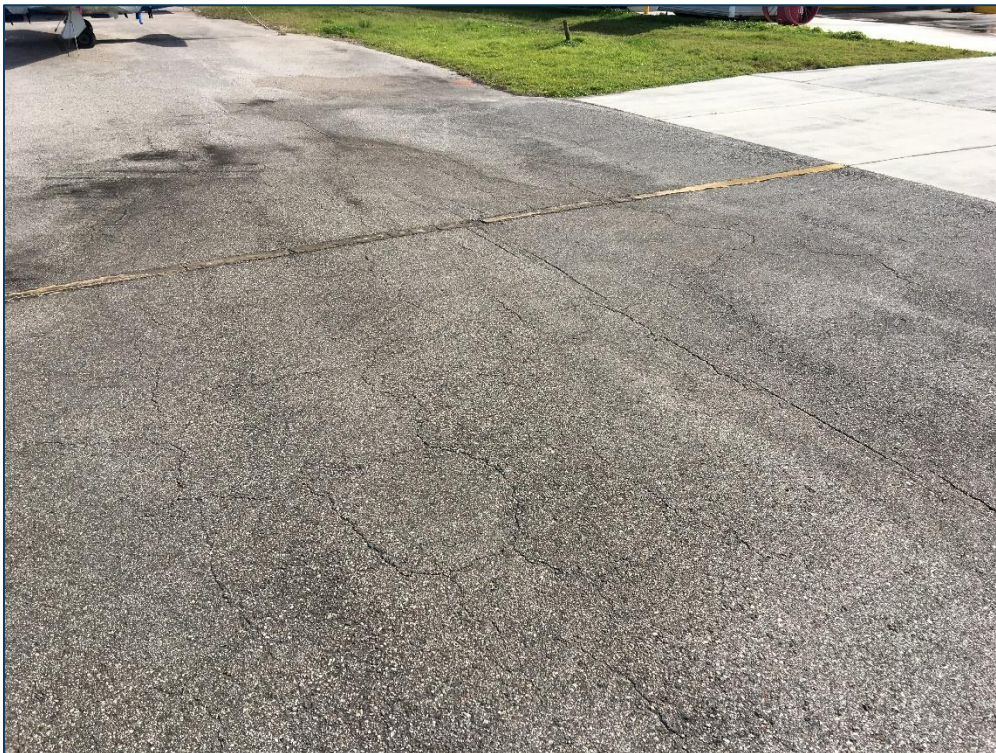
AP S, Section 4105, Sample Unit 200 - Low Severity (43) Block Cracking, Low Severity (45) Depression, Low Severity (48) Longitudinal & Transverse Cracking, Low Severity (56) Swelling, and Medium Severity (57) Weathering
