FLORIDA DEPARTMENT OF TRANSPORTATION
AVIATION AND SPACEPORTS OFFICE

Statewide Airfield Pavement Management Program

Airport Pavement Evaluation Report November 2019

**Ocala International/
Jim Taylor Field (OCF)**
Commercial Airport
District 5

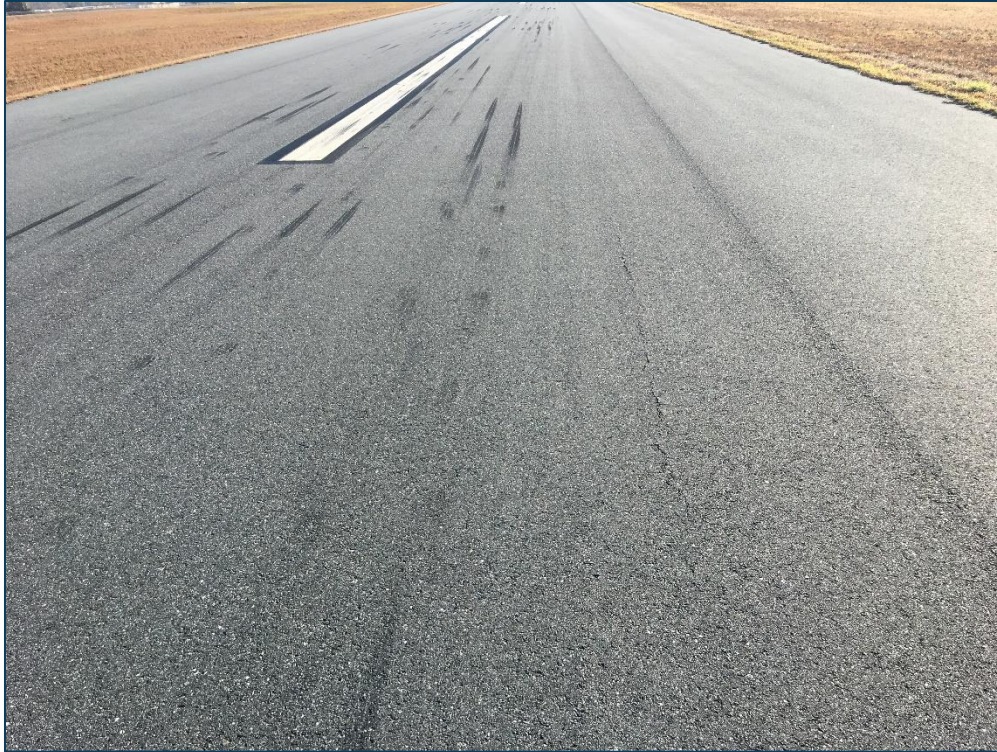
RW 8-26, Section 6205, Sample Unit 104 - Low Severity (48) Longitudinal & Transverse Cracking and Low Severity (57) Weathering

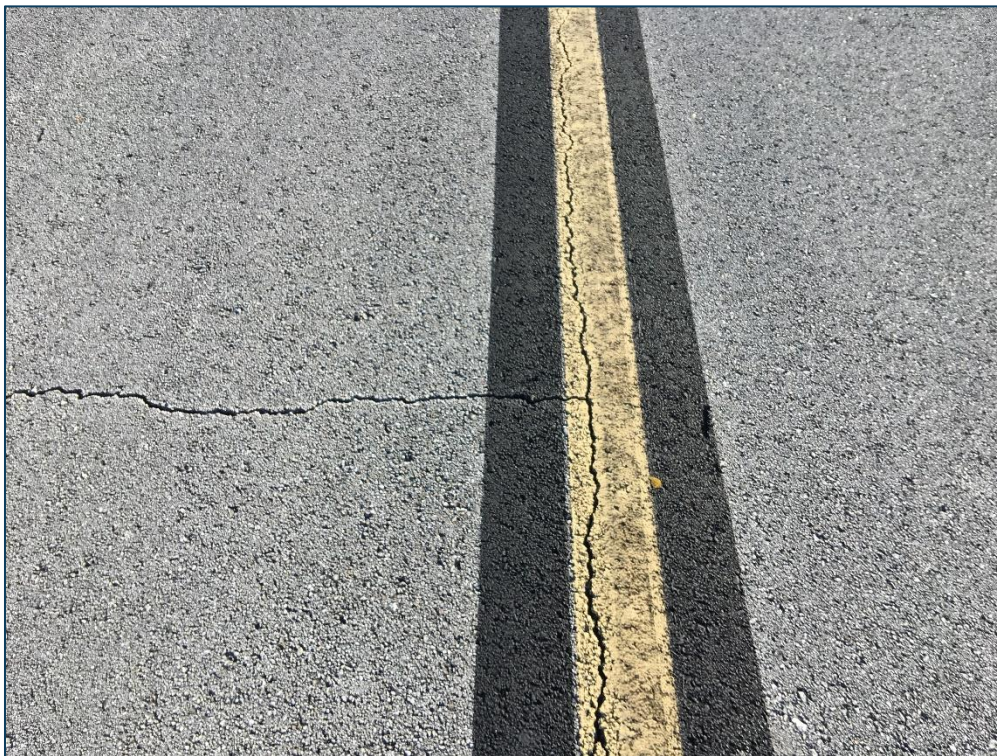
RW 8-26, Section 6205, Sample Unit 128 - Low Severity (48) Longitudinal & Transverse Cracking and Low Severity (57) Weathering

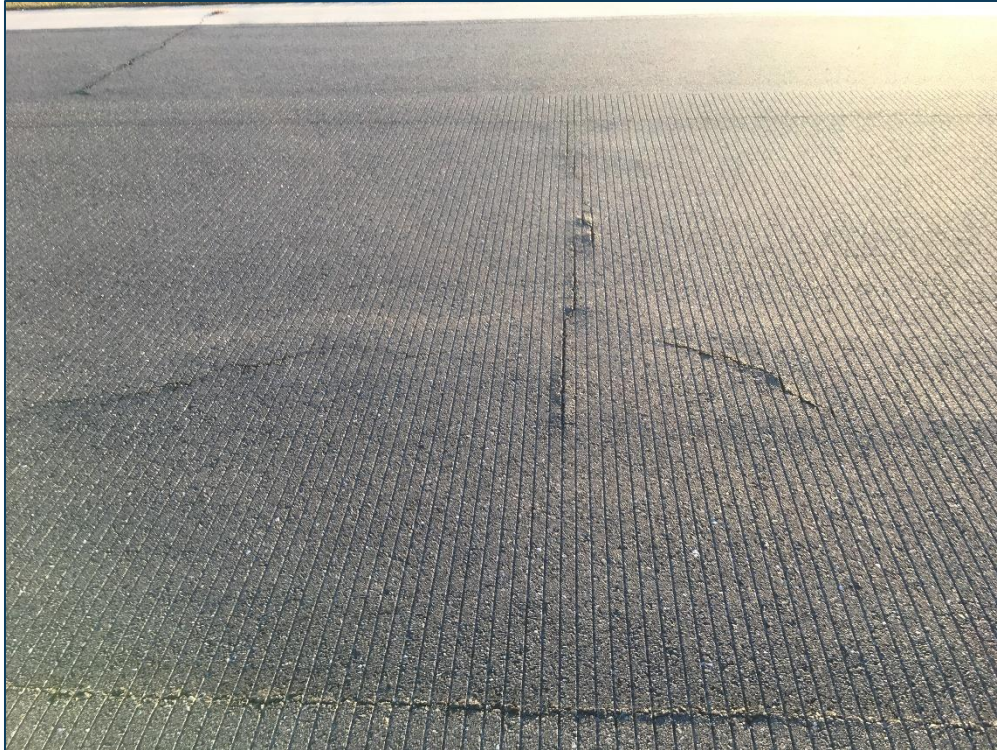
RW 18-36, Section 6110, Sample Unit 564 - Low Severity (48) Longitudinal & Transverse Cracking, Low Severity (56) Swelling, and Low Severity (57) Weathering

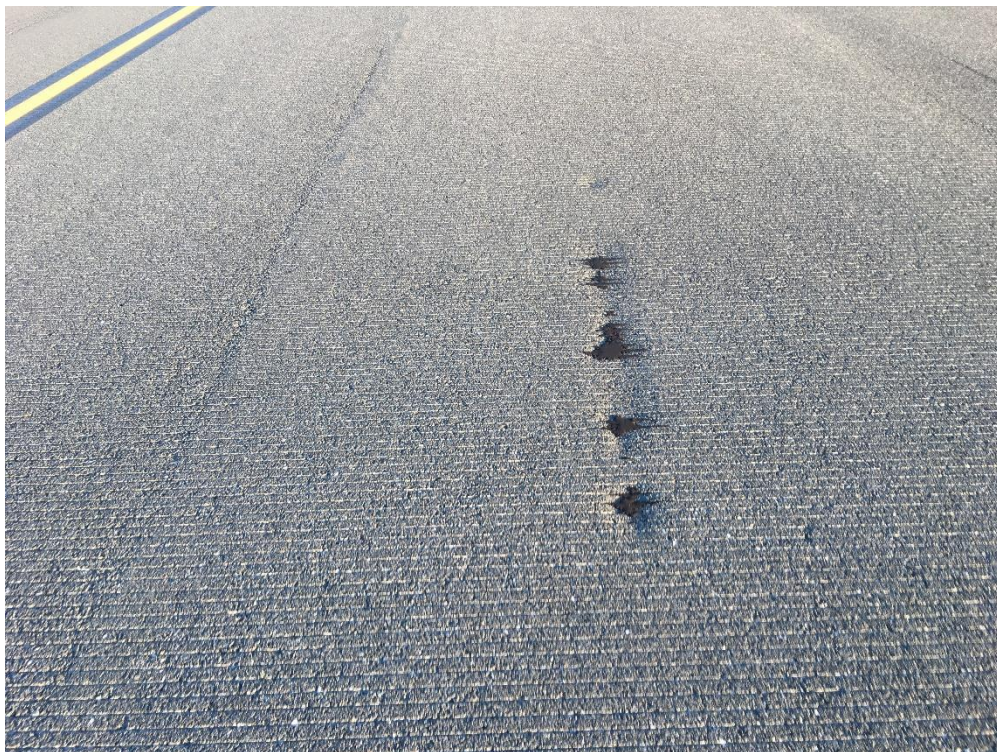
RW 18-36, Section 6105, Sample Unit 362 - (42) Bleeding, Low Severity (48) Longitudinal & Transverse Cracking, and Low Severity (57) Weathering

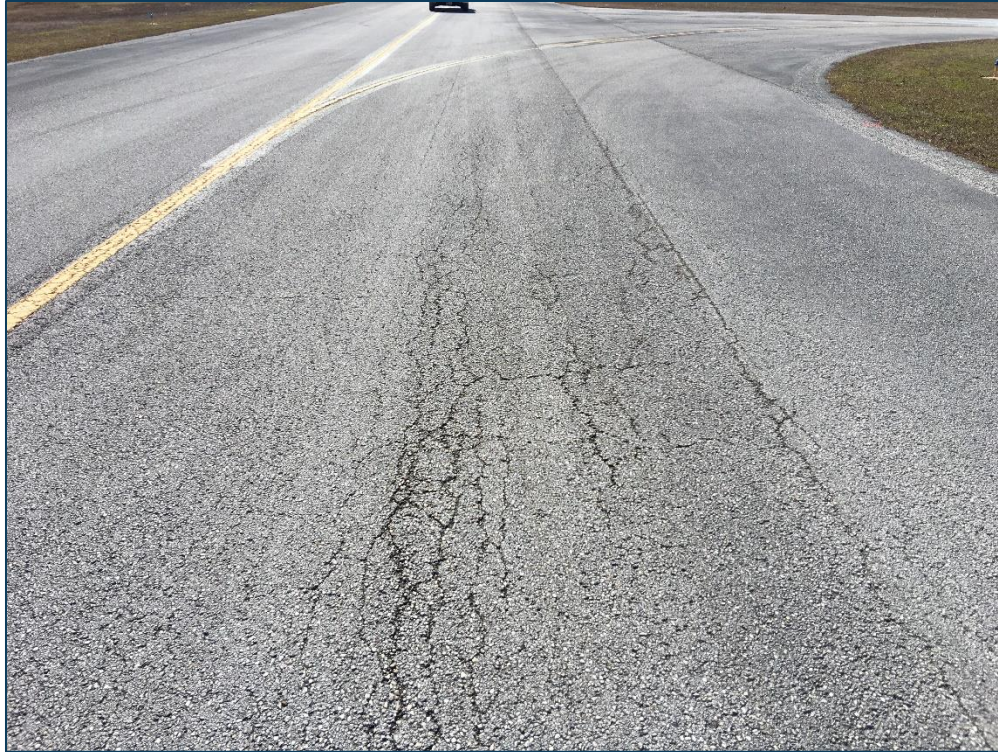
TW A, Section 540, Sample Unit 122 - Low Severity (41) Alligator Cracking, Medium Severity (41) Alligator Cracking, Low Severity (48) Longitudinal & Transverse Cracking, Medium Severity (48) Longitudinal & Transverse Cracking, Low Severity (52) Raveling, and Medium Severity (52) Raveling

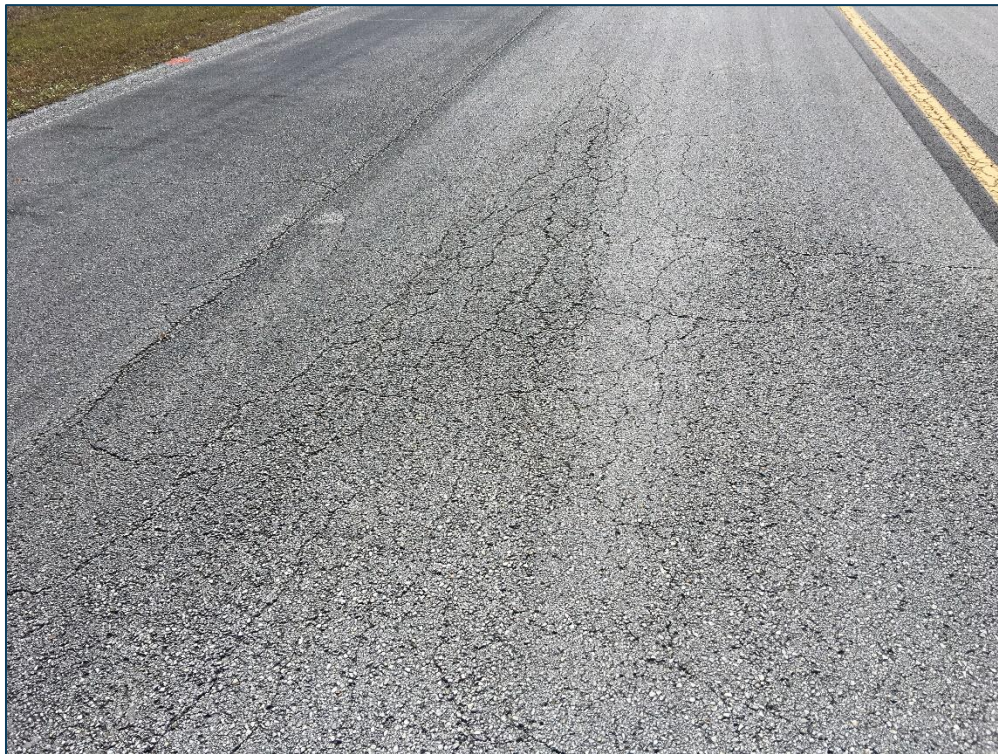
TW A, Section 540, Sample Unit 114 - Low Severity (41) Alligator Cracking, Medium Severity (41) Alligator Cracking, Low Severity (48) Longitudinal & Transverse Cracking, Medium Severity (48) Longitudinal & Transverse Cracking, Low Severity (52) Raveling, Medium Severity (52) Raveling, and Low Severity (53) Rutting

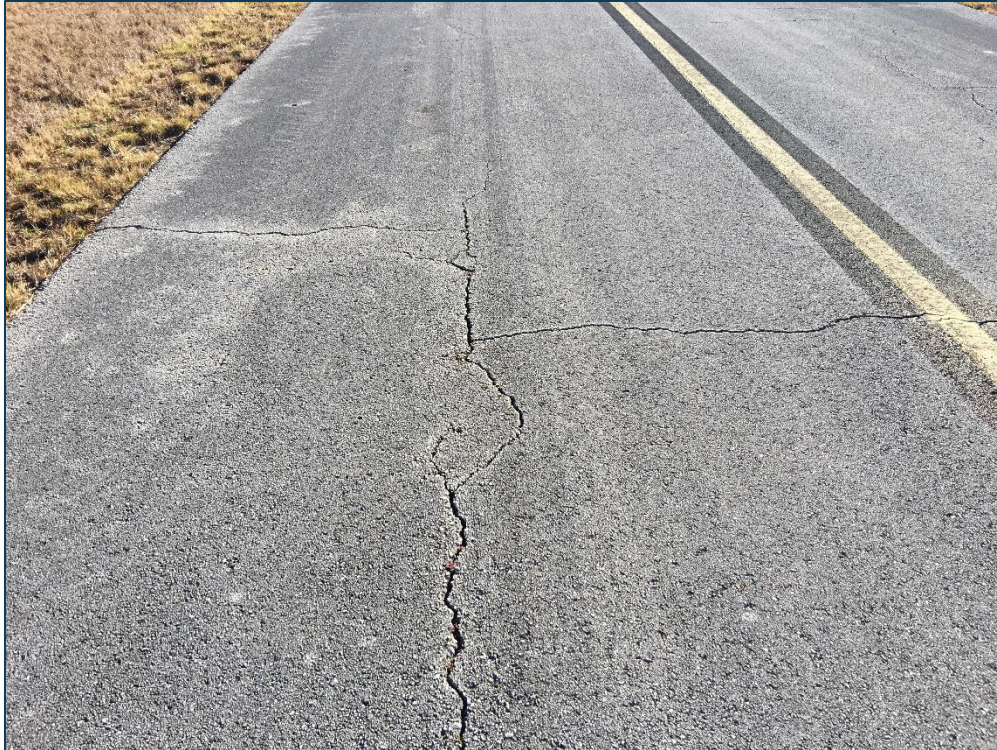
TW B, Section 105, Sample Unit 107 - Low Severity (48) Longitudinal & Transverse Cracking, Medium Severity (48) Longitudinal & Transverse Cracking, and Low Severity (52) Raveling

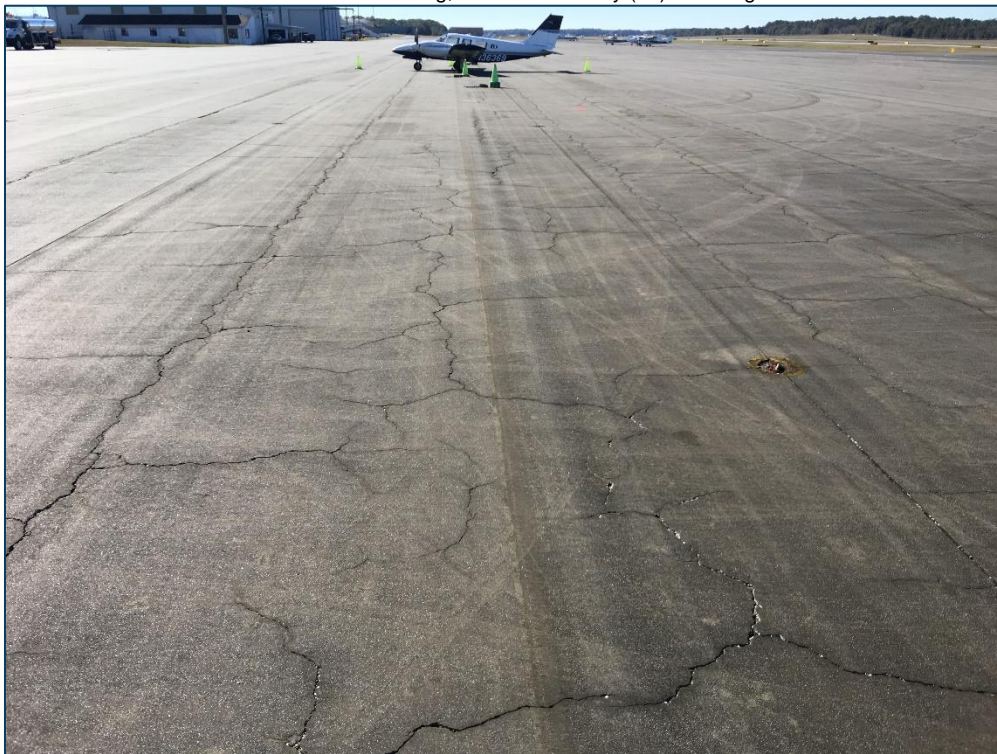
AP CENTER, Section 4120, Sample Unit 515 - Low Severity (43) Block Cracking, Low Severity (48) Longitudinal & Transverse Cracking, and Low Severity (57) Weathering

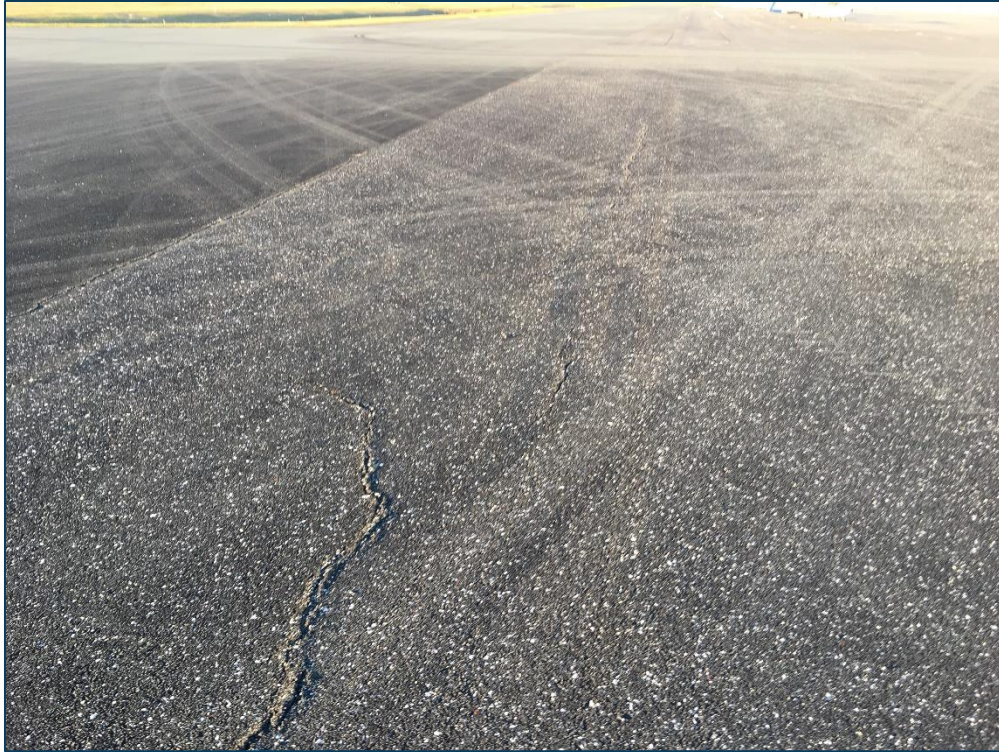
AP CENTER, Section 4105, Sample Unit 104 - Low Severity (48) Longitudinal & Transverse Cracking, Medium Severity (48) Longitudinal & Transverse Cracking, Low Severity (56) Swelling, Low Severity (57) Weathering, and Medium Severity (57) Weathering

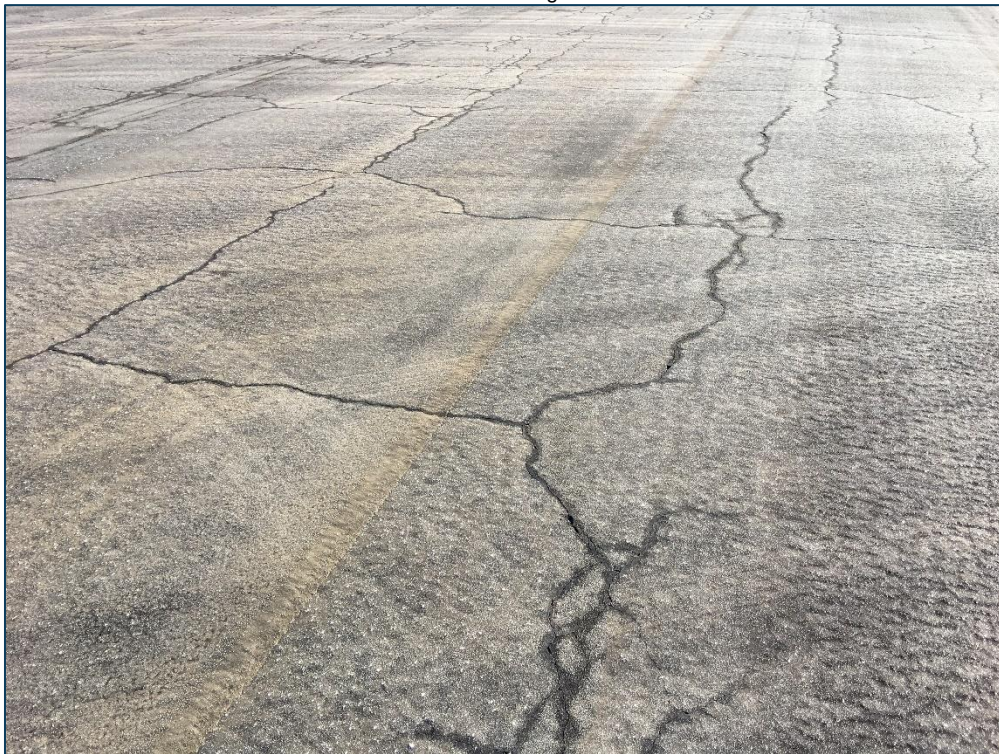
AP N, Section 4210, Sample Unit 700 - Low Severity (43) Block Cracking, Medium Severity (43) Block Cracking, and Low Severity (57) Weathering
