## Statewide Airfield Pavement Management Program

Airport Pavement Evaluation Report 2019

Ormond Beach Municipal Airport (OMN)

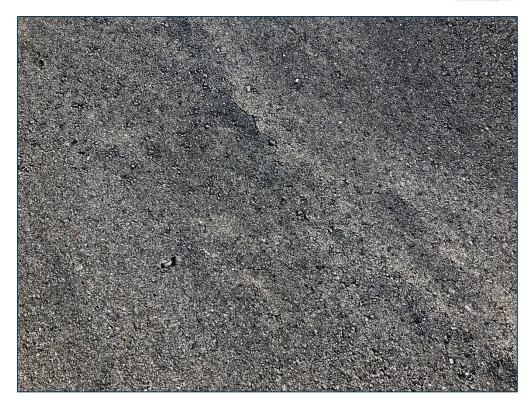
RW 17-35, Section 6205, Sample Unit 159 - Low Severity (48) Longitudinal & Transverse Cracking, Low Severity (52) Raveling, Low Severity (56) Swelling, and Low Severity (57) Weathering

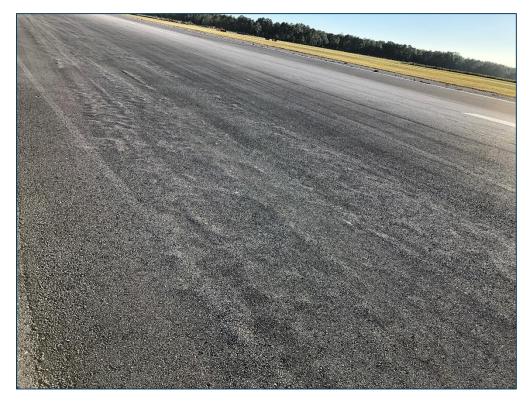
RW 17-35, Section 6205, Sample Unit 165 - Low Severity (52) Raveling, Low Severity (56) Swelling, and Low Severity (57) Weathering

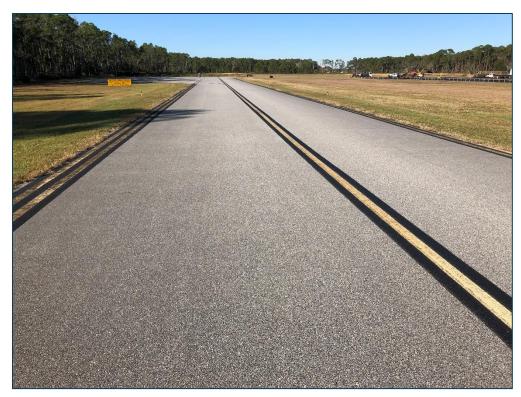
TW A, Section 100, Sample Unit 107 - Low Severity (57) Weathering

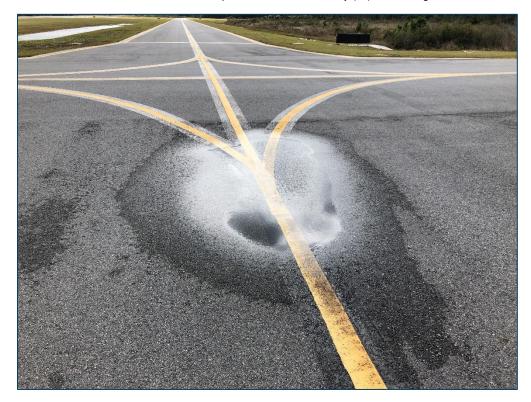
TW G, Section 700, Sample Unit 115 - Low Severity (45) Depression and Low Severity (57) Weathering

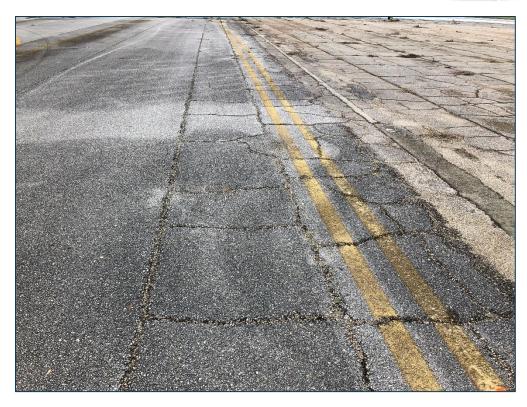
TW D, Section 405, Sample Unit 101 - Medium Severity (43) Block Cracking and Low Severity (52) Raveling

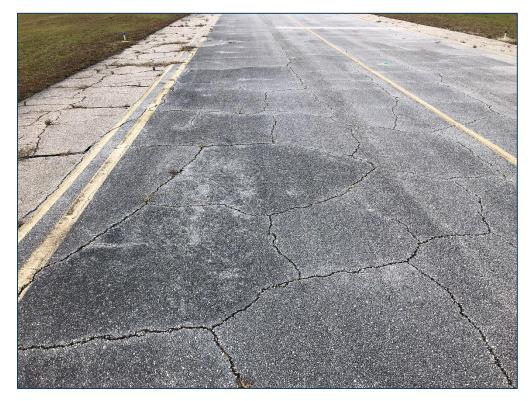
TW E, Section 505, Sample Unit 107 - Medium Severity (43) Block Cracking and Low Severity (52) Raveling

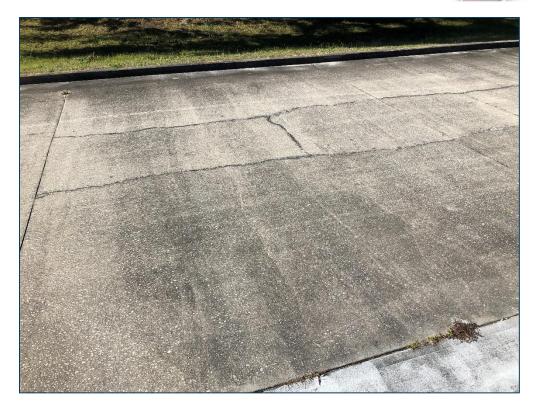
TW T-HANG, Section 2004, Sample Unit 602 - High Severity (65) Joint Seal Damage and Low Severity (72) Shattered Slab

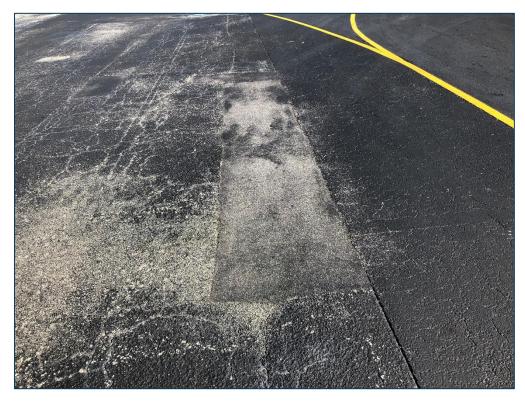
AP CENTER, Section 4205, Sample Unit 111 - Low Severity (48) Longitudinal & Transverse Cracking, Low Severity (50) Patching, Low Severity (52) Raveling, and Medium Severity (52) Raveling

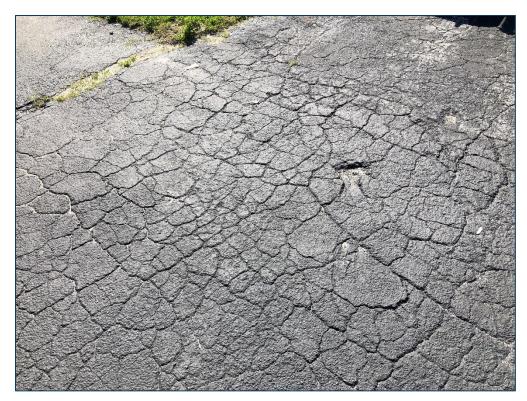
AP E, Section 4305, Sample Unit 101 - Medium Severity (41) Alligator Cracking, High Severity (41) Alligator Cracking, and Low Severity (52) Raveling
