FLORIDA DEPARTMENT OF TRANSPORTATION AVIATION AND SPACEPORTS OFFICE

Statewide Airfield Pavement Management Program

Airport Pavement Evaluation Report November 2019

Space Coast Regional Airport (TIX) Commercial Airport District 5

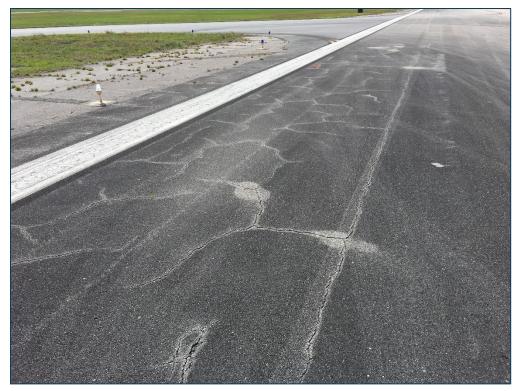
RUNWAY 9-27, Section 6210, Sample Unit 148 - Low Severity (43) Block Cracking, Low Severity (48) Longitudinal & Transverse Cracking, and Low Severity (57) Weathering

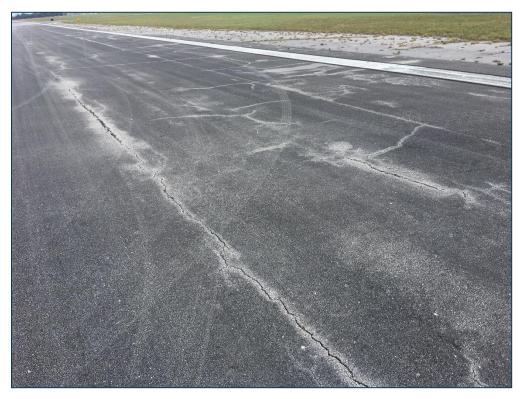
RW 9-27, Section 6210, Sample Unit 162 - Low Severity (43) Block Cracking, Low Severity (48) Longitudinal & Transverse Cracking, Medium Severity (48) Longitudinal & Transverse Cracking, Low Severity (57) Weathering, and Medium Severity (57) Weathering

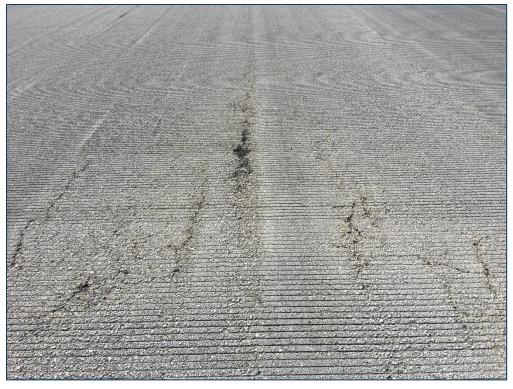
RW 18-36, Section 6105, Sample Unit 386 - Severity (48) Longitudinal & Transverse Cracking, High Severity (48) Longitudinal & Transverse Cracking, Low Severity (52) Raveling, and Medium Severity (52) Raveling

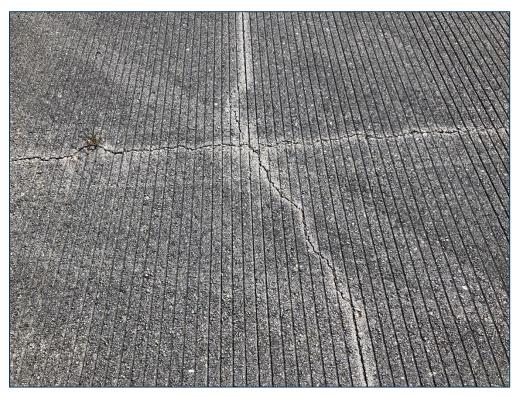
RW 18-36, Section 6110, Sample Unit 176 - Low Severity (48) Longitudinal & Transverse Cracking, Low Severity (52) Raveling, and Low Severity (57) Weathering

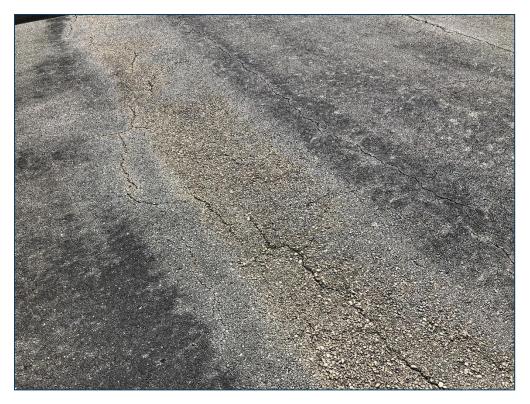
TW A, Section 120, Sample Unit 162 - Low Severity (48) Longitudinal & Transverse Cracking, Medium Severity (48) Longitudinal & Transverse Cracking, Low Severity (52) Raveling, and Medium Severity (57) Weathering

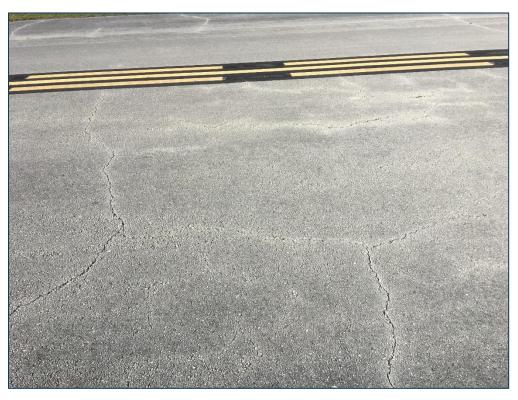
TW B, Section 205, Sample Unit 502 - Low Severity (43) Block Cracking, Low Severity (48) Longitudinal & Transverse Cracking, Low Severity (52) Raveling, and Medium Severity (57) Weathering

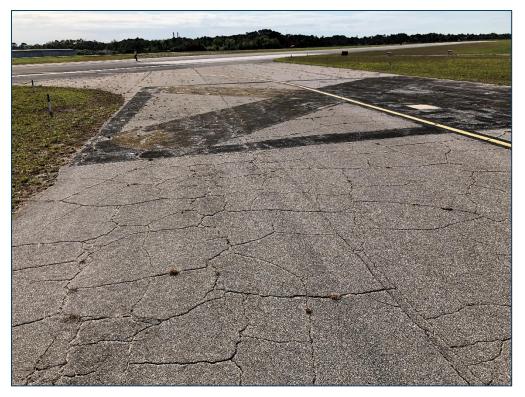
TW F, Section 605, Sample Unit 301 - Medium Severity (43) Block Cracking, Low Severity (50) Patching, and Medium Severity (52) Raveling

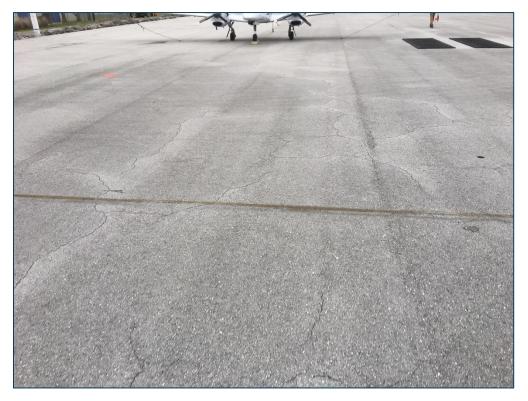
AP E, Section 4205, Sample Unit 250 - Low Severity (43) Block Cracking, Low Severity (48) Longitudinal & Transverse Cracking, and Low Severity (57) Weathering

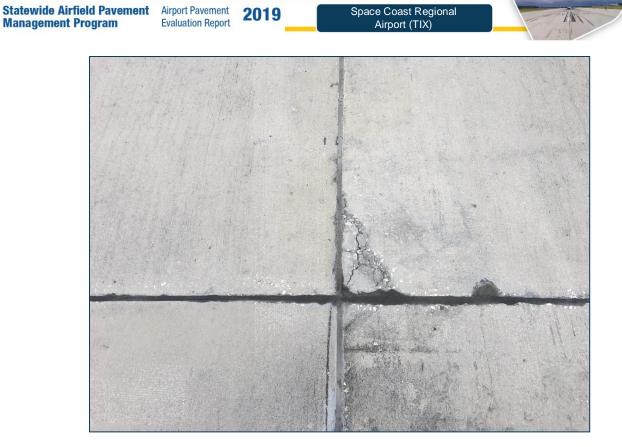
AP HELI, Section 4260, Sample Unit 643 - Low Severity (75) Corner Spall
