# Statewide Airfield Pavement Management Program

**Airport Pavement  
Evaluation Report  
November 2019**

**Williston Municipal  
Airport (X60)**  
General Aviation Airport  
District 2

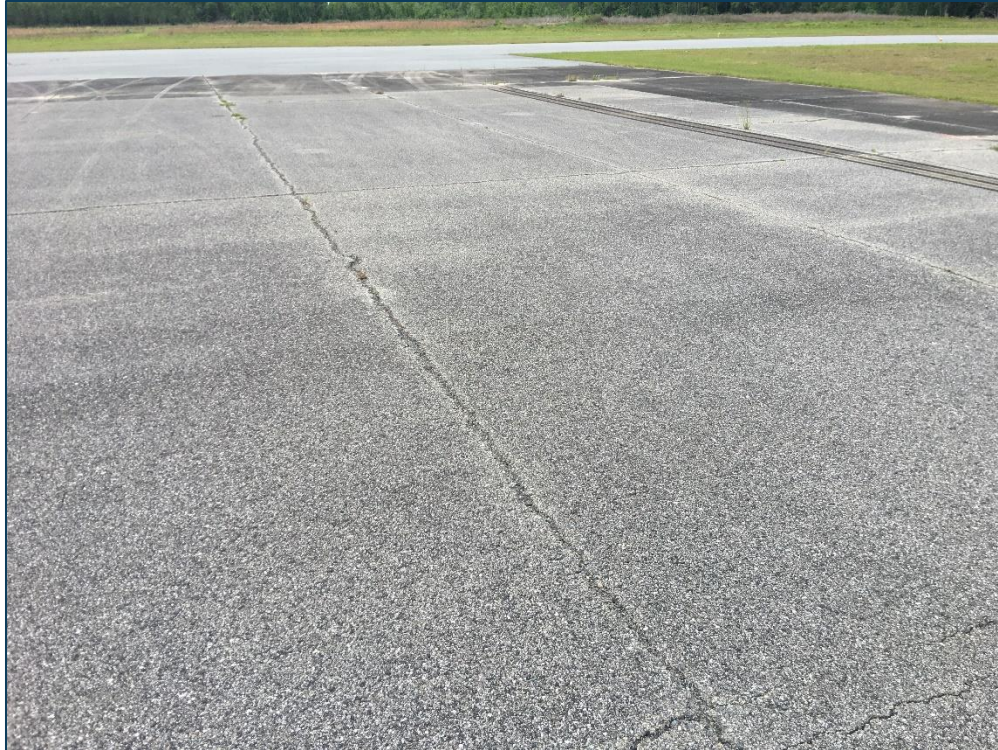
RW 5-23, Section 6112, Sample Unit 304 - Low Severity (47) Joint Reflection Cracking, Medium Severity (47) Joint Reflection Cracking, Low Severity (48) Longitudinal & Transverse Cracking, Low Severity (52) Raveling, and Low Severity (57) Weathering

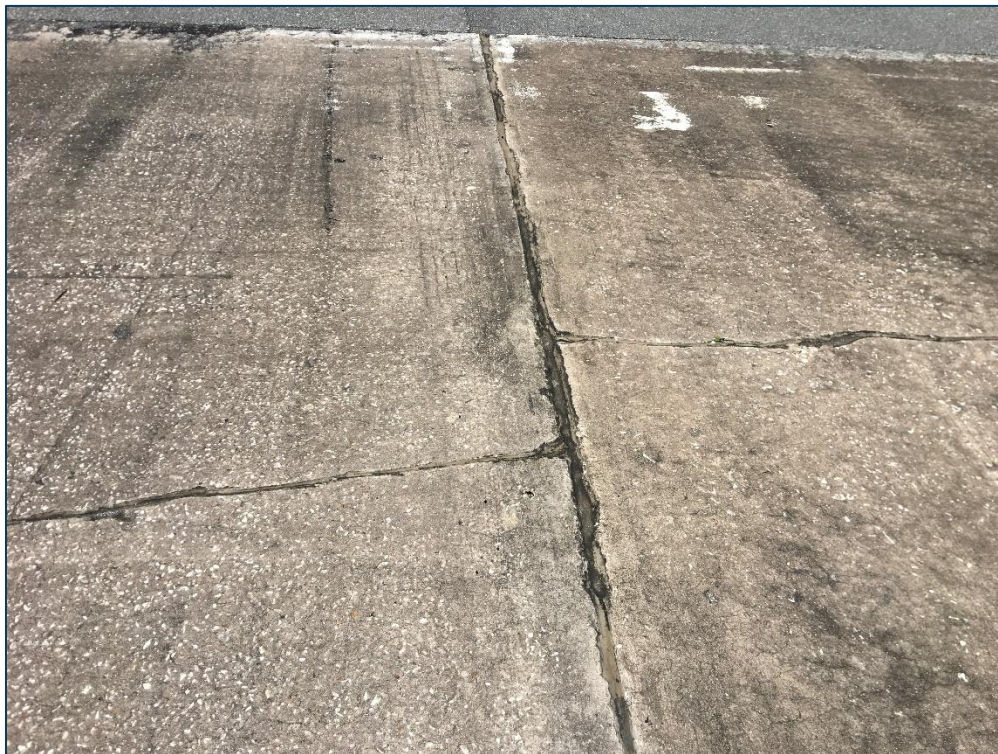
RW 14-32, Section 6205, Sample Unit 303 - Low Severity (63) Linear Cracking, Low Severity (65) Joint Seal Damage, and (73) Shrinkage Cracking

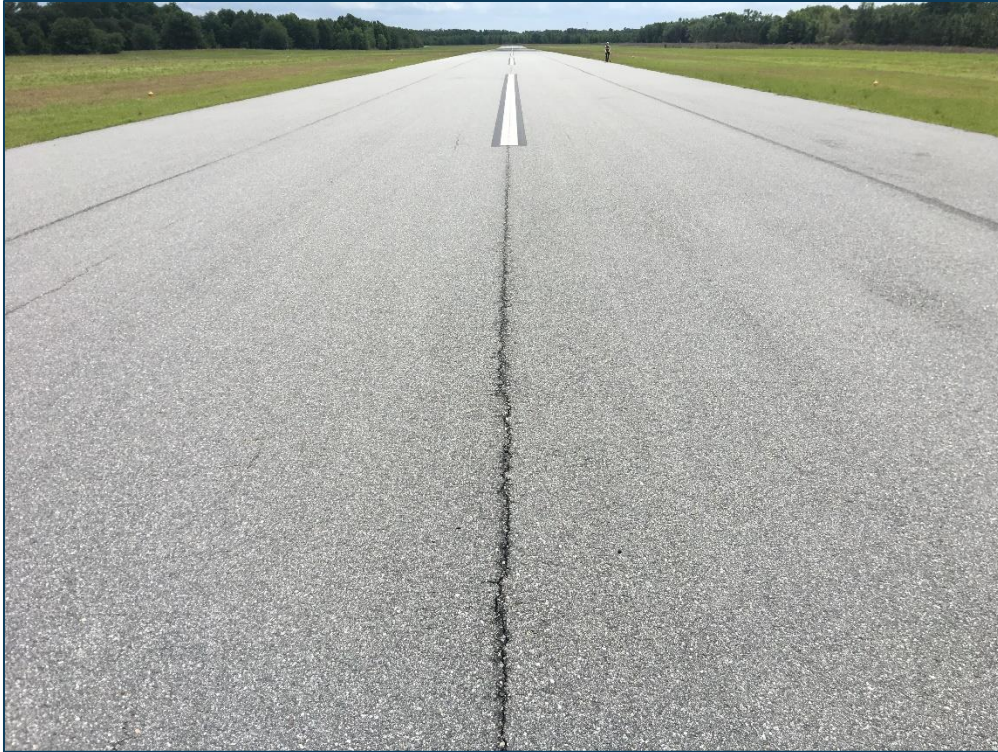
RW 14-32, Section 6215, Sample Unit 322 - Low Severity (48) Longitudinal & Transverse Cracking and Low Severity (57) Weathering

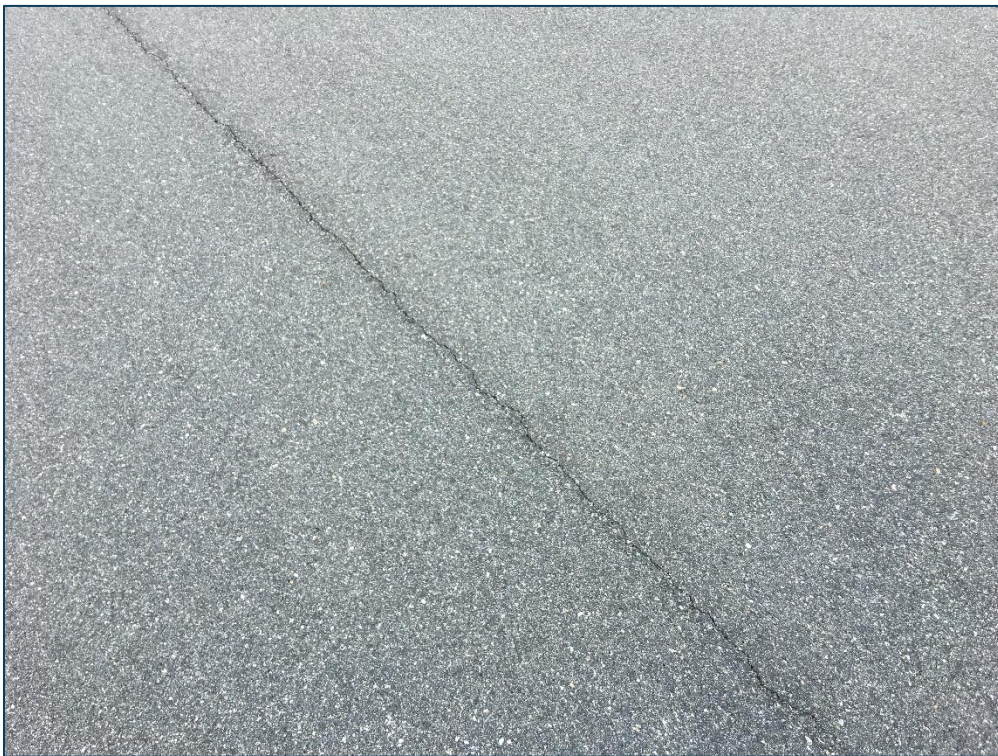
TW A, Section 205, Sample Unit 164 - Low Severity (48) Longitudinal & Transverse Cracking and Low Severity (57) Weathering

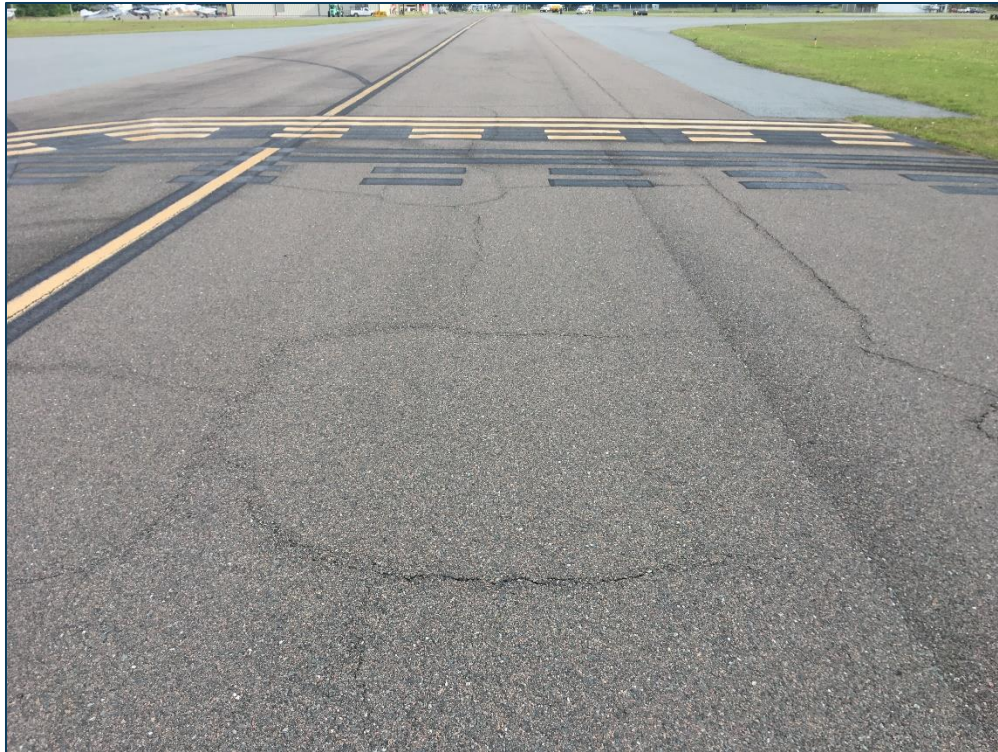
TW C, Section 105, Sample Unit 101 - Low Severity (48) Longitudinal & Transverse Cracking, Low Severity (52) Raveling, Low Severity (56) Swelling, and Low Severity (57) Weathering

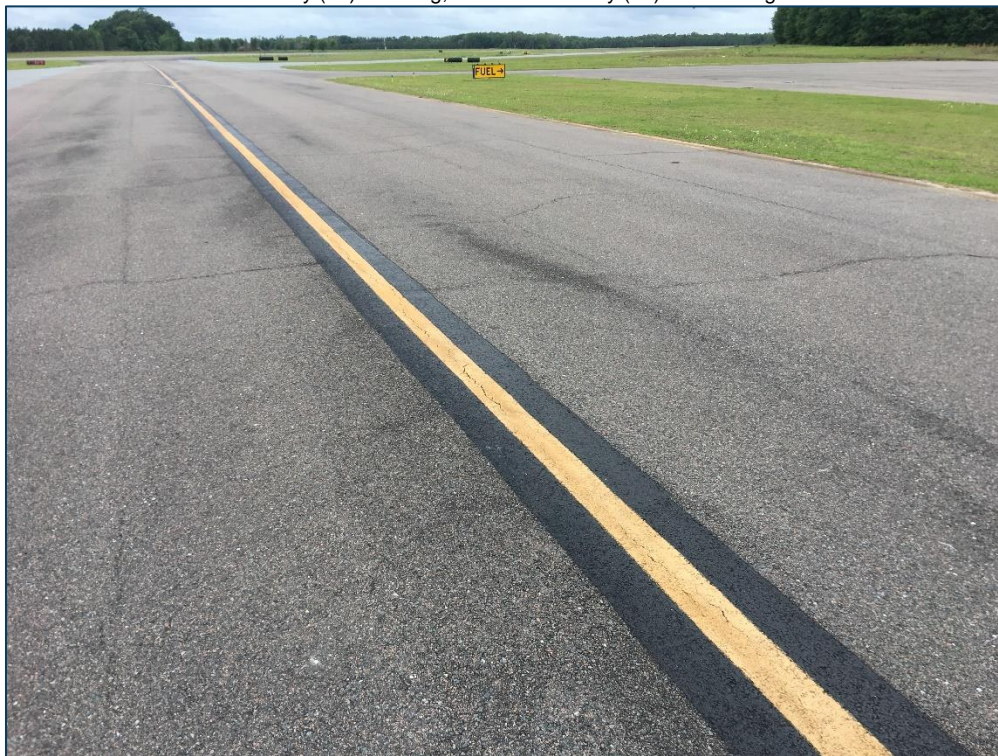
TW C, Section 105, Sample Unit 107 - Low Severity (45) Depression, Low Severity (48) Longitudinal & Transverse Cracking, Medium Severity (48) Longitudinal & Transverse Cracking, Low Severity (52) Raveling, Low Severity (56) Swelling, and Low Severity (57) Weathering

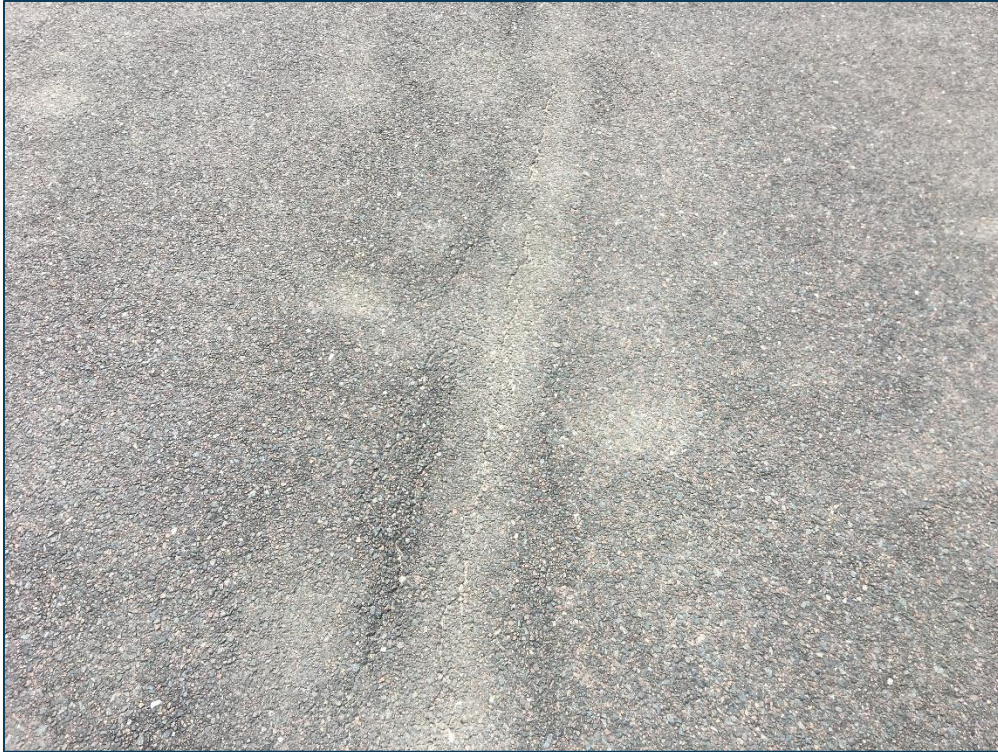
AP, Section 4105, Sample Unit 200 - Low Severity (48) Longitudinal & Transverse Cracking, Low Severity (52) Raveling, Low Severity (56) Swelling, and Low Severity (57) Weathering

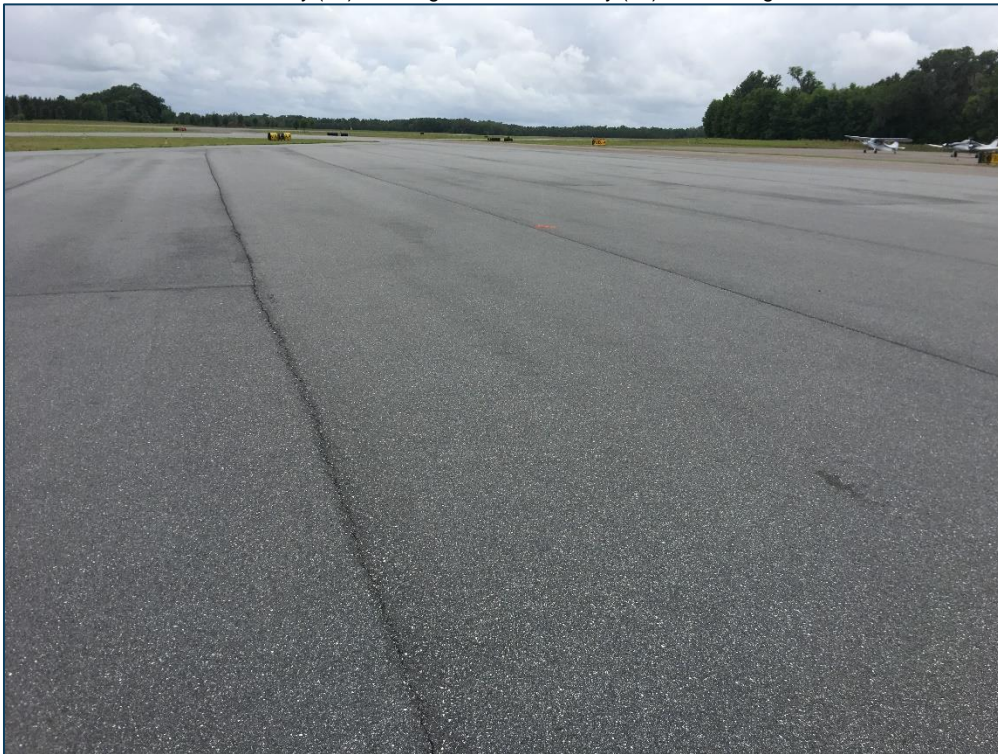
AP, Section 4110, Sample Unit 502 - Low Severity (48) Longitudinal & Transverse Cracking and Low Severity (57) Weathering
