# **Statewide Airfield Pavement Management Program**

**Airport Pavement  
Evaluation Report  
November 2019**

**Herlong Recreational  
Airport (HEG)**  
Reliever Airport  
District 2

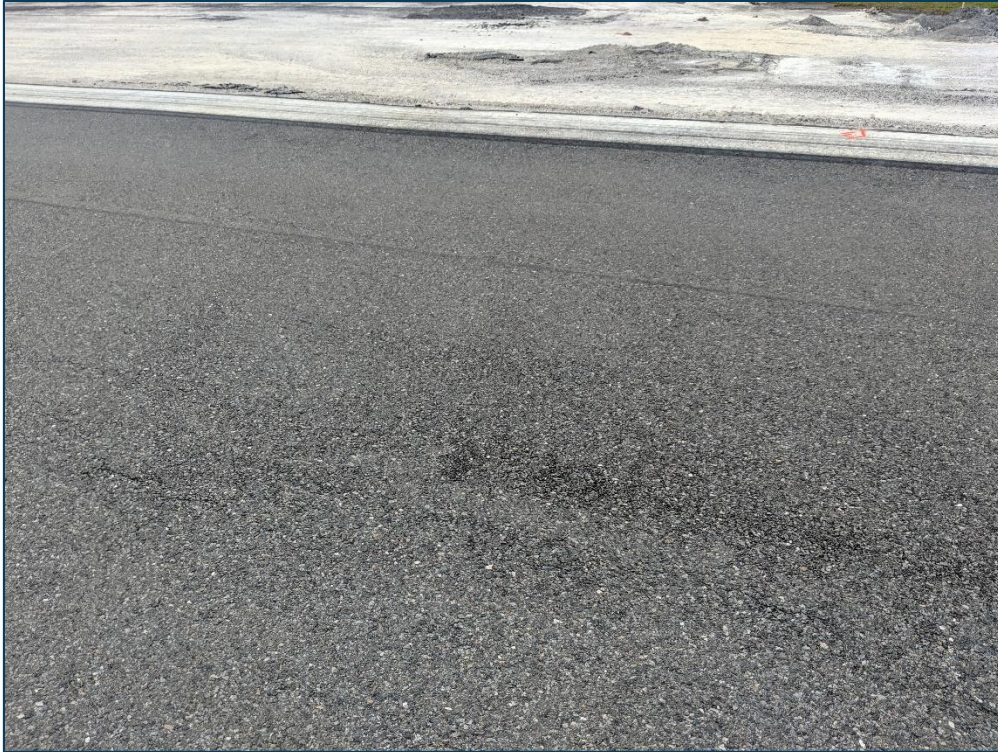
RW 7-25, Section 6105, Sample Unit 161 - Low Severity (48) Longitudinal & Transverse Cracking, Low Severity (52) Raveling, and Low Severity (57) Weathering

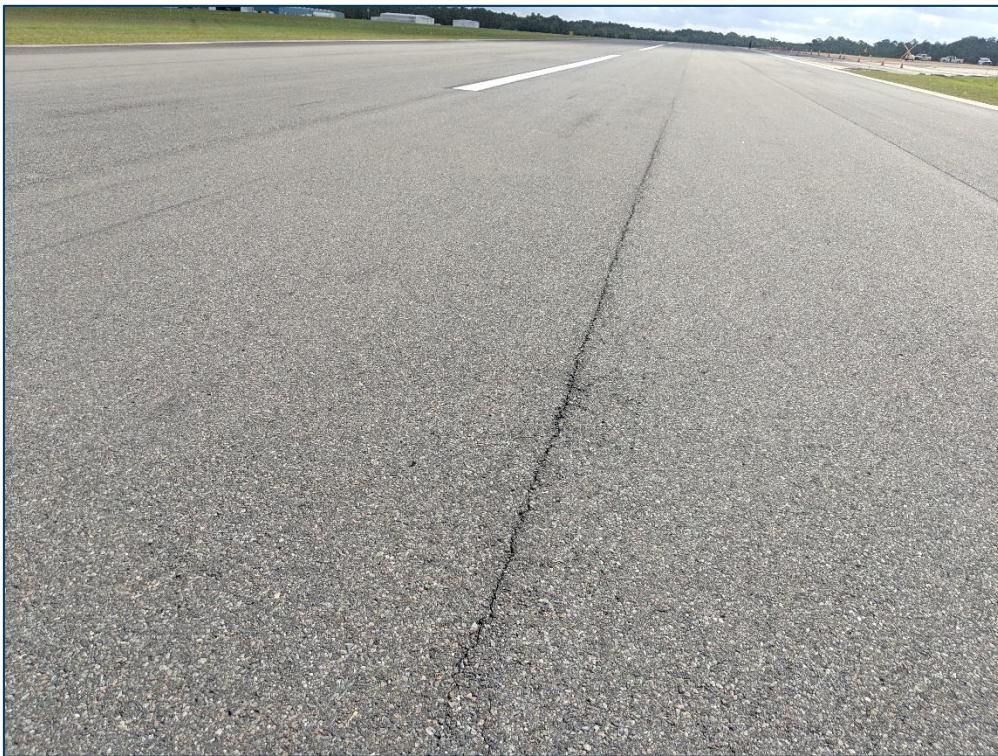
RW 7-25, Section 6110, Sample Unit 133 - Low Severity (48) Longitudinal & Transverse Cracking, Low Severity (52) Raveling, and Low Severity (57) Weathering

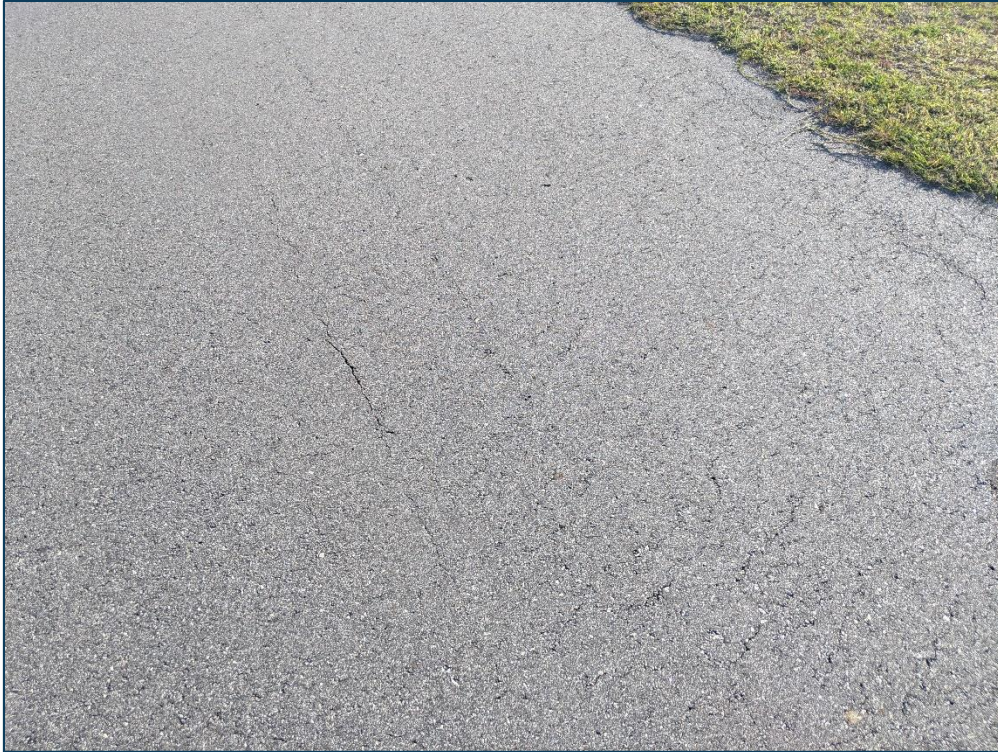
TWA, Section 105, Sample Unit102 - Low Severity (48) Longitudinal & Transverse Cracking and Low Severity (57) Weathering

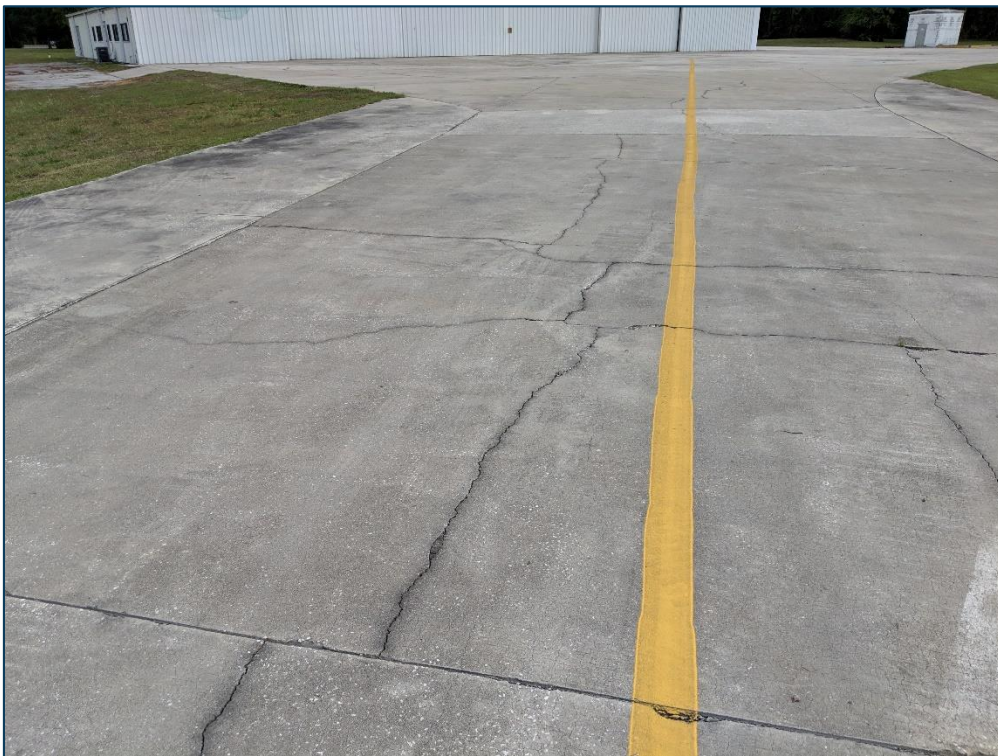
TWNE AP, Section 1105, Sample Unit500 - Low Severity (65) Joint Seal Damage and Medium Severity (72) Shattered Slab

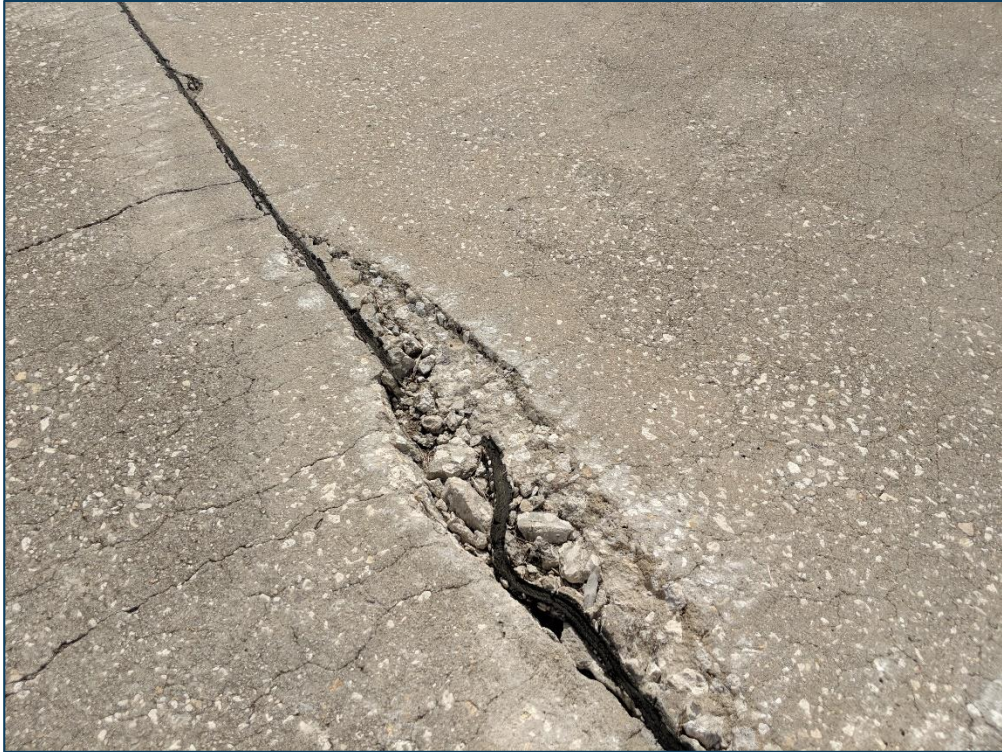
TW NE AP, Section 1105, Sample Unit 500 - High Severity (74) Joint Spall

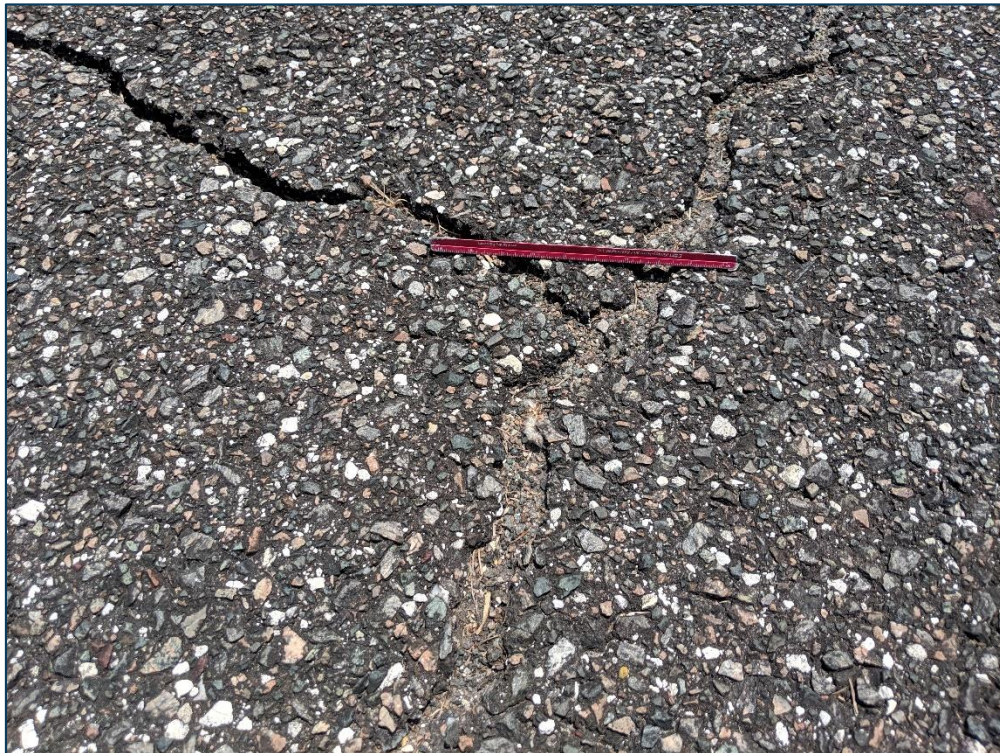
TW T-HANG, Section 925, Sample Unit 200 - Medium Severity (48) Longitudinal & Transverse Cracking, Low Severity (52) Raveling, and Medium Severity (57) Weathering

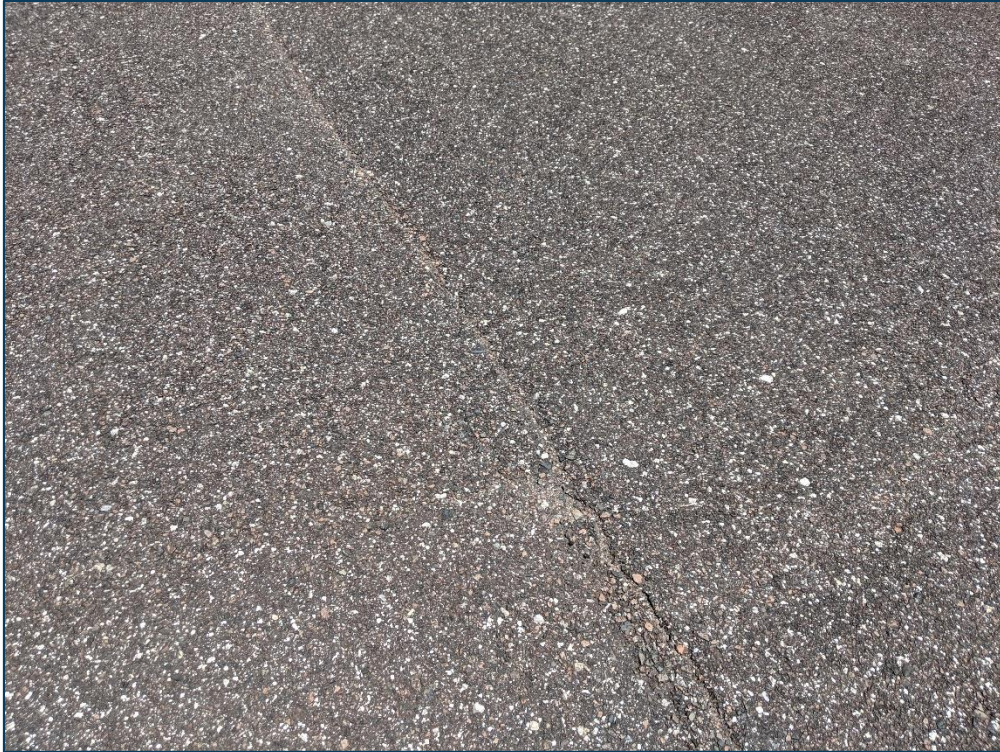
AP NW, Section 4115, Sample Unit 502 - Low Severity (48) Longitudinal & Transverse Cracking, Low Severity (52) Raveling, and Low Severity (57) Weathering

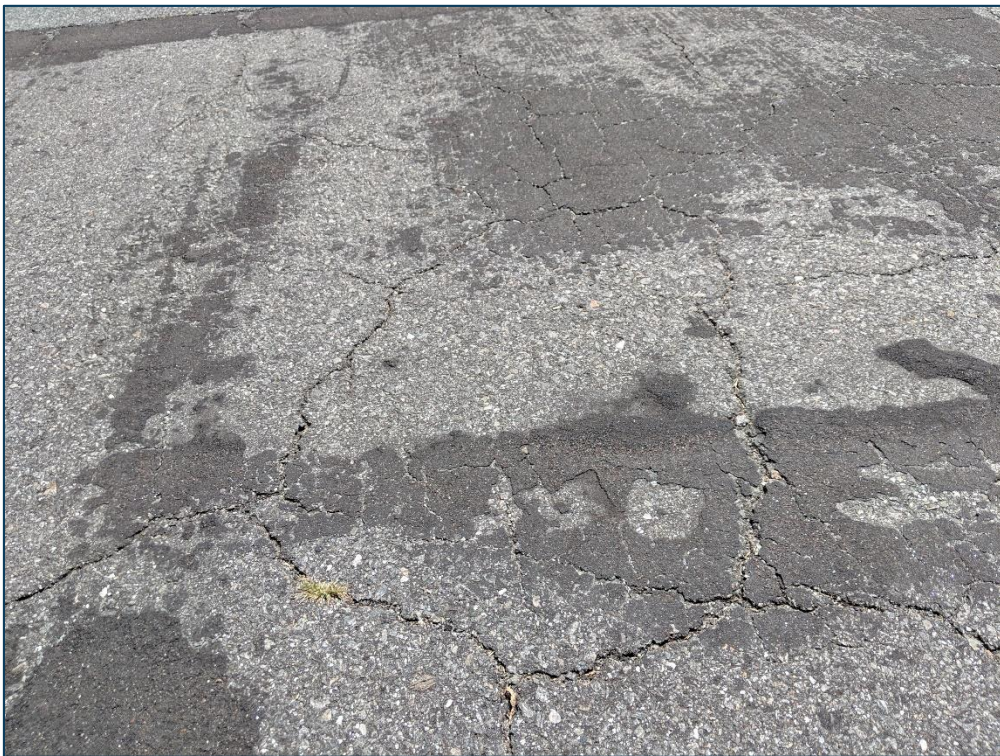
TWT-HANG, Section 905, Sample Unit 100 - Medium Severity (43) Block Cracking and Low Severity (52) Raveling
