FLORIDA DEPARTMENT OF TRANSPORTATION
AVIATION AND SPACEPORTS OFFICE

Airport Pavement Evaluation Report November 2019

**Fernandina Beach
Municipal Airport (FHB)**
General Aviation Airport
District 2

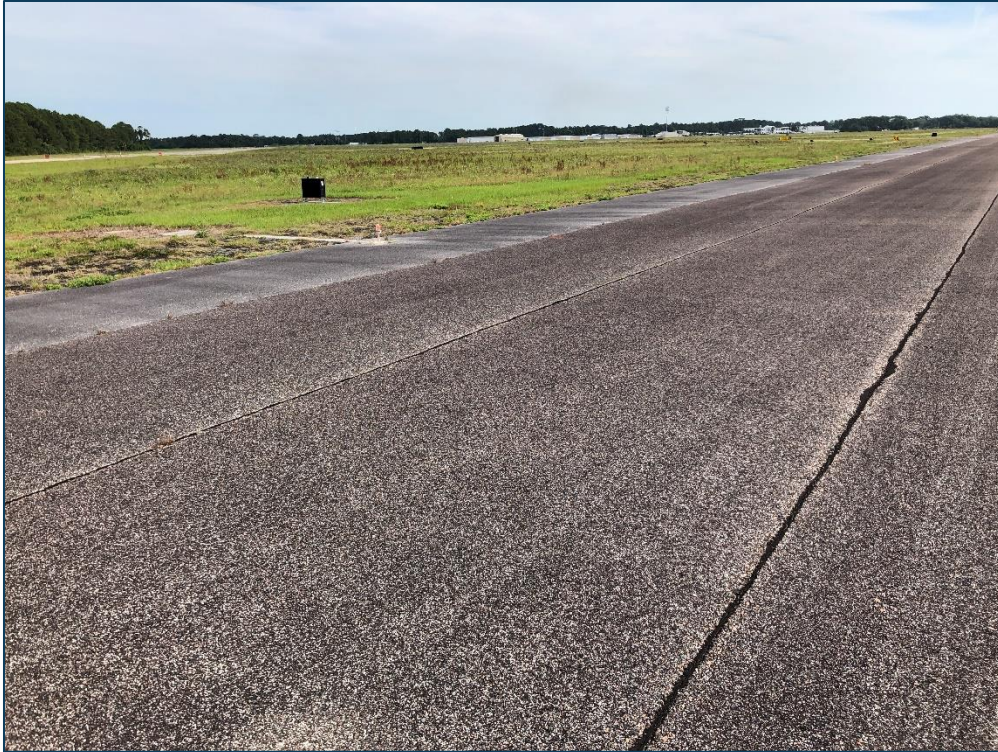
RW 4-22, Section 6105, Sample Unit 108 - Low Severity (48) Longitudinal & Transverse Cracking, Low Severity (52) Raveling, and Low Severity (57) Weathering

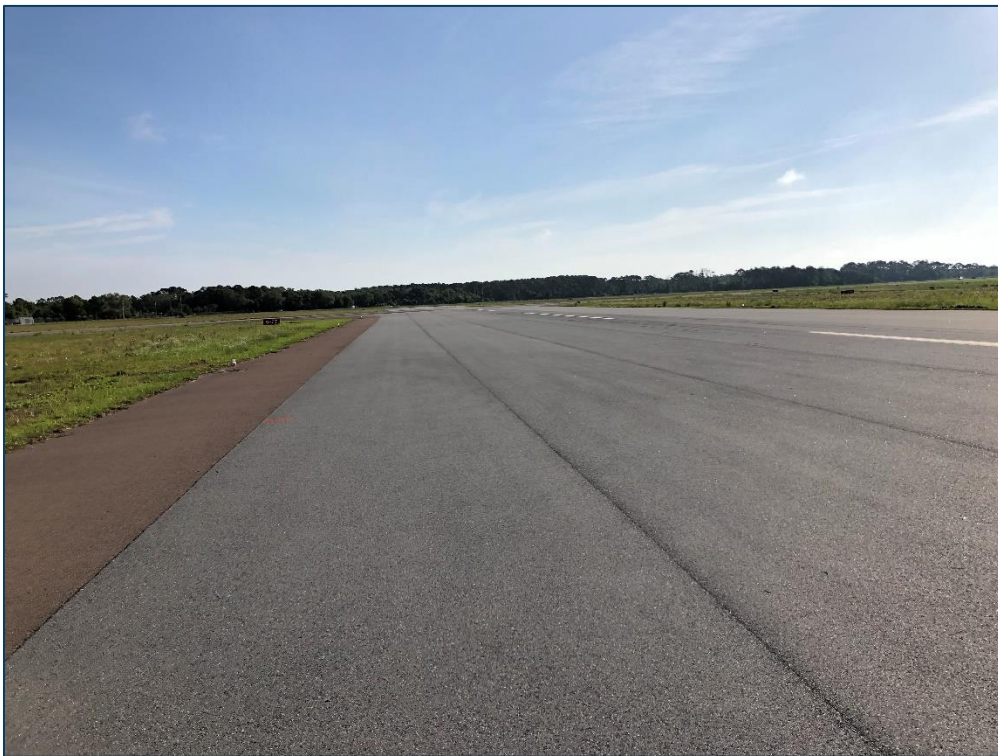
RW 4-22, Section 6110, Sample Unit 177 - Low Severity (48) Longitudinal & Transverse Cracking and Low Severity (57) Weathering

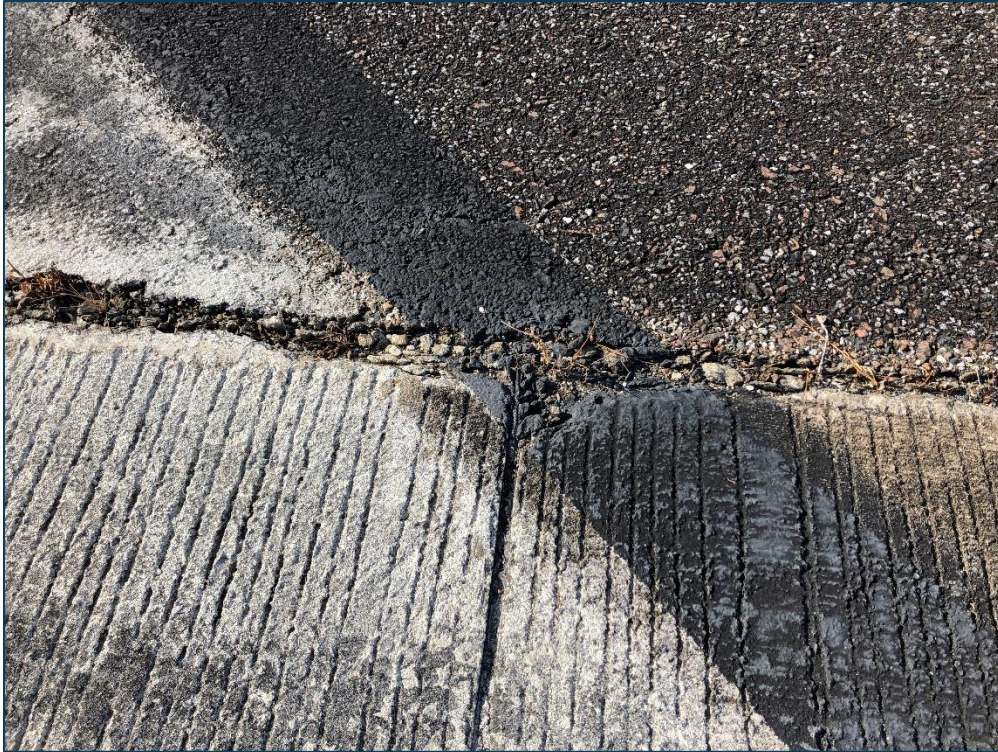
RW 9-27, Section 6305, Sample Unit 309 - Low Severity (65) Joint Seal Damage and Low Severity (75) Corner Spall

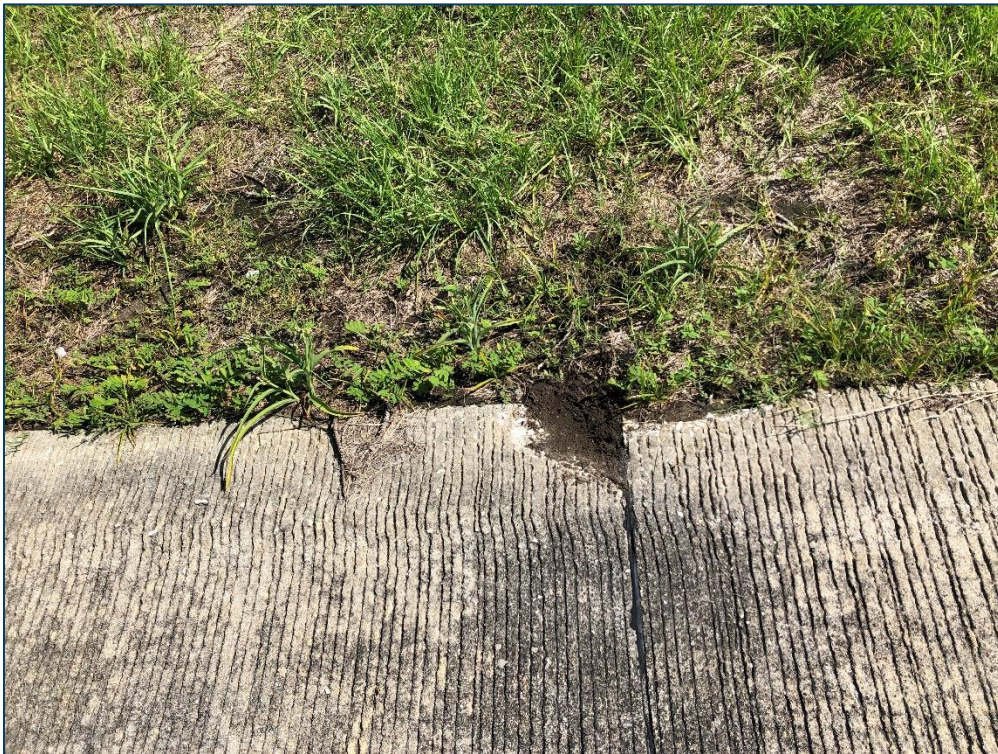
RW 9-27, Section 6335, Sample Unit 406 - High Severity (65) Joint Seal Damage and Medium Severity (75) Corner Spall

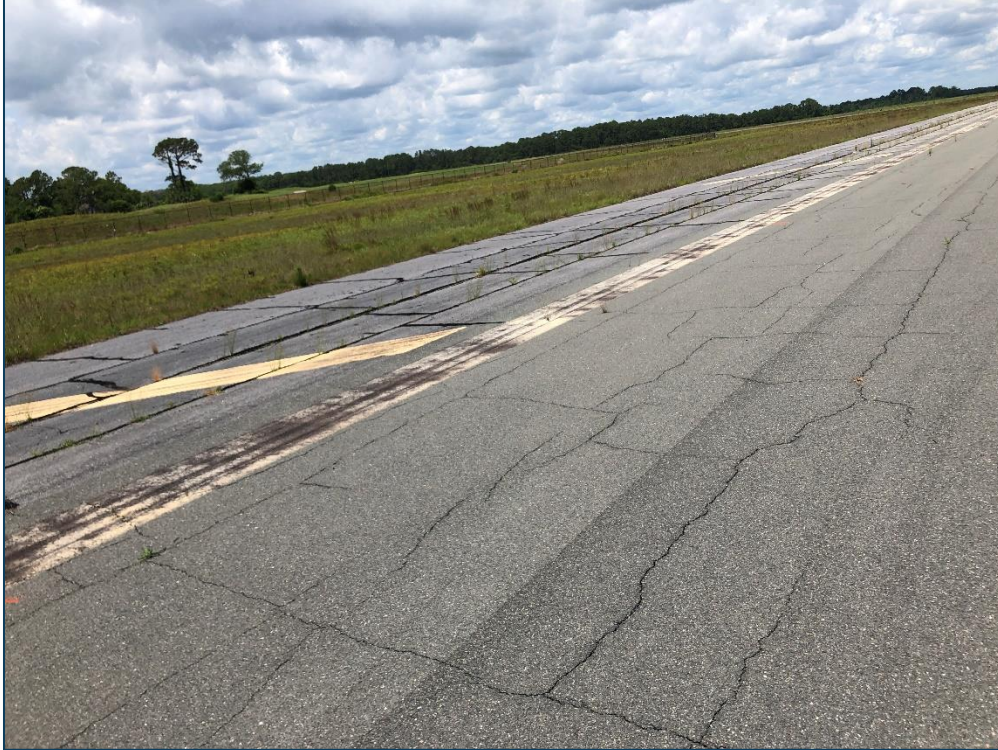
RW 13-31, Section 6215, Sample Unit 329 - Low Severity (43) Block Cracking, Low Severity (48) Longitudinal & Transverse Cracking, and Low Severity (57) Weathering

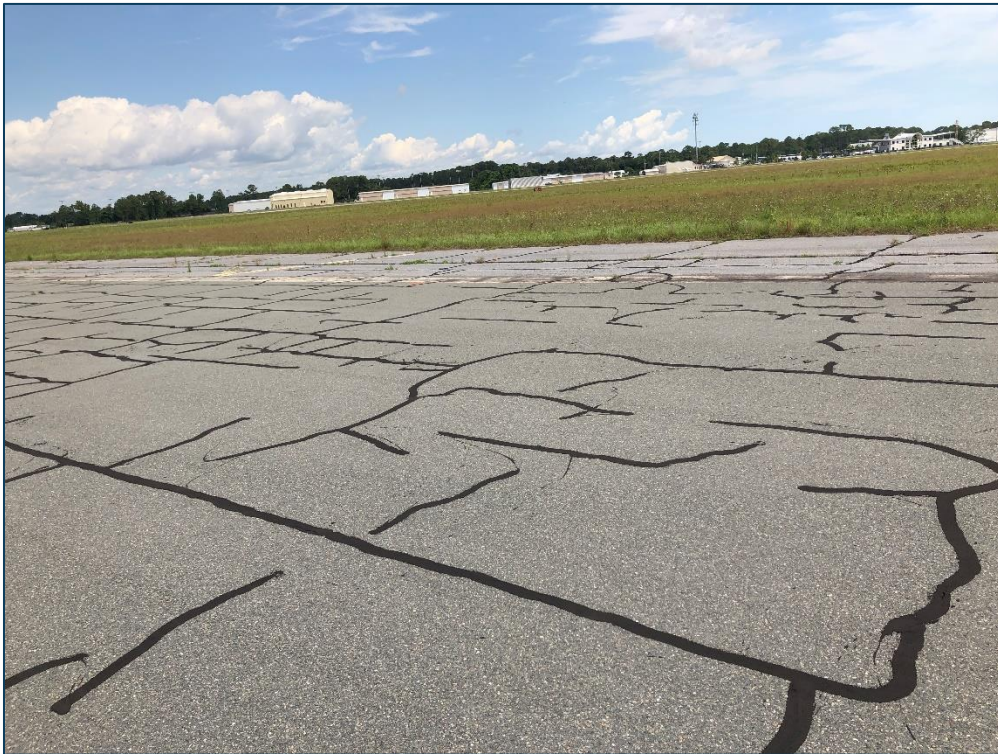
RW 13-31, Section 6215, Sample Unit 365 - Low Severity (43) Block Cracking, Low Severity (48) Longitudinal & Transverse Cracking, and Low Severity (57) Weathering

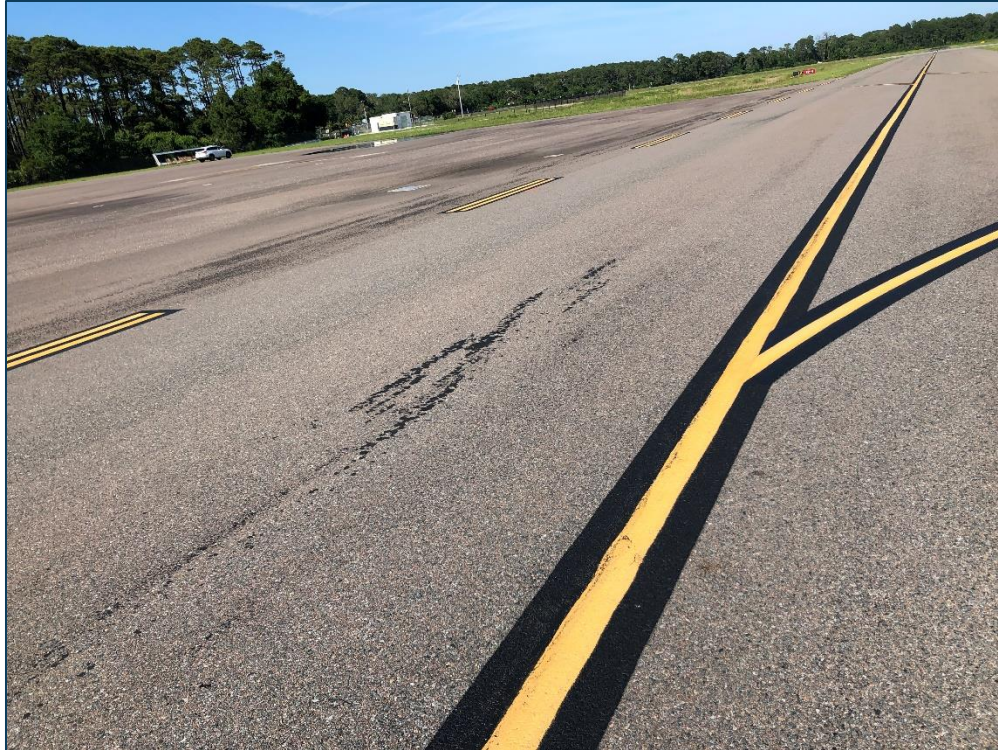
TW A, Section 325, Sample Unit 125 - (42) Bleeding Low Severity (57) Weathering

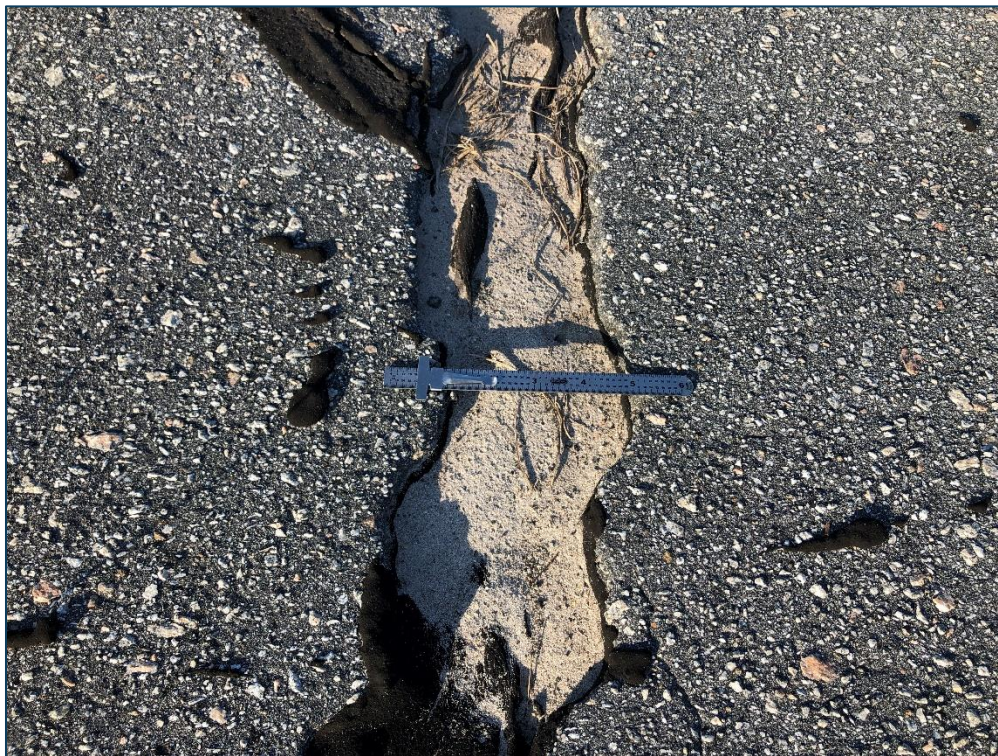
TW B, Section 230, Sample Unit 141 – High Severity (48) Longitudinal & Transverse Cracking, Low Severity (52) Raveling, and Low Severity (57) Weathering

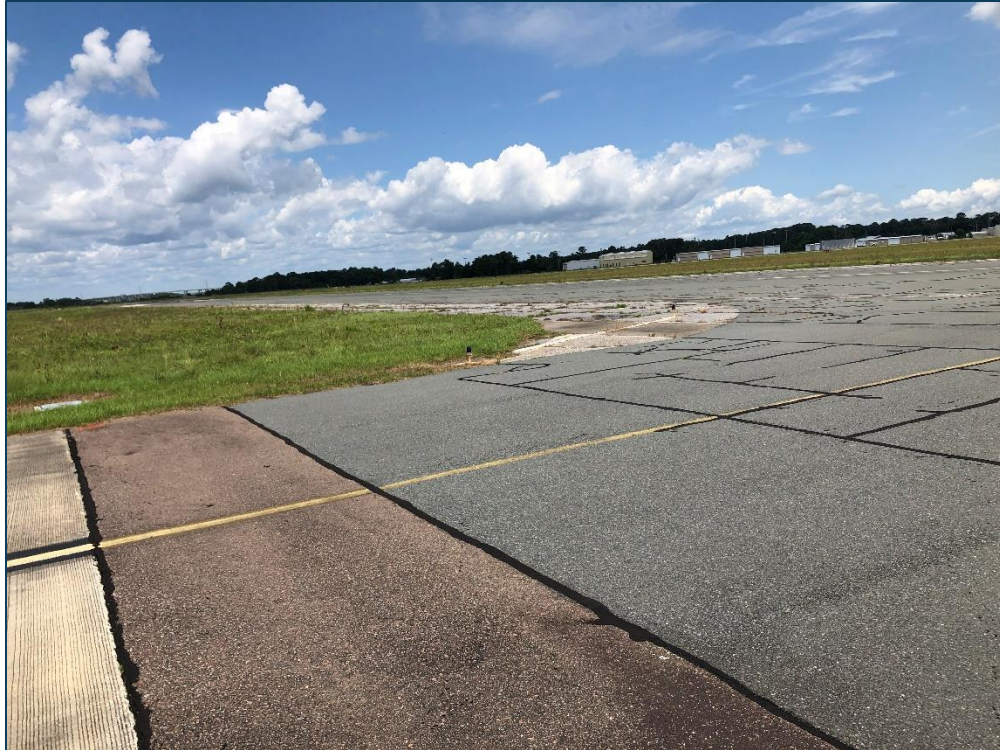
TW C, Section 120, Sample Unit 116 - Low Severity (48) Longitudinal & Transverse Cracking, Low Severity (50) Patching, and Low Severity (57) Weathering

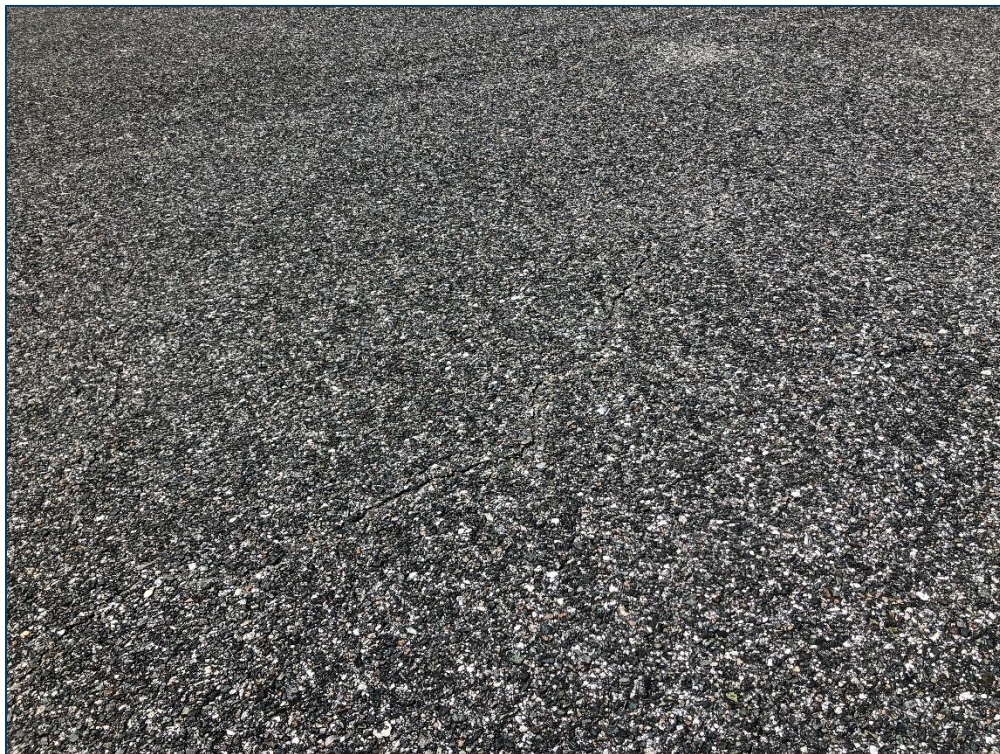
AP N, Section 4215, Sample Unit 208 - Low Severity (48) Longitudinal & Transverse Cracking, Low and Medium Severity (57) Weathering

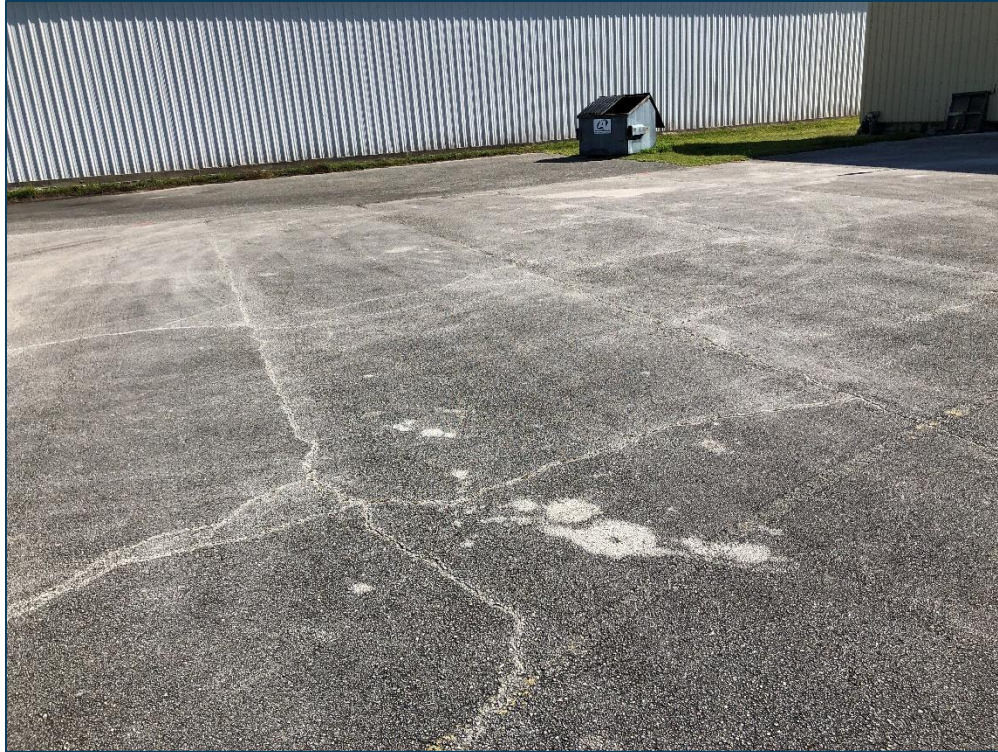
AP NW, Section 4110, Sample Unit 300 - Low Severity and Medium Severity (43) Block Cracking, Low Severity (52) Raveling, and Low Severity (57) Weathering
