Statewide Airfield Pavement Management Program

Airport Pavement Evaluation Report November 2019

**Palm Beach County
Park Airport (LNA)**
Reliever Airport
District 4

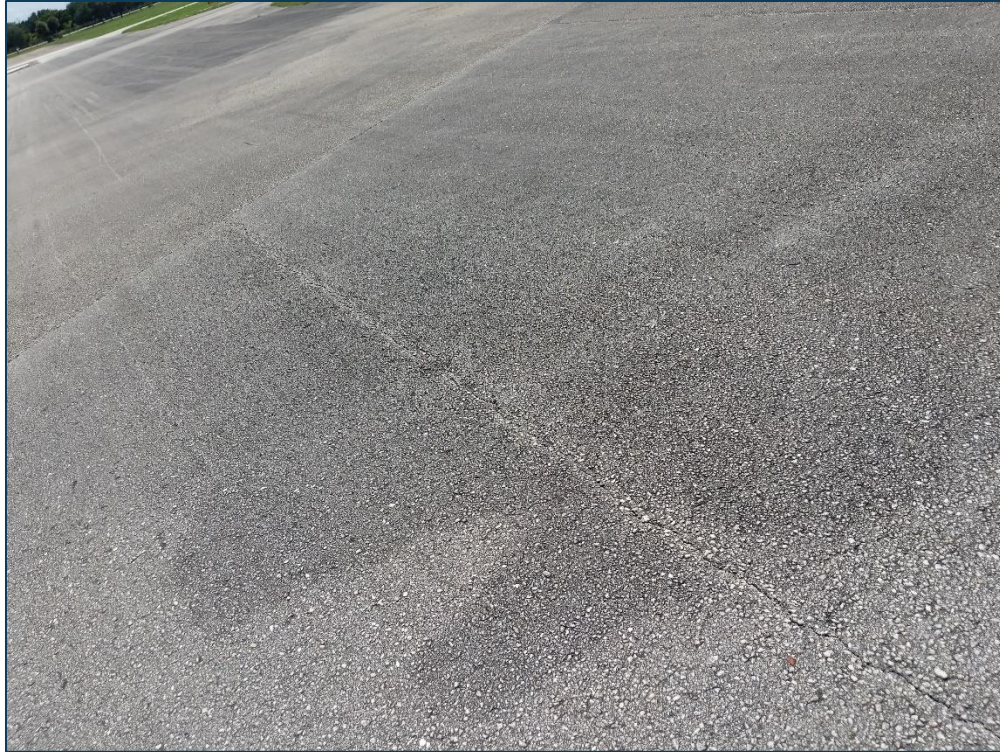
RW 4-22, Section 6305, Sample Unit 106 - Low Severity (48) Longitudinal & Transverse Cracking, Low Severity (52) Raveling, and Low Severity (57) Weathering

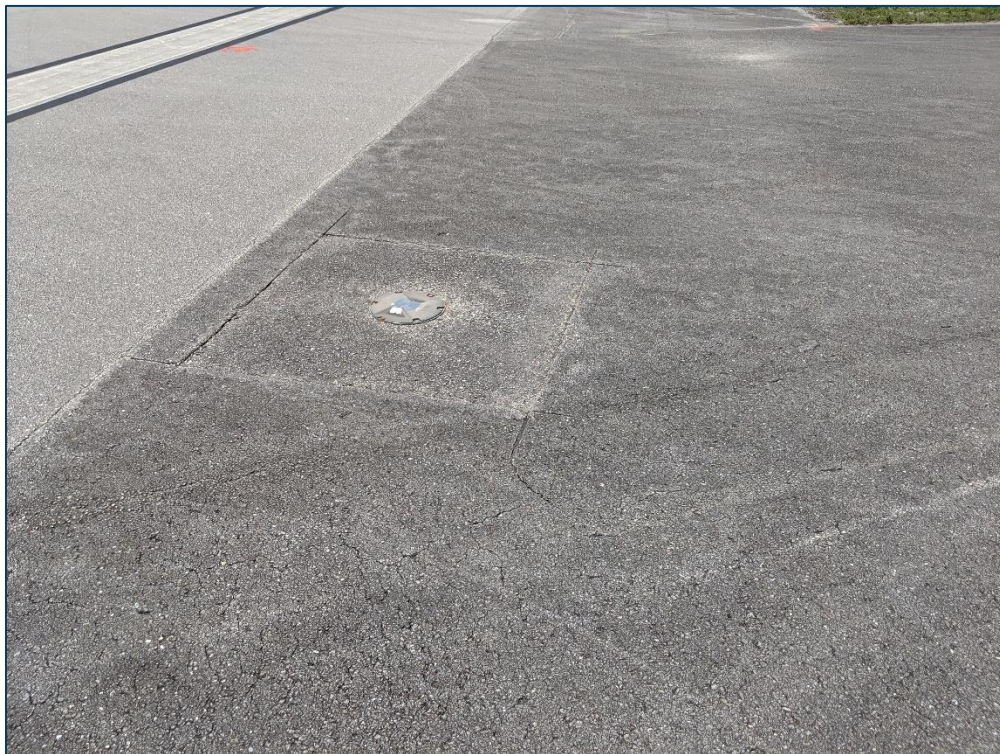
RW 4-22, Section 6305, Sample Unit 159 - Low Severity (48) Longitudinal & Transverse Cracking, Medium Severity (50) Patching, Low Severity (52) Raveling, and Low Severity (57) Weathering

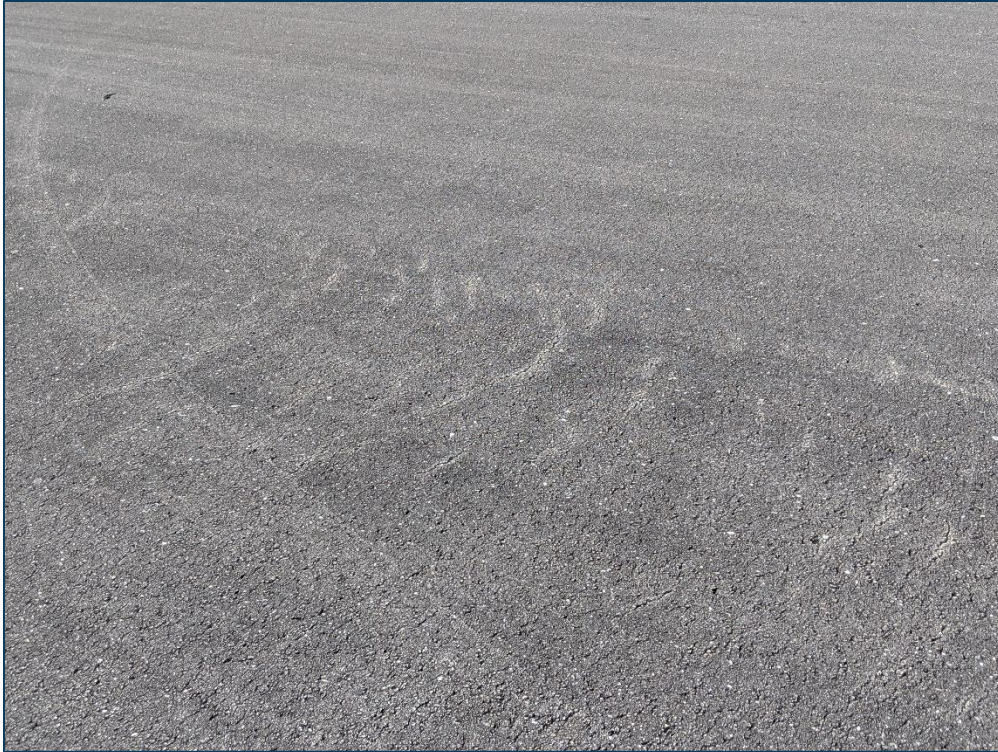
RW 10-28, Section 6105, Sample Unit 364 - Low Severity (48) Longitudinal & Transverse Cracking, Low Severity (52) Raveling, and Low Severity (57) Weathering

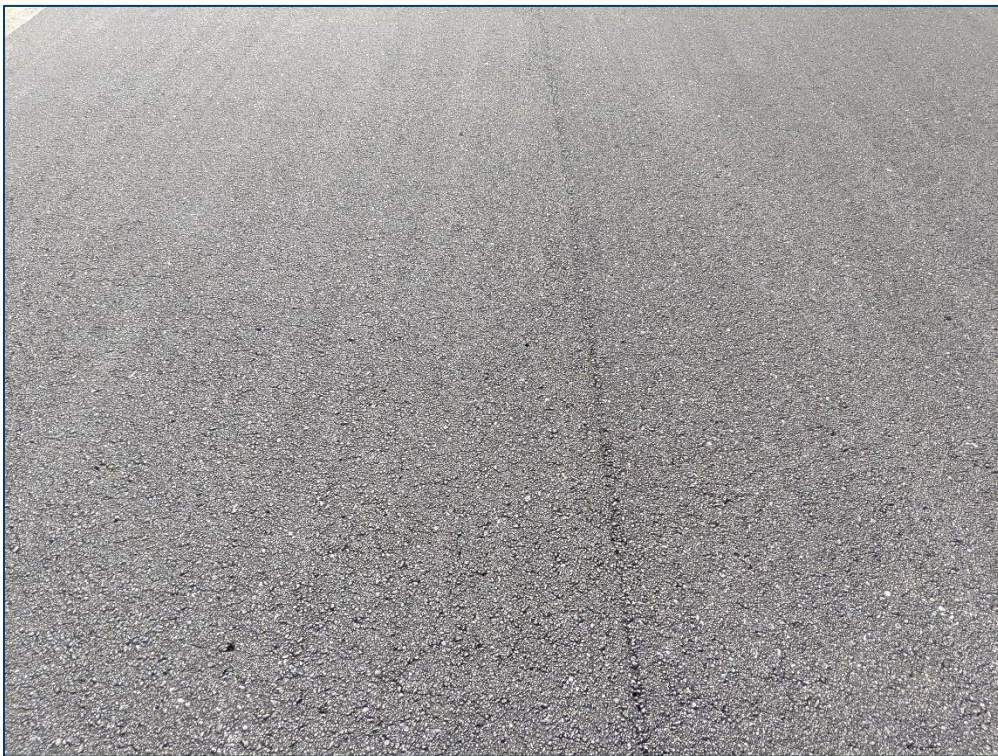
RW 10-28, Section 6105, Sample Unit 337 - Low Severity (52) Raveling and Low Severity (57) Weathering

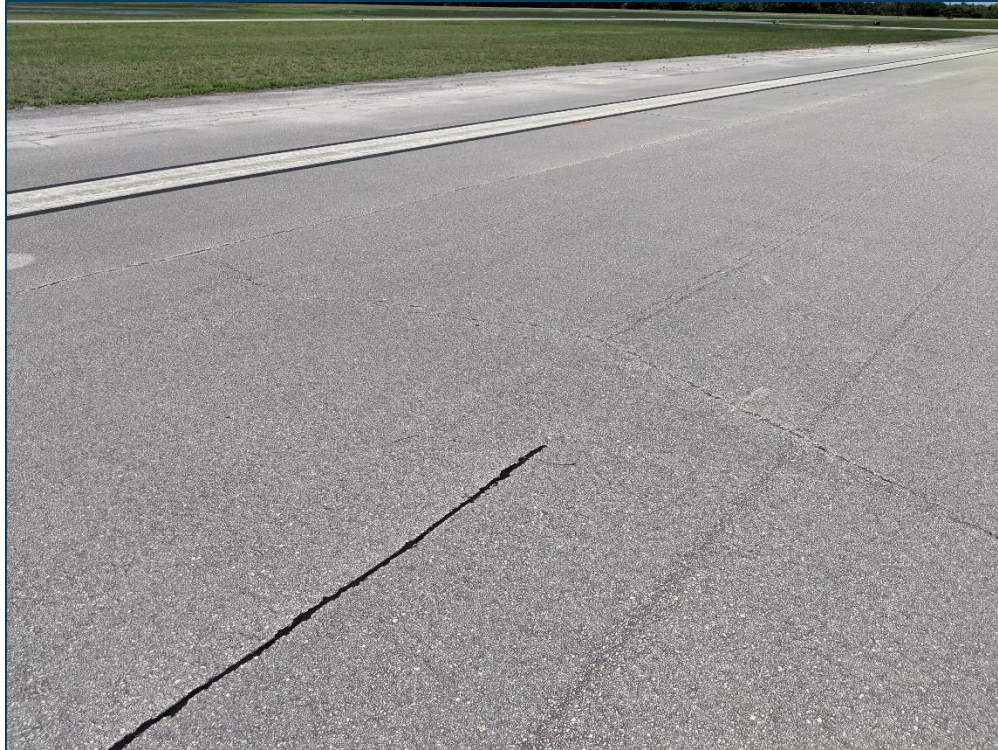
RW 16-34, Section 6215, Sample Unit 124 - Low Severity (48) Longitudinal & Transverse Cracking and Low Severity (52) Raveling

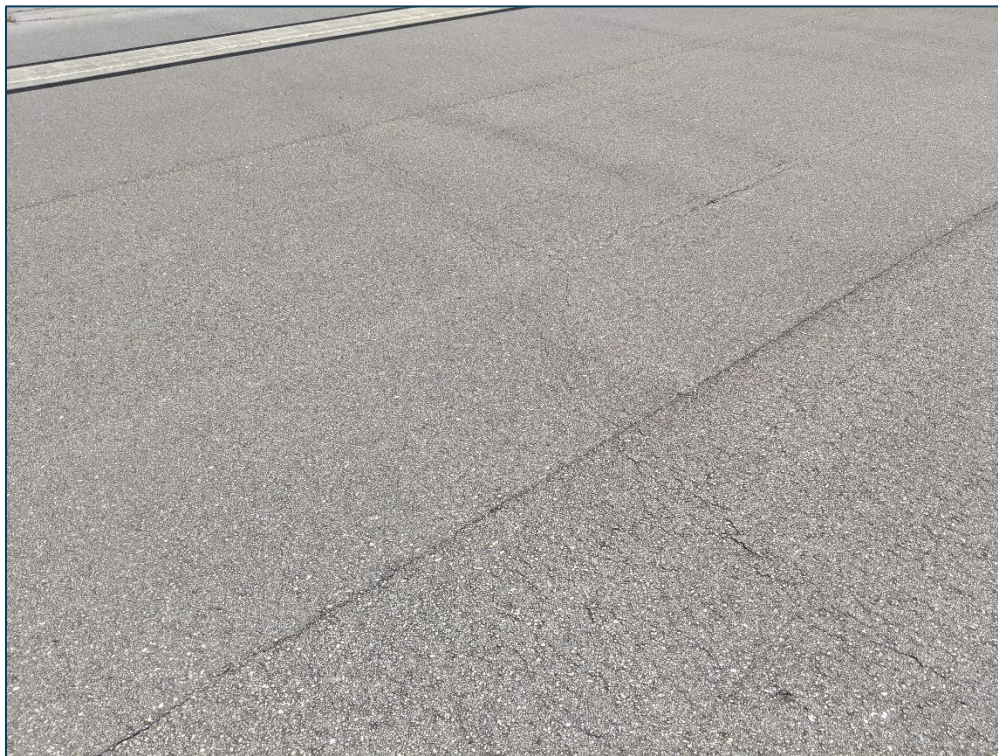
RW 16-34, Section 6215, Sample Unit 134 - Low Severity (48) Longitudinal & Transverse Cracking, Low Severity (52) Raveling, and Low Severity (57) Weathering

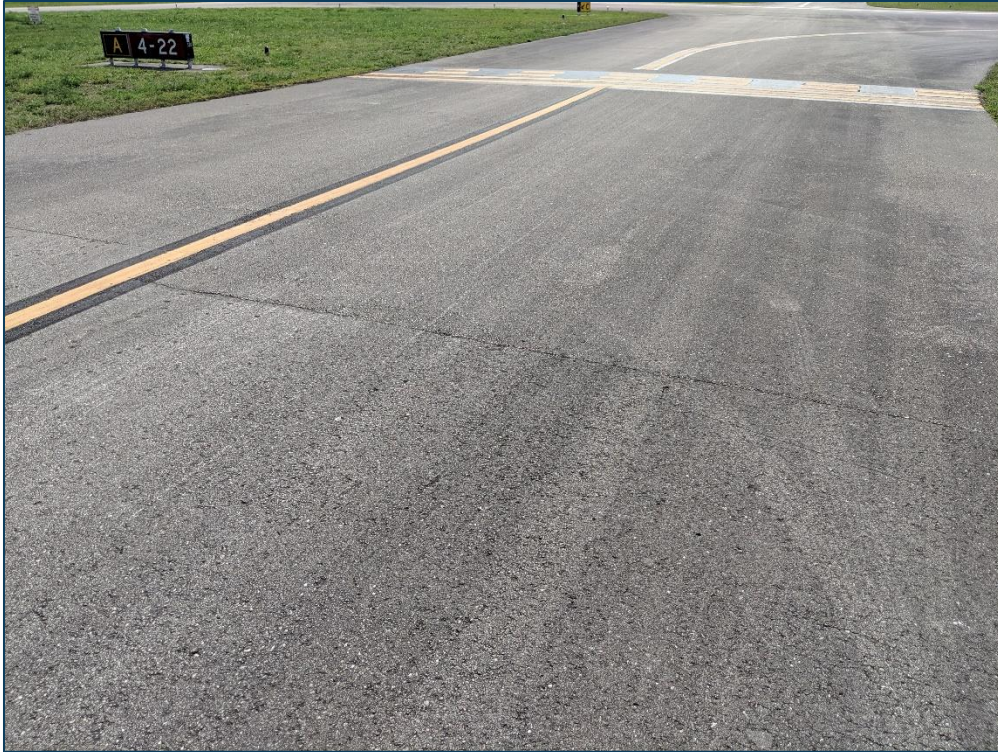
TW A, Section 310, Sample Unit 307 - Low Severity (48) Longitudinal & Transverse Cracking and Low Severity (52) Raveling

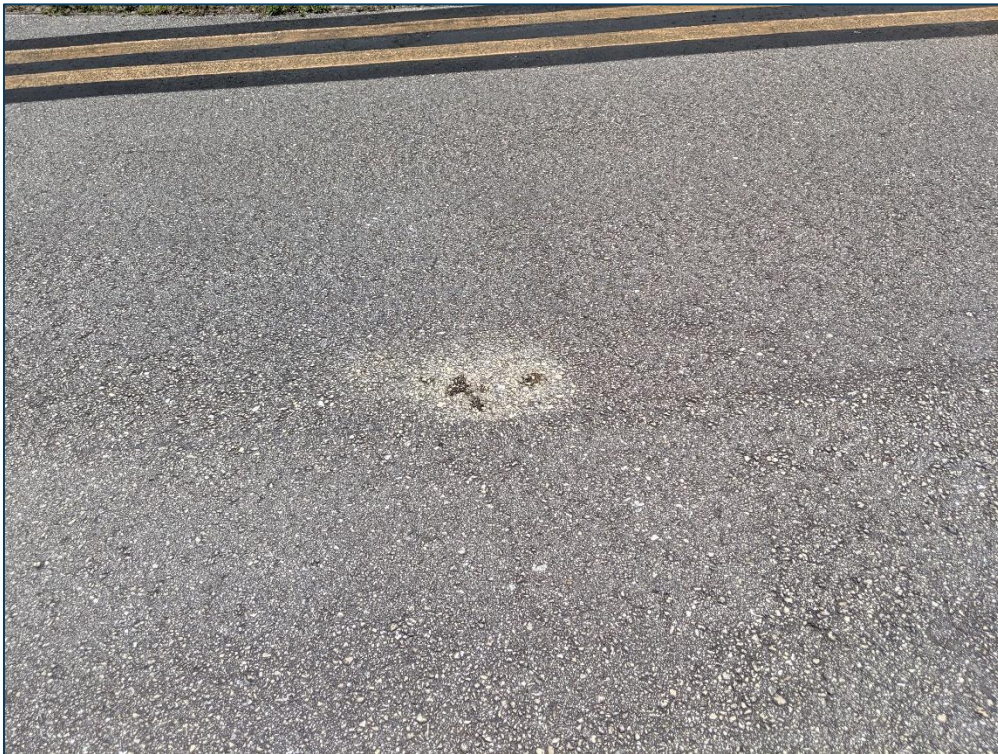
TW B, Section 217, Sample Unit 100 – Low and Medium Severity (57) Weathering

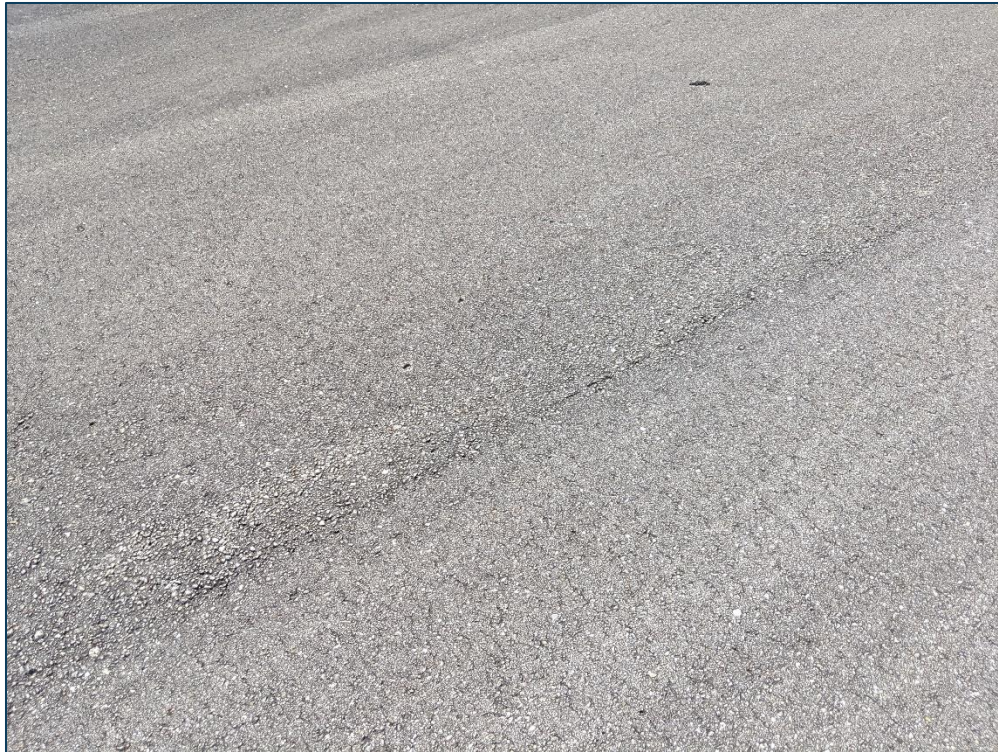
TW C, Section 103, Sample Unit 101 - Low Severity (48) Longitudinal & Transverse Cracking, Low Severity (52) Raveling, and Low Severity (57) Weathering

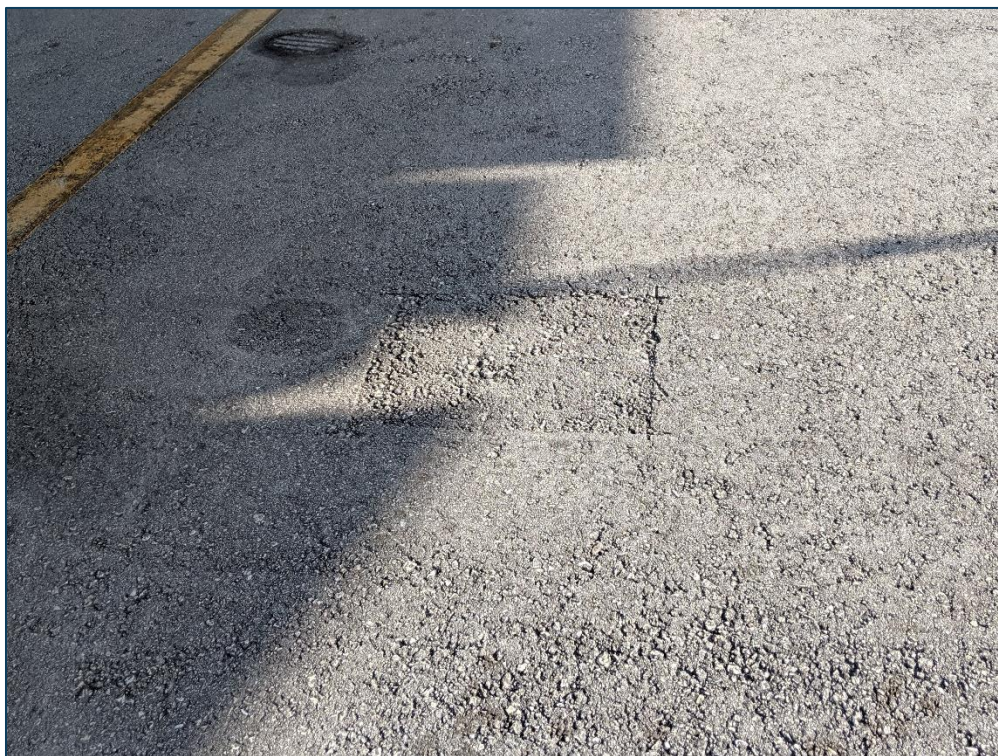
AP GA, Section 4105, Sample Unit 360 - Low Severity (50) Patching, Low Severity (52) Raveling, and Low Severity (57) Weathering

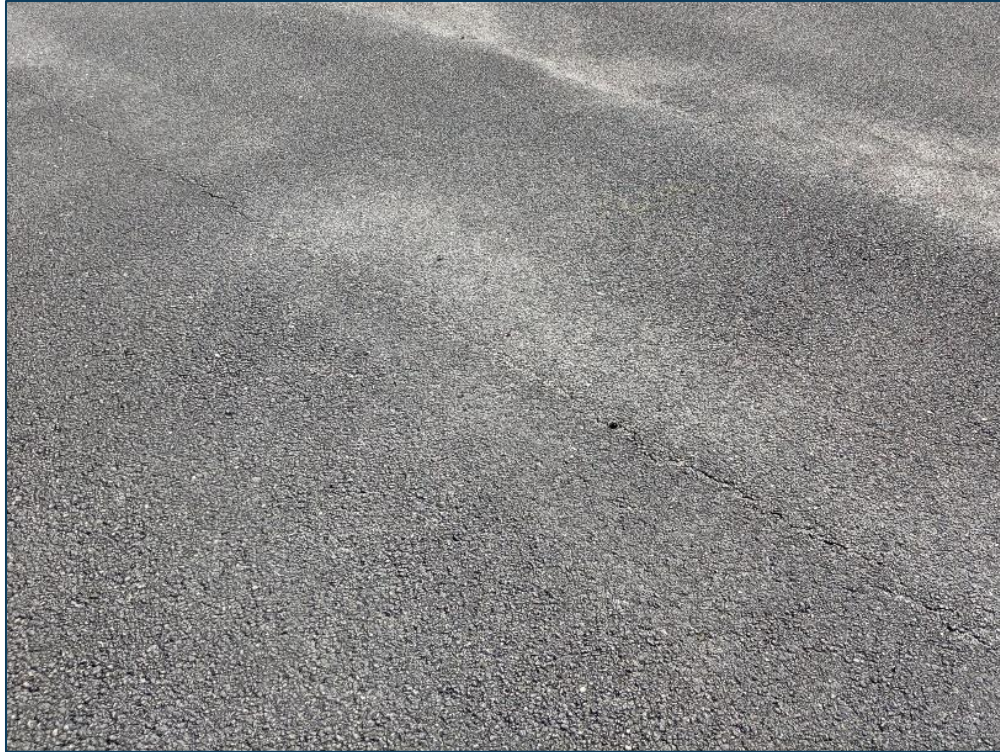
AP GA, Section 4110, Sample Unit 553 - Low Severity (48) Longitudinal & Transverse Cracking and Low Severity (52) Raveling
