FLORIDA DEPARTMENT OF TRANSPORTATION
AVIATION AND SPACEPORTS OFFICE

Statewide Airfield Pavement Management Program

**Airport Pavement
Evaluation Report
November 2019**

Boca Raton Airport (BCT)
Reliever Airport
District 4

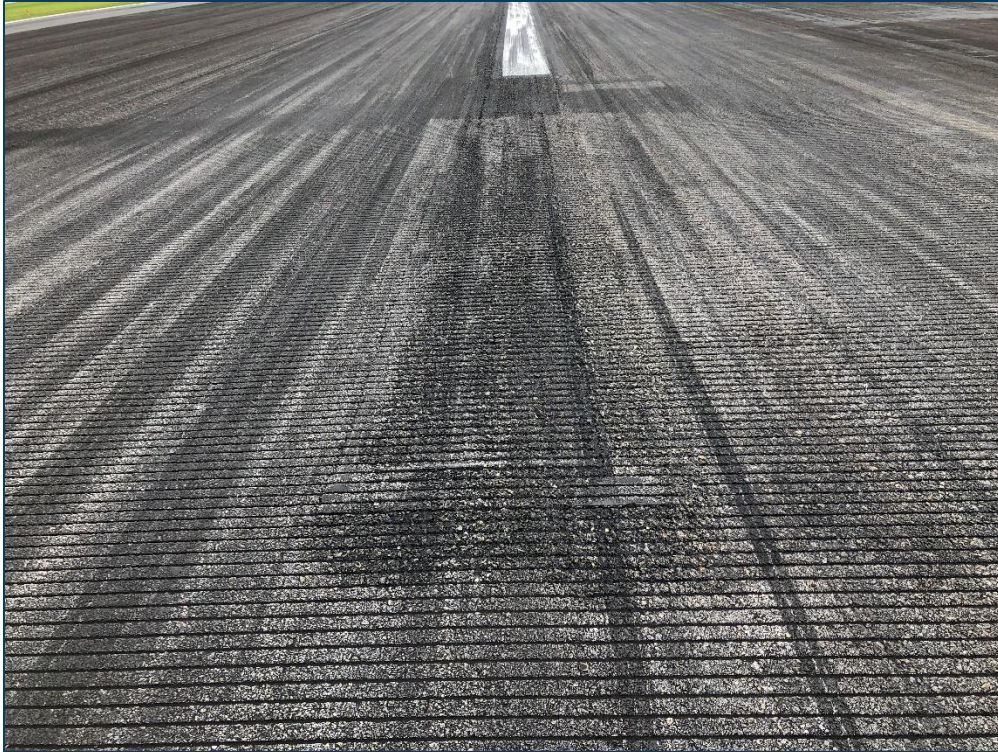
RW 5-23, Section 6105, Sample Unit 382 - Low Severity (48) Longitudinal & Transverse Cracking, Low Severity (52) Raveling, and Low Severity (57) Weathering

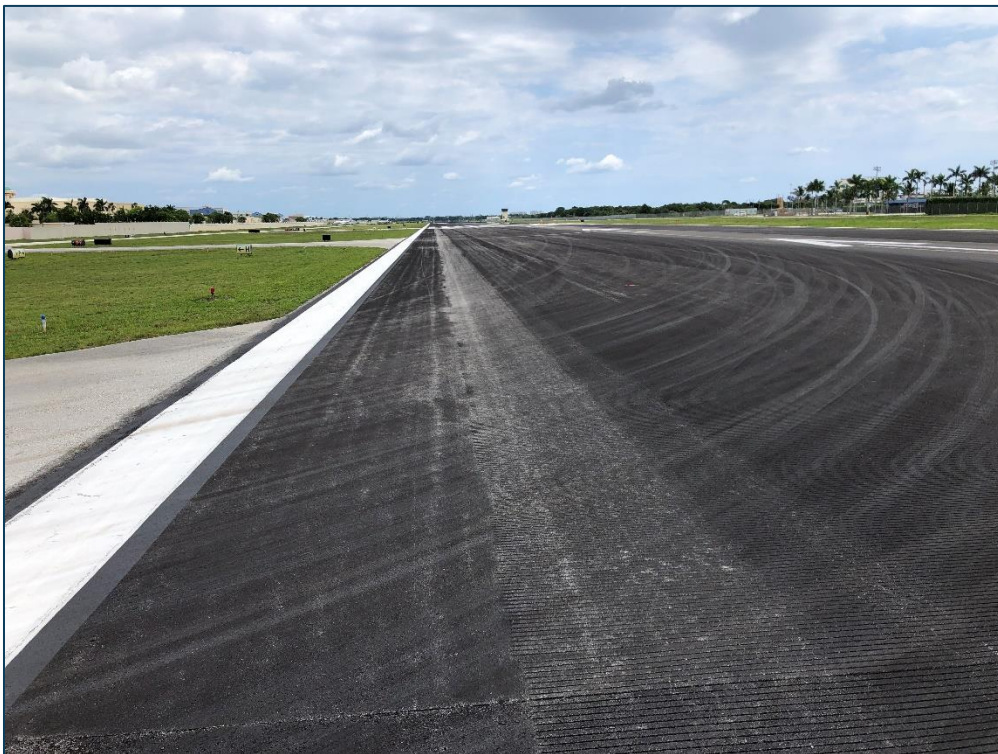
RW 5-23, Section 6111, Sample Unit 84 - Low Severity (48) Longitudinal & Transverse Cracking and Low Severity (57) Weathering

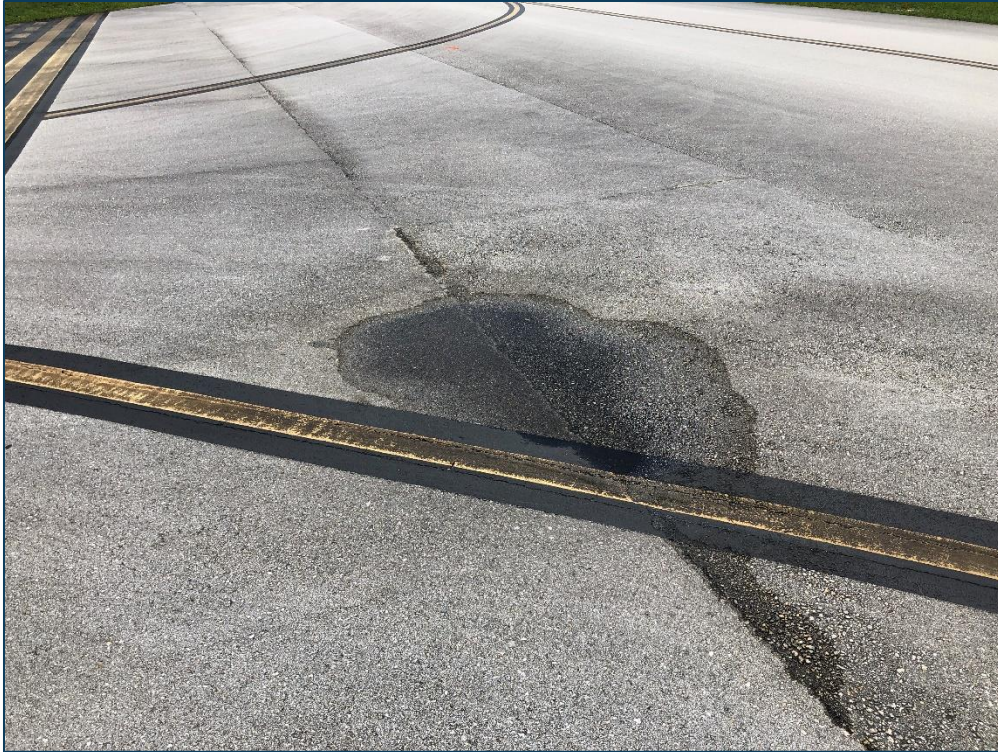
TW E, Section 116, Sample Unit 251 - Low Severity (45) Depression, Low Severity (48) Longitudinal & Transverse Cracking, and Low Severity (57) Weathering

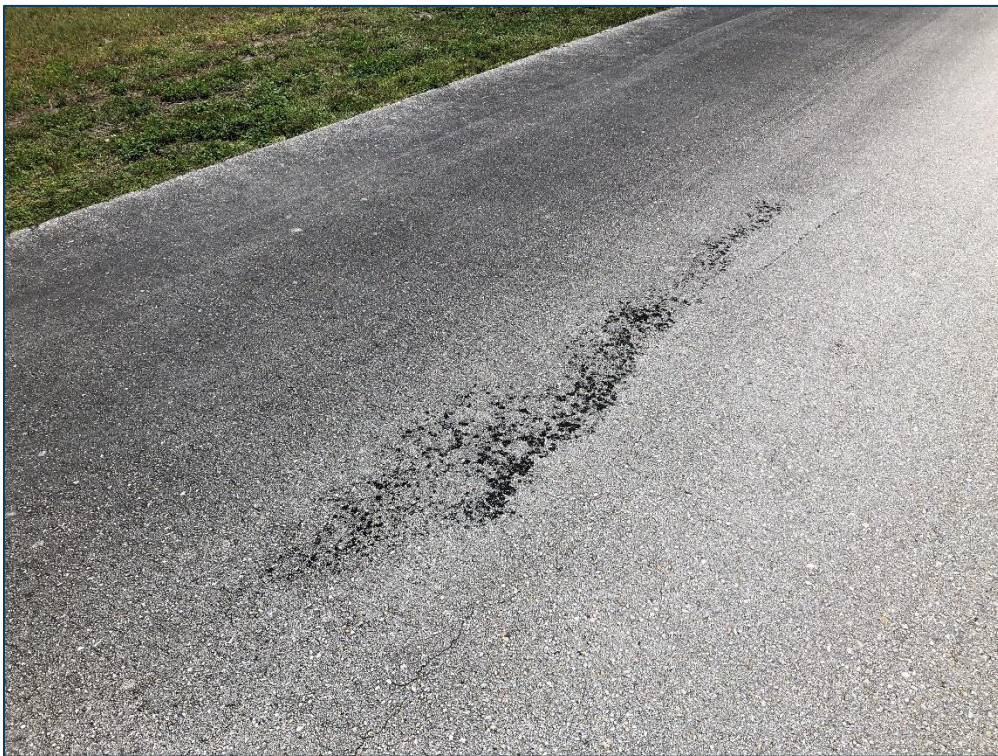
TW P, Section 105, Sample Unit 105 - (42) Bleeding, Low Severity (48) Longitudinal & Transverse Cracking, and Low Severity (57) Weathering

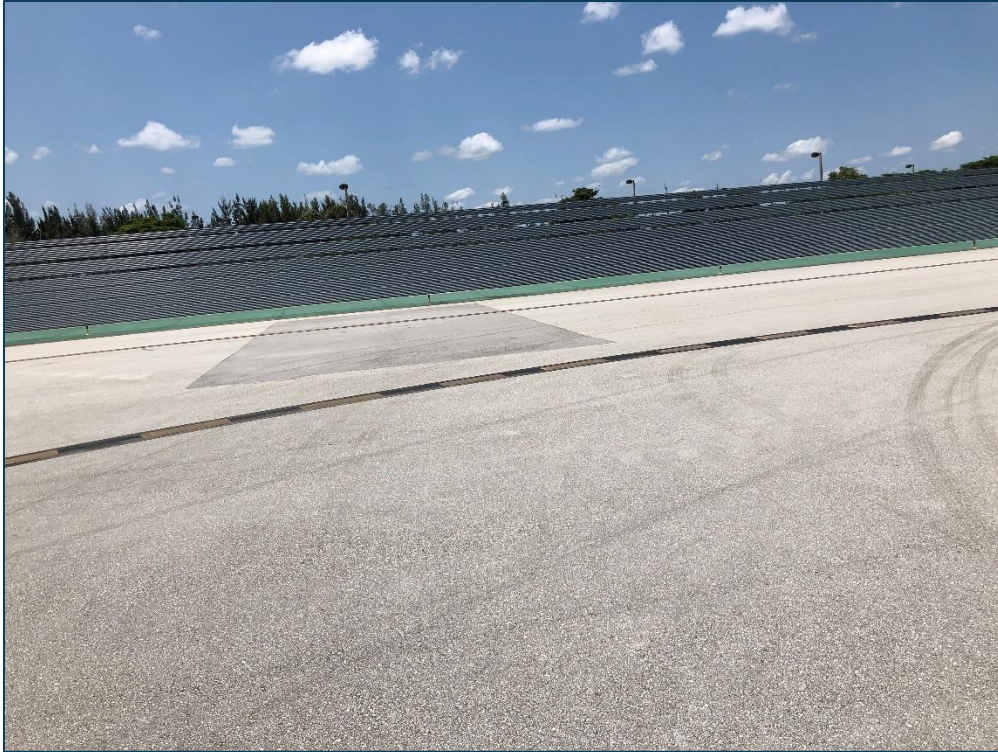
AP RU 5, Section 5105, Sample Unit 100 - Low Severity (50) Patching and Low Severity (57) Weathering

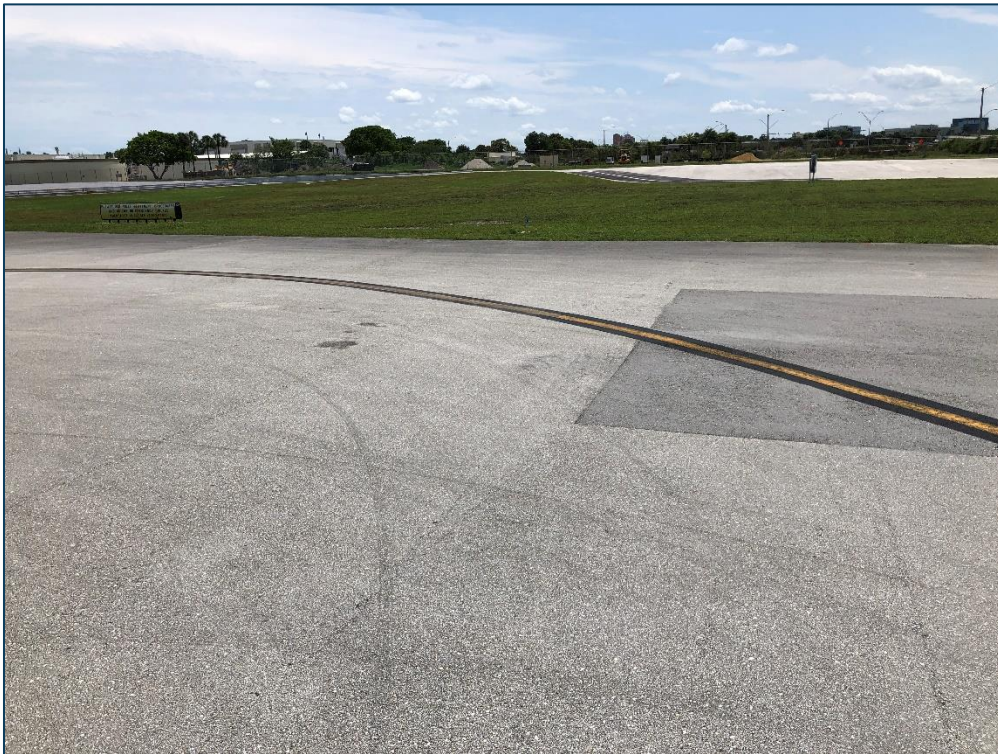
AP RU 5, Section 5115, Sample Unit 201 - Low Severity (48) Longitudinal & Transverse Cracking, Low Severity (50) Patching, and Low Severity (57) Weathering
