Statewide Airfield Pavement Management Program

Airport Pavement Evaluation Report

2IS - Airglades Airport | District 1

Florida Department of Transportation

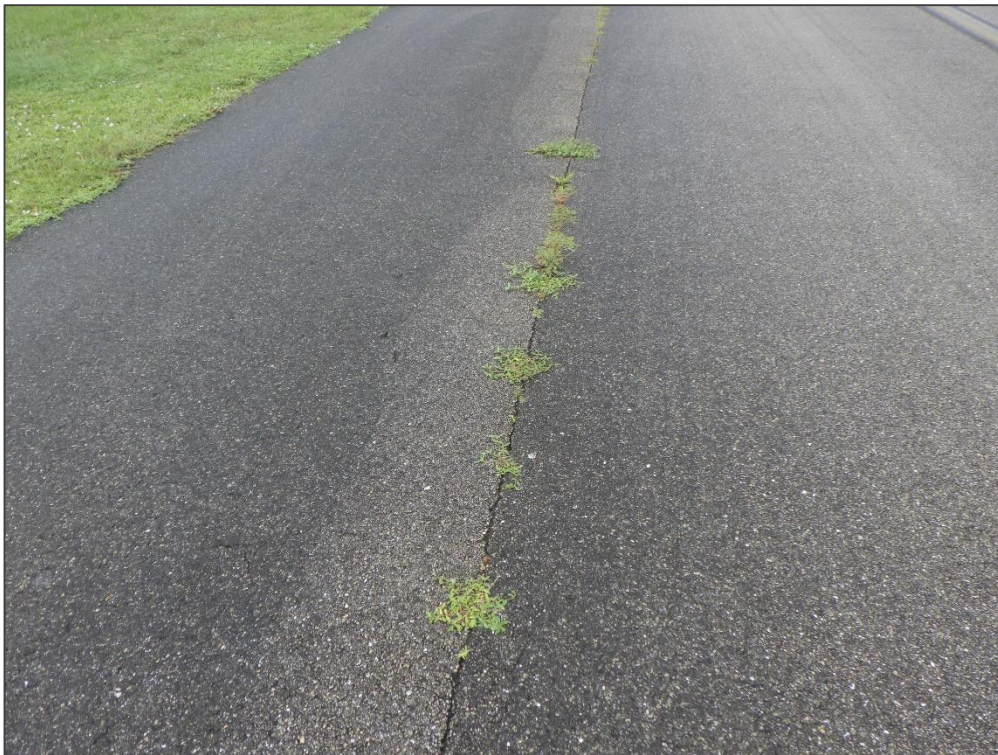
TW A, Section 105, Sample Unit 113 - Longitudinal & Transverse Cracking

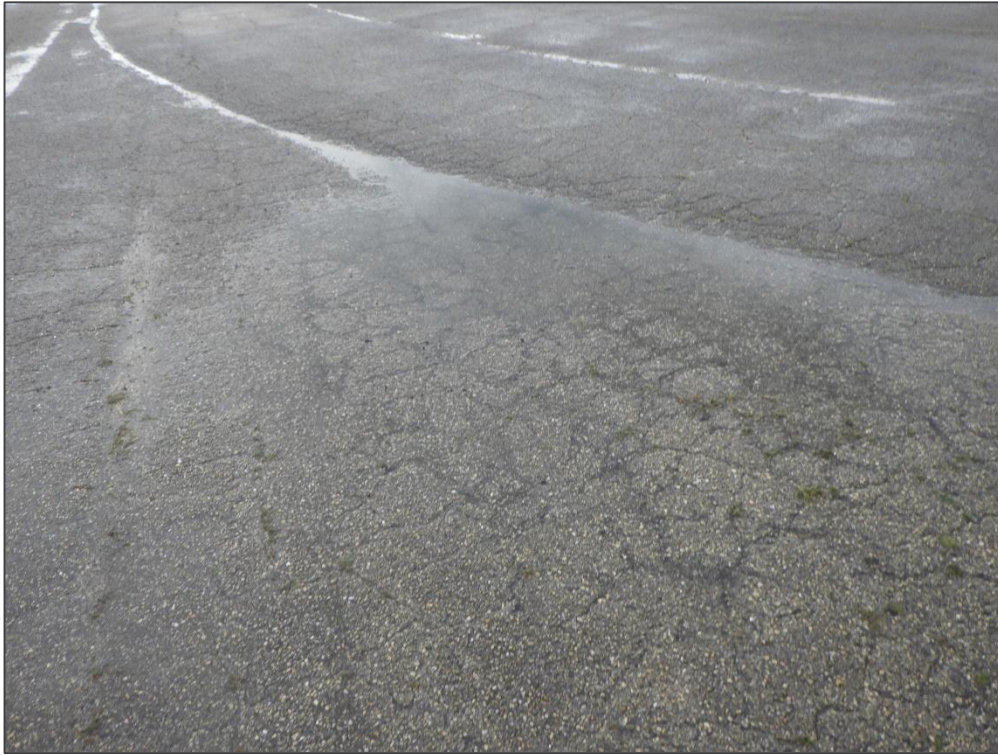
TW HANG, Section 405, Sample Unit 103 - Alligator Cracking and Depression

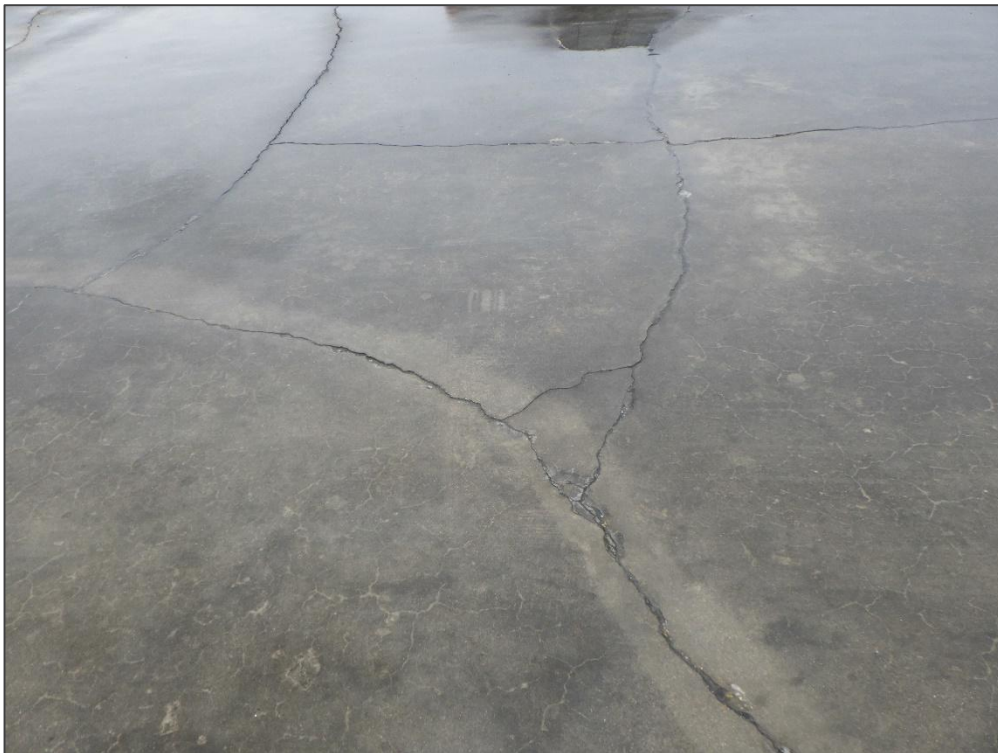
AP NW, Section 4410, Sample Unit 100 - Shattered Slab

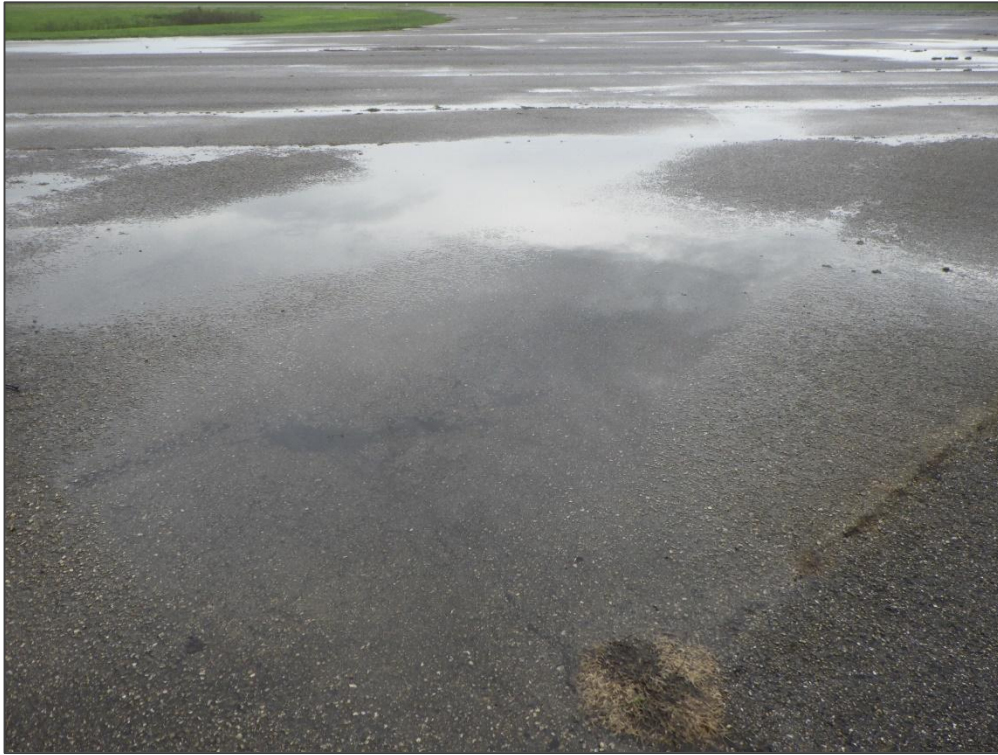
AP S, Section 4305, Sample Unit 201 - Depression
