Florida Department of Transportation

Statewide Airfield Pavement Management Program

Airport Pavement Evaluation Report

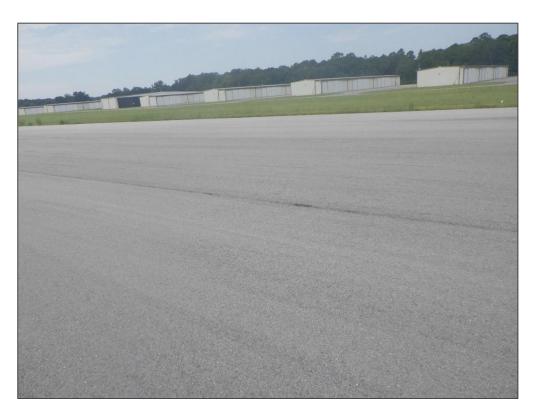
RW 18-36, Section 6105, Sample Unit 105 - Vicinity

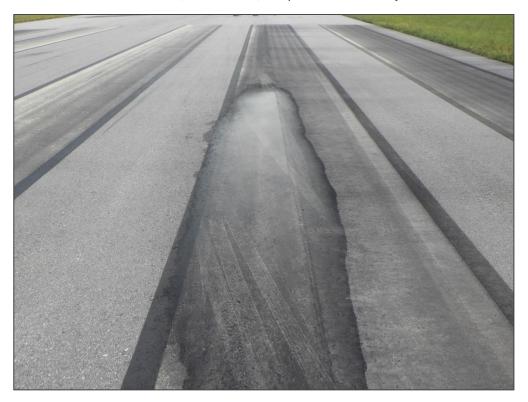
RW 18-36, Section 6105, Sample Unit 171 - Depression

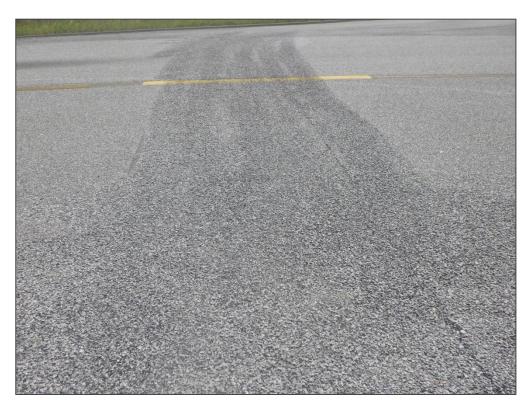
TW A, Section 150, Sample Unit 107 - Raveling

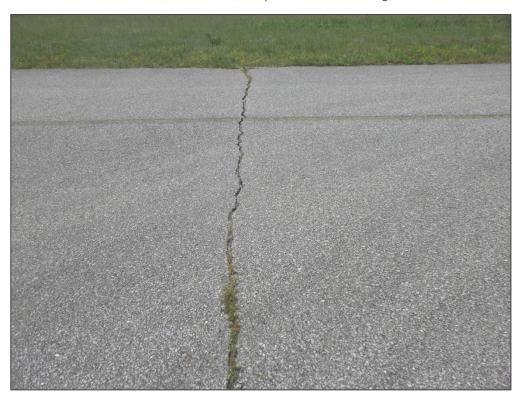
TW B, Section 205, Sample Unit 118 - Longitudinal & Transverse Cracking

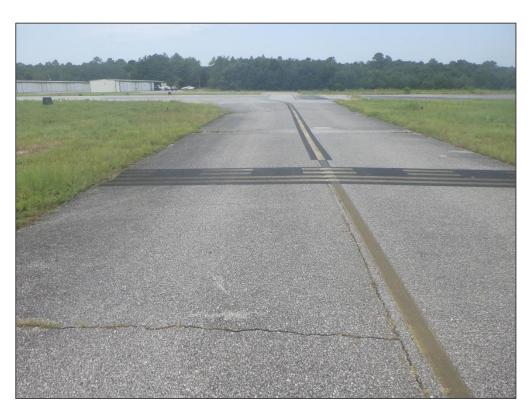
TW B, Section 290, Sample Unit 100 - Longitudinal & Transverse Cracking

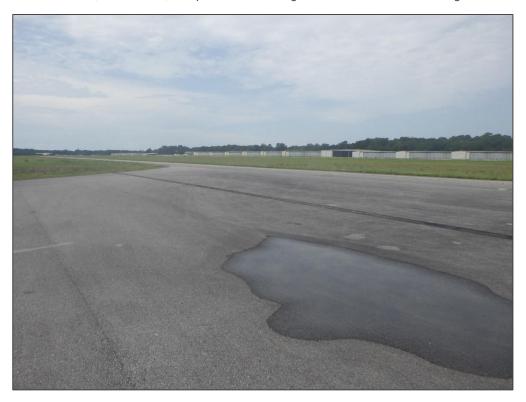
AP RU 18, Section 5105, Sample Unit 101 - Depression

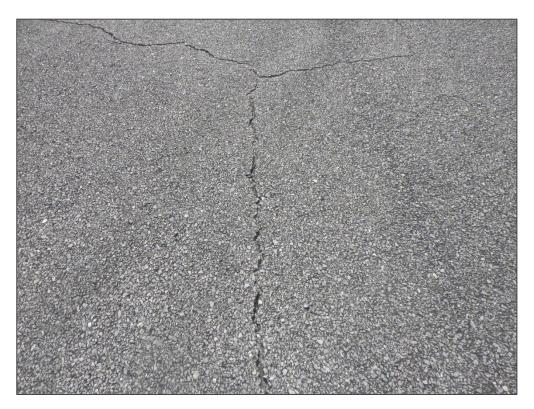
AP W, Section 4115, Sample Unit 502 - Longitudinal & Transverse Cracking

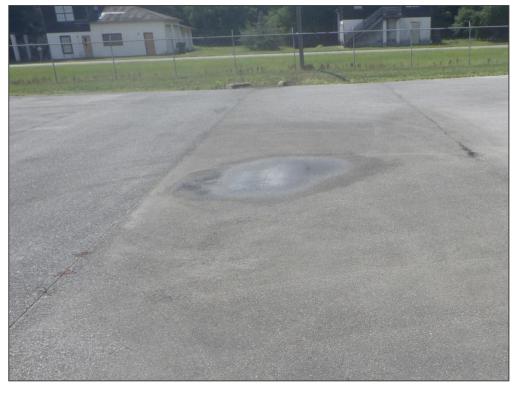
AP W, Section 4130, Sample Unit 700 - Depression
