Statewide Airfield Pavement Management Program

Airport Pavement Evaluation Report

INF - Inverness Airport | District 7

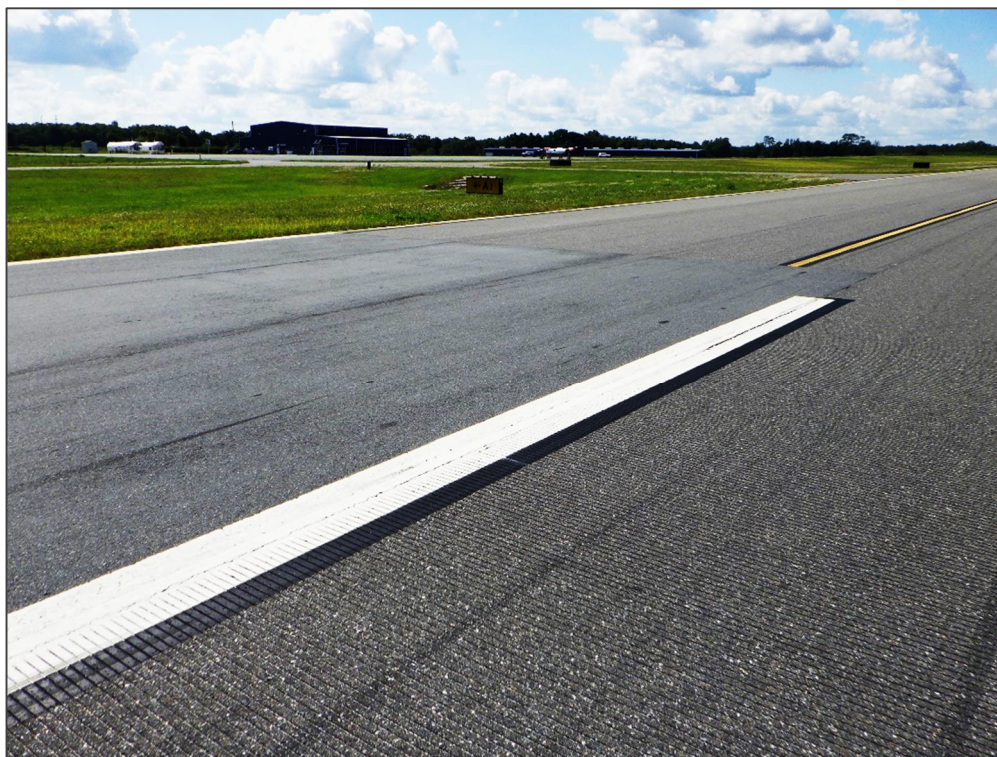
RW 1-19, Section 6105, Sample Unit 130 - Patching

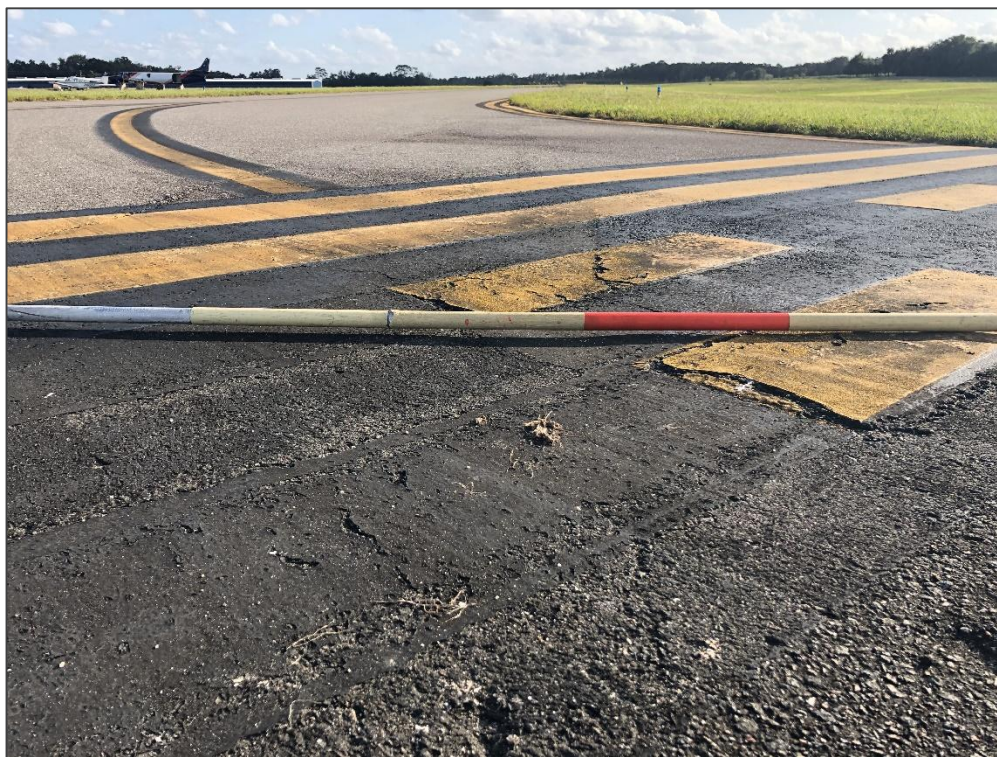
TW A1, Section 115, Sample Unit 201 - Depression

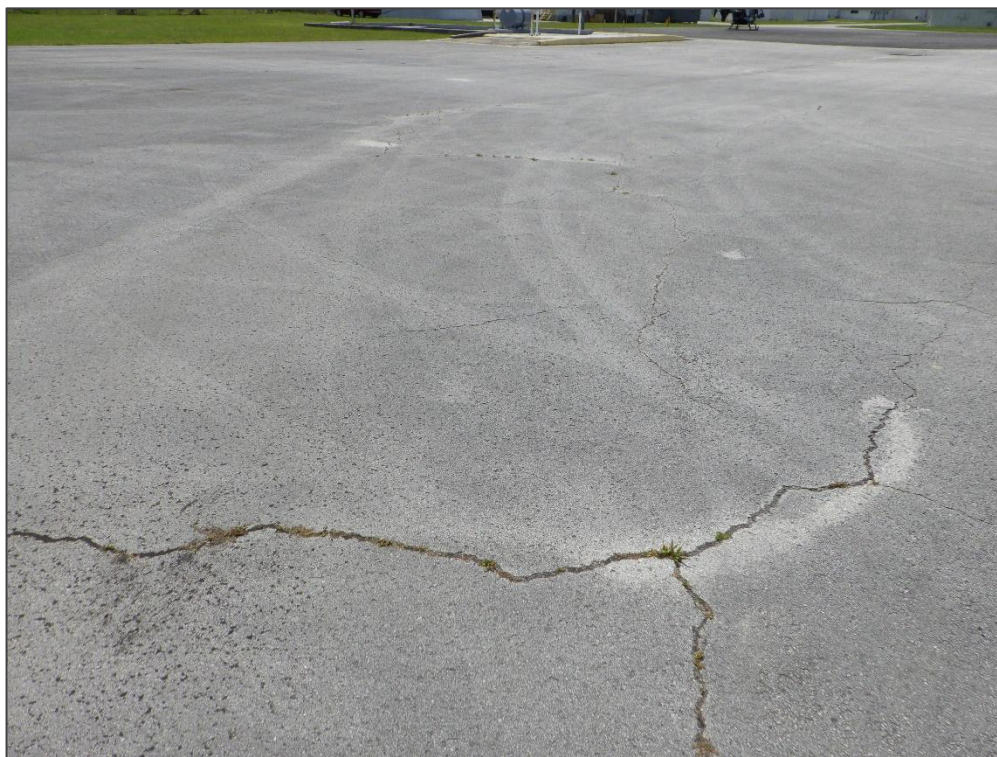
Section ID	Surface Type	Section Area (SF)	PCI	Condition Rating
4005	AC	35,044	55	Poor
4015	AC	26,880	86	Good
4020	AC	72,207	88	Good

AP GA, Section 4005, Sample Unit 604 - Longitudinal & Transverse Cracking

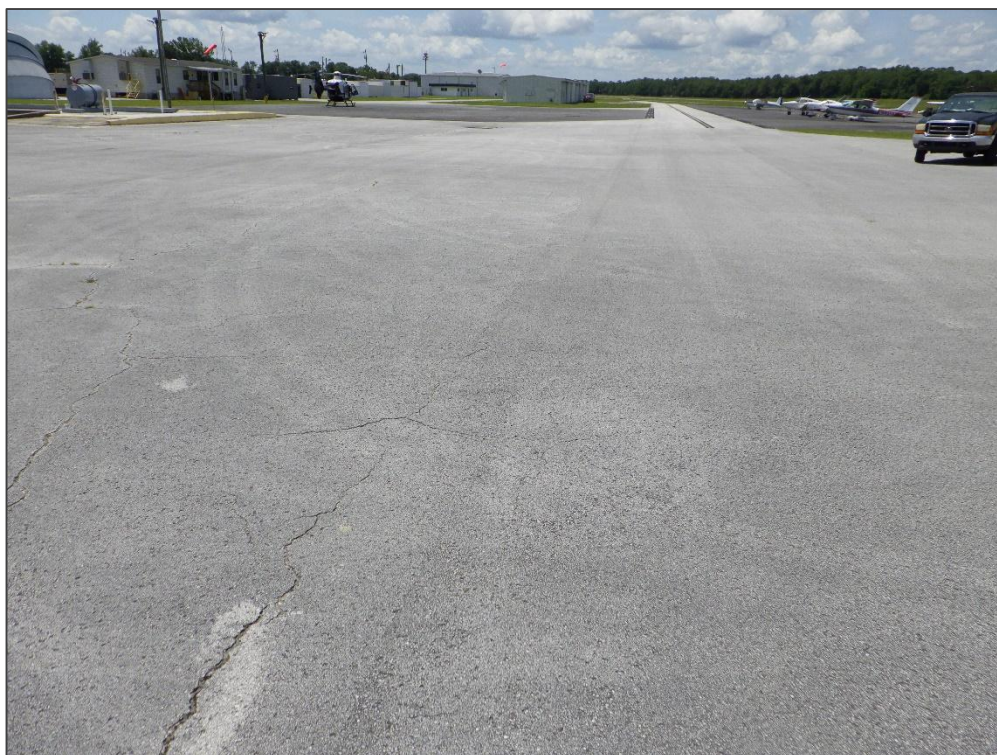
AP GA, Section 4005, Sample Unit 604 - Longitudinal & Transverse Cracking
