Statewide Airfield Pavement Management Program

Airport Pavement Evaluation Report

X59 - Valkaria Airport | *District 5*

Florida Department of Transportation

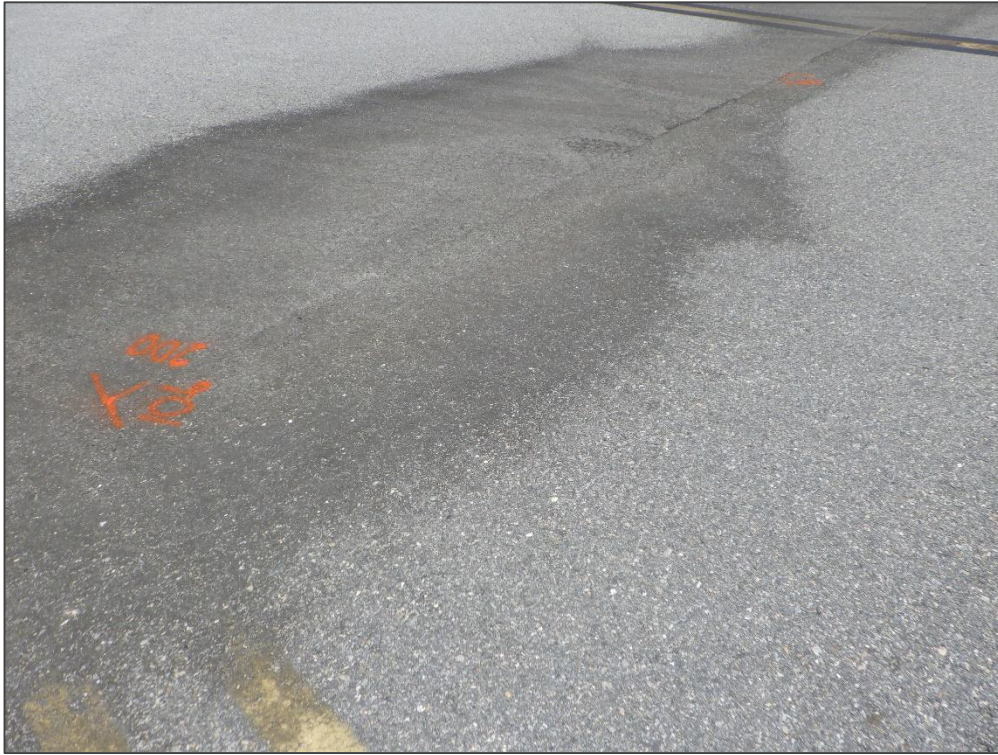
RW 10-28, Section 6205, Sample Unit 106 - Depression

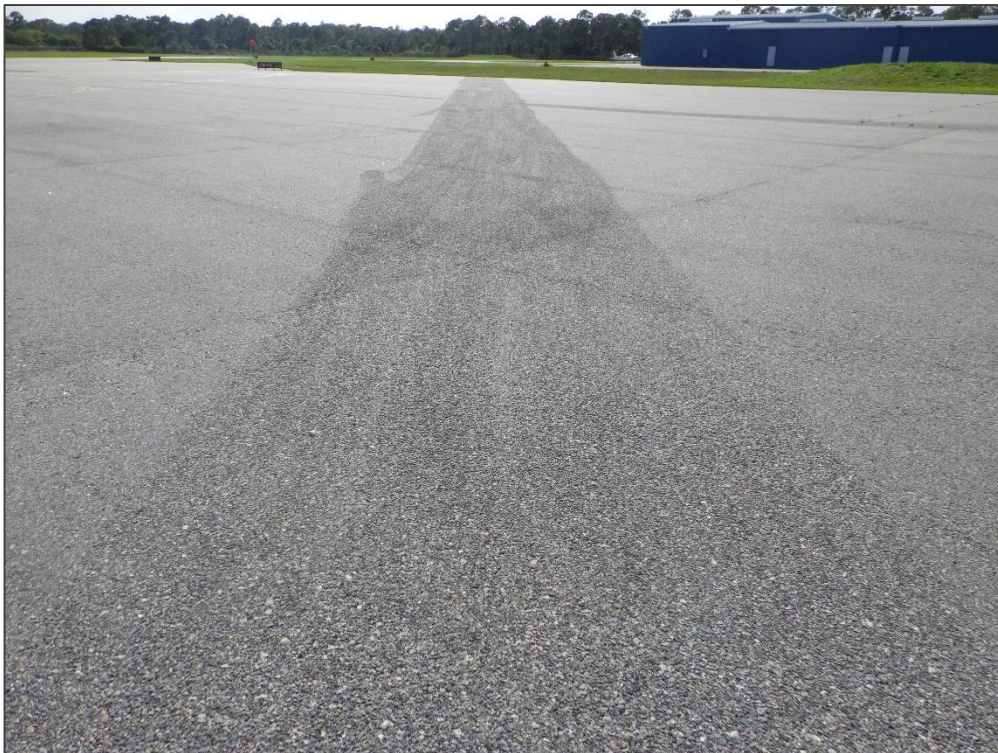
AP, Section 4105, Sample Unit 300 - Raveling

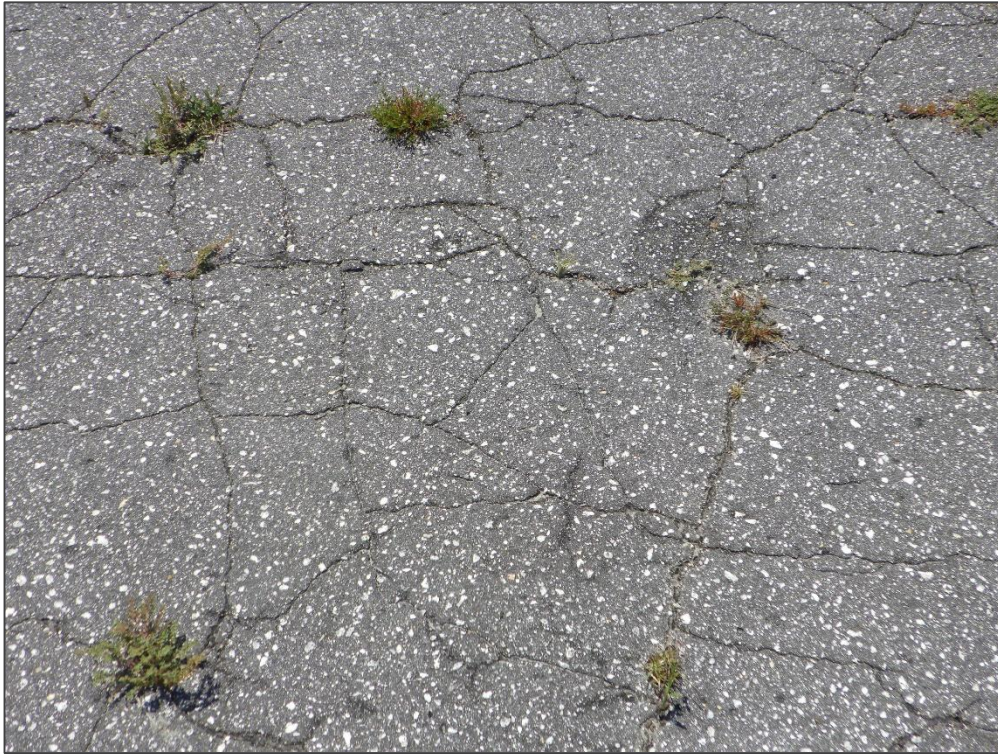
AP, Section 4130, Sample Unit 104 - Alligator Cracking

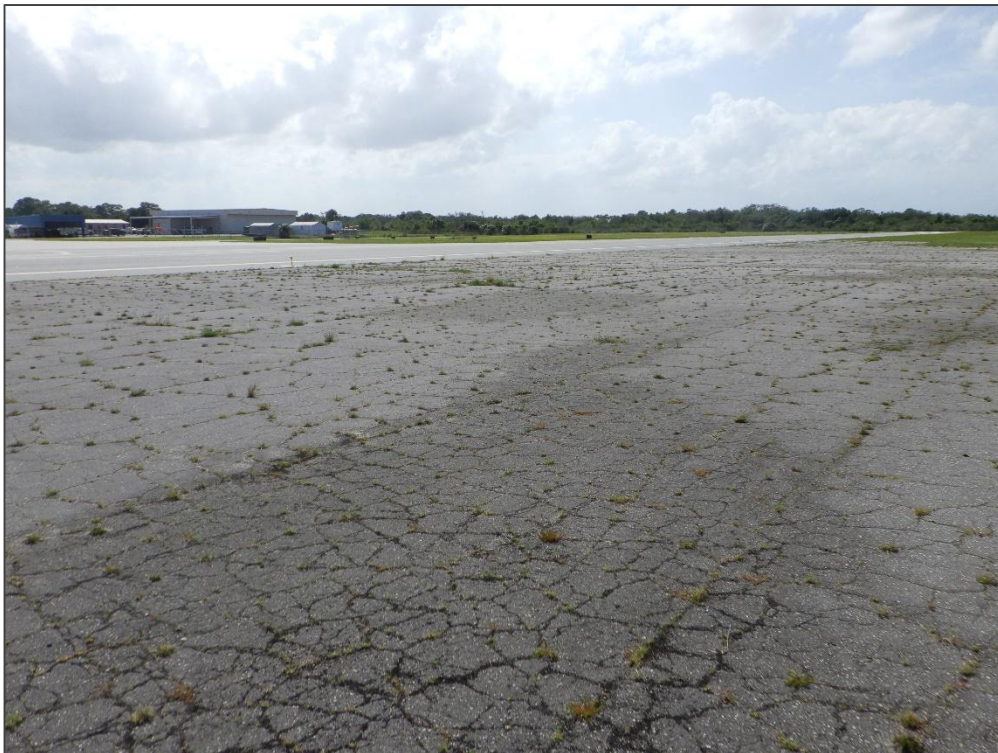
AP, Section 4145, Sample Unit 202 - Vicinity

X59	AP	Apron	4145	161,691	5	Failed
X59	AP	Apron	4150	106,940	100	Good
X59	AP	Apron	4155	42,012	100	Good
