Statewide Airfield Pavement Management Program

Airport Pavement Evaluation Report

BCT - Boca Raton Airport | *District 4*

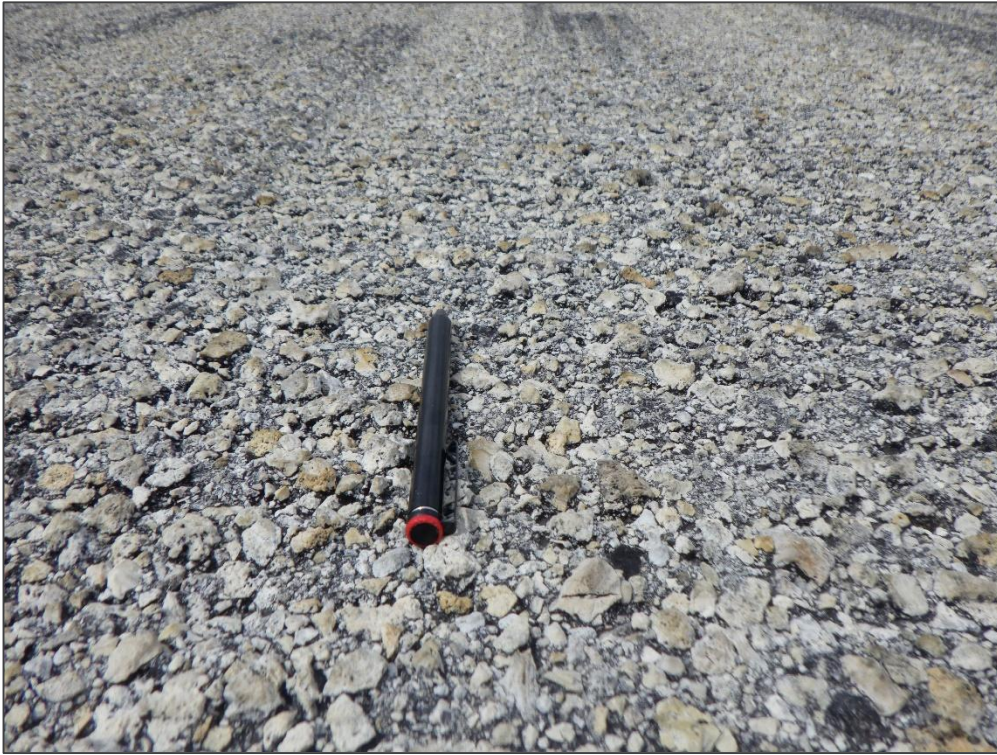
RW 5-23, Section 6105, Sample Unit 304 –Raveling

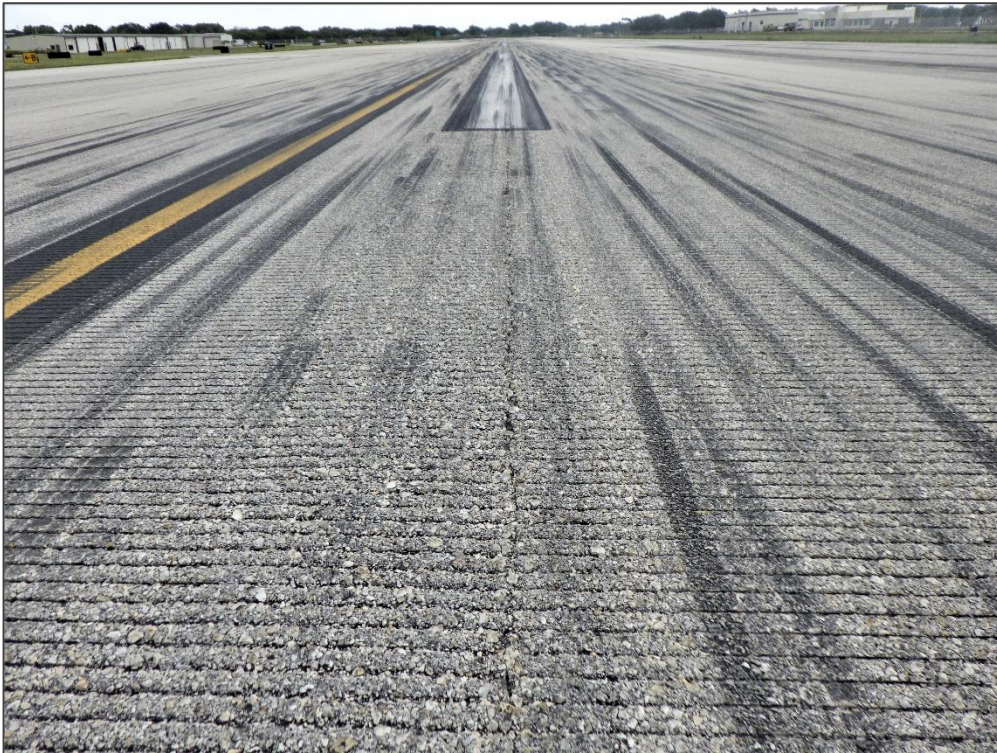
RW 5-23, Section 6105, Sample Unit 382 – Longitudinal & Transverse Cracking and Raveling

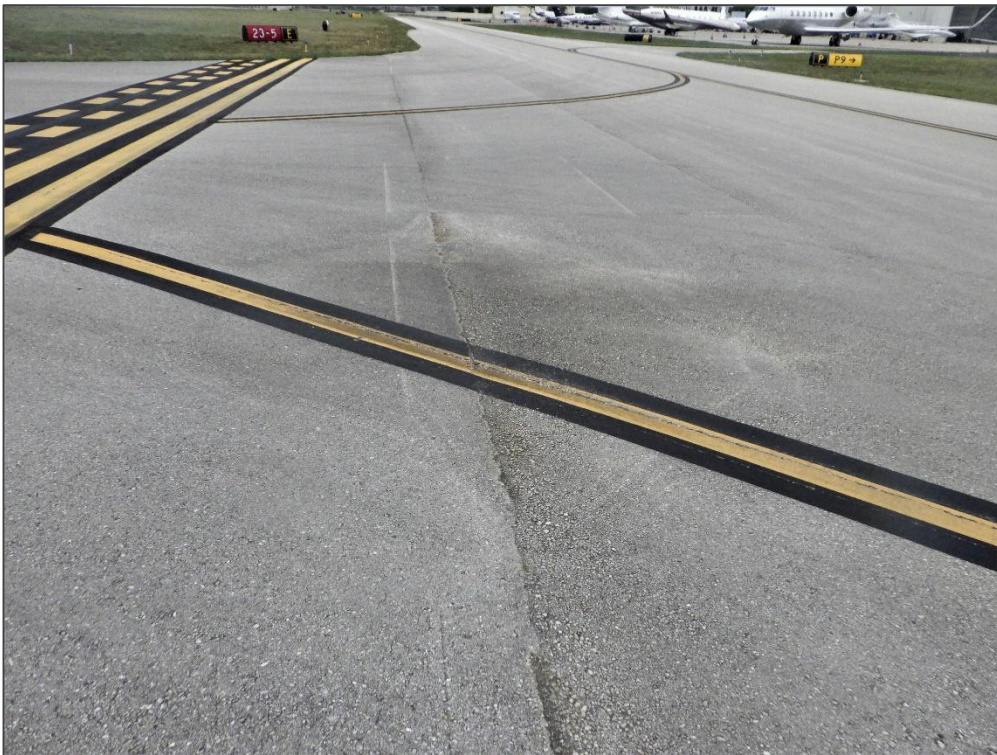
TW E, Section 116, Sample Unit 251 – Depression and Longitudinal & Transverse Cracking

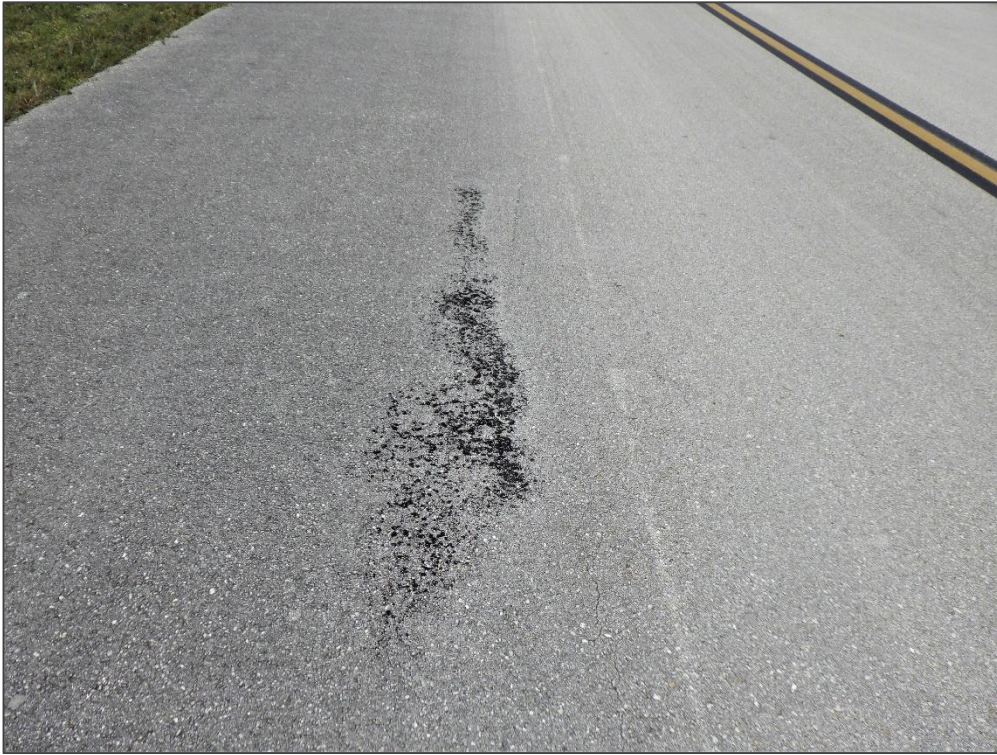
TW P, Section 105, Sample Unit 105 – Bleeding

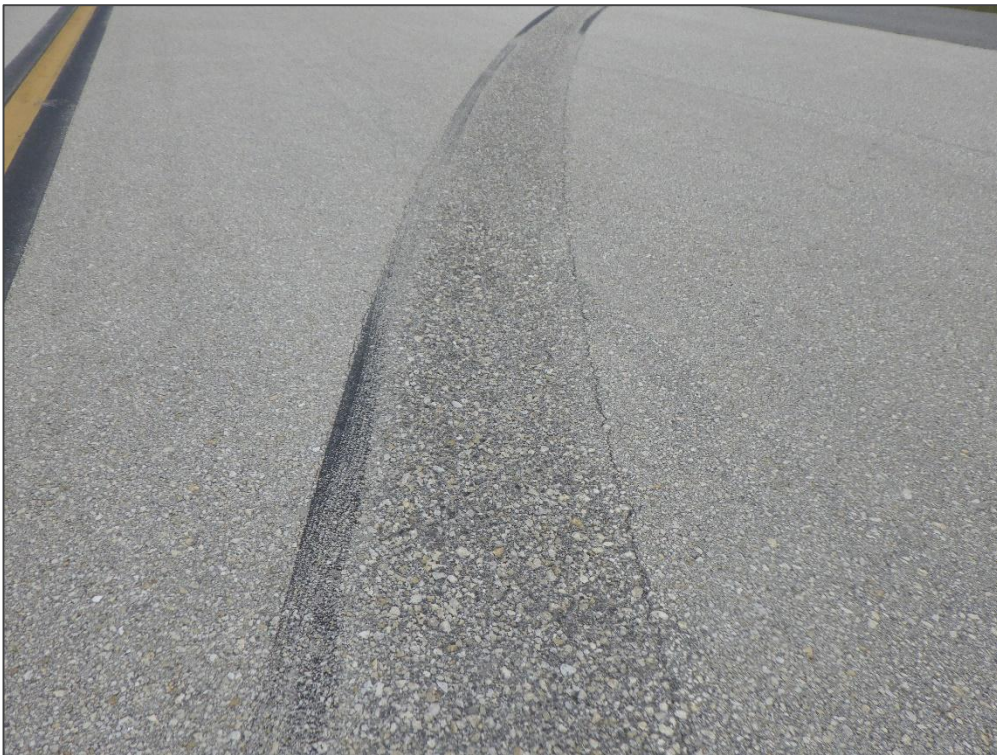
TW P, Section 105, Sample Unit 145 – Raveling

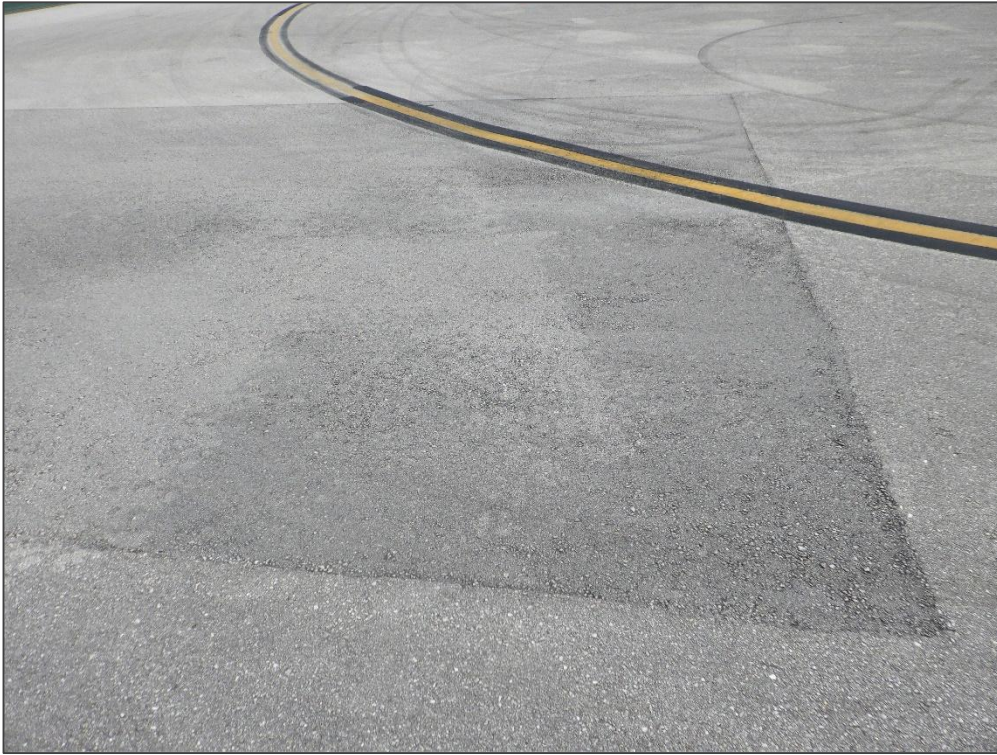
AP RU 5, Section 5115, Sample Unit 201 – Patching

AP RU 5:5115
2027 | AC REHAB
\$0.15 M
