*Statewide Airfield Pavement Management Program*

# Airport Pavement Evaluation Report

CLW - Clearwater Air Park | *District 7*

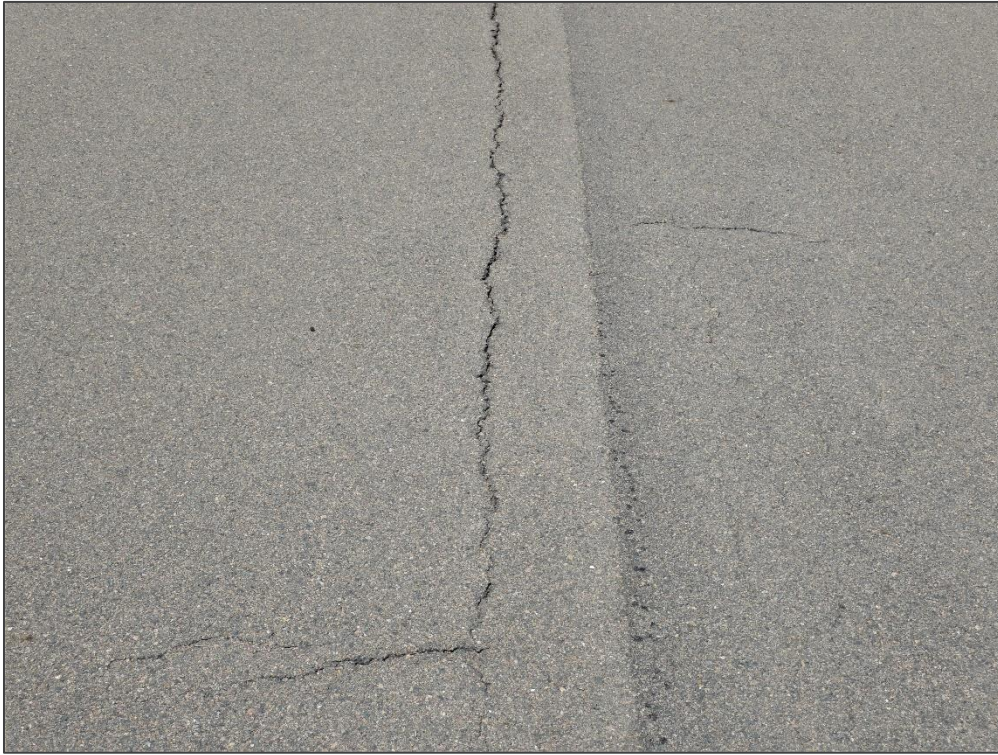
RW 16-34, Section 6110, Sample Unit 110 – Longitudinal & Transverse Cracking

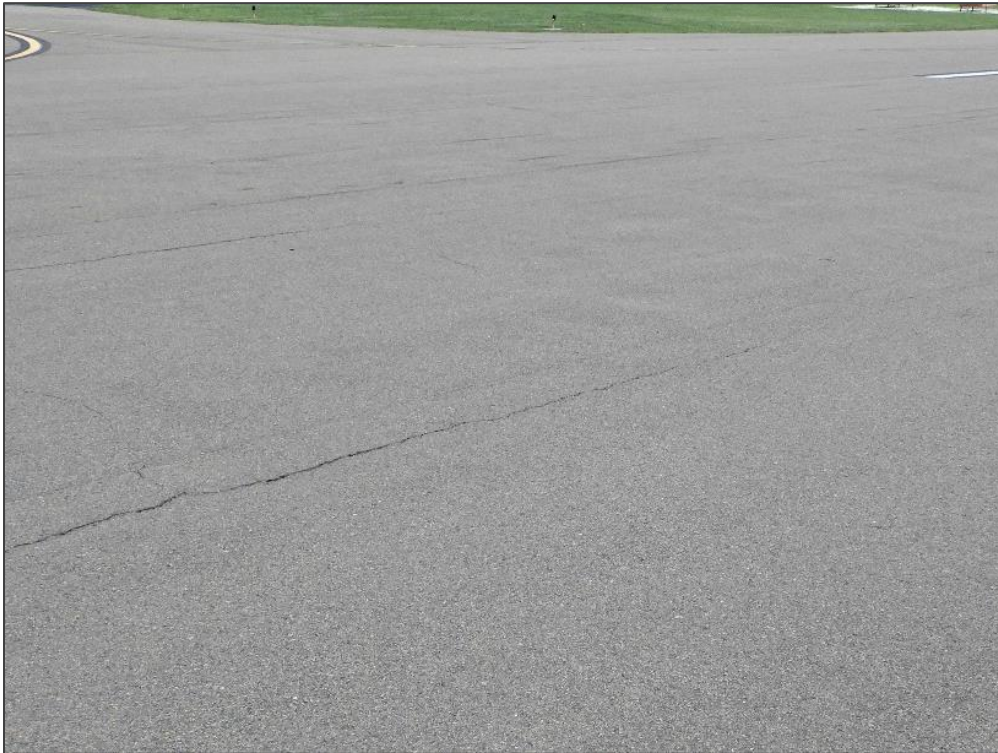
RW 16-34, Section 6110, Sample Unit 130 – Longitudinal & Transverse Cracking and Swelling

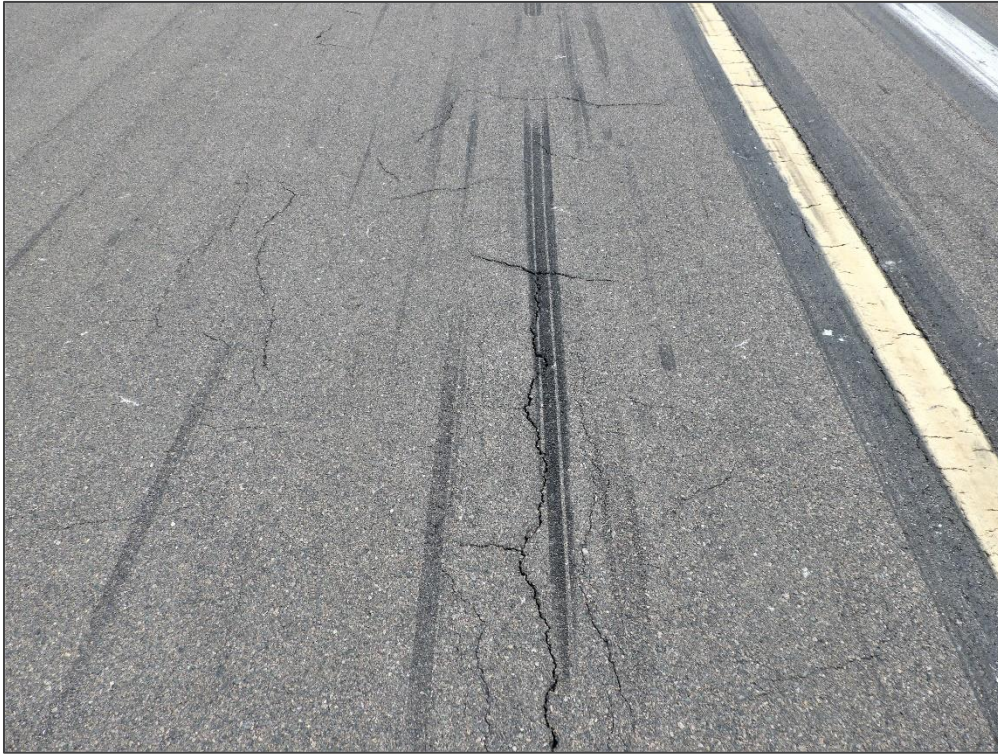
RW 16-34, Section 6110, Sample Unit 155 – Longitudinal & Transverse Cracking

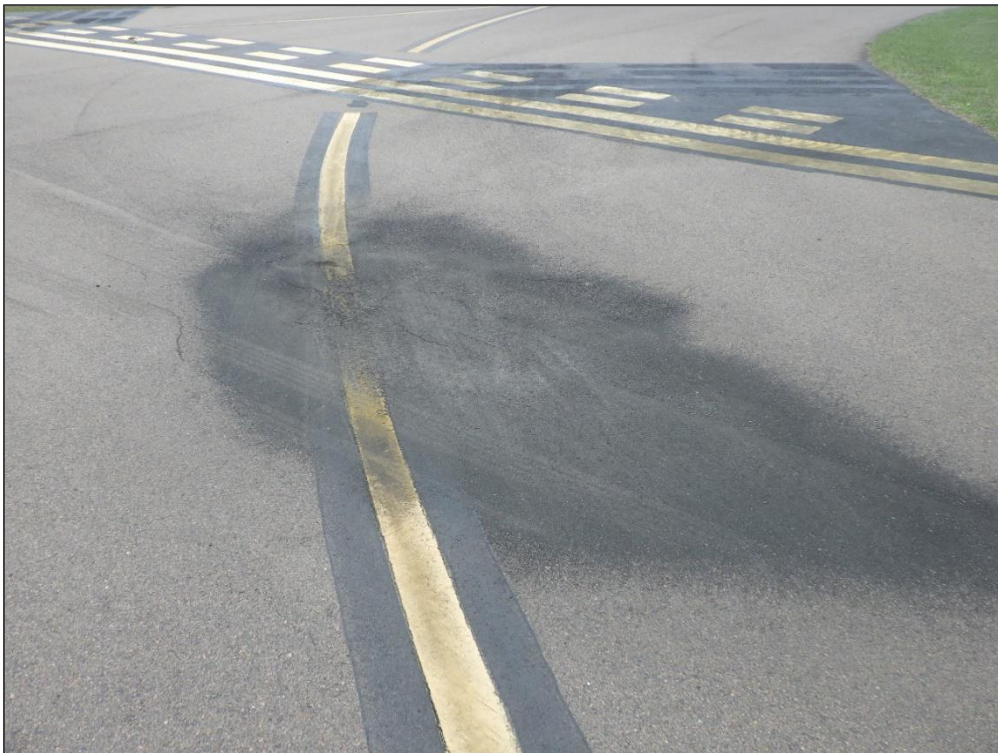
TW A, Section 105, Sample Unit 102 – Depression

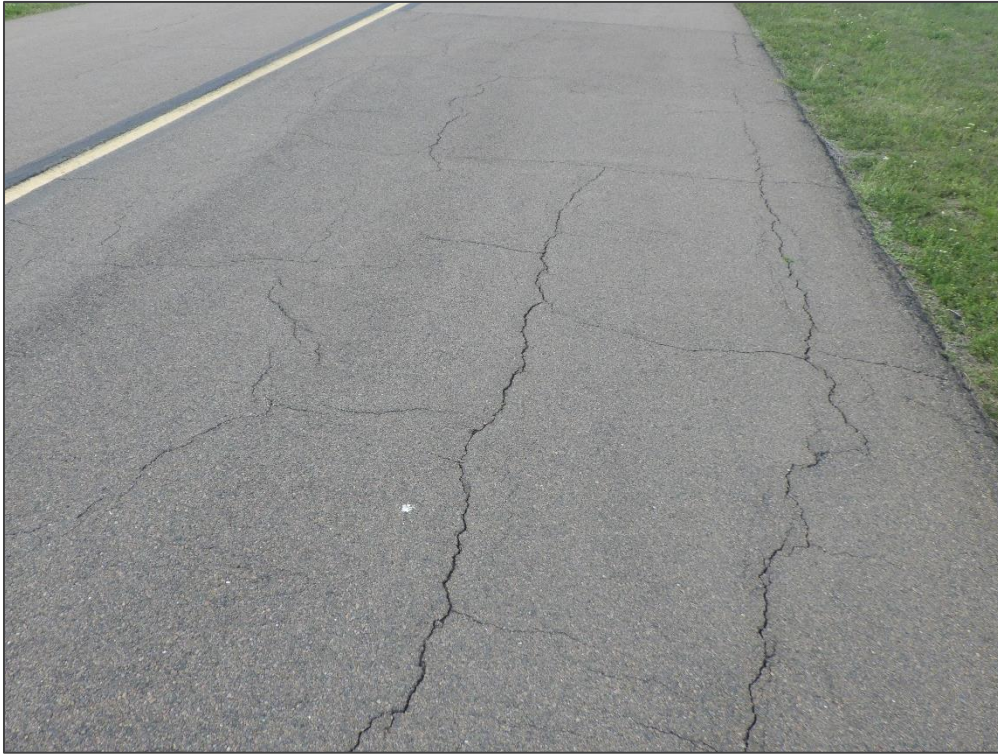
TW A, Section 135, Sample Unit 128 – Block Cracking

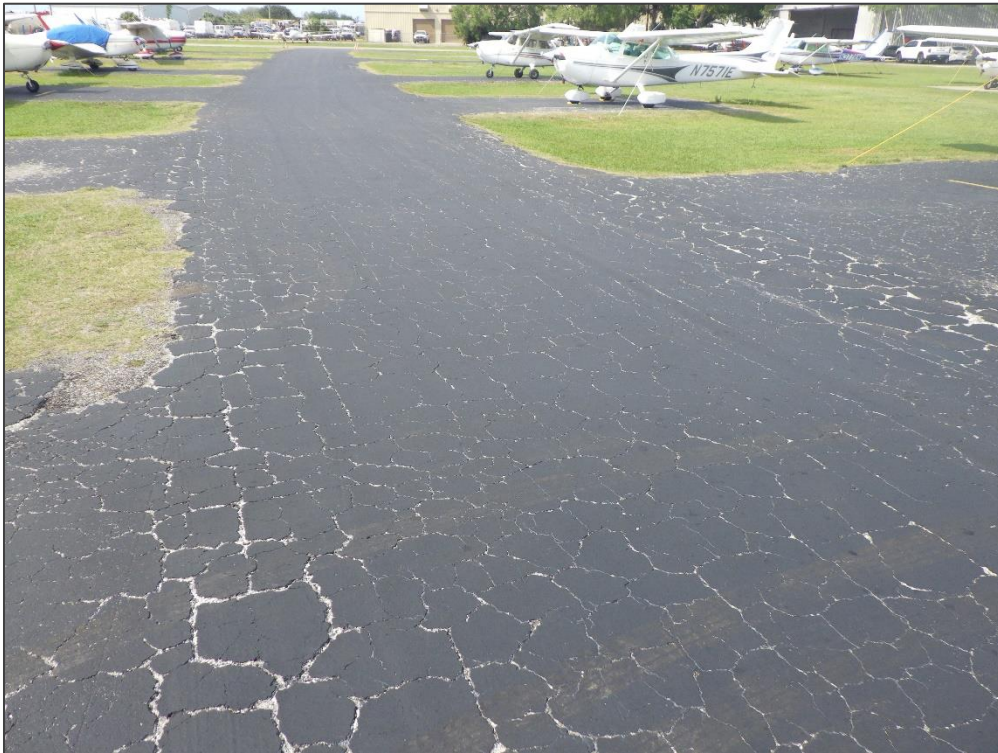
TL CENTER, Section 3410, Sample Unit 301 – Raveling

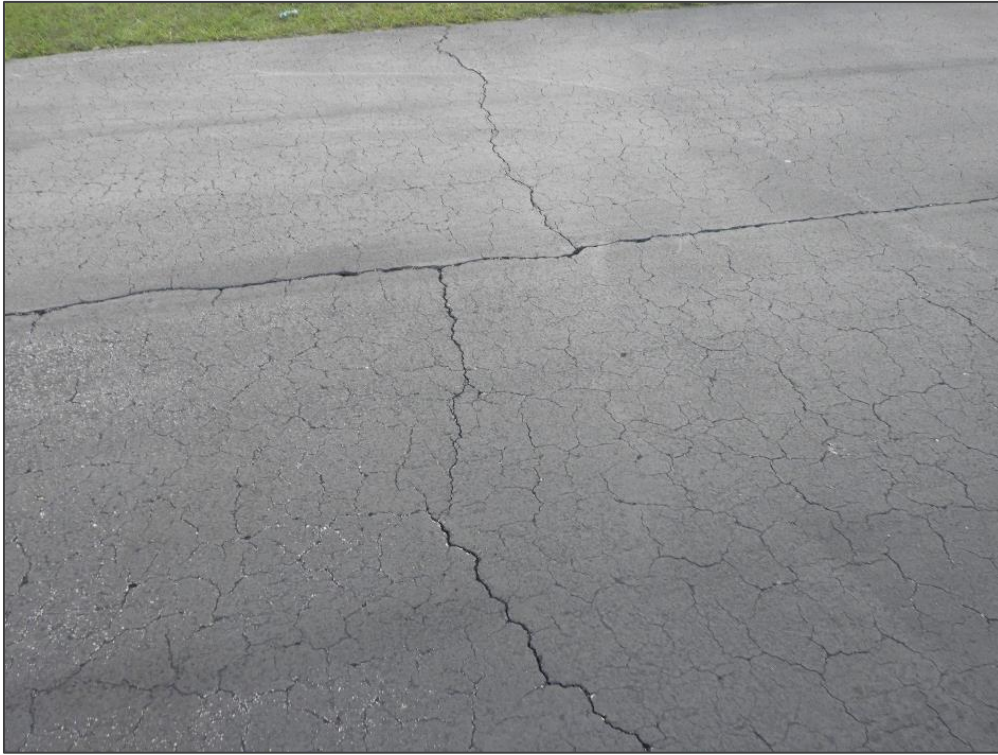
TL T-HANG, Section 3605, Sample Unit 105 – Longitudinal & Transverse Cracking and Raveling

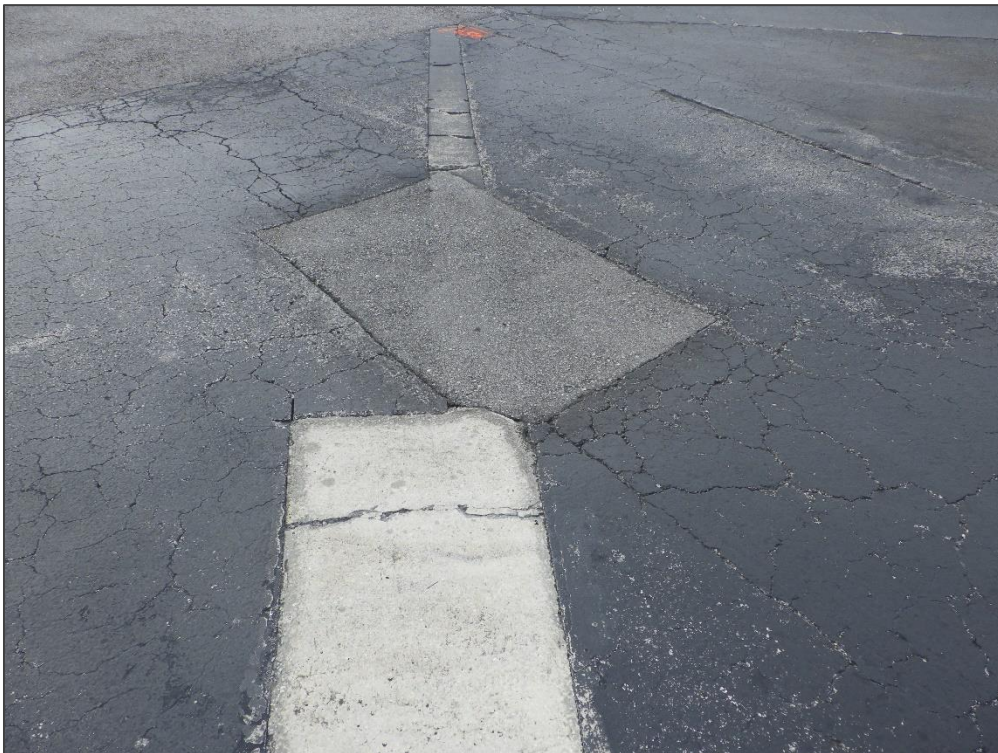
AP T-HANG, Section 4305, Sample Unit 650 – Patching and Raveling
