FLORIDA DEPARTMENT OF TRANSPORTATION | AVIATION OFFICE 2022

Statewide Airfield Pavement Management Program

Airport Pavement Evaluation Report

EVB - New Smyrna Beach Municipal Airport | District 5

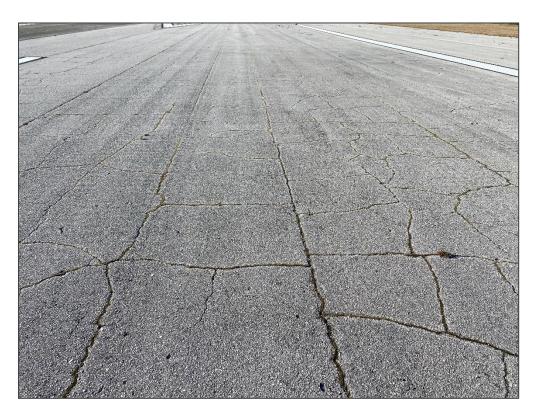
RW 2-20, Section 6405, Sample Unit 107 - Block Cracking

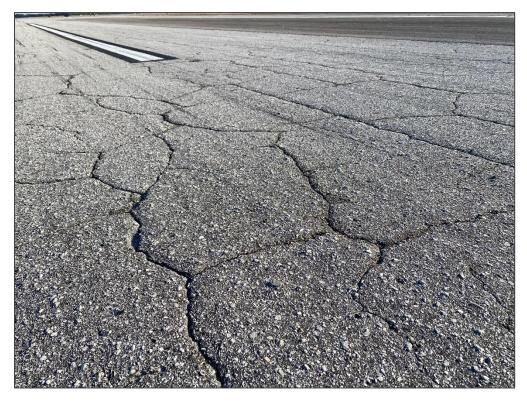
RW 2-20, Section 6425, Sample Unit 128 - Block Cracking

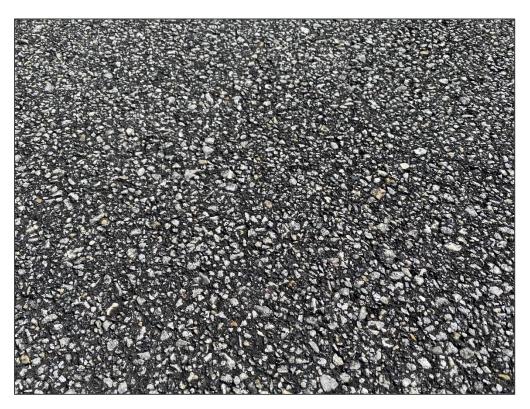
RW 7-25, Section 6202, Sample Unit 103 - Weathering

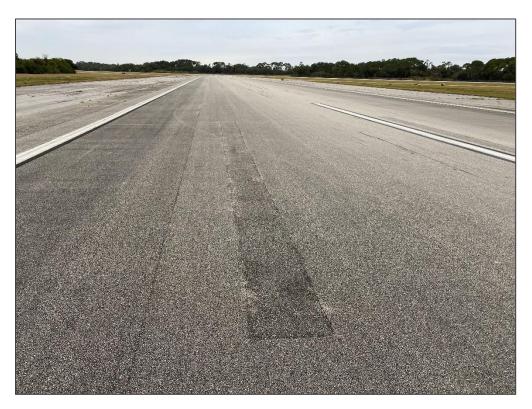
RW 11-29, Section 6105, Sample Unit 119 - Patching

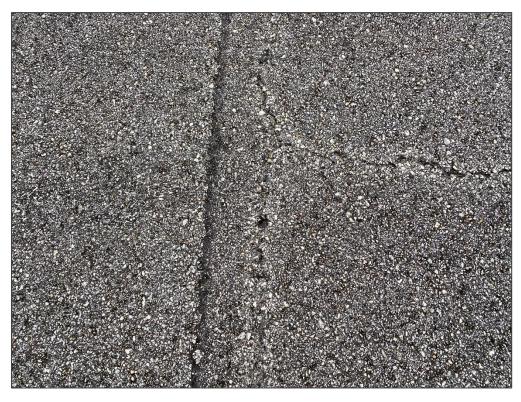
RW 11-29, Section 6105, Sample Unit 170 - Longitudinal & Transverse Cracking

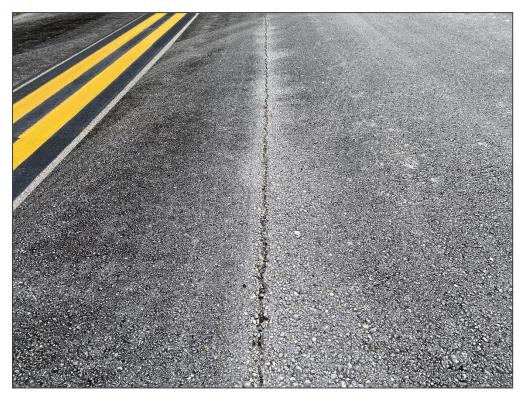
TW B, Section 215, Sample Unit 123 - Longitudinal & Transverse Cracking

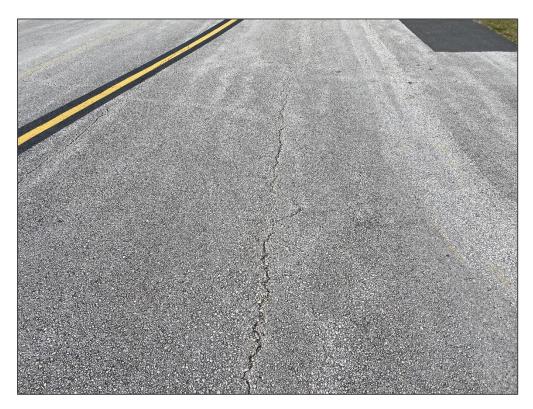
TW C, Section 310, Sample Unit 135 - Longitudinal & Transverse Cracking

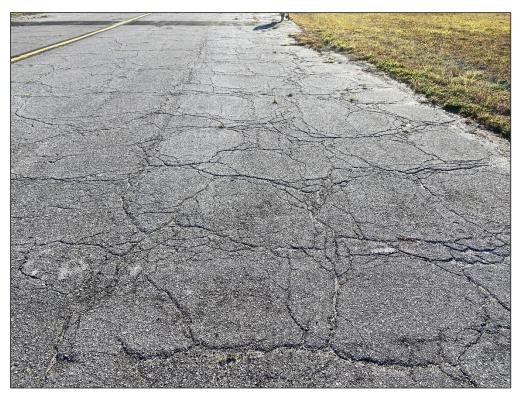
TW D, Section 415, Sample Unit 98 - Block Cracking

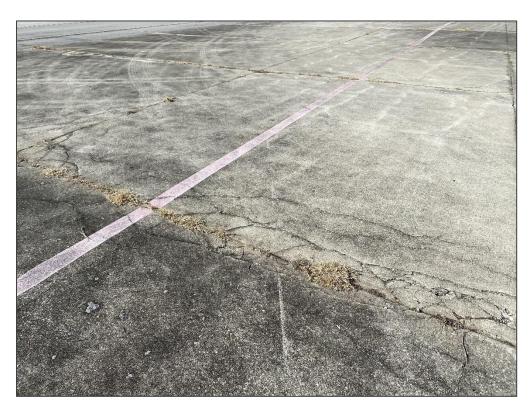
AP, Section 4102, Sample Unit 101 - Vicinity

| Network ID | Branch ID | Branch Use | Section ID | Area (SF) | PCI | Condition Rating |
|---|---|---|---|---|---|---|
| EVB | AP | Apron | 4102 | 20,539 | 4 | Failed |

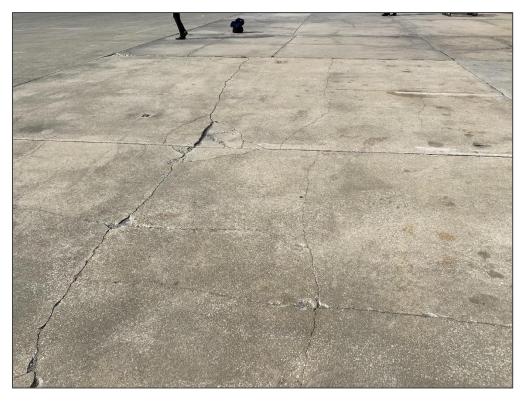
| Network ID | Branch ID | Branch Use | Section ID | Area (SF) | PCI | Condition Rating |
|---|---|---|---|---|---|---|
| EVB | AP | Apron | 4115 | 8,775 | 1 | Failed |

AP, Section 4115, Sample Unit 101 - Shattered Slab

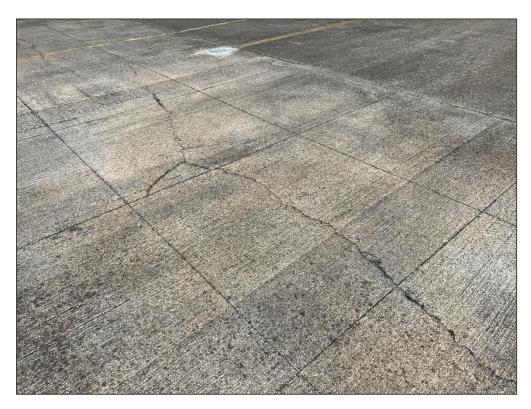
AP, Section 4121, Sample Unit 100 (Whitetopping) - Slab Cracking

| Program Year | Network ID | Branch ID | Section ID | Surface | Area (SF) | PASER Value Before | Rehabilitation Type | lanning Cost stimate |
|---|---|---|---|---|---|---|---|---|
| 2023 | EVB | AP | 4121 | WT | 12,650 | 2 | PCC Rehabilitation | \$ 190,000 |

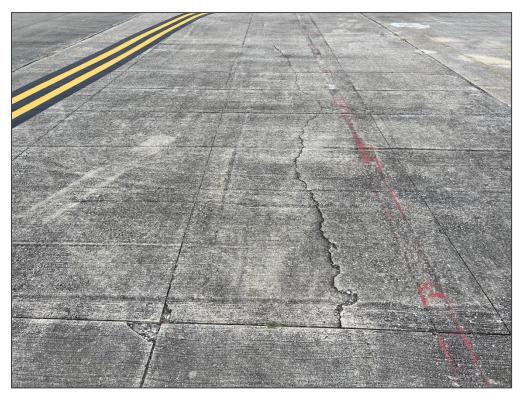
| Network ID | Branch ID | Branch Use | Section ID | Area (SF) | Surface | PASER Value | Surface Rating | Sample Units Inspected | Total Sample Units in Section |
|---|---|---|---|---|---|---|---|---|---|
| EVB | AP | Apron | 4155 | 3,500 | WT | 3 | Fair | 1 | 1 |

AP, Section 4155, Sample Unit 102 (Whitetopping) - Slab Cracking
