Statewide Airfield Pavement Management Program

Airport Pavement Evaluation Report

FHB - Fernandina Beach Municipal Airport | *District 2*

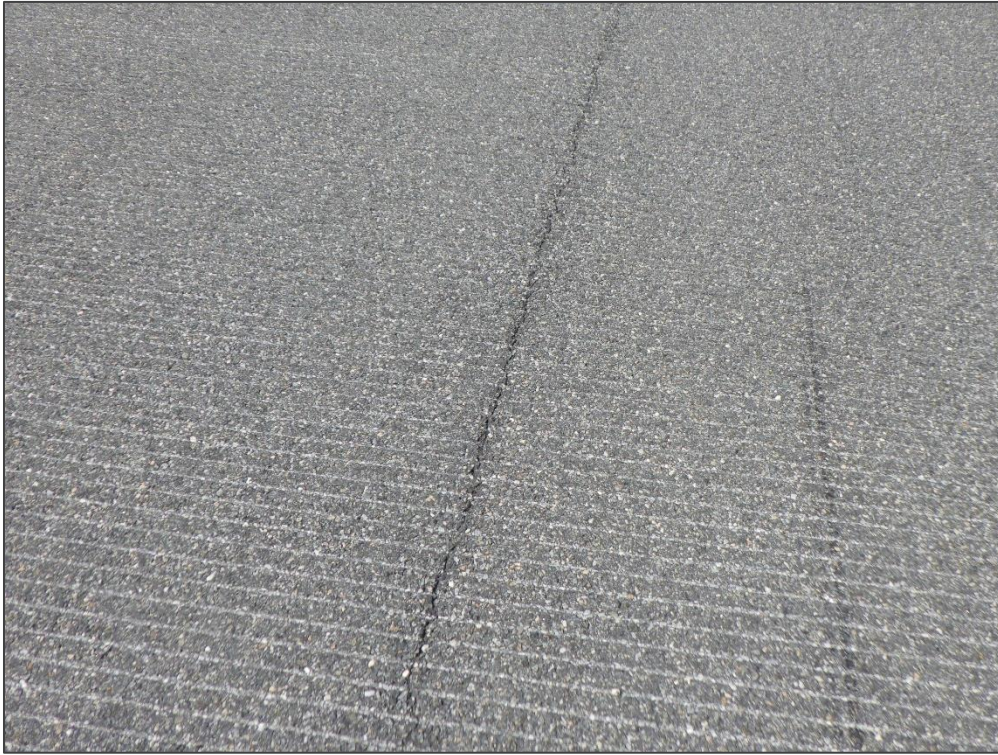
RW 4-22, Section 6110, Sample Unit 185 – Longitudinal & Transverse Cracking

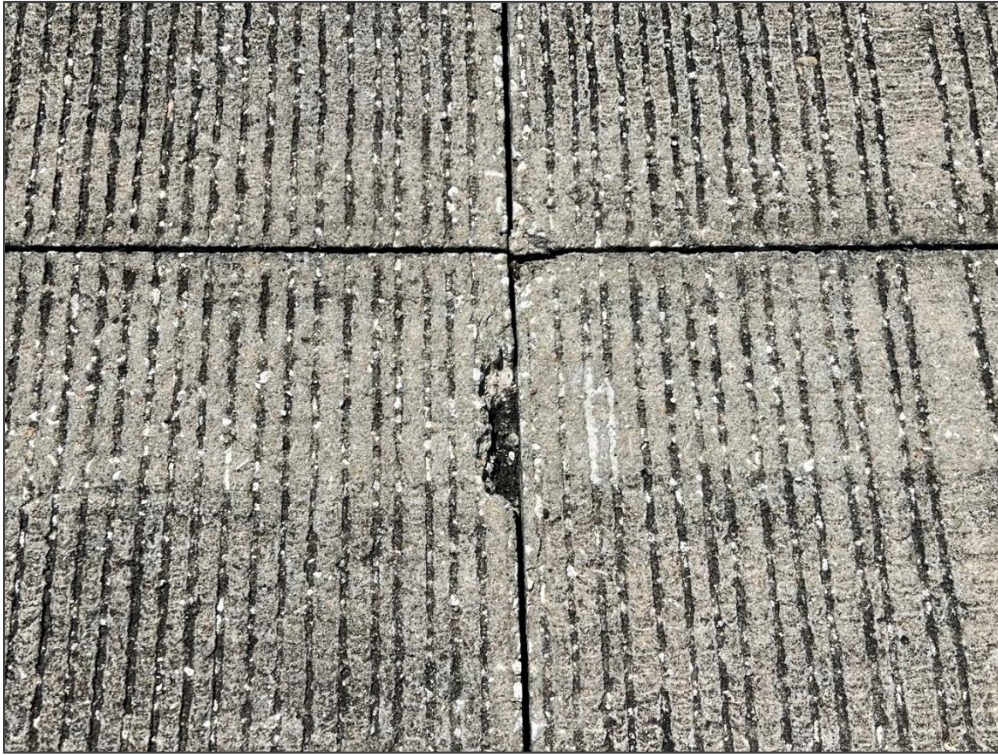
RW 9-27, Section 6315, Sample Unit 324 (Whitetopping) – Spalling

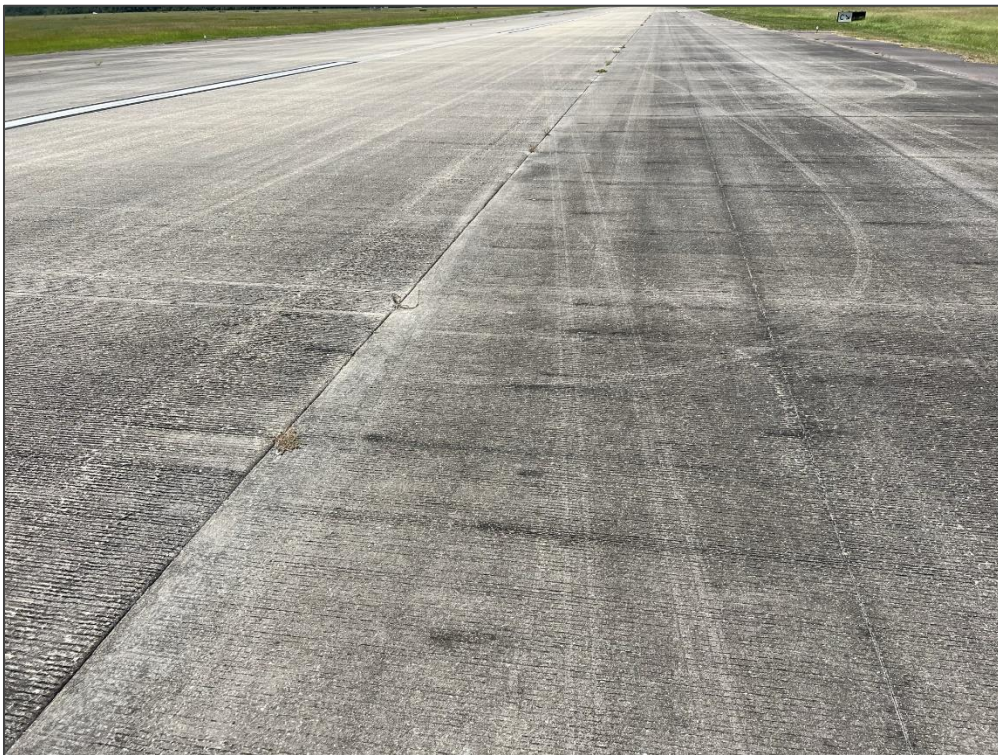
RW 9-27, Section 6330, Sample Unit 364 (Whitetopping) – Joint Seal Damage

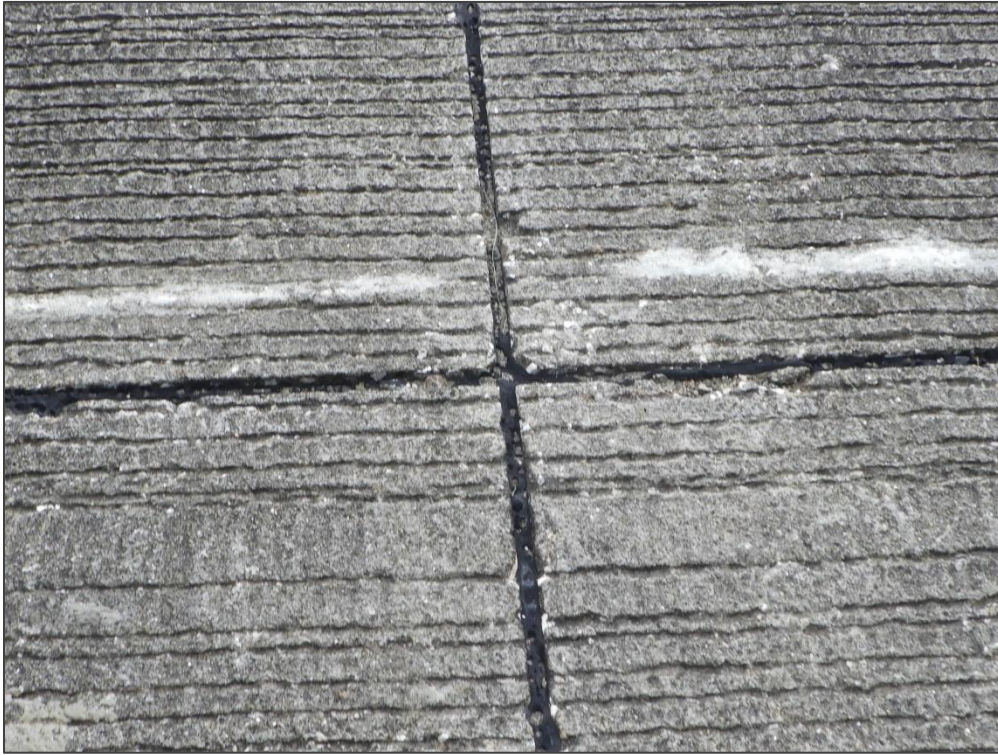
RW 9-27, Section 6335, Sample Unit 406 – Joint Seal Damage

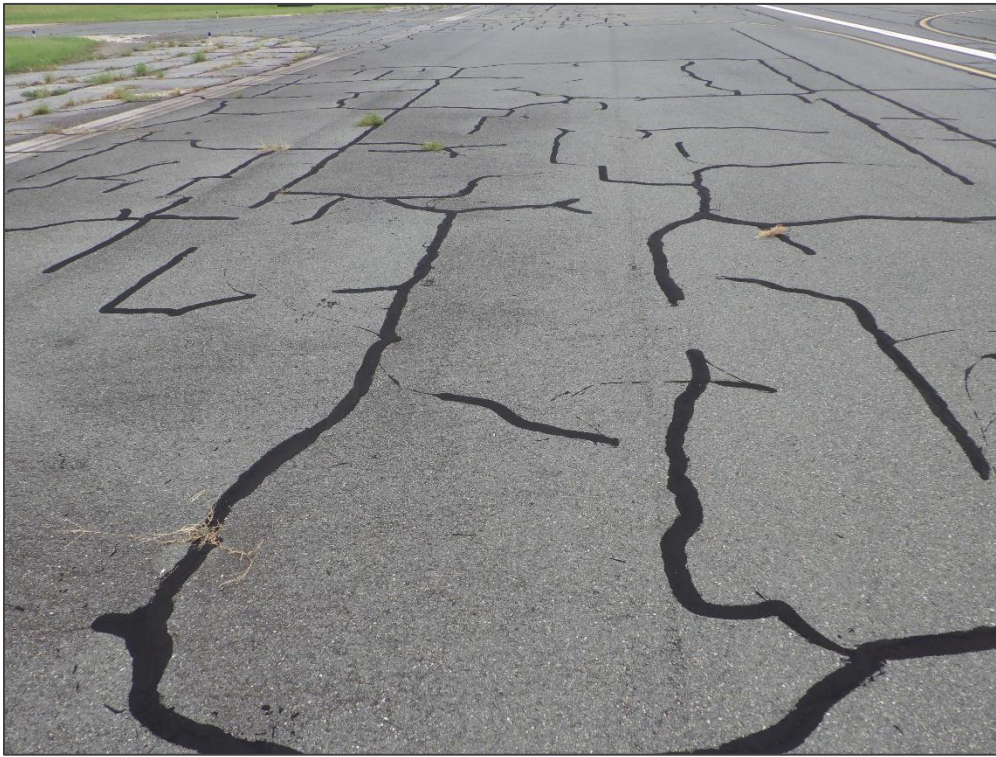
RW 13-31, Section 6215, Sample Unit 365 – Longitudinal & Transverse Cracking

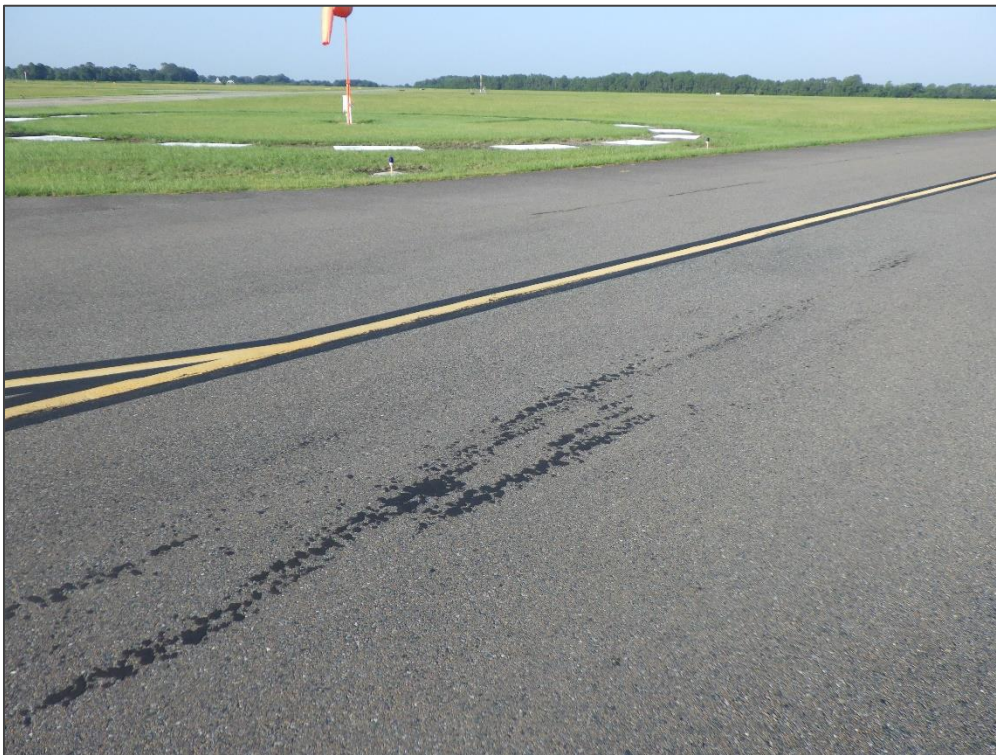
TW A, Section 325, Sample Unit 125 – Bleeding

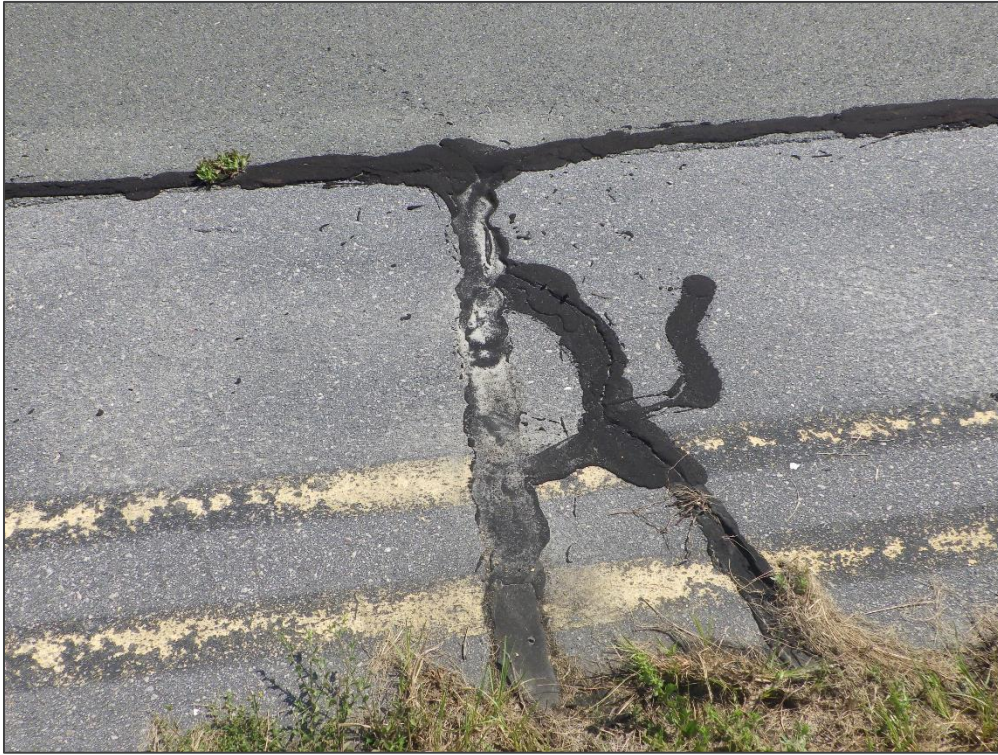
TW B, Section 230, Sample Unit 141 – Longitudinal & Transverse Cracking

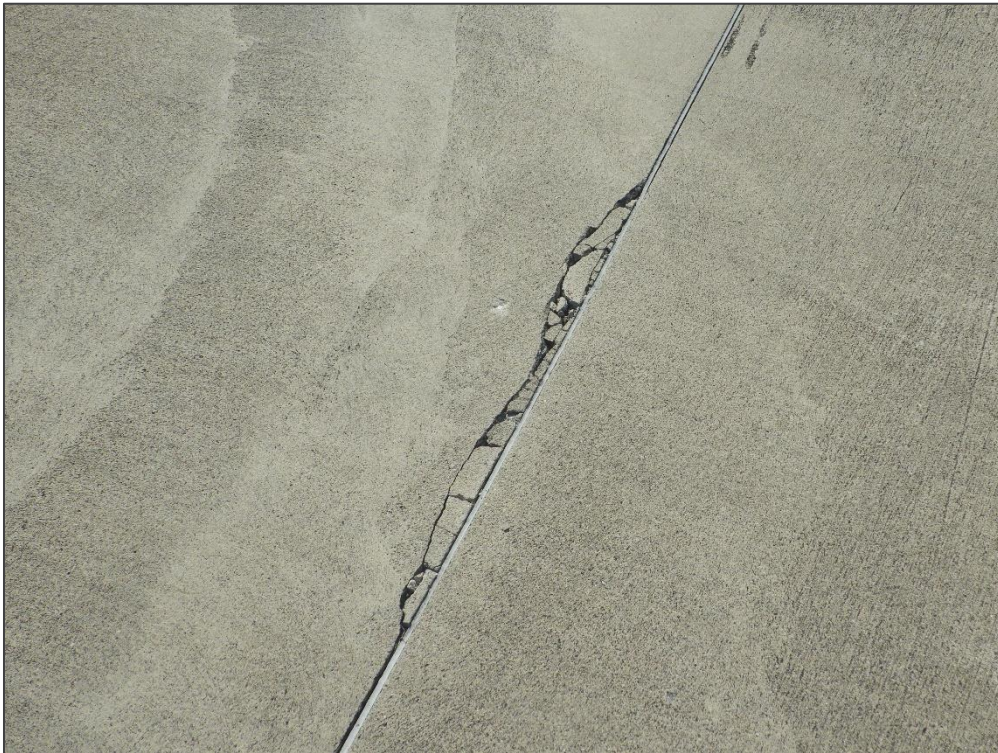
TW C, Section 125, Sample Unit 99 – Joint Spall

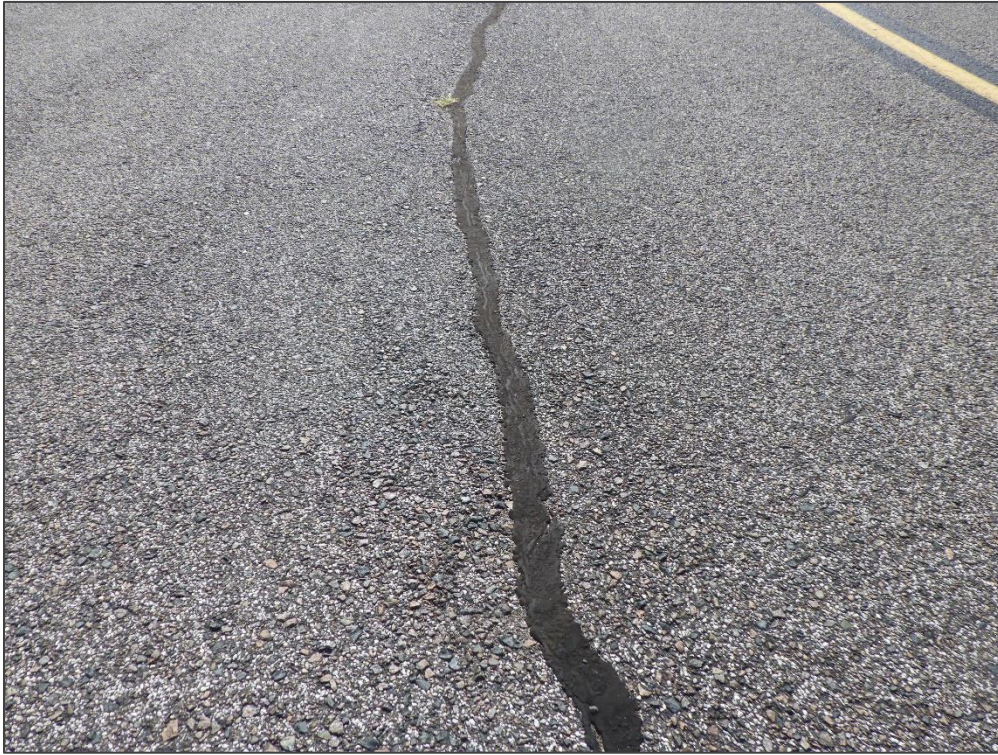
TW D, Section 410, Sample Unit 103 – Longitudinal & Transverse Cracking

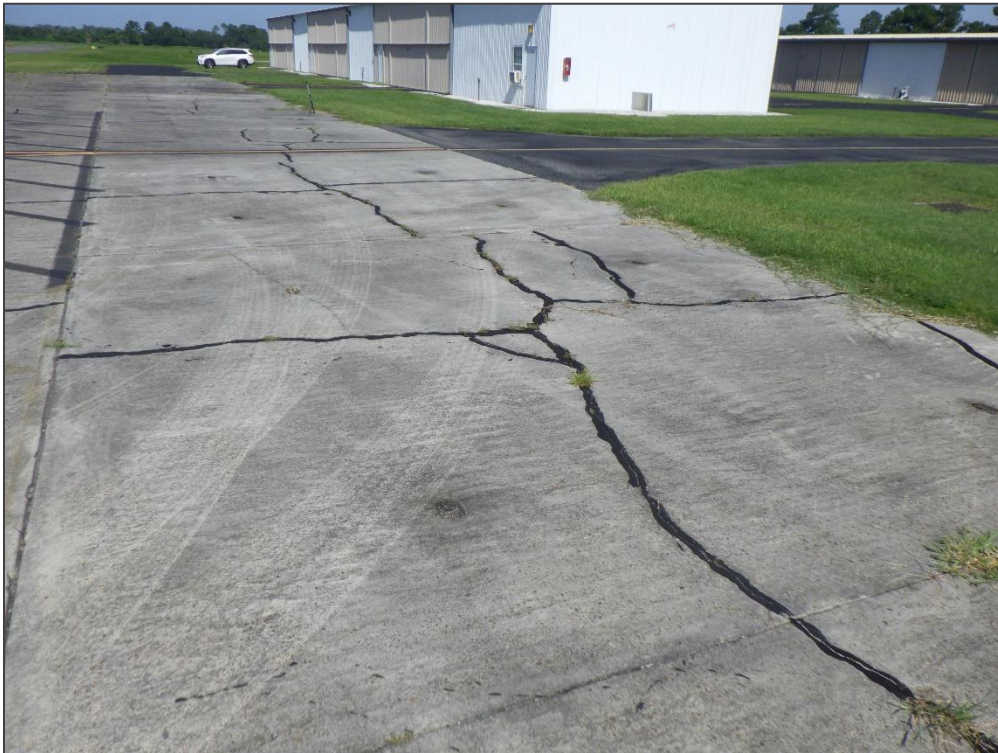
AP N, Section 4220, Sample Unit 365 – Shattered Slab

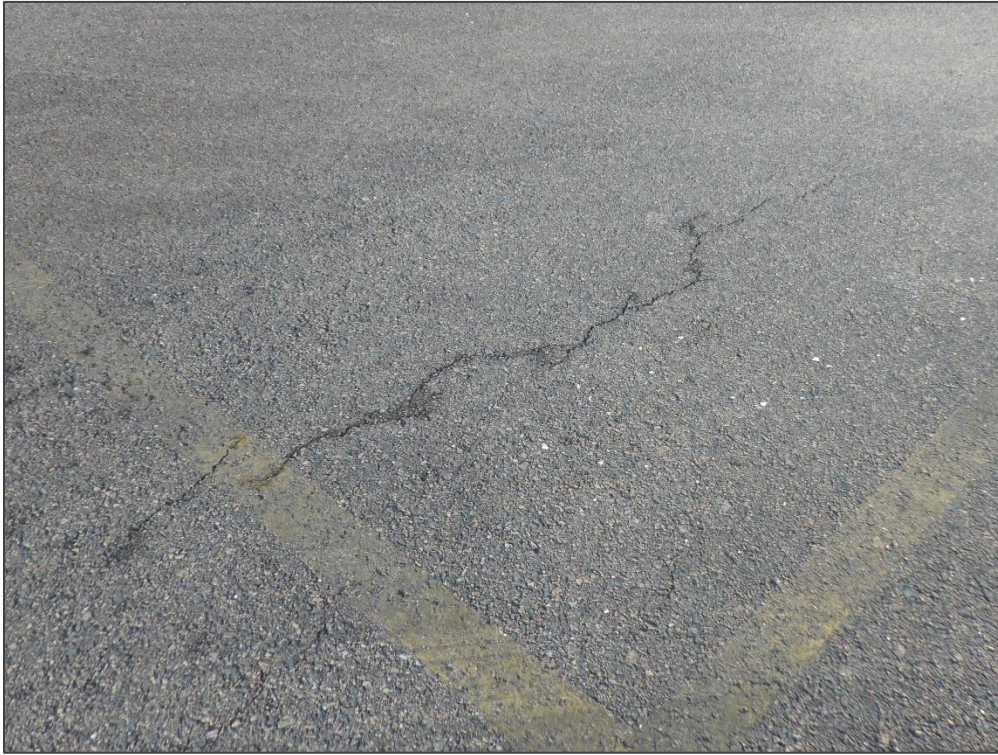
AP N, Section 4240, Sample Unit 252 – Longitudinal & Transverse Cracking

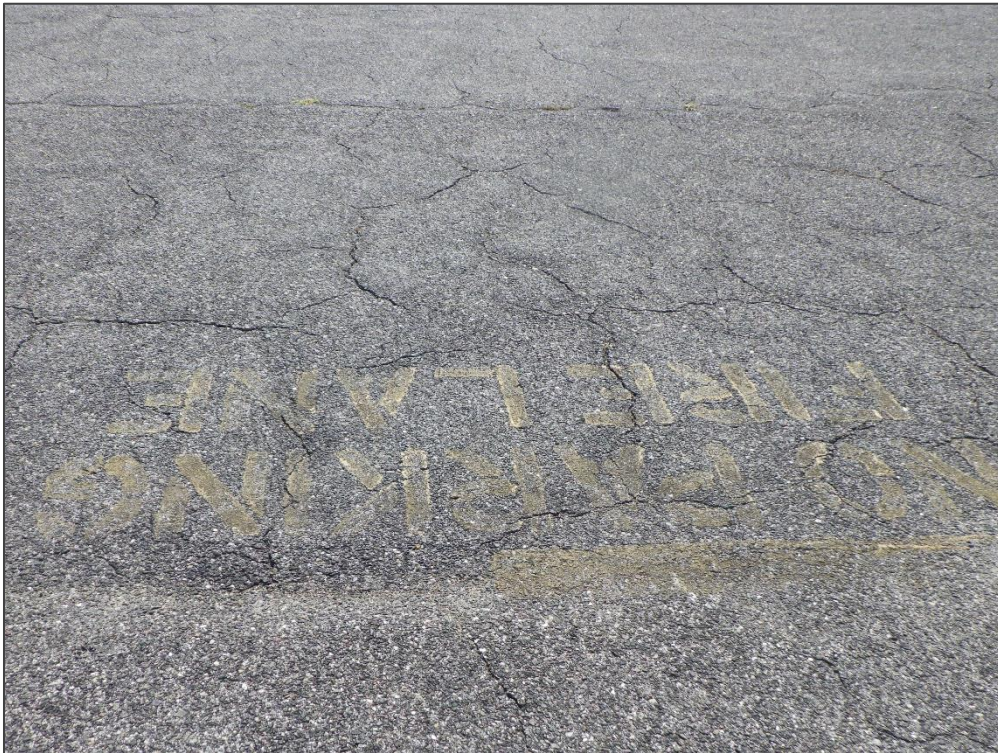
AP NW, Section 4105, Sample Unit 100 – Block Cracking and Swelling
