Statewide Airfield Pavement Management Program

Airport Pavement Evaluation Report

HEG - Herlong Recreational Airport | *District 2*

Florida Department of Transportation

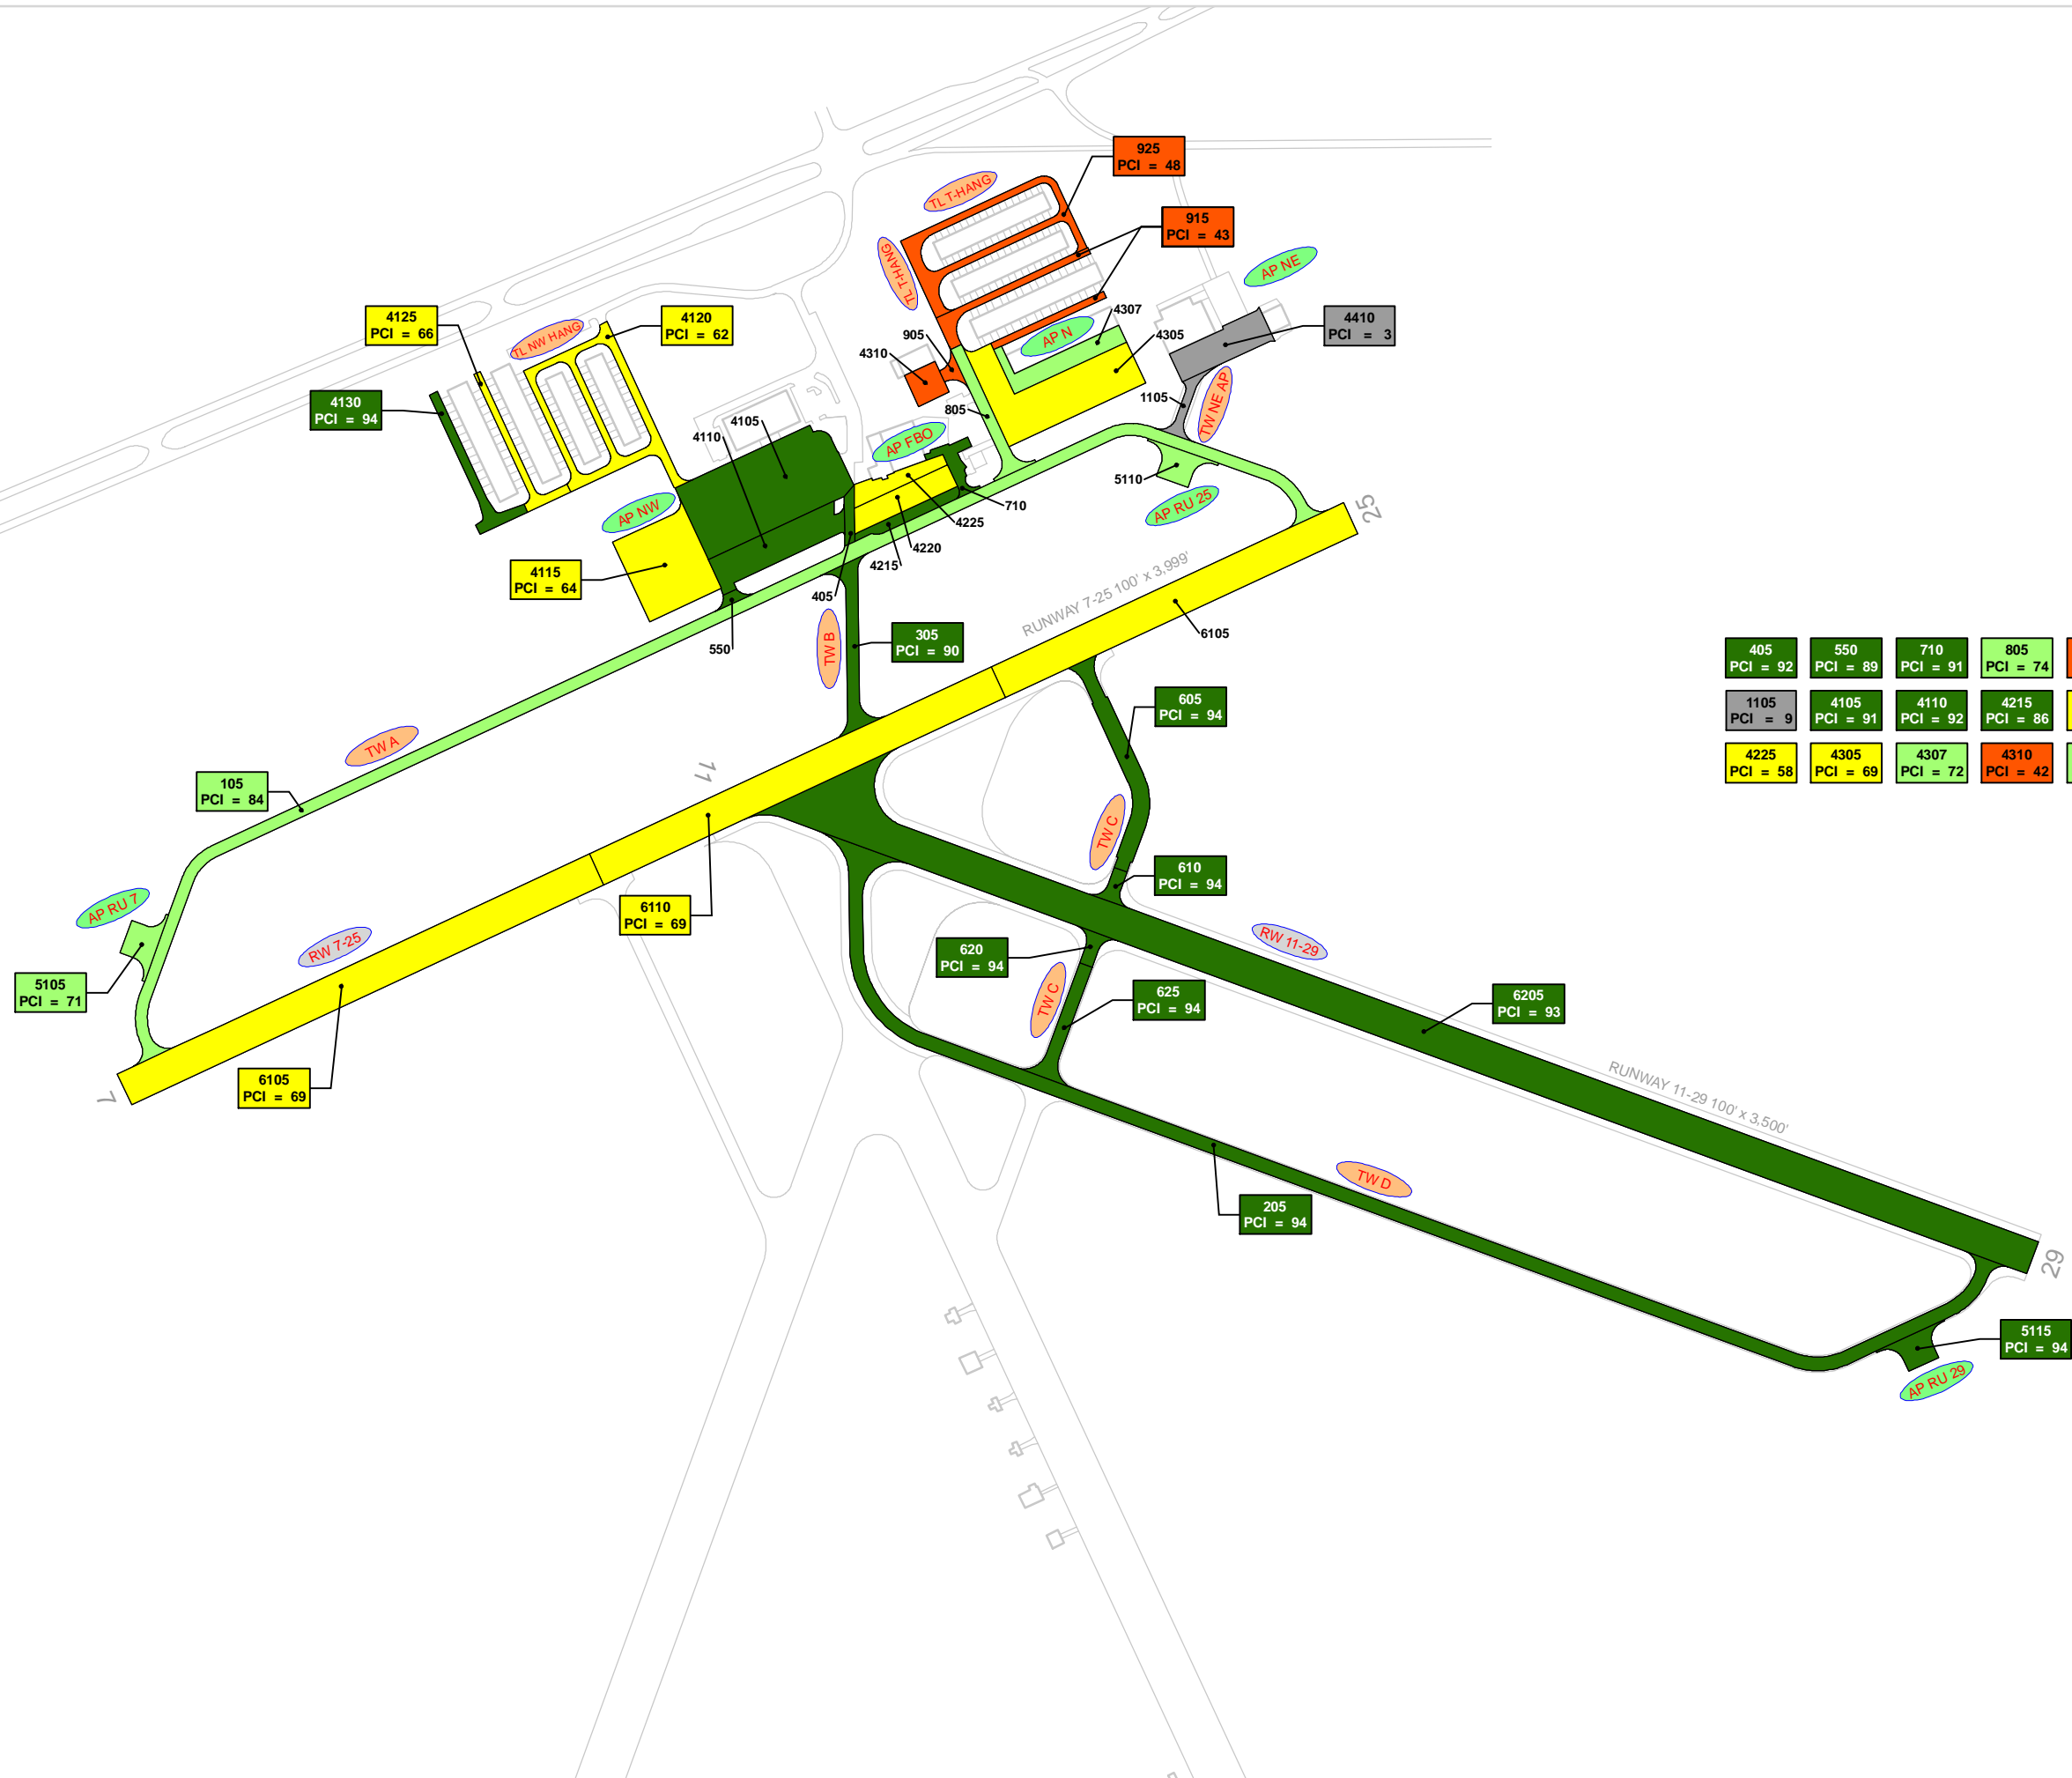
2022 PAVEMENT CONDITION INDEX

405 PCI = 92	550 PCI = 89	710 PCI = 91	805 PCI = 74	905 PCI = 41
1105 PCI = 9	4105 PCI = 91	4110 PCI = 92	4215 PCI = 86	4220 PCI = 61
4225 PCI = 58	4305 PCI = 69	4307 PCI = 72	4310 PCI = 42	5110 PCI = 77

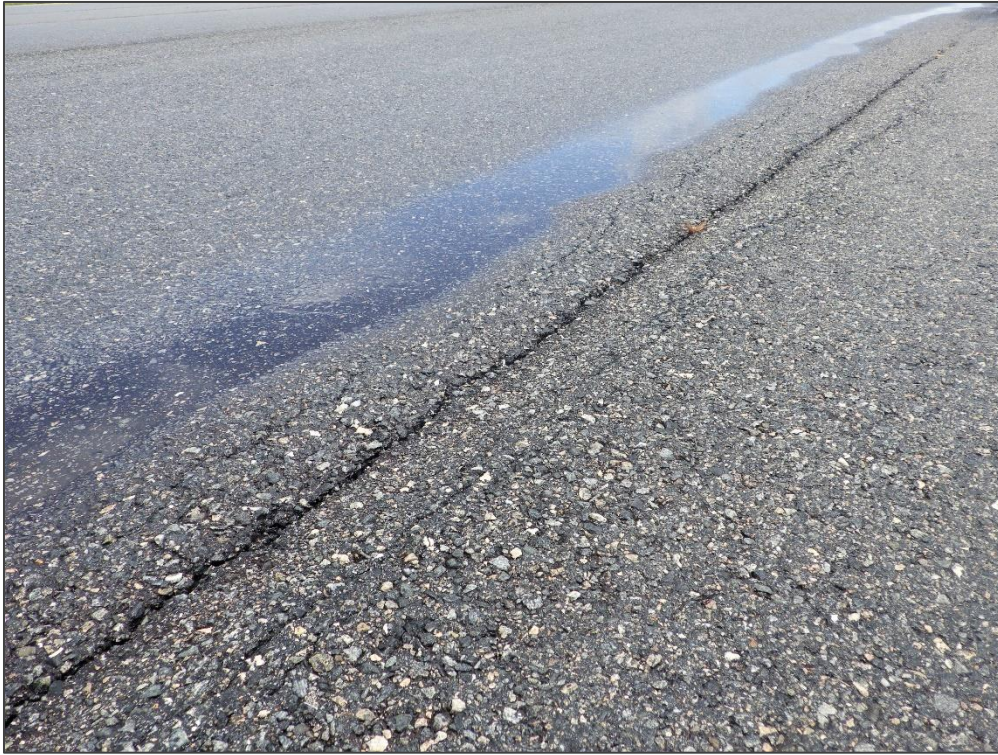
RW 7-25, Section 6105, Sample Unit 161 – Longitudinal & Transverse Cracking and Swelling

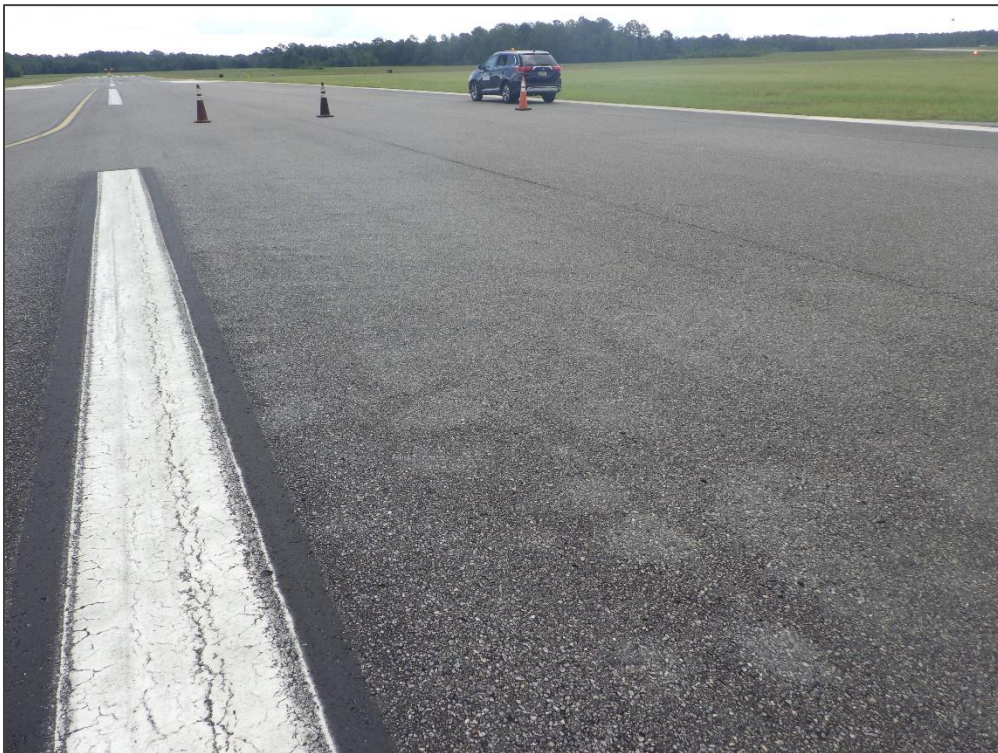
RW 7-25, Section 6110, Sample Unit 149 – Swelling

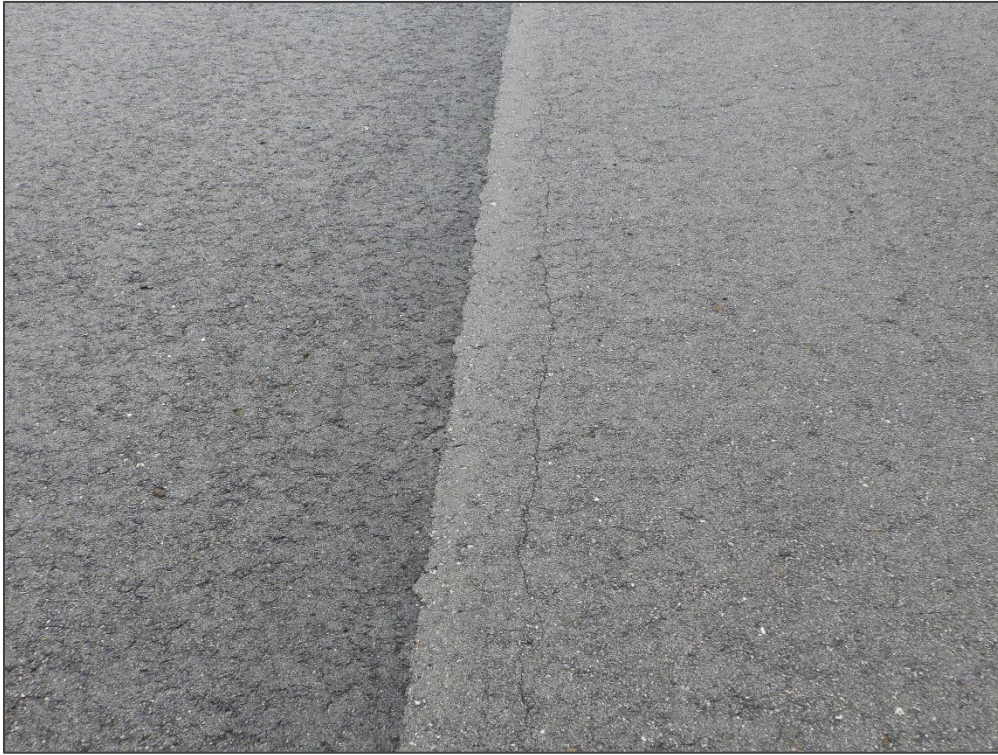
RW 11-29, Section 6205, Sample Unit 143 – Longitudinal & Transverse Cracking

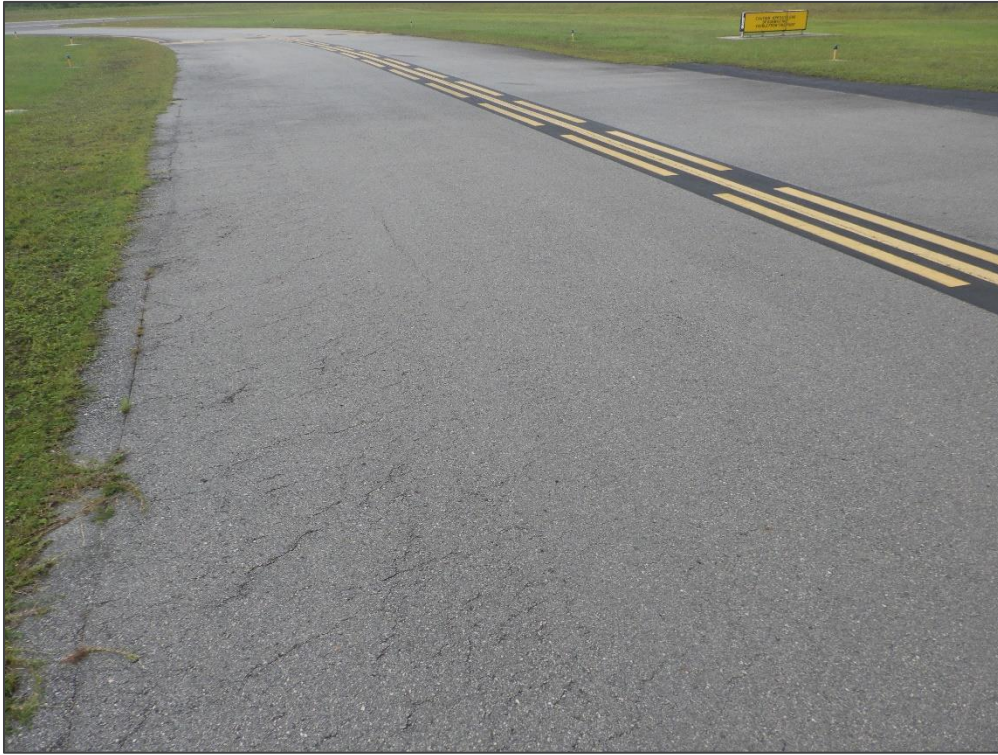
TW A, Section 105, Sample Unit 102 – Longitudinal & Transverse Cracking and Patching

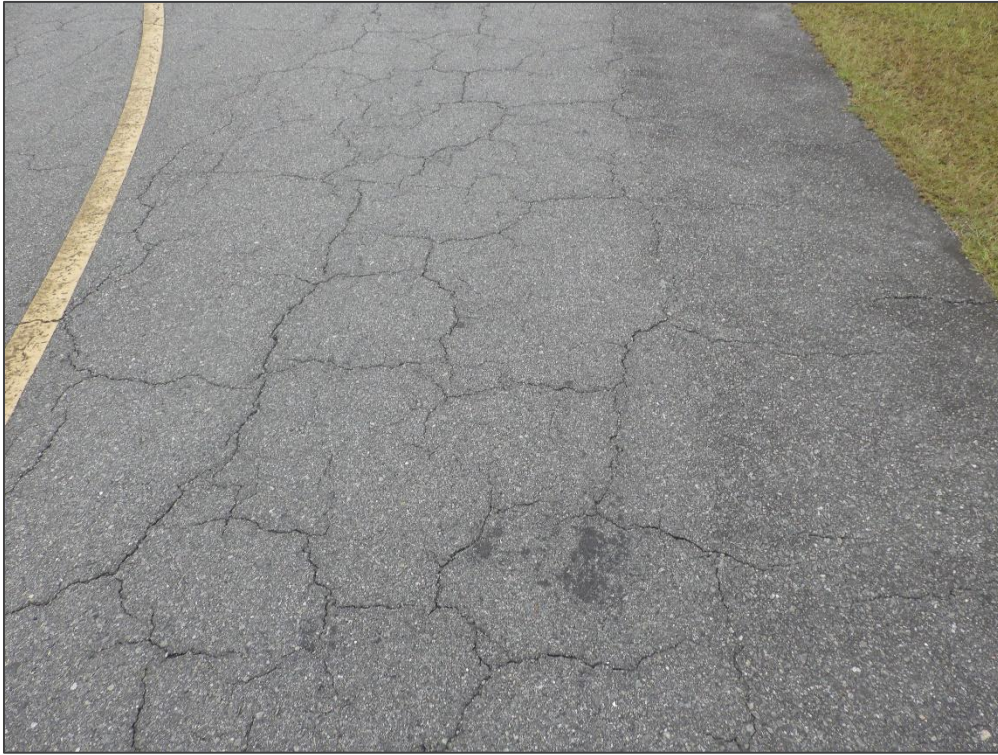
TL T-HANG, Section 915, Sample Unit 300 – Block Cracking

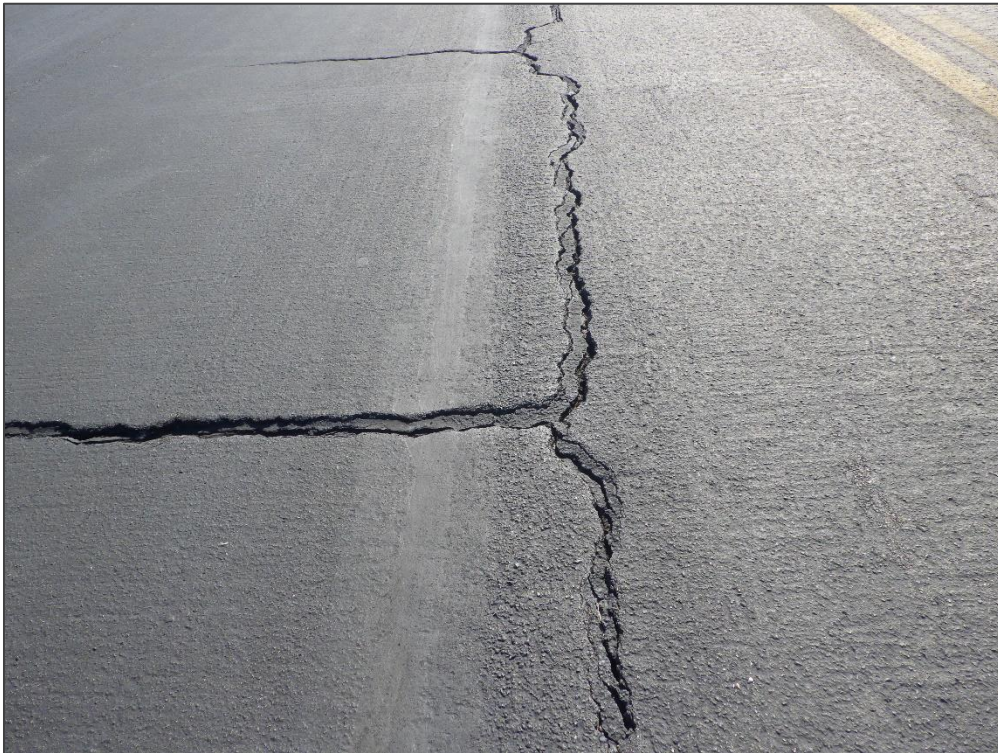
AP FBO, Section 4220, Sample Unit 250 – Longitudinal & Transverse Cracking

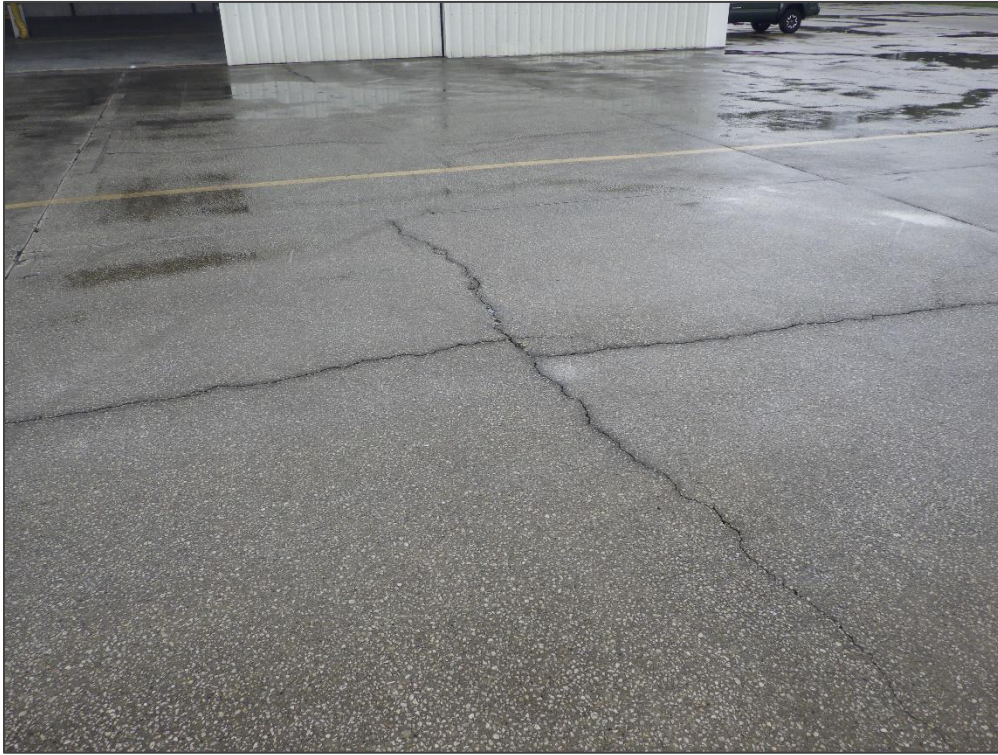
AP NE, Section 4410, Sample Unit 101 – Shattered Slab

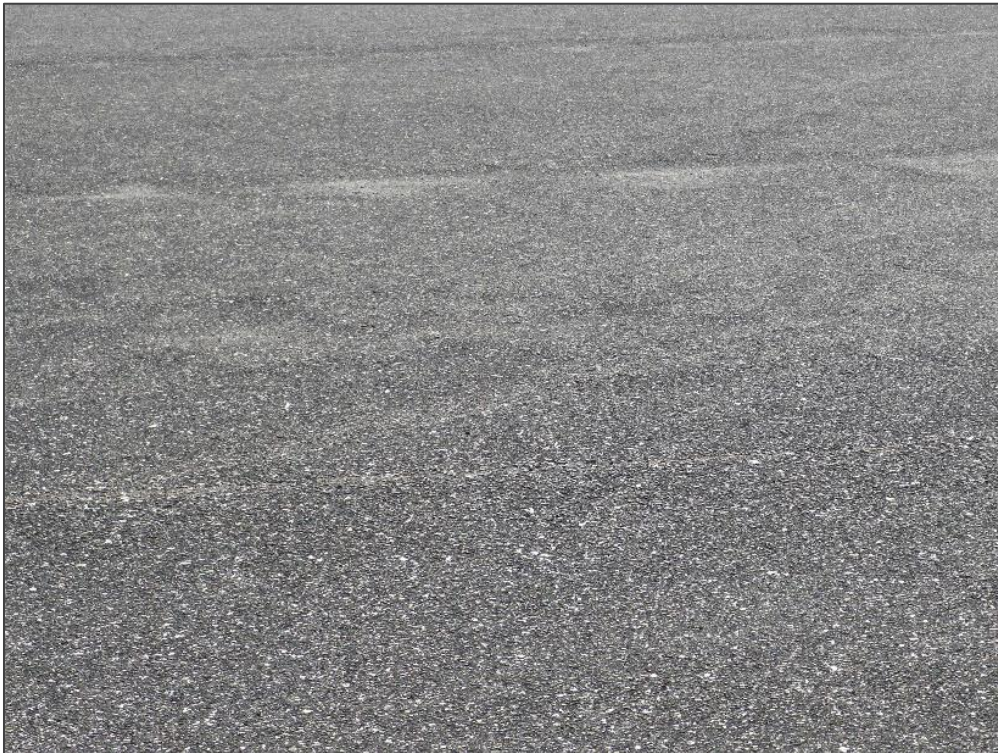
AP NW, Section 4115, Sample Unit 502 – Swelling and Weathering
