Statewide Airfield Pavement Management Program

# Airport Pavement Evaluation Report

LNA - Palm Beach County Park Airport | *District 4*

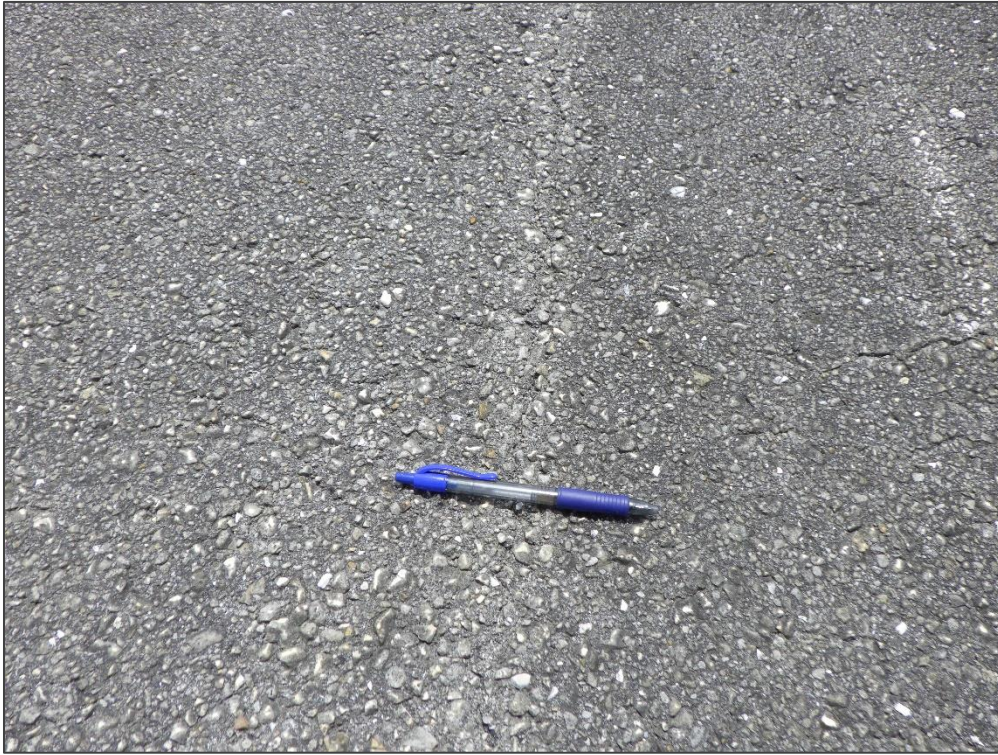
RW 4-22, Section 6305, Sample Unit 124 – Longitudinal and Transverse Cracking

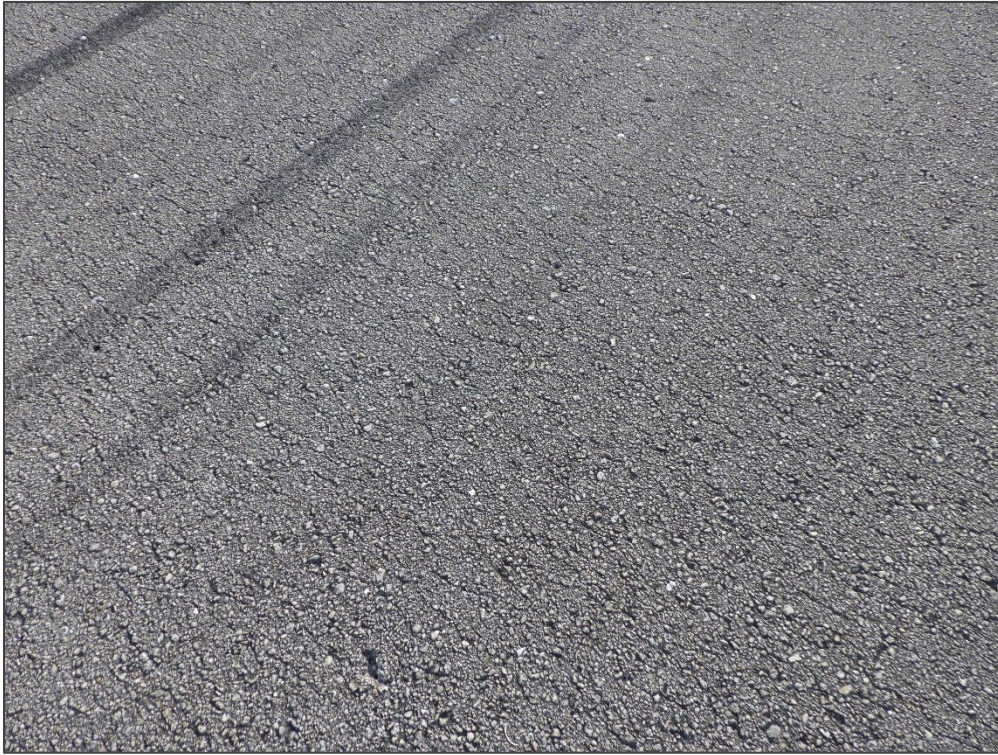
RW 10-28, Section 6105, Sample Unit 331 – Weathering

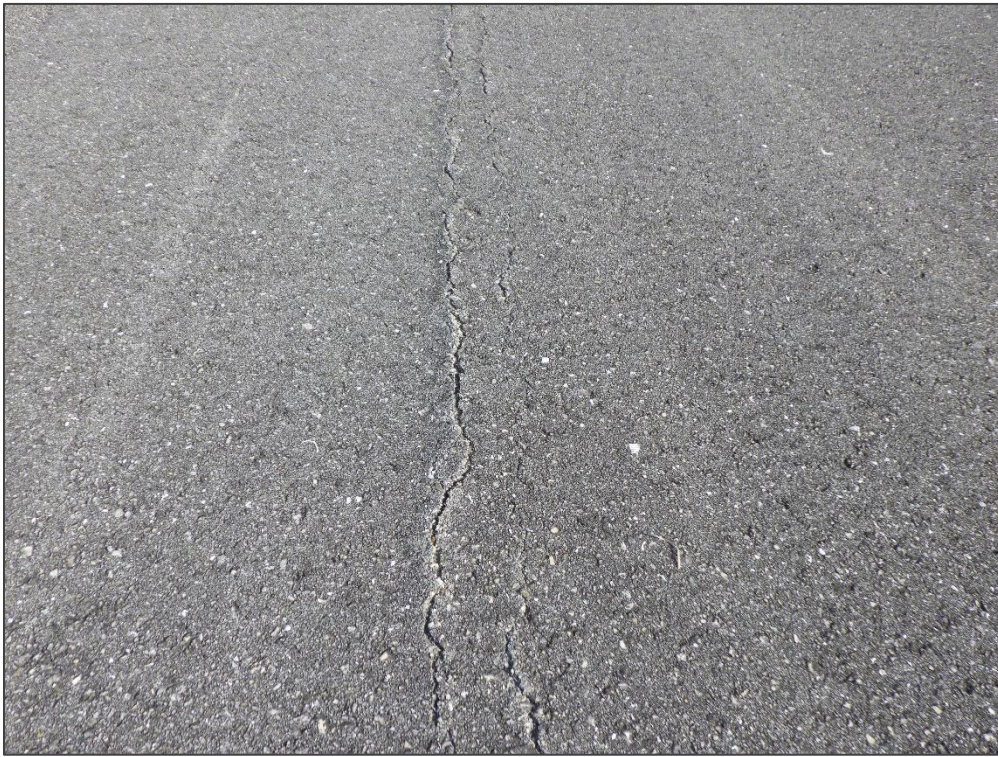
RW 16-34, Section 6215, Sample Unit 152 – Longitudinal and Transverse Cracking

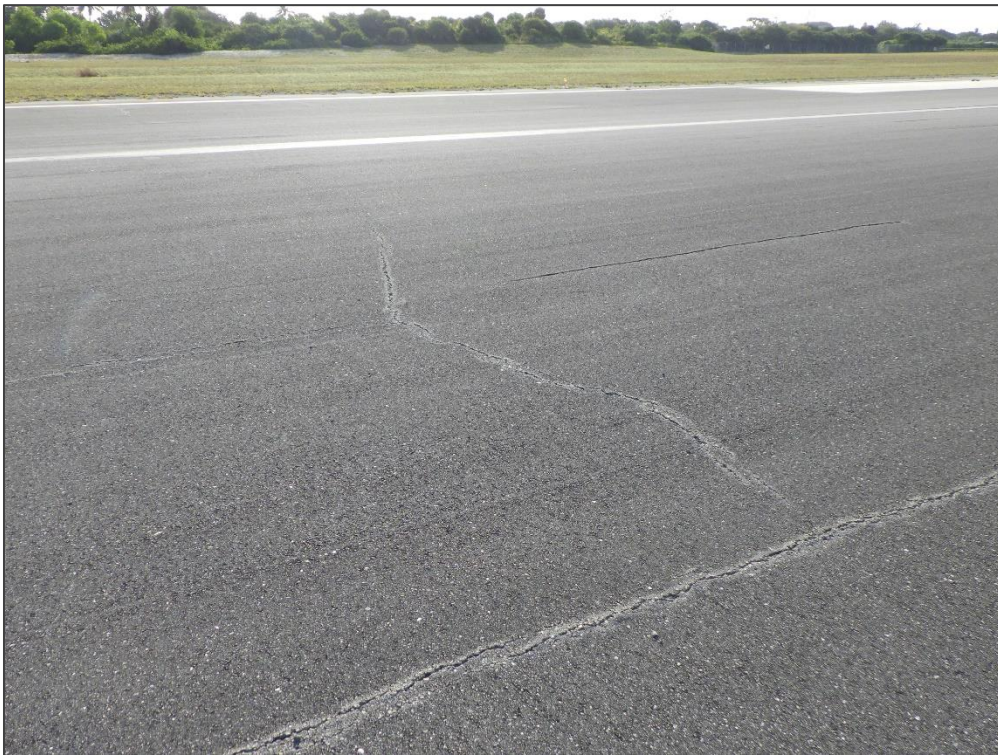
RW 16-34, Section 6215, Sample Unit 124 – Longitudinal and Transverse Cracking

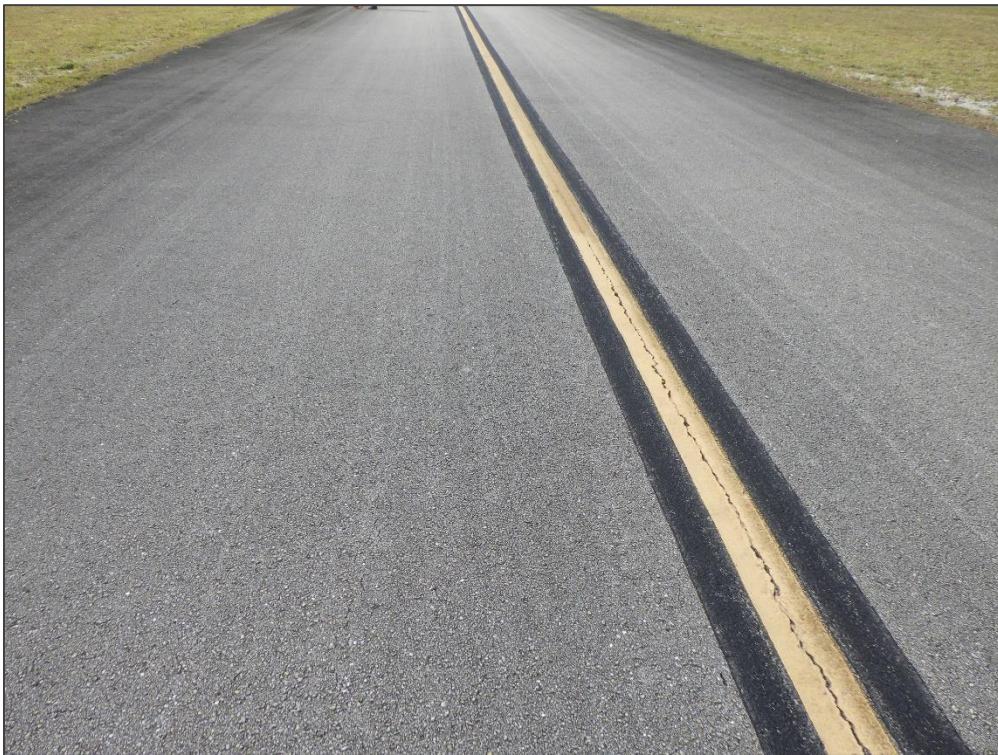
TW B, Section 205, Sample Unit 109 – Longitudinal and Transverse Cracking

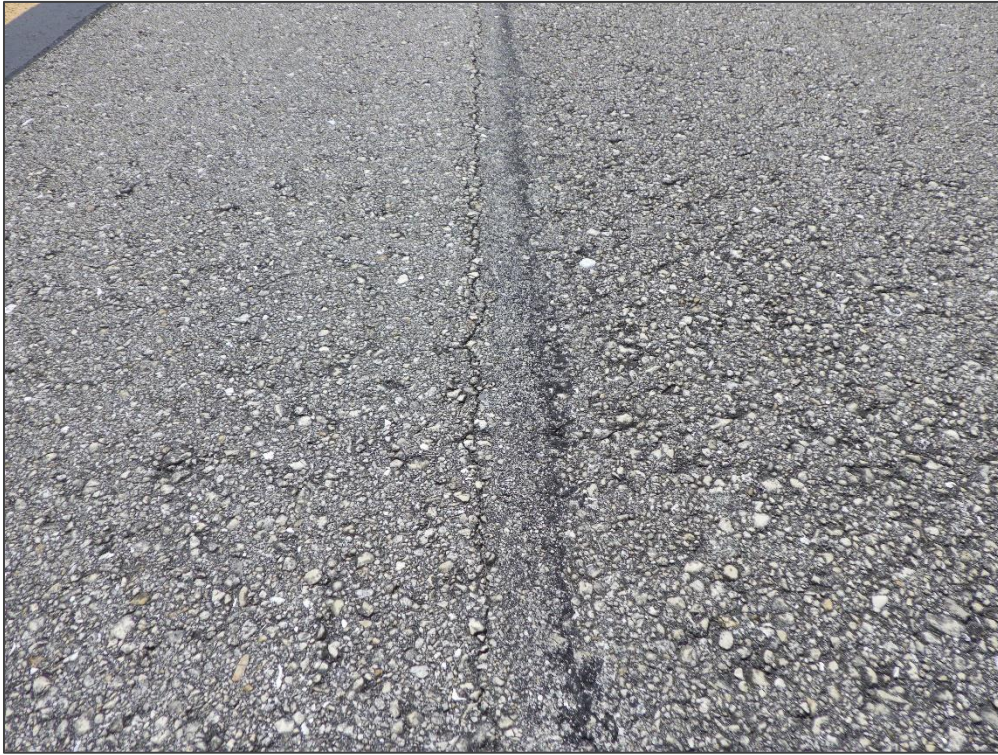
TW C, Section 105, Sample Unit 115 – Longitudinal and Transverse Cracking

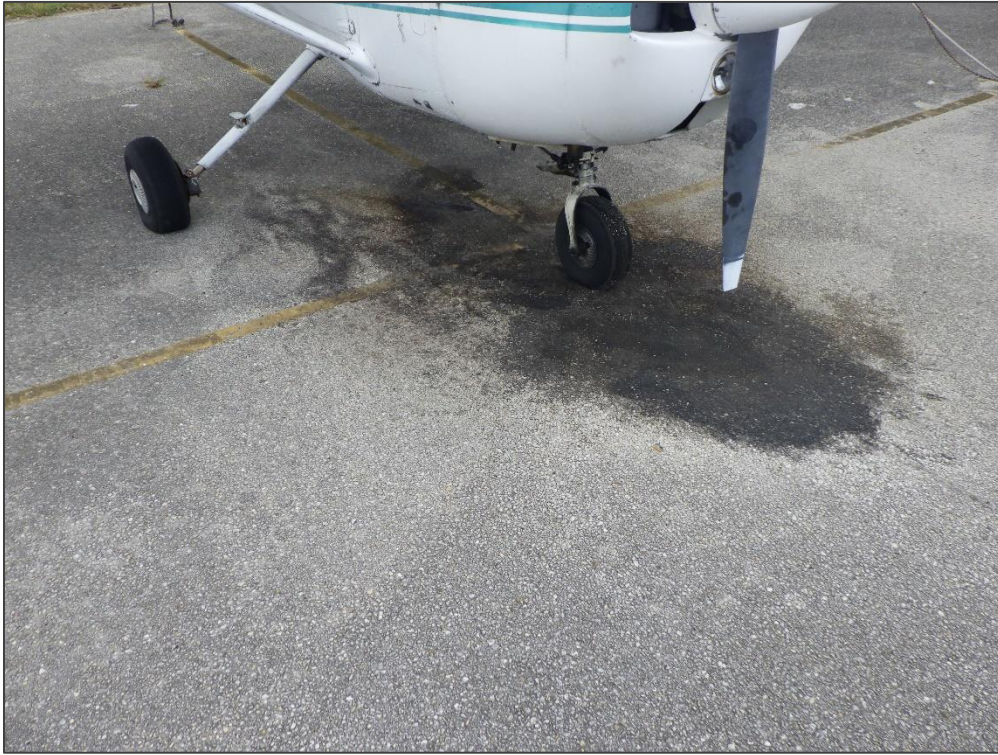
AP GA, Section 4110, Sample Unit 553 – Oil Spillage

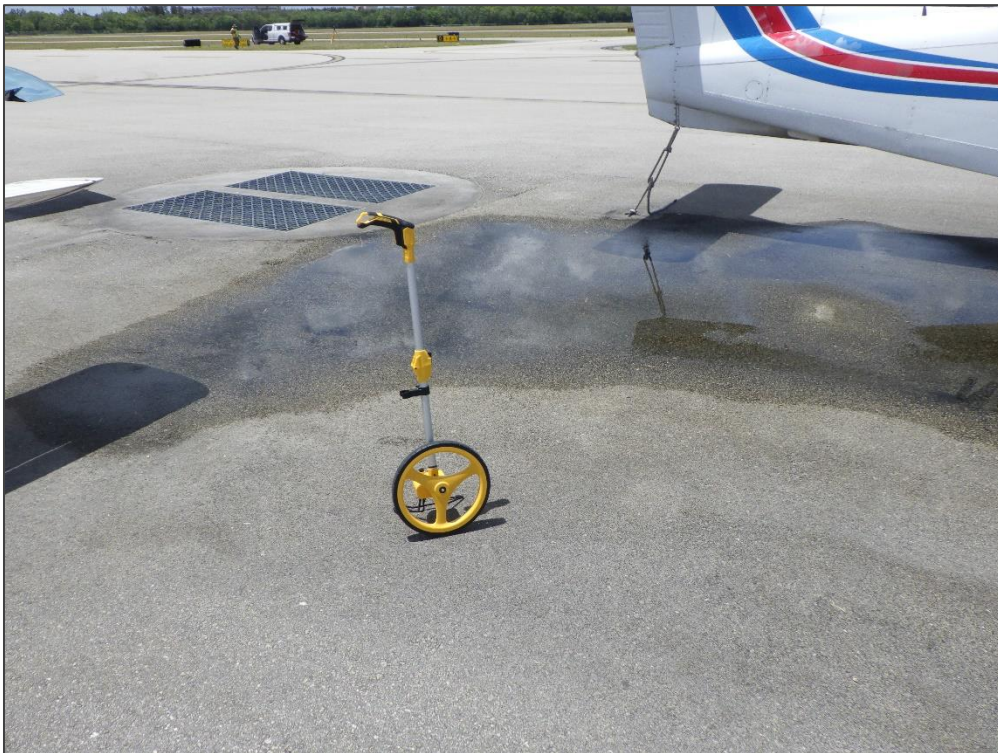
AP GA, Section 4120, Sample Unit 667 – Depression
