2022

Statewide Airfield Pavement Management Program

Airport Pavement Evaluation Report

OCF - Ocala International Airport - Jim Taylor Field | *District 5*

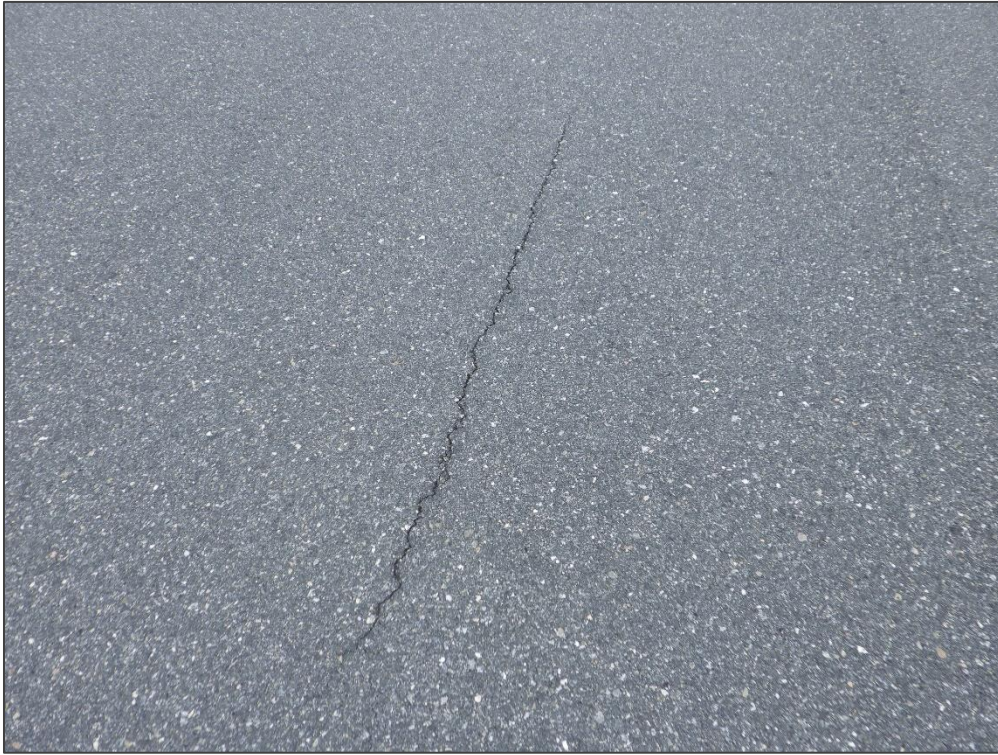
RW 8-26, Section 6205, Sample Unit 104 – Longitudinal & Transverse Cracking

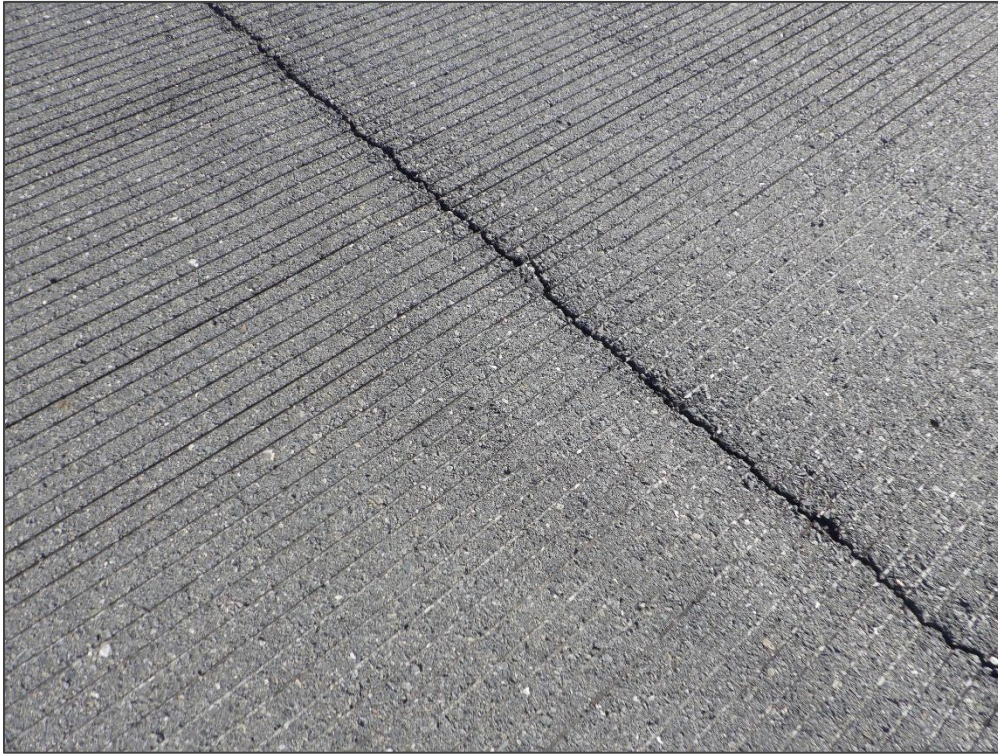
RW 18-36, Section 6105, Sample Unit 333 – Longitudinal & Transverse Cracking

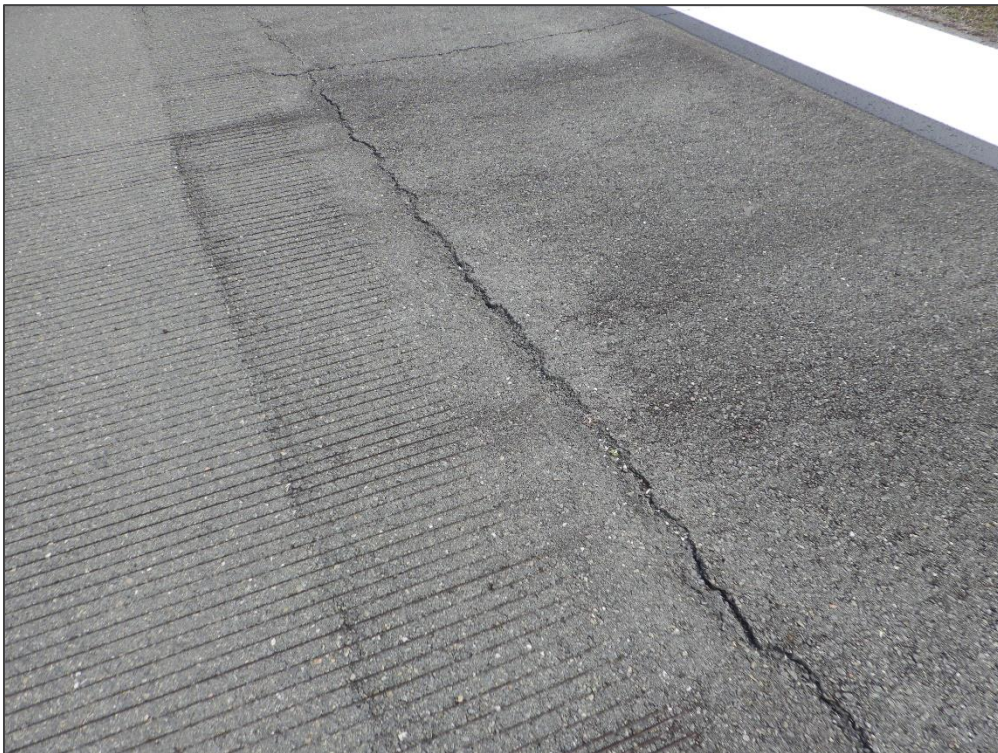
RW 18-36, Section 6110, Sample Unit 564 – Longitudinal & Transverse Cracking

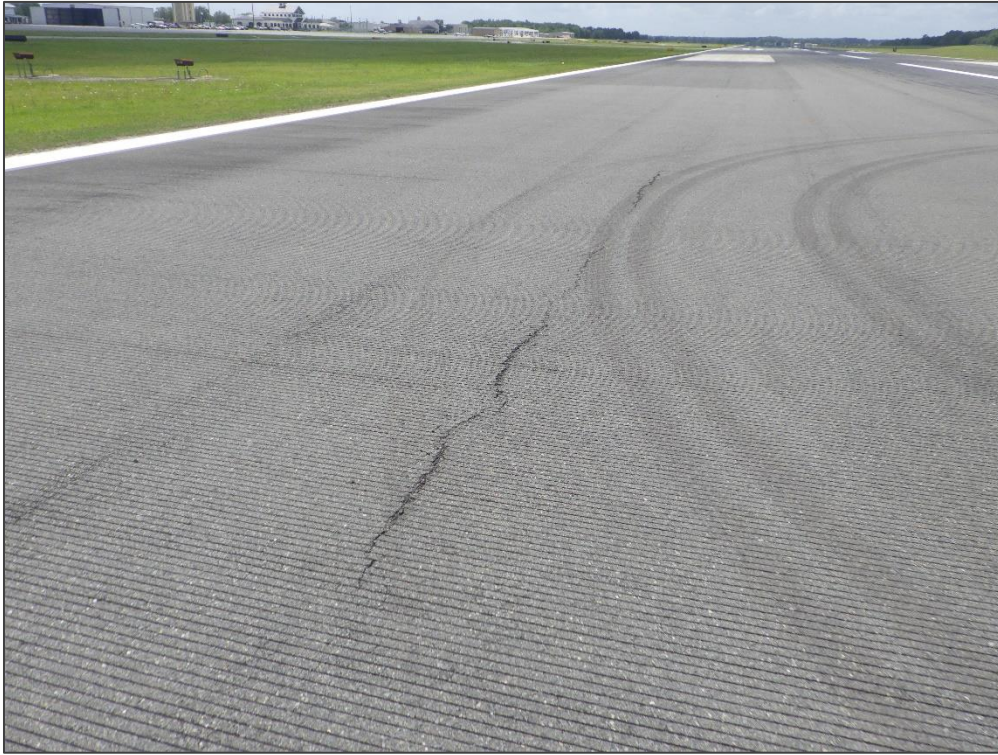
RW 18-36, Section 6110, Sample Unit 606 – Longitudinal & Transverse Cracking

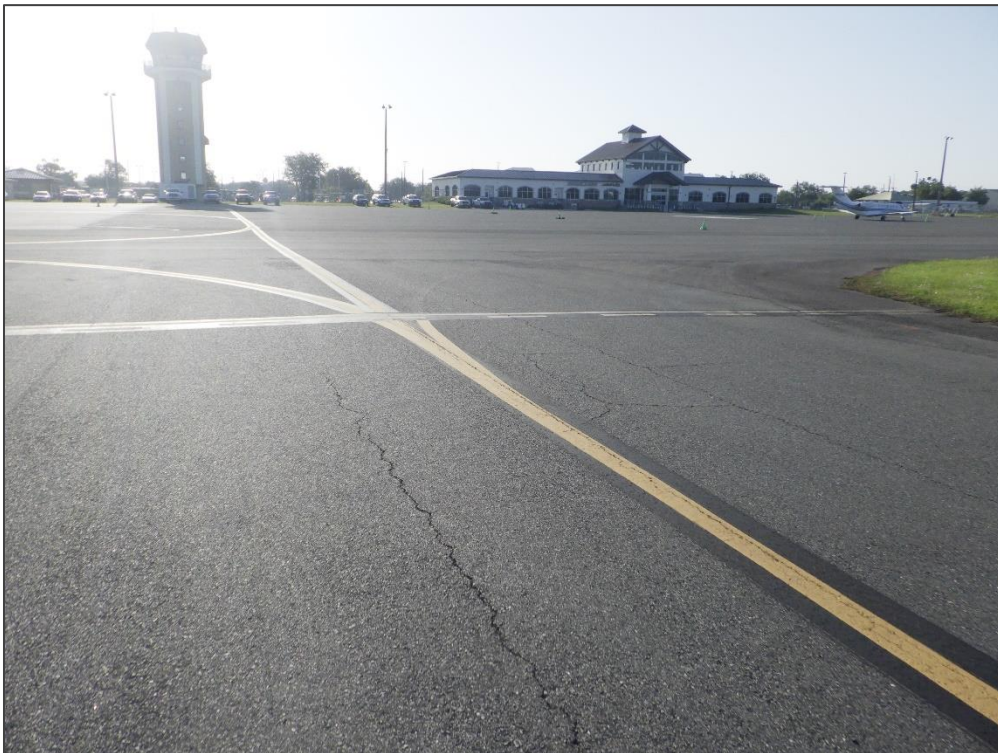
TW A5, Section 520, Sample Unit 401 – Longitudinal & Transverse Cracking

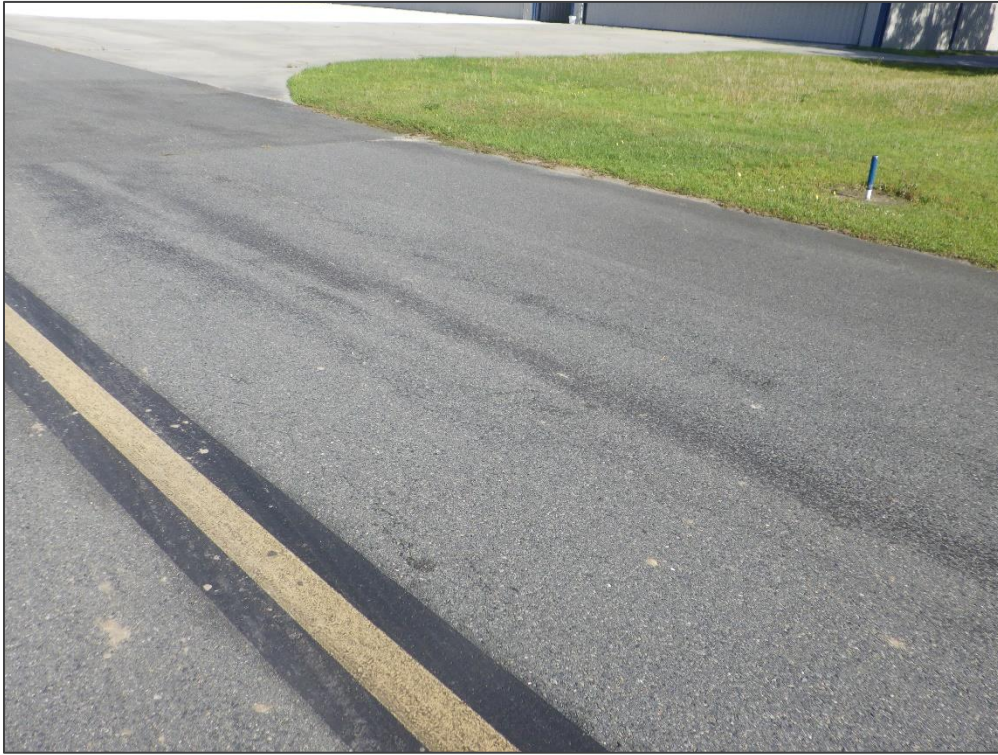
TW A9, Section 550, Sample Unit 105 – Bleeding

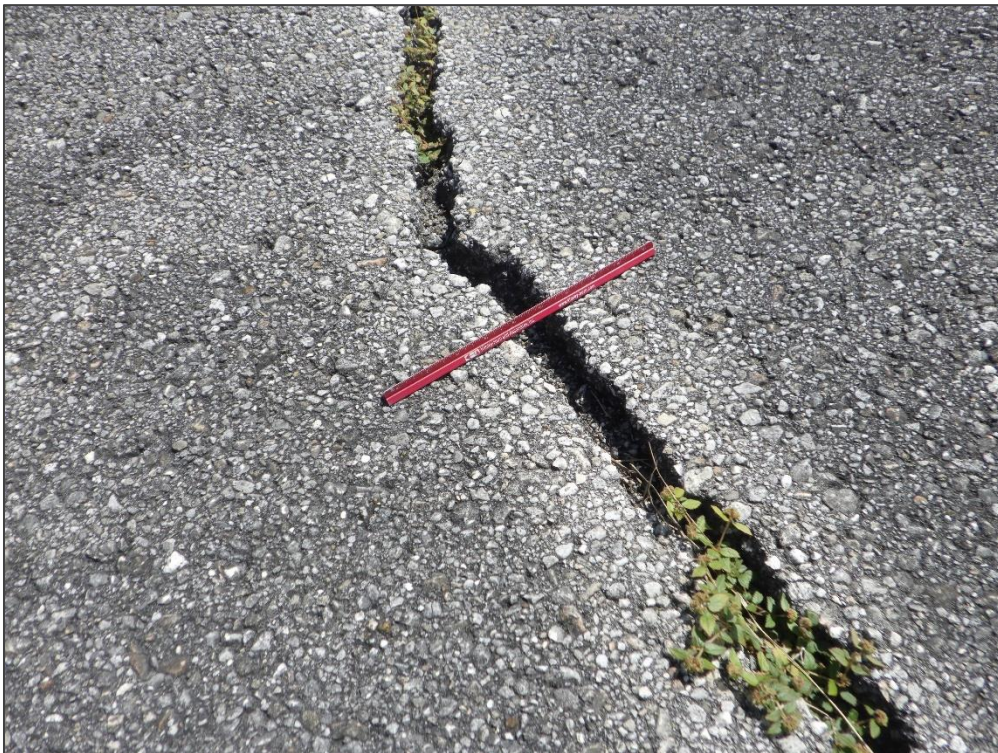
TW B, Section 105, Sample Unit 102 – Longitudinal & Transverse Cracking

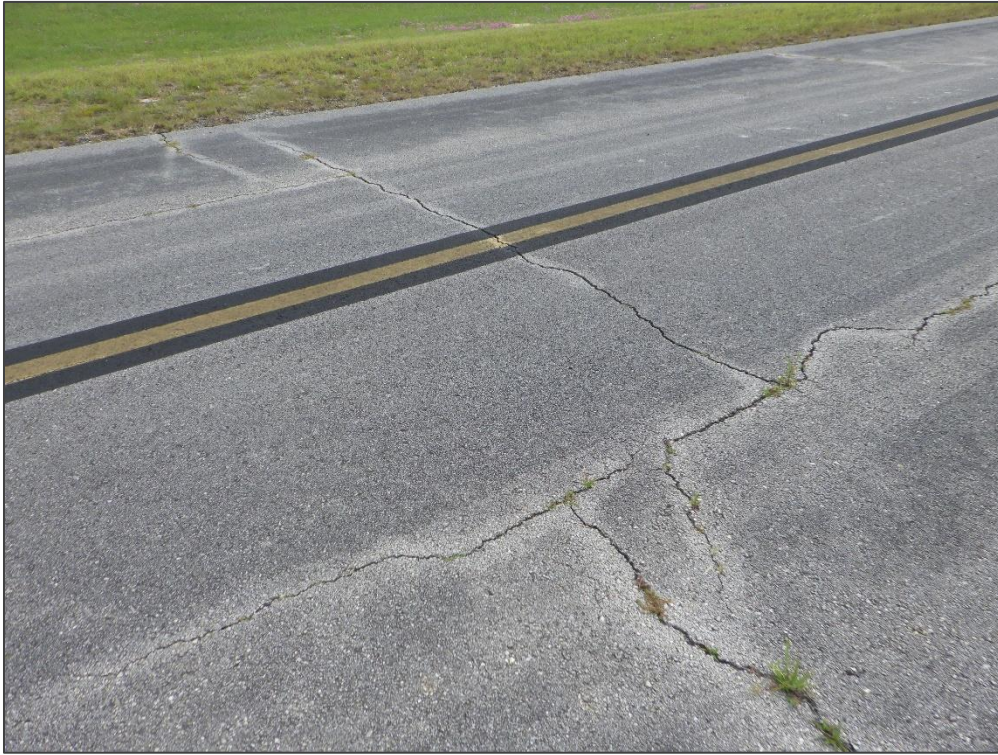
TW B, Section 105, Sample Unit 107 – Longitudinal & Transverse Cracking

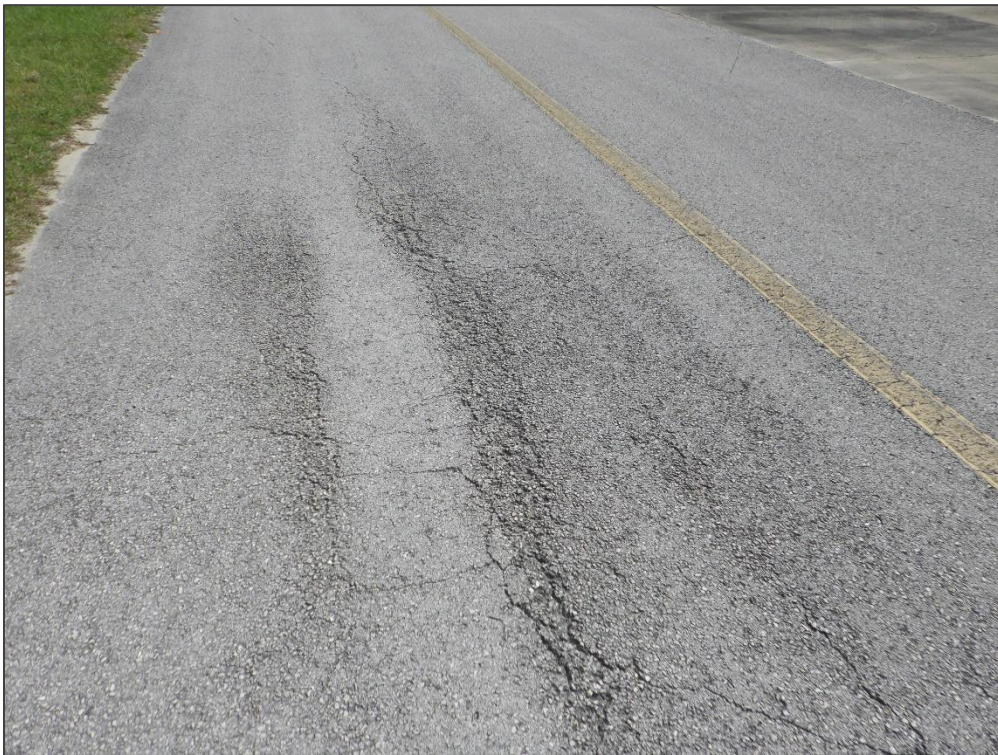
TL T-HANG, Section 3580, Sample Unit 902 – Alligator Cracking and Raveling

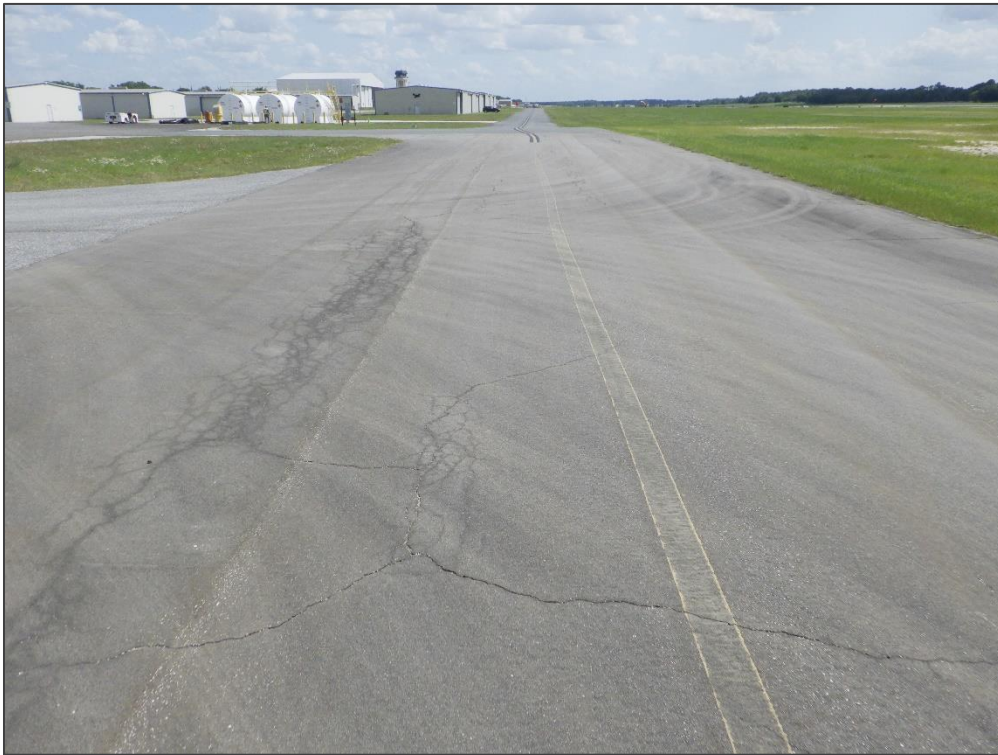
TW AP N, Section 595, Sample Unit 301 – Alligator Cracking and Longitudinal & Transverse Cracking

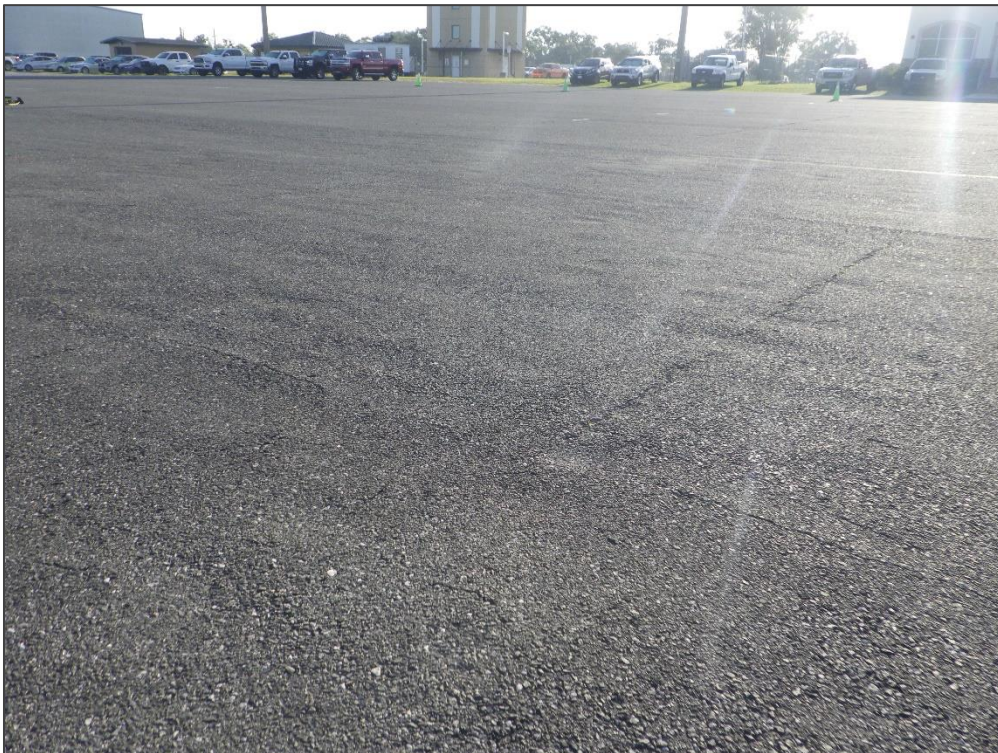
AP CENTER, Section 4105, Sample Unit 303 – Longitudinal & Transverse Cracking and Swelling

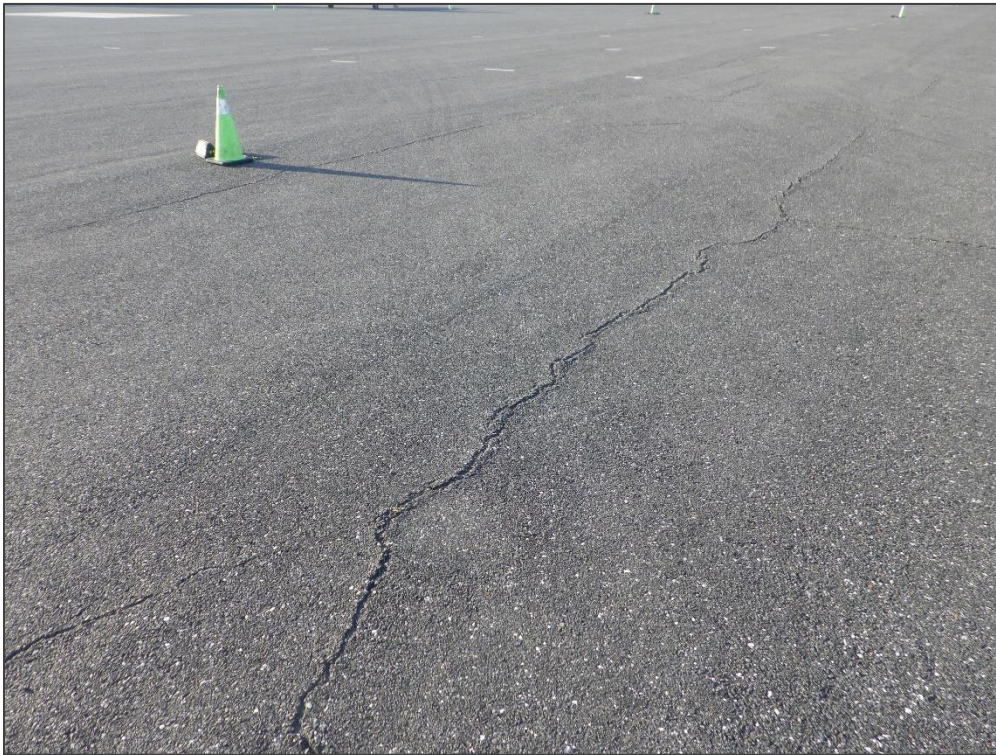
AP CENTER, Section 4105, Sample Unit 104 – Longitudinal & Transverse Cracking and Swelling

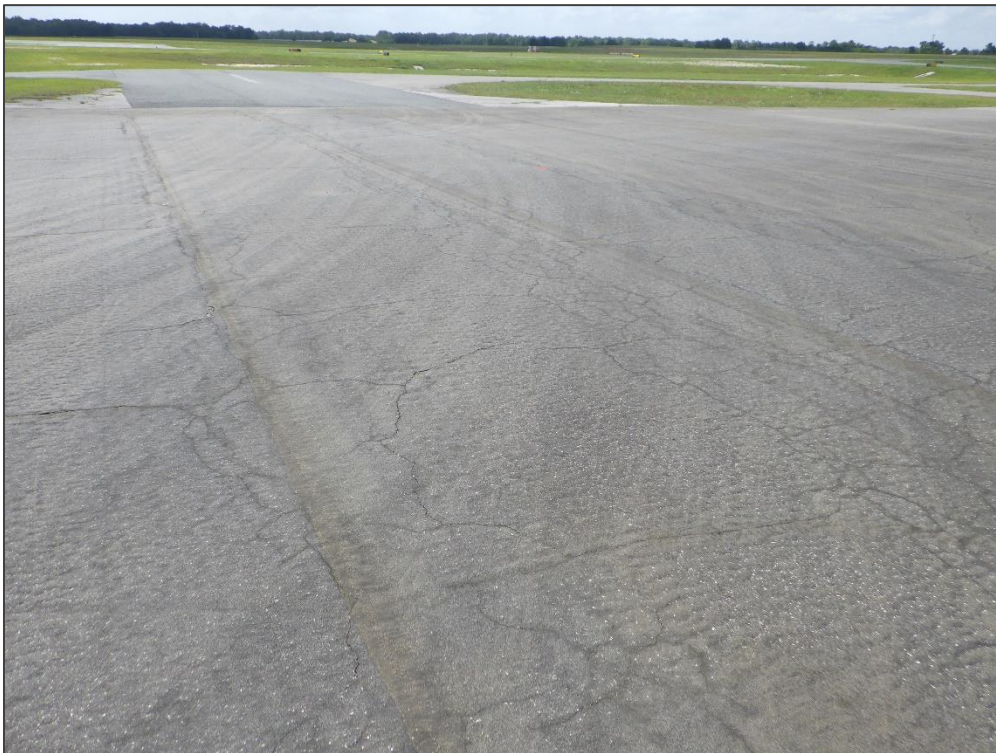
AP N, Section 4210, Sample Unit 700 – Block Cracking
