*Statewide Airfield Pavement Management Program*

# Airport Pavement Evaluation Report

TIX - Space Coast Regional Airport | *District 5*

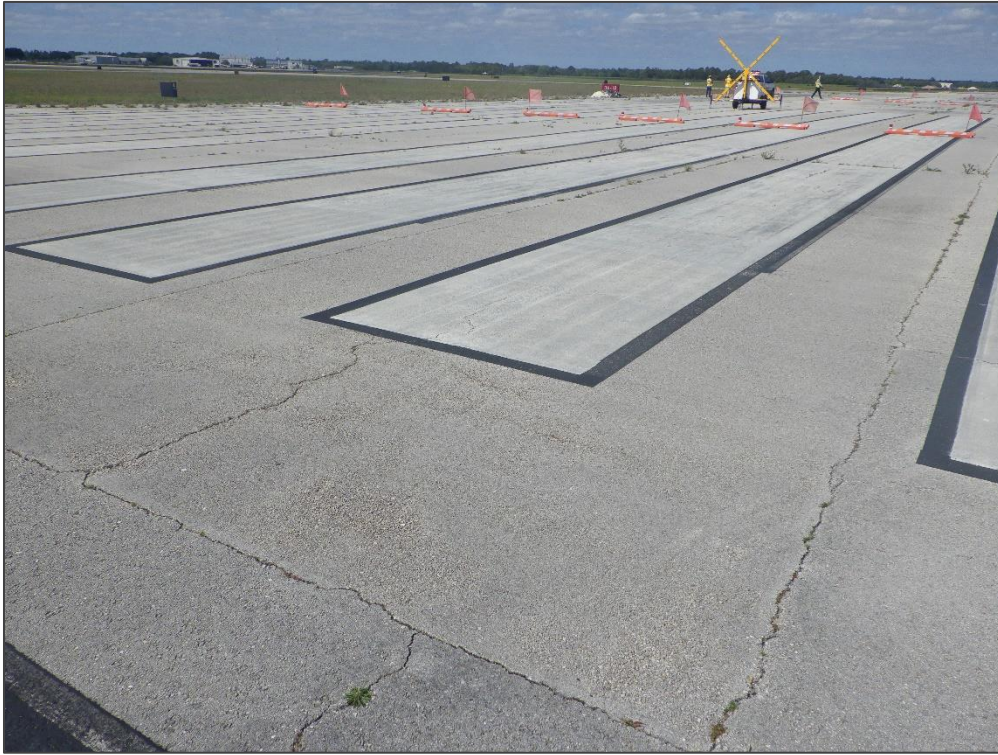
RW 9-27, Section 6205, Sample Unit 100 – Longitudinal & Transverse Cracking and Weathering

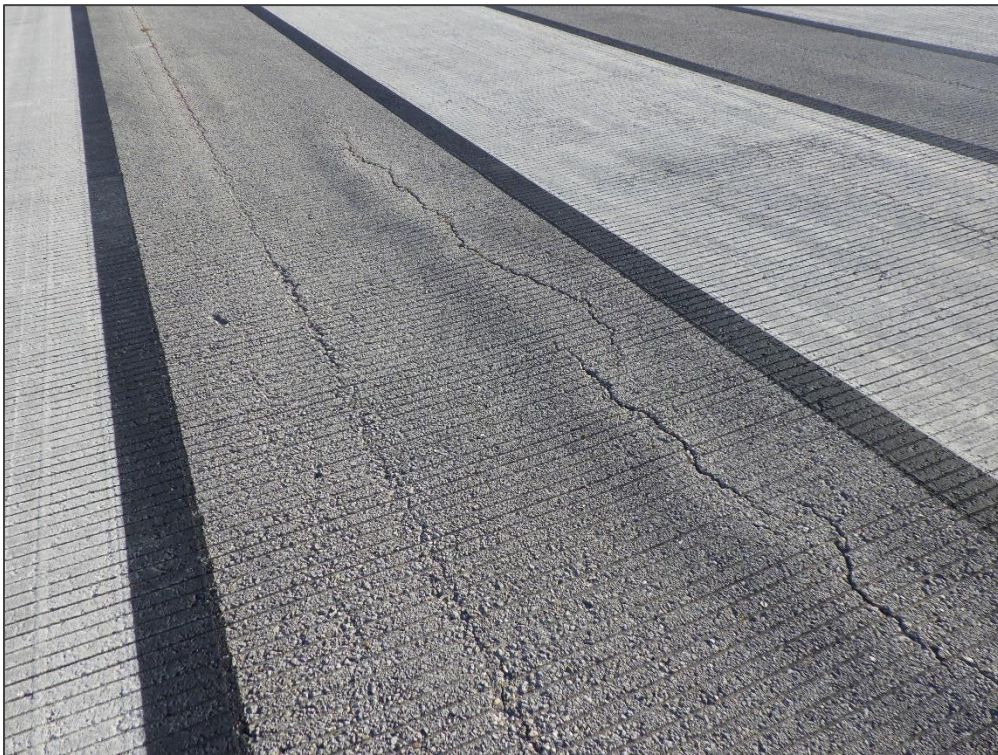
RW 18-36, Section 6105, Sample Unit 302 – Longitudinal & Transverse Cracking and Swelling

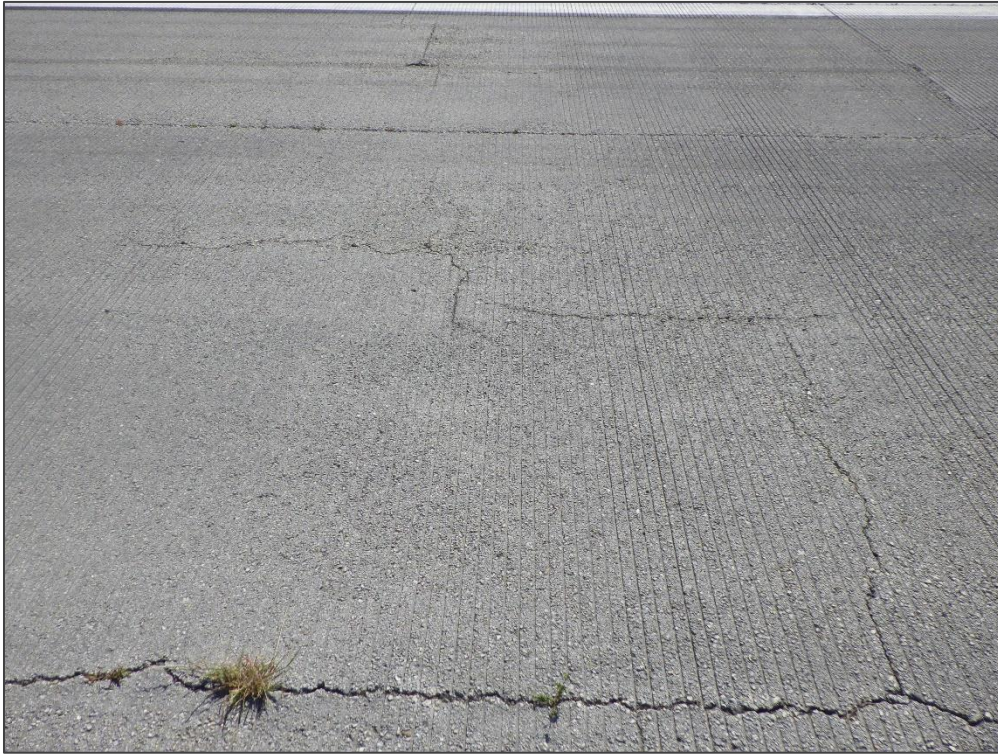
RW 18-36, Section 6105, Sample Unit 376 – Longitudinal & Transverse Cracking

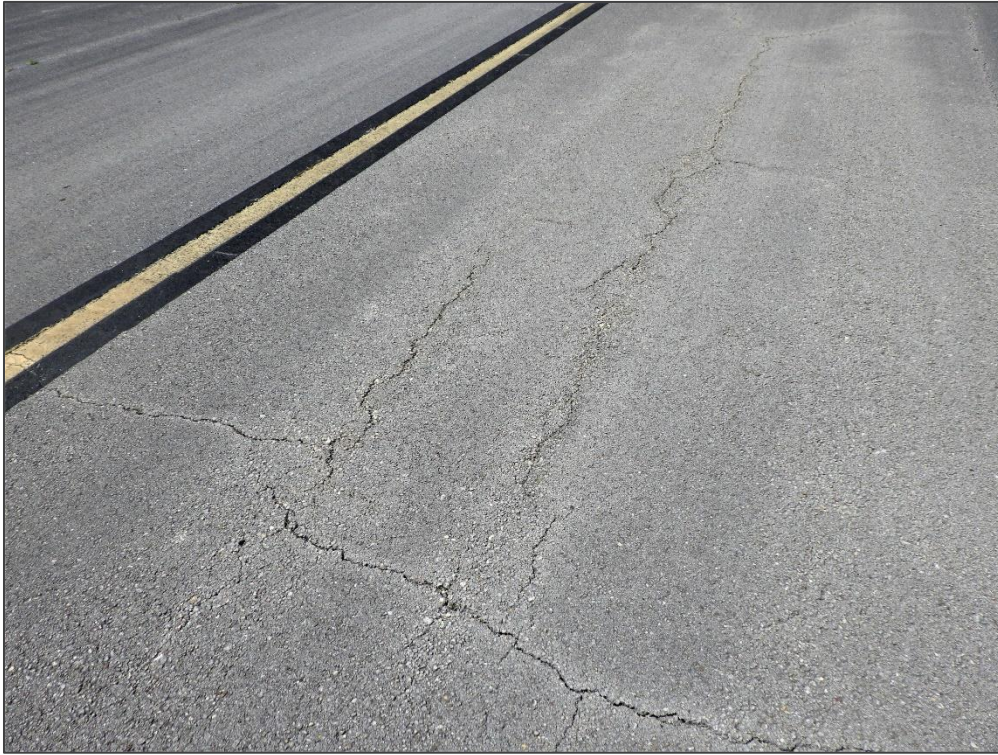
TW A, Section 105, Sample Unit 108 – Longitudinal & Transverse Cracking and Weathering

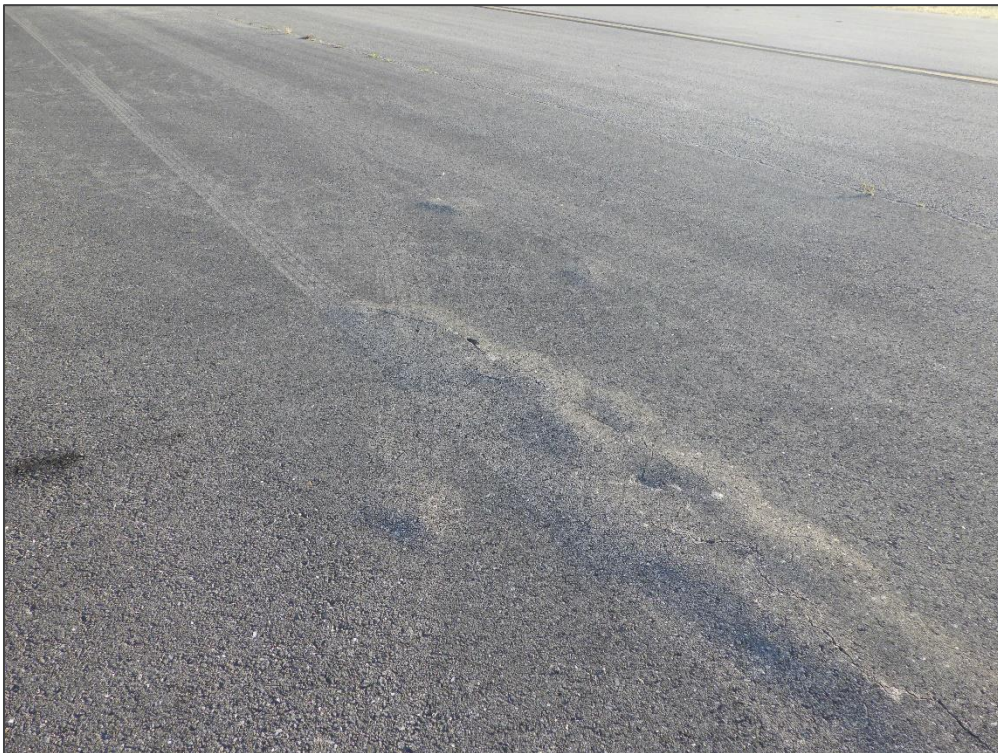
TW A, Section 120, Sample Unit 151 – Swelling

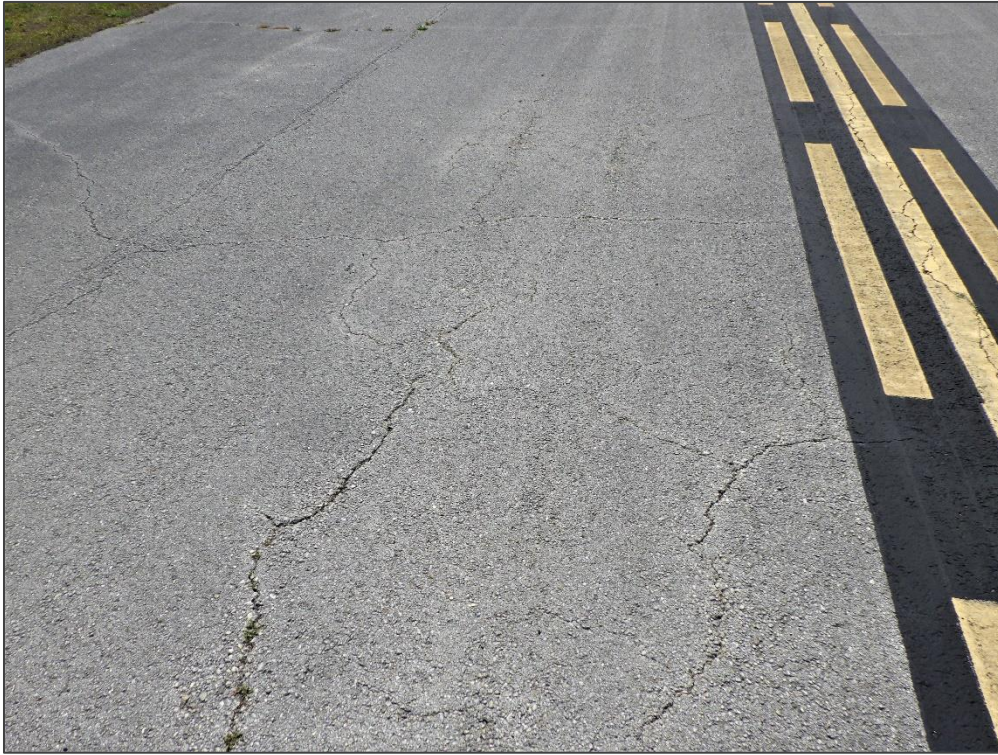
TW B, Section 205, Sample Unit 502 – Longitudinal & Transverse Cracking

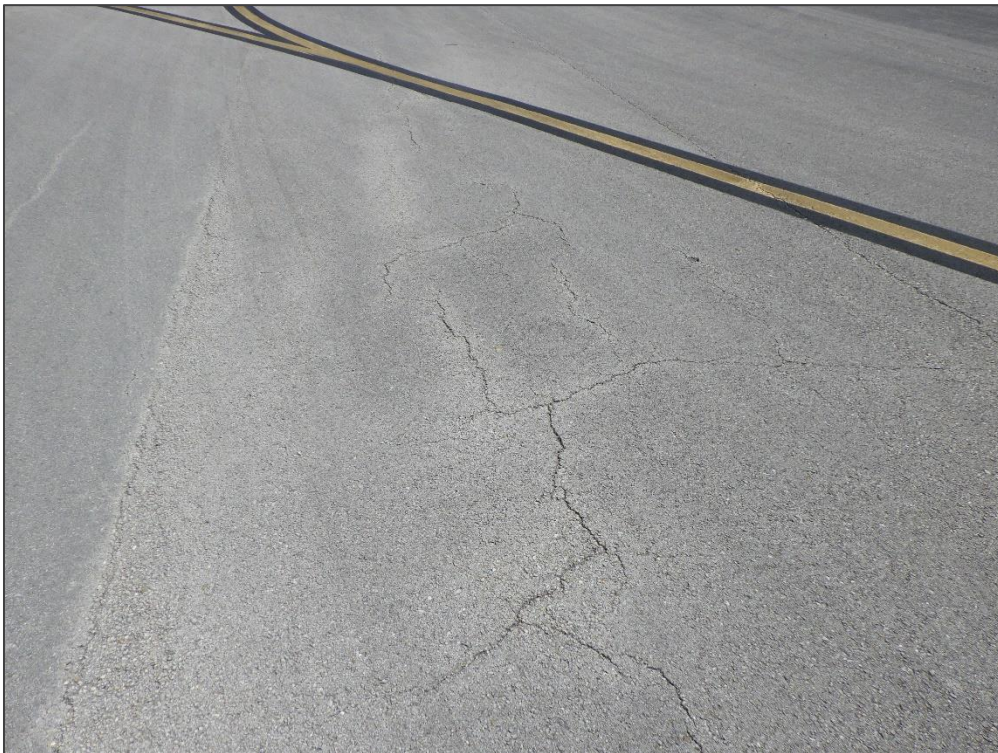
TW C, Section 305, Sample Unit 704– Longitudinal & Transverse Cracking

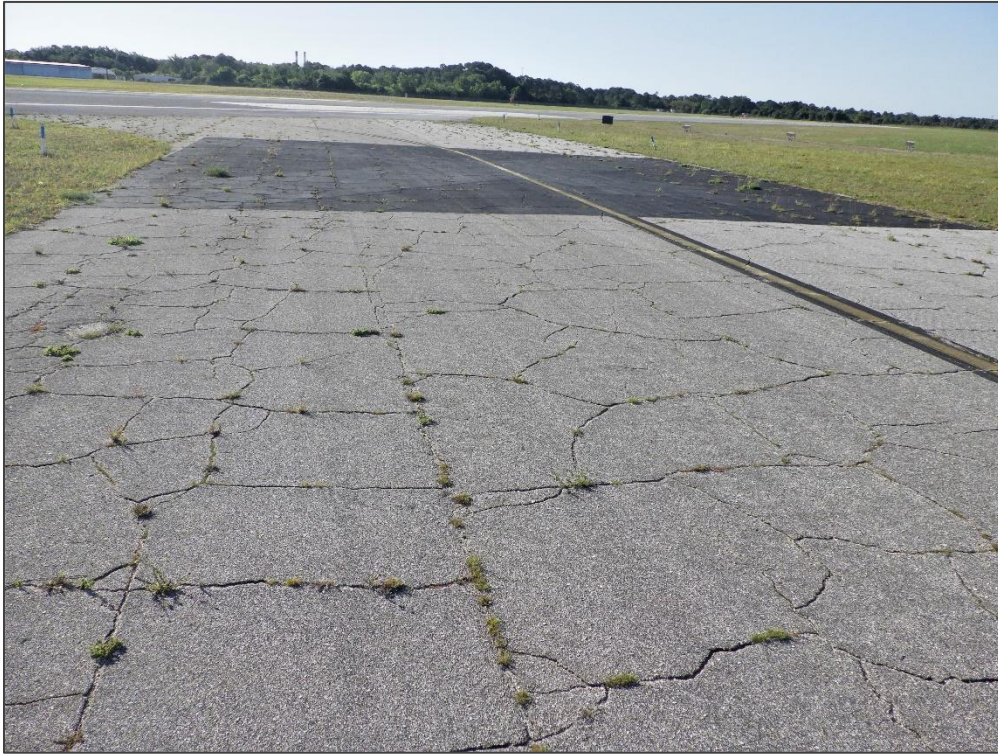
TW F, Section 605, Sample Unit 301 – Block Cracking

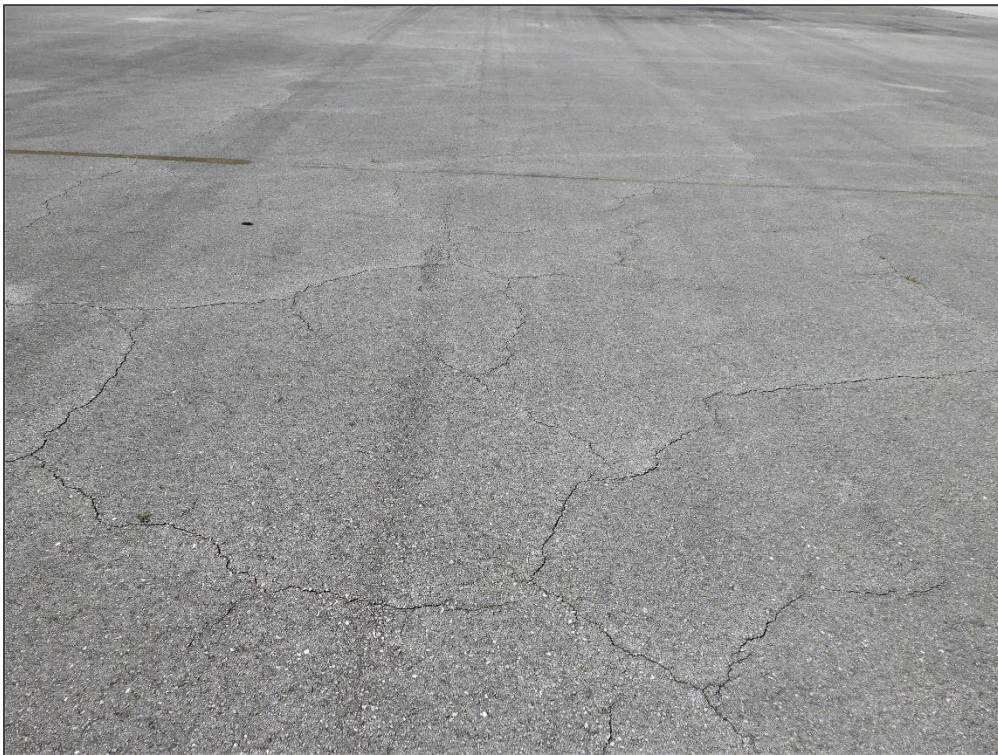
AP E, Section 4205, Sample Unit 250 – Block Cracking

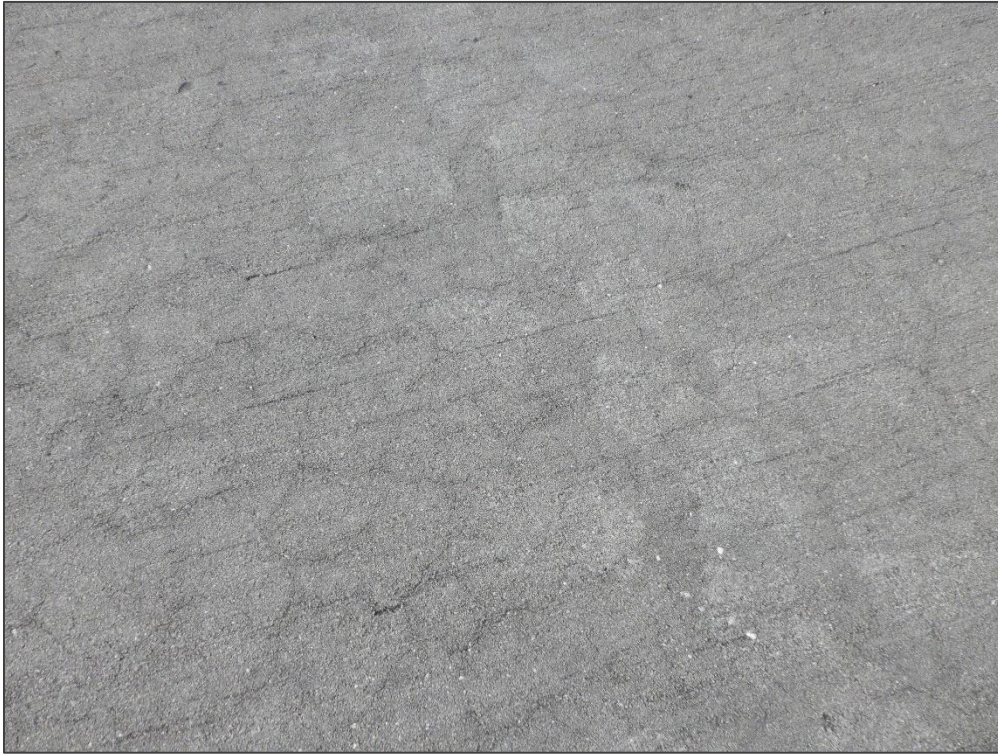
AP HELI, Section 4260, Sample Unit 646 – Shrinkage Cracking
