Statewide Airfield Pavement Management Program

Airport Pavement Evaluation Report

TPF - Peter O. Knight Airport | *District 7*

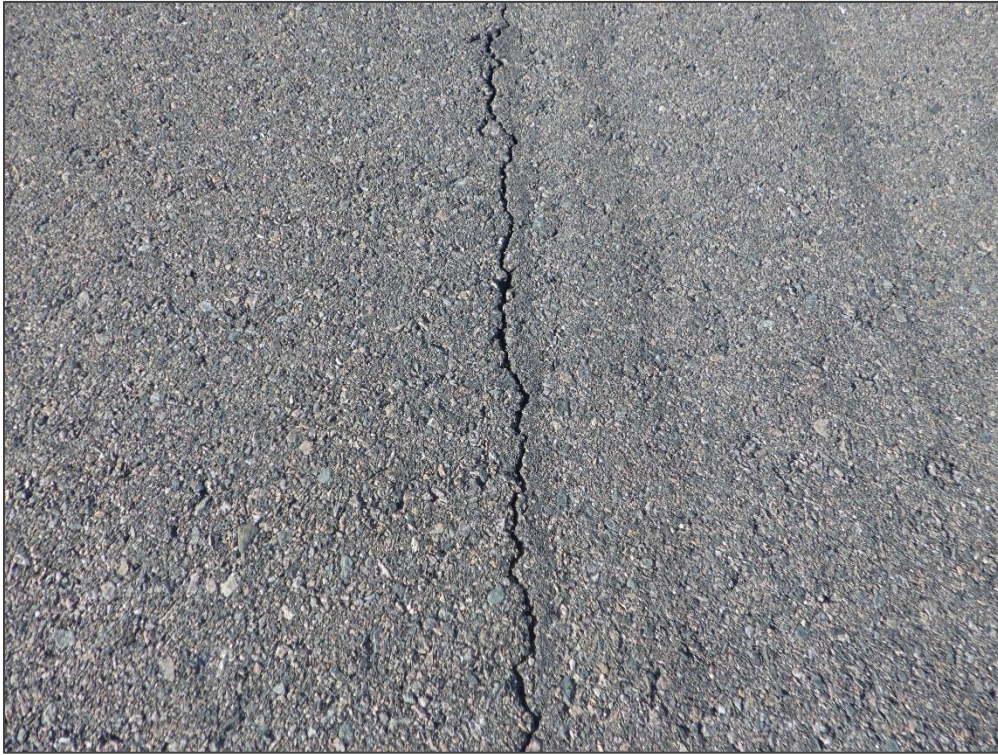
RW 4-22, Section 6105, Sample Unit 121 – Longitudinal & Transverse Cracking

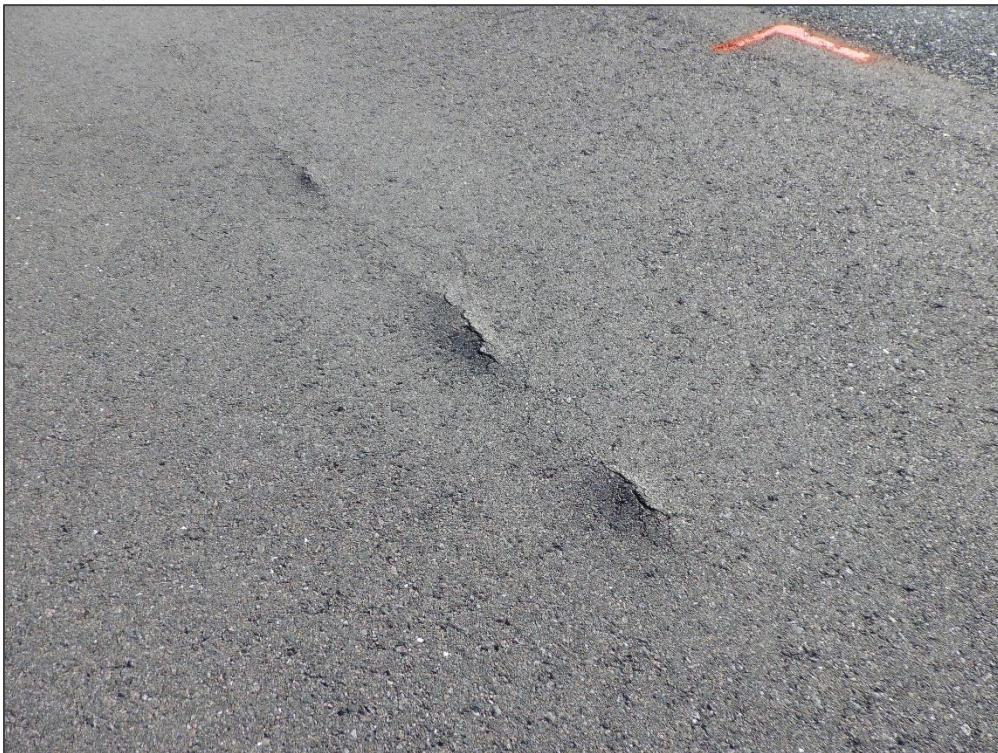
RW 4-22, Section 6105, Sample Unit 161 – Longitudinal & Transverse Cracking and Swelling

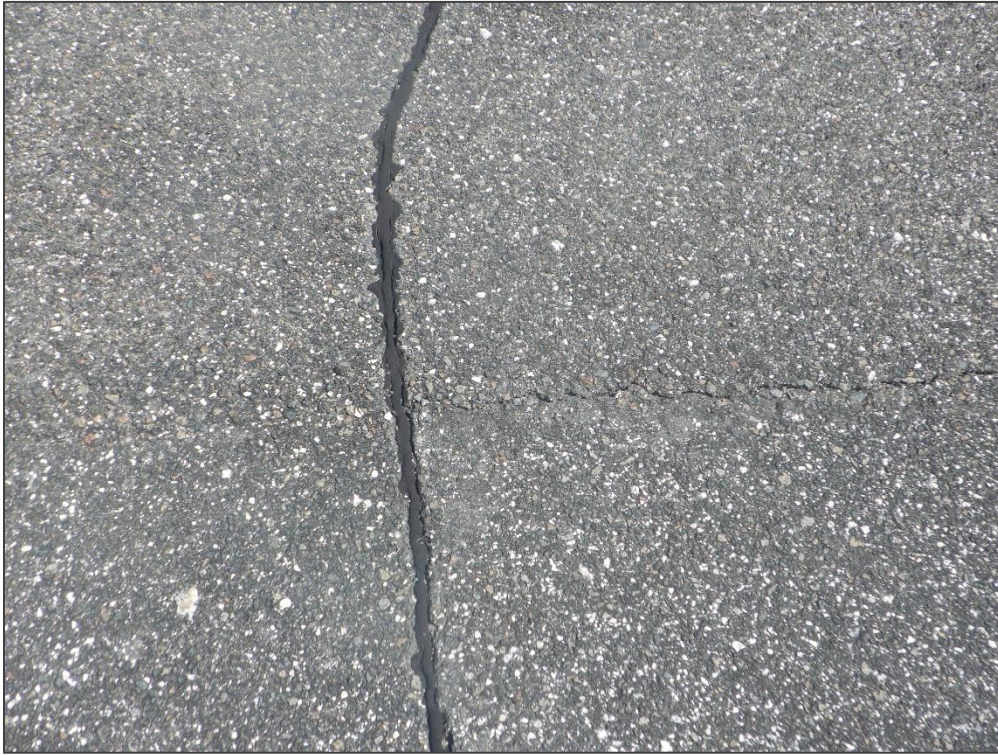
RW 18-36, Section 6205, Sample Unit 102 – Longitudinal & Transverse Cracking

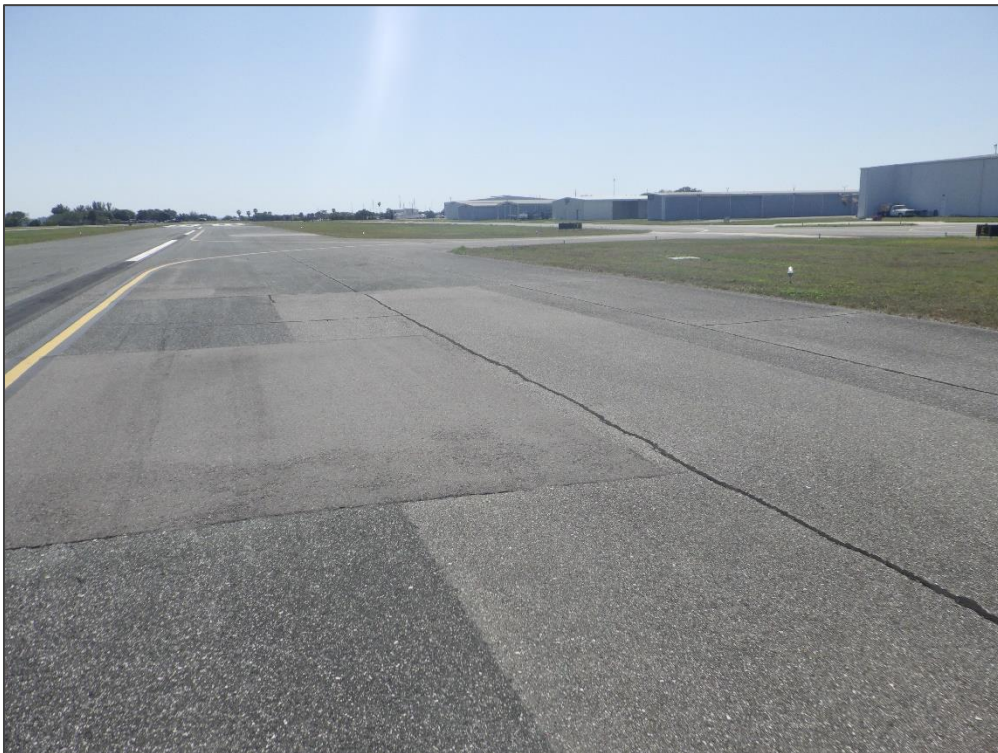
RW 18-36, Section 6205, Sample Unit 122 – Longitudinal & Transverse Cracking and Patching

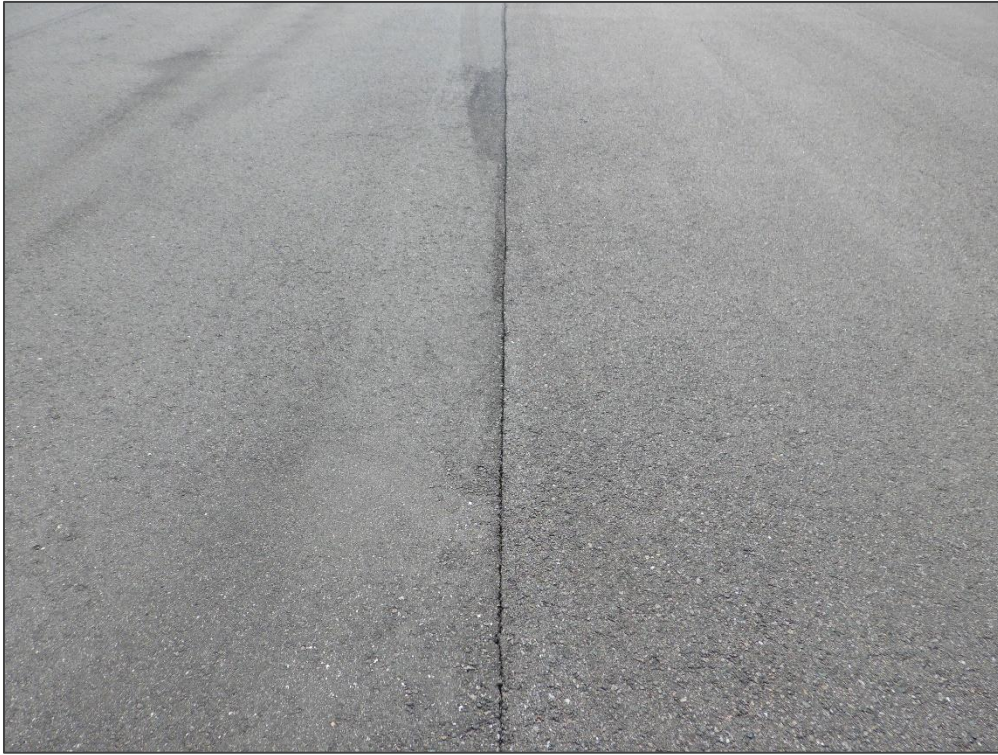
TW A, Section 105, Sample Unit 122 – Longitudinal & Transverse Cracking

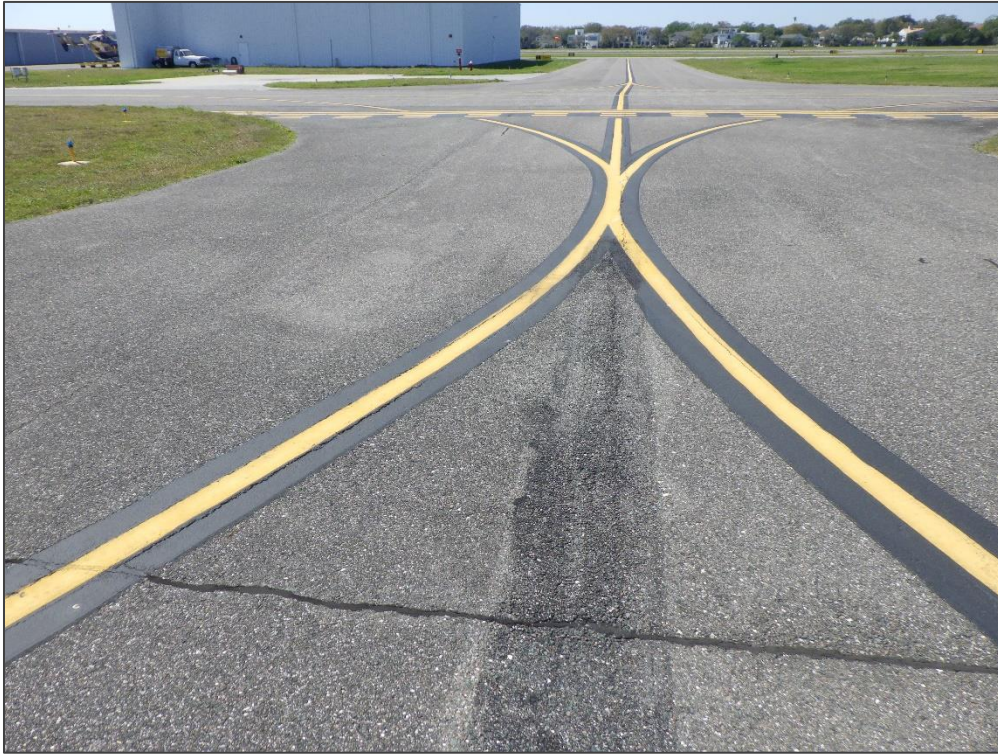
TW E, Section 650, Sample Unit 300– Longitudinal & Transverse Cracking and Raveling

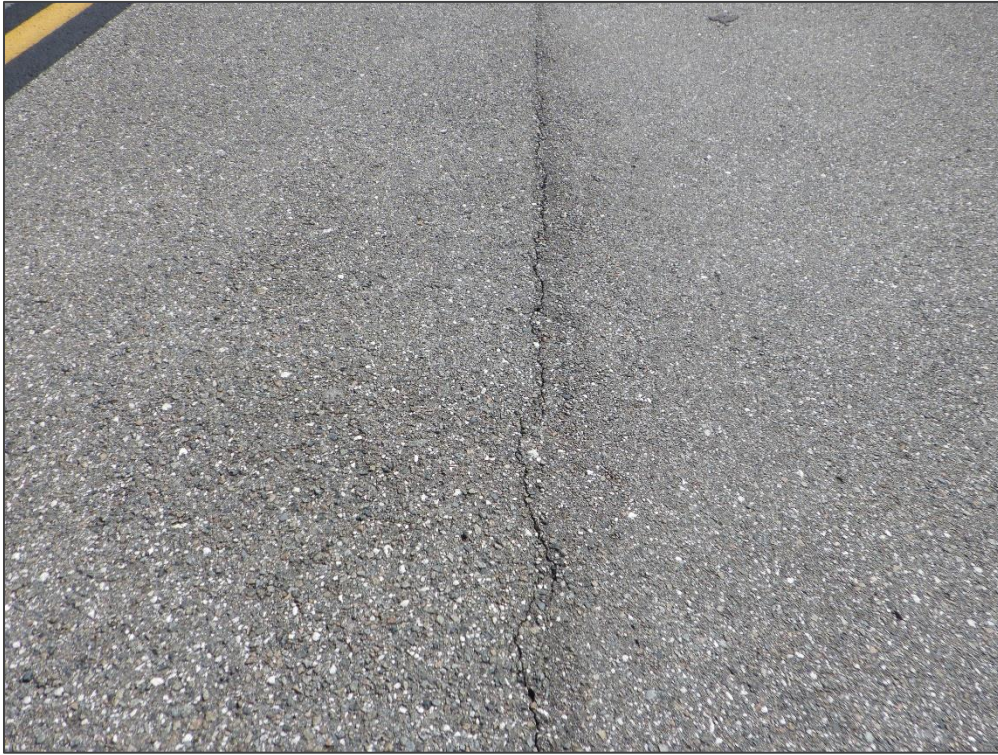
TW G, Section 750, Sample Unit 401 – Longitudinal & Transverse Cracking and Weathering

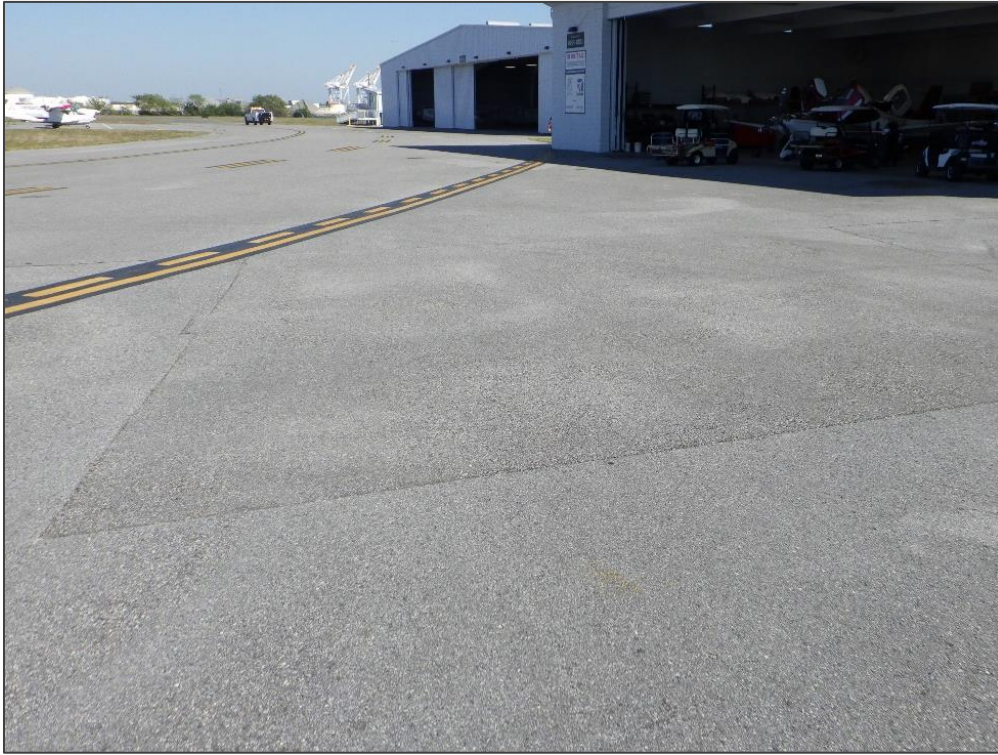
AP MID, Section 4110, Sample Unit 603 – Patching

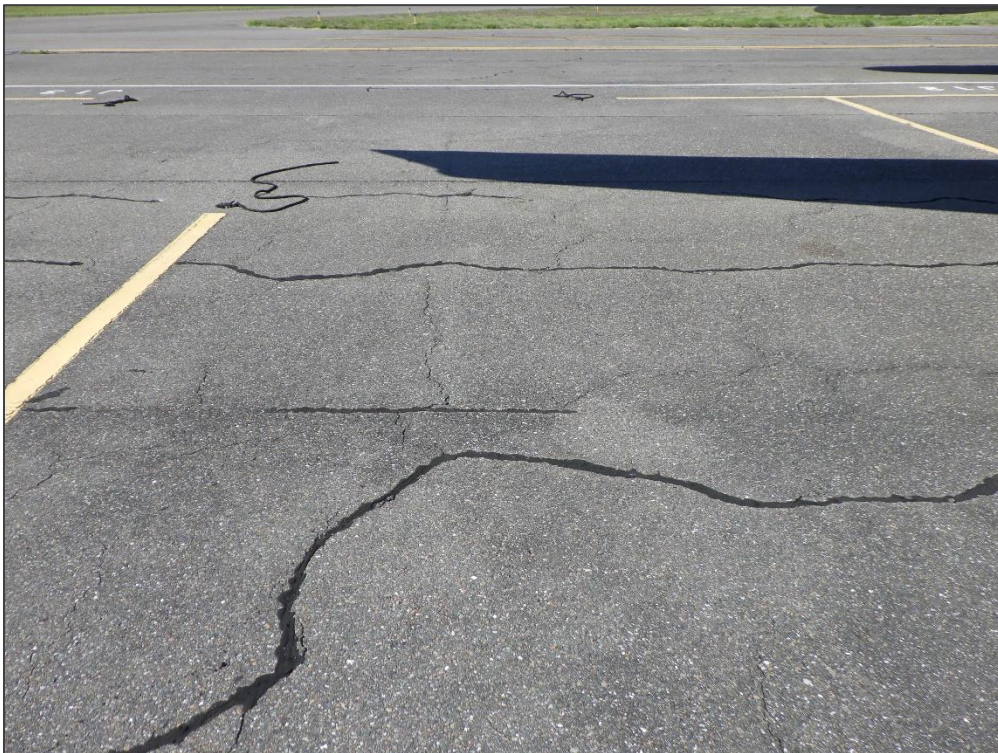
AP MID, Section 4125, Sample Unit 401 – Longitudinal & Transverse Cracking
