Statewide Airfield Pavement Management Program

Airport Pavement Evaluation Report

VDF - Tampa Executive Airport | *District 7*

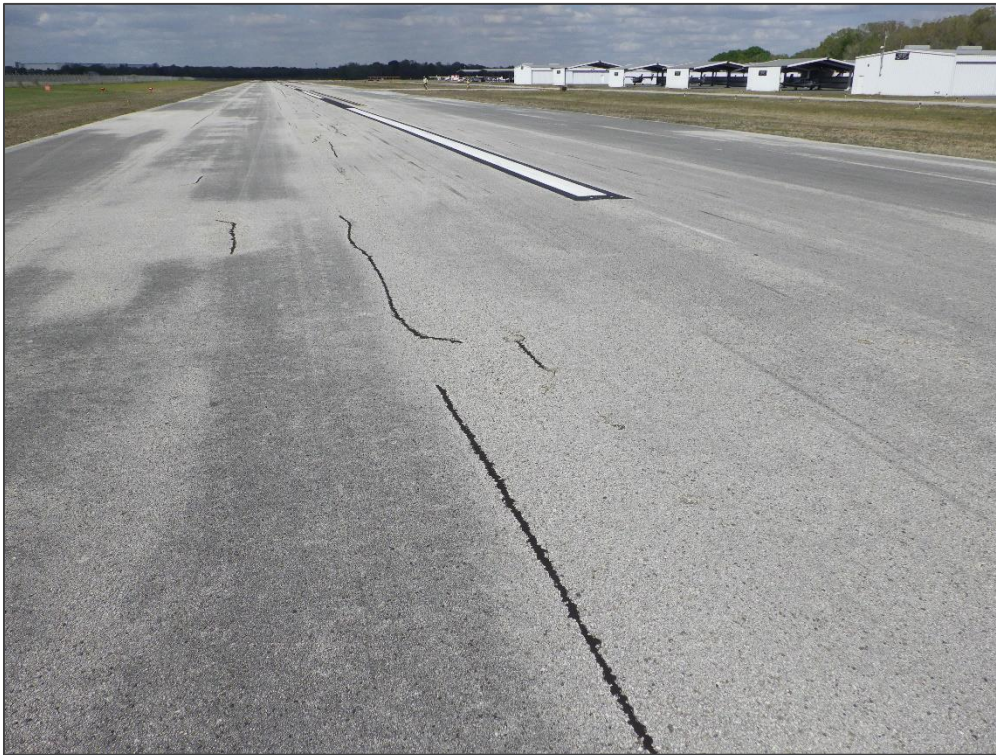
RW 18-38, Section 6105, Sample Unit 105 – Longitudinal & Transverse Cracking

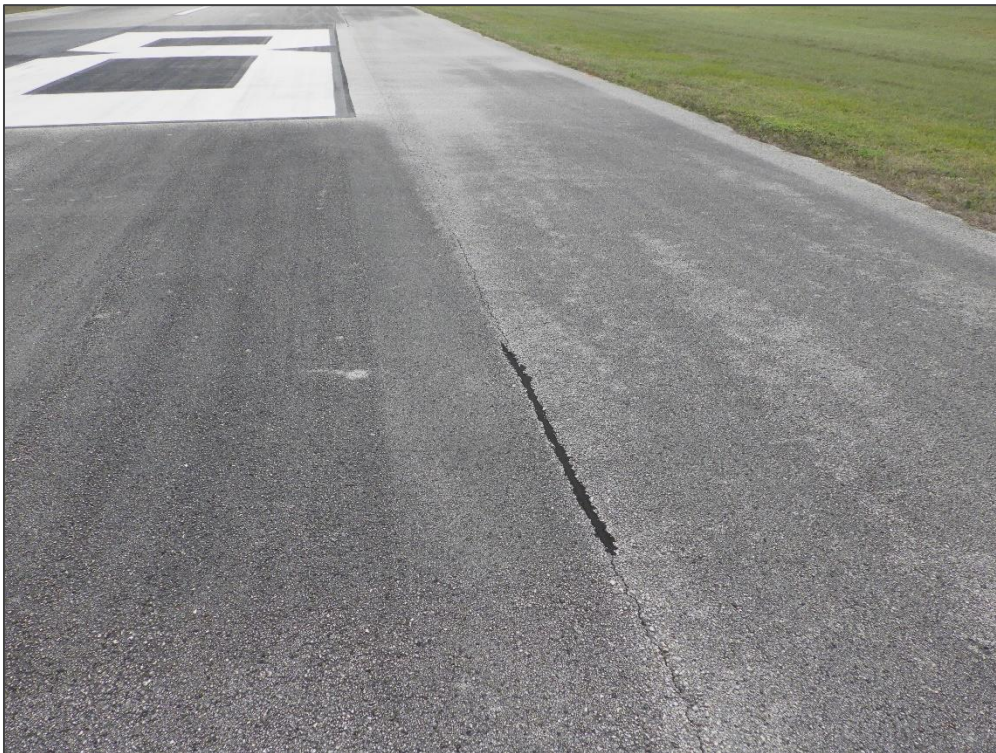
RW 18-36, Section 6105, Sample Unit 160 – Longitudinal & Transverse Cracking

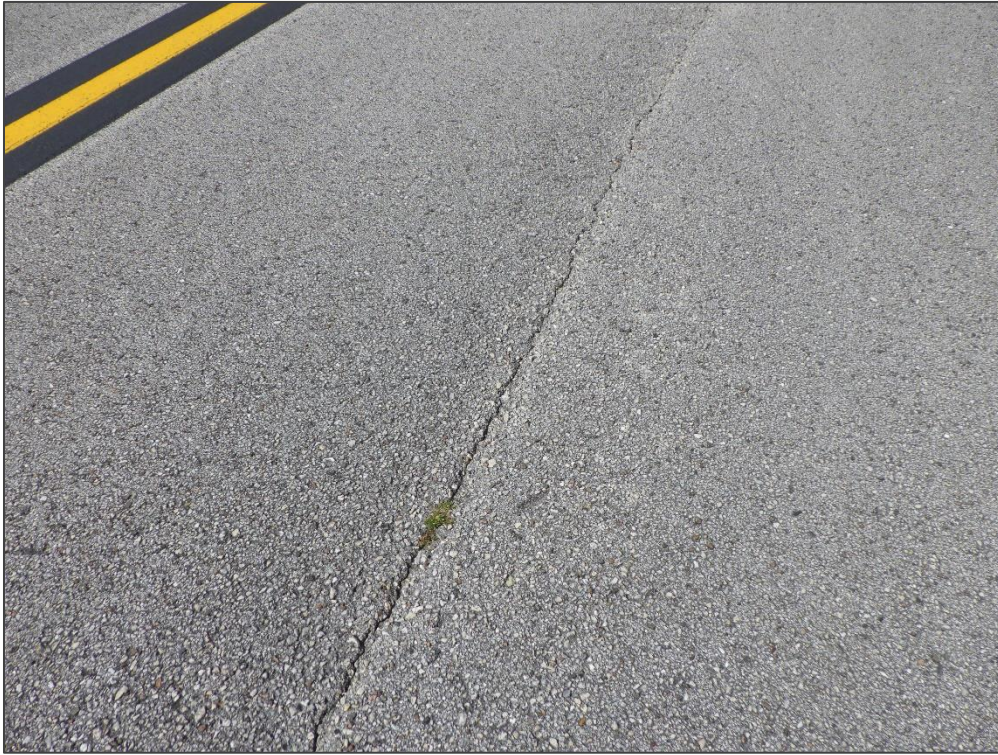
TW A, Section 105, Sample Unit 109 – Longitudinal & Transverse Cracking

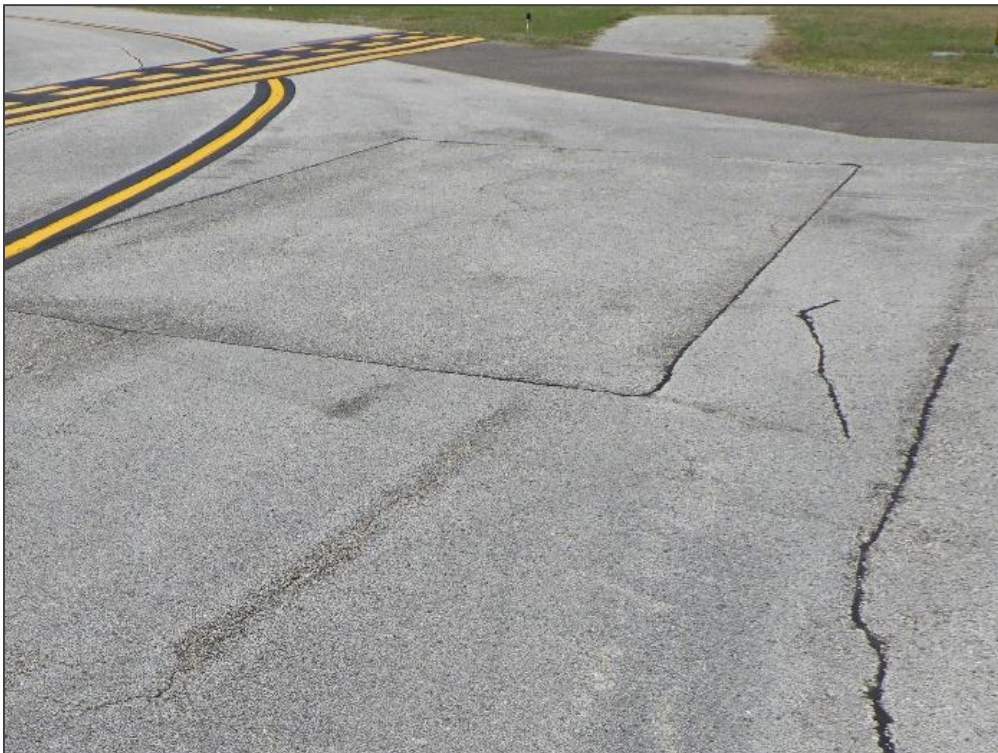
TW A6, Section 190, Sample Unit 130 – Patching and Longitudinal & Transverse Cracking

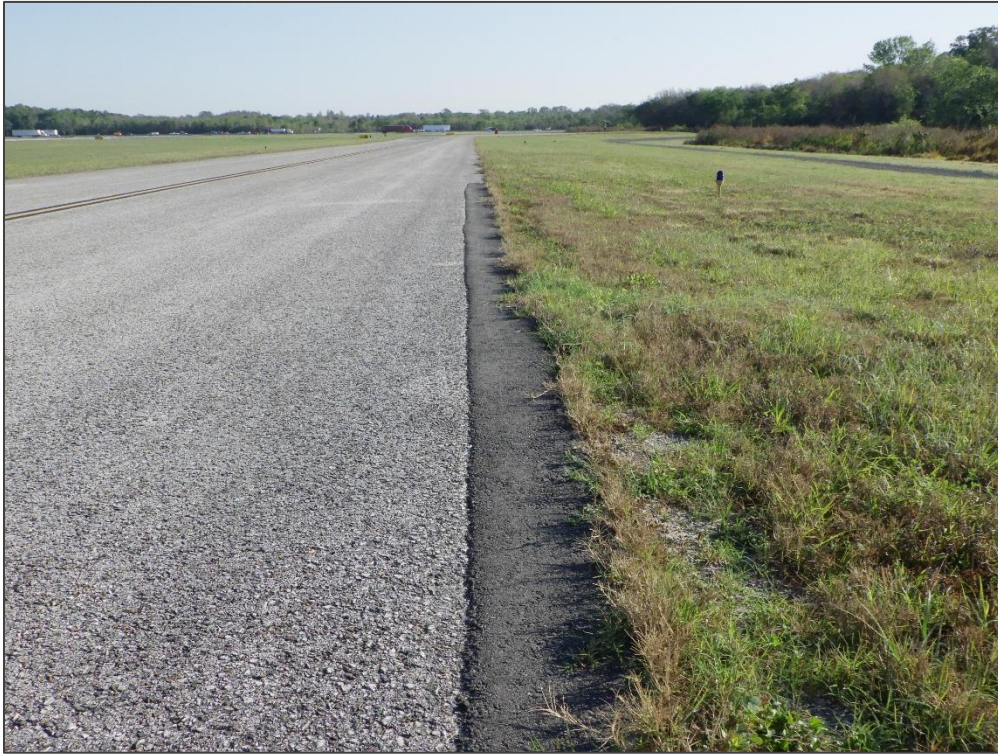
TW E, Section 505, Sample Unit 134 – Patching

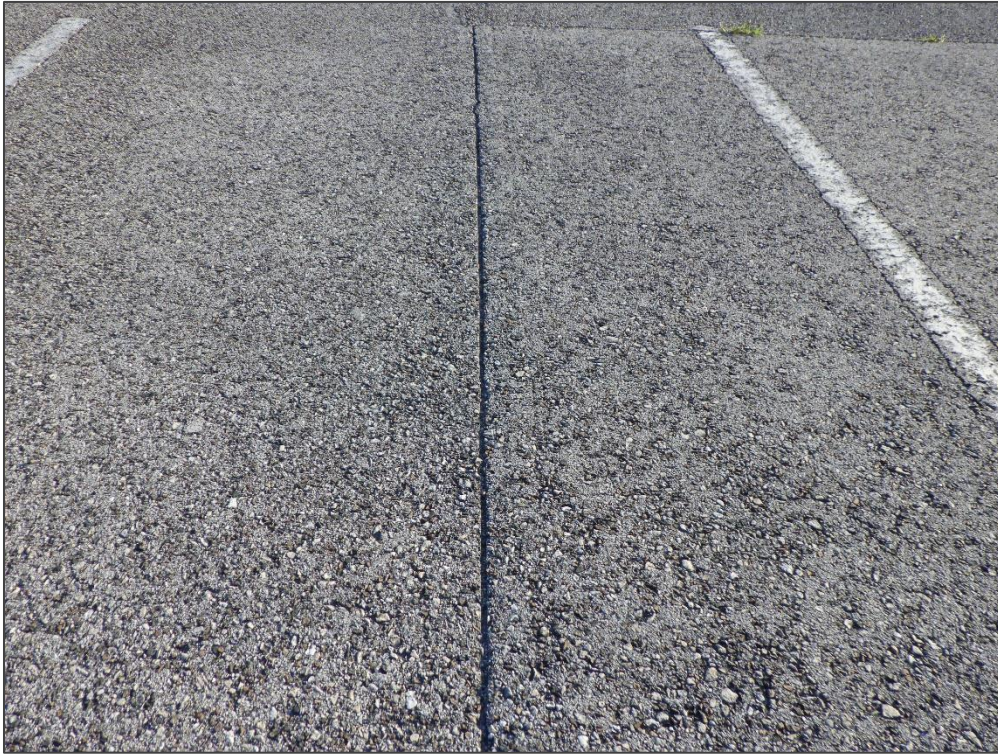
AP MAIN, Section 4410, Sample Unit 450 – Longitudinal & Transverse Cracking

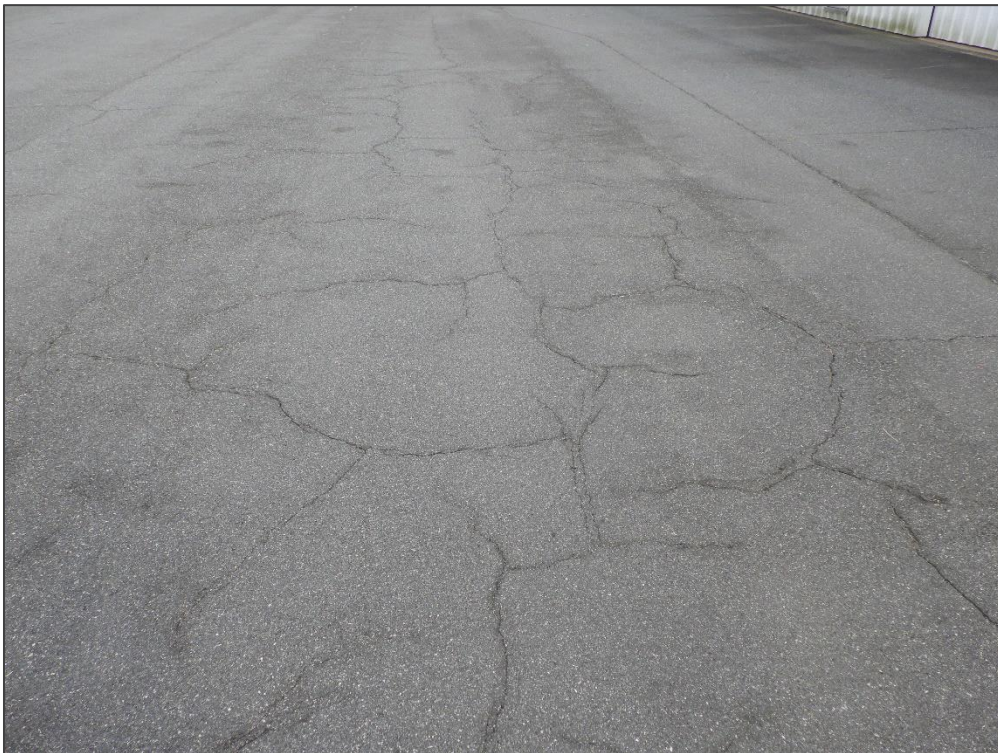
AP N, Section 4210, Sample Unit 306 – Block Cracking

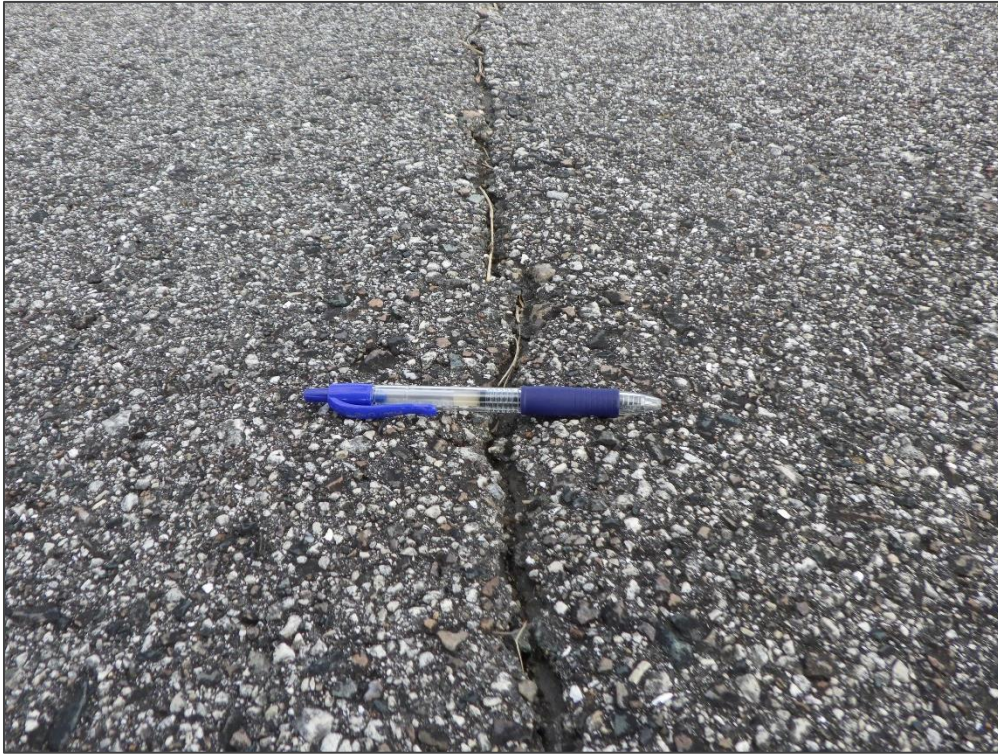
AP S, Section 4110, Sample Unit 252 – Longitudinal & Transverse Cracking

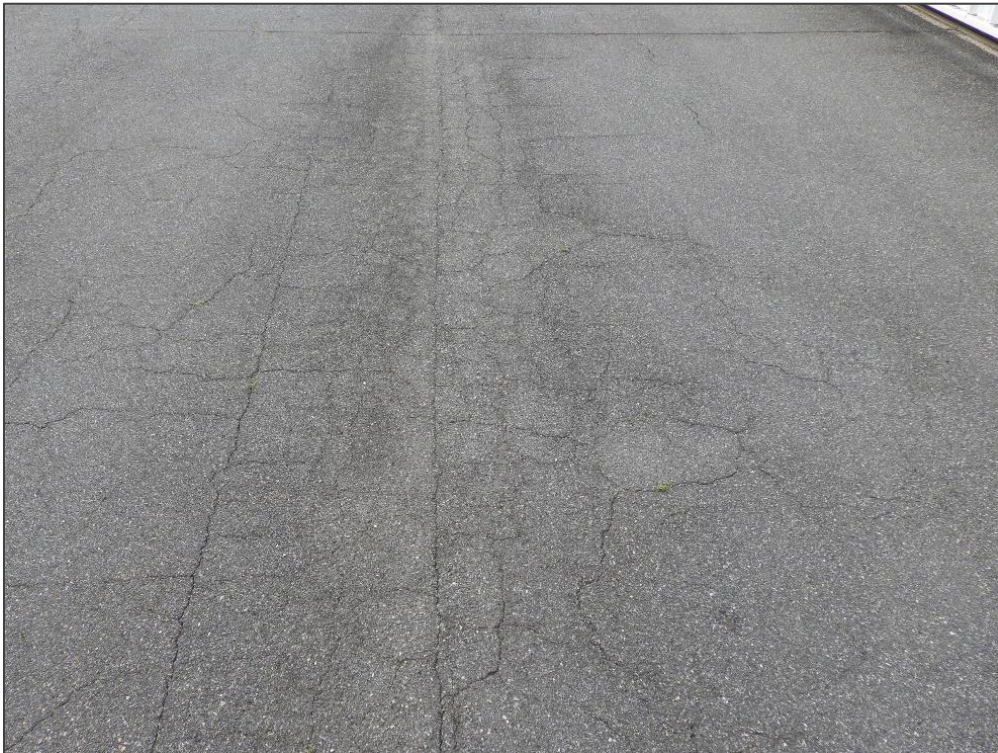
AP T-HANG, Section 4310, Sample Unit 105 – Alligator Cracking
