Statewide Airfield Pavement Management Program

Airport Pavement Evaluation Report

VPS - Destin-Fort Walton Beach Airport | *District 3*

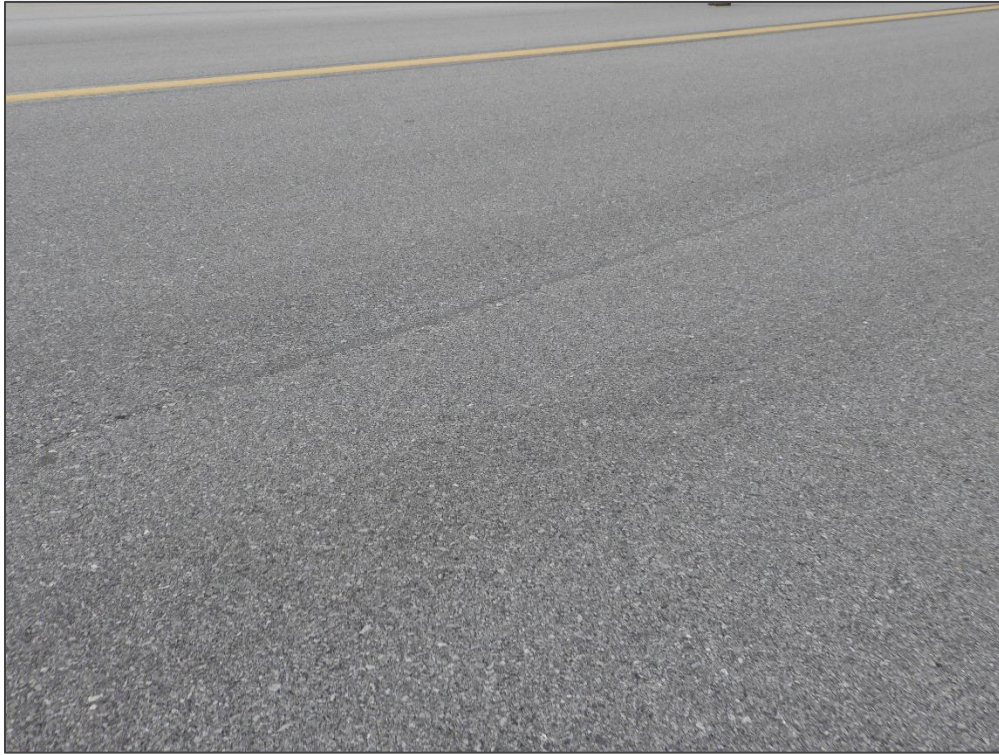
TW D1, Section 105, Sample Unit 114 – Rutting

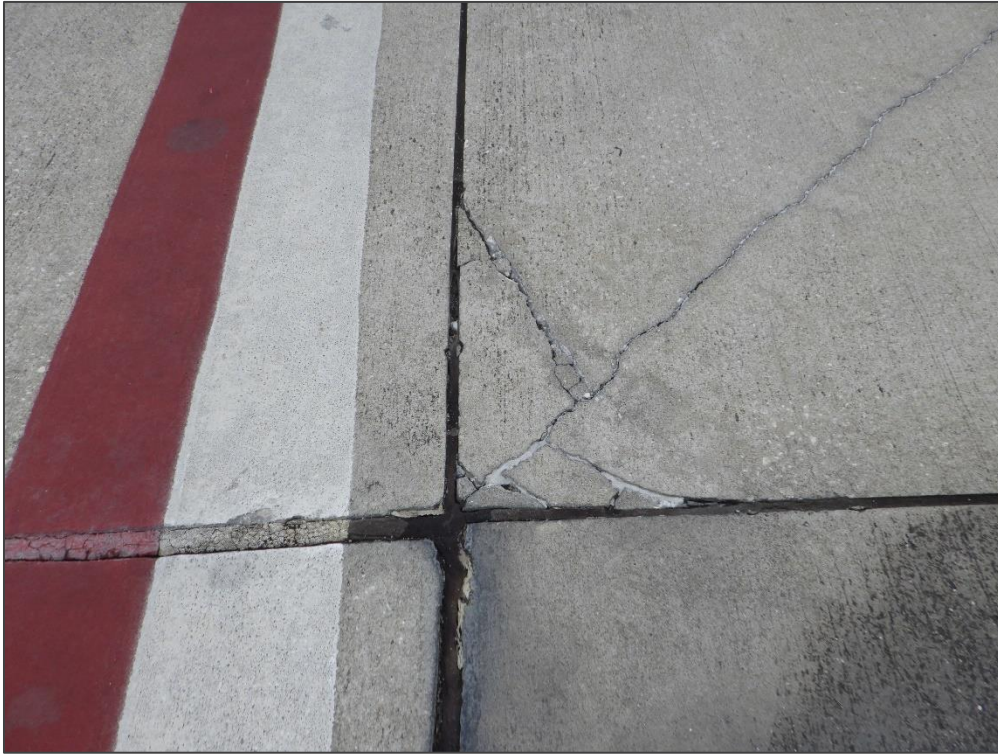
AP TERM, Section 4110, Sample Unit 153 – Linear Cracking and Corner Spall

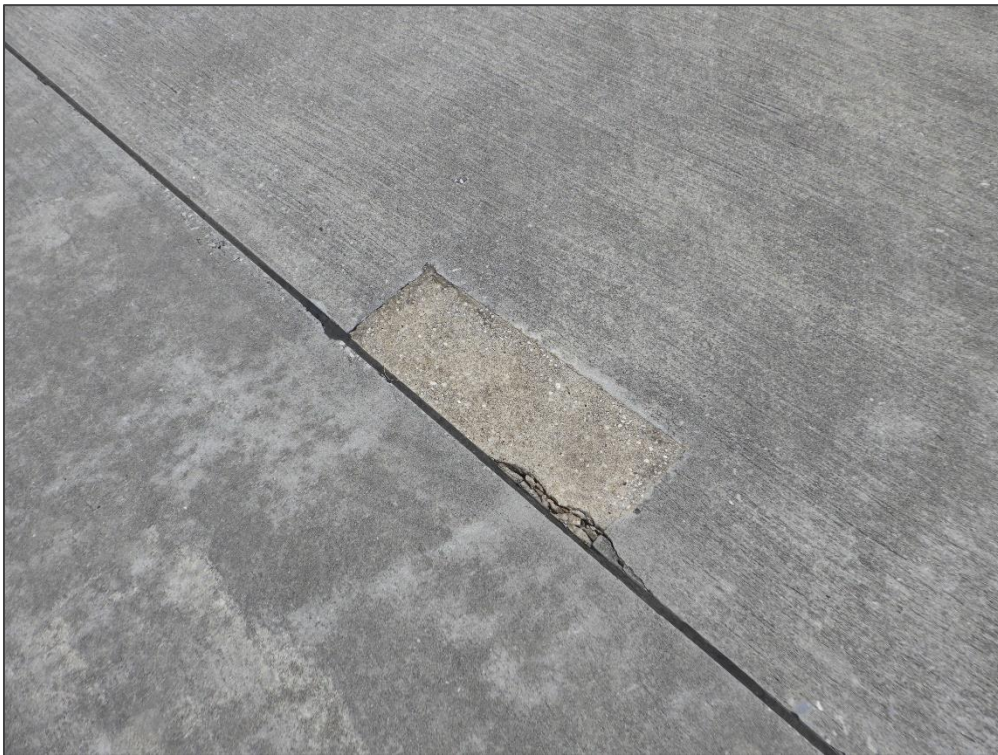
AP TERM, Section 4115, Sample Unit 512 – Small Patch

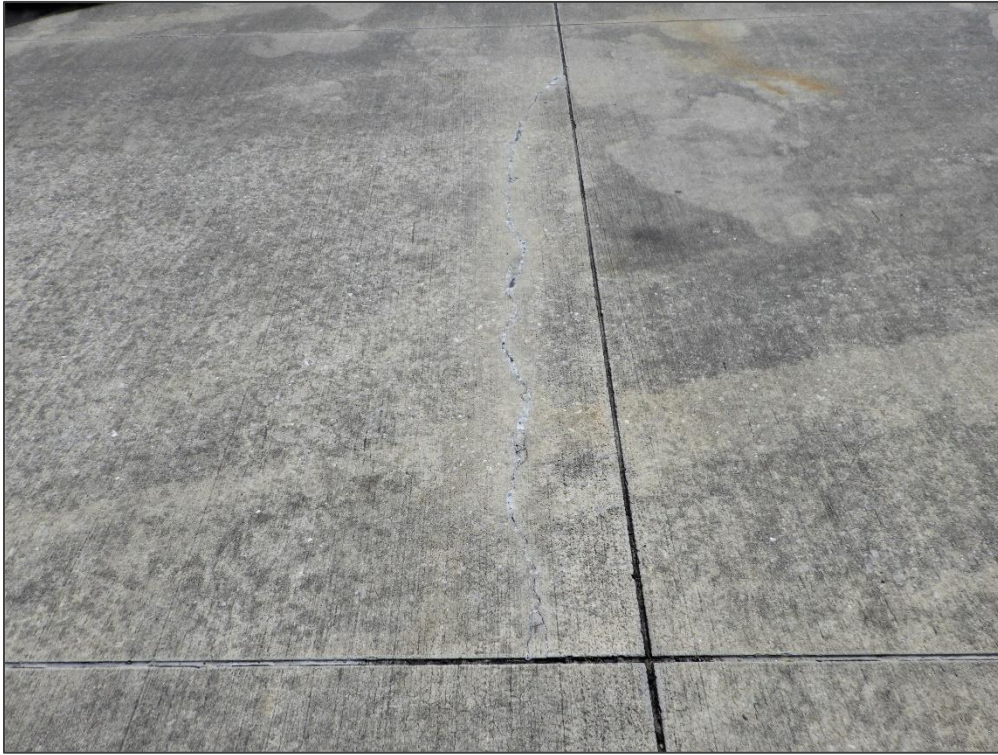
AP TERM, Section 4120, Sample Unit 304 – Linear Cracking

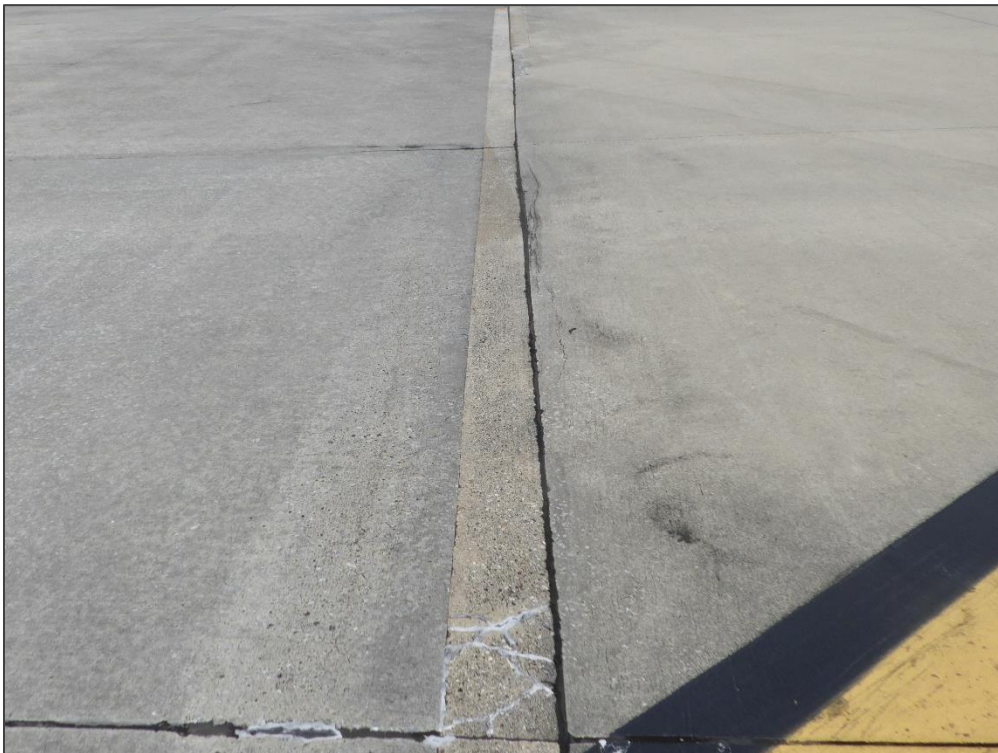
AP TERM, Section 4120, Sample Unit 450 – Large Patch
