*Statewide Airfield Pavement Management Program*

# Airport Pavement Evaluation Report

X60 - Williston Municipal Airport | *District 2*

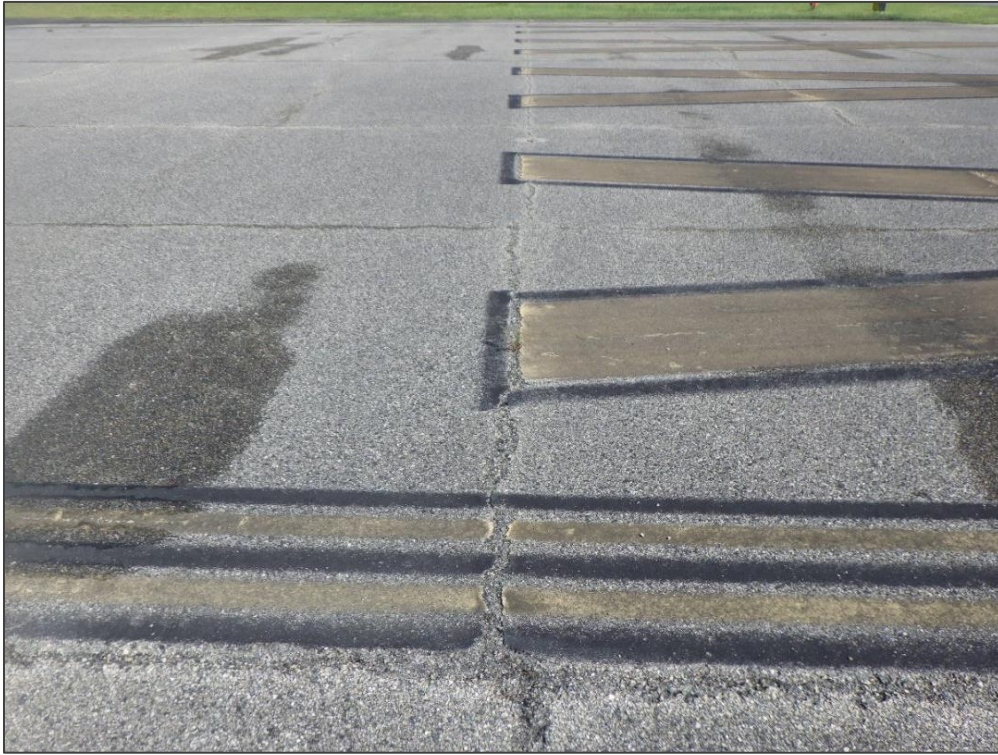
RW 5-23, Section 6112, Sample Unit 304 – Joint Reflection Cracking

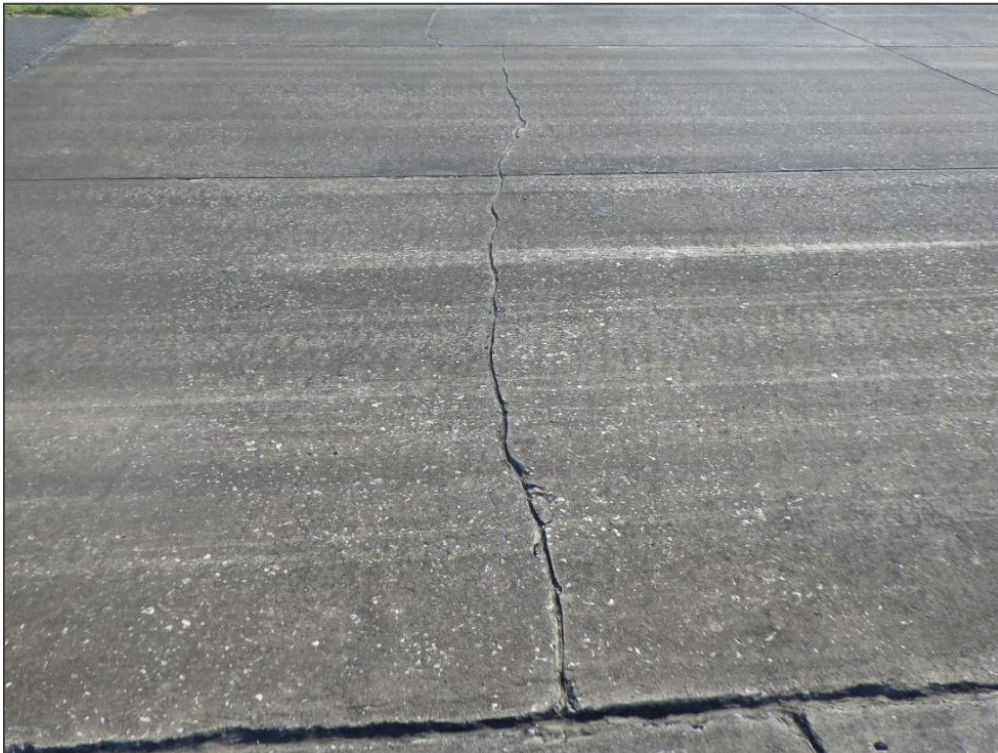
RW 14-32, Section 6205, Sample Unit 303 – Linear Cracking

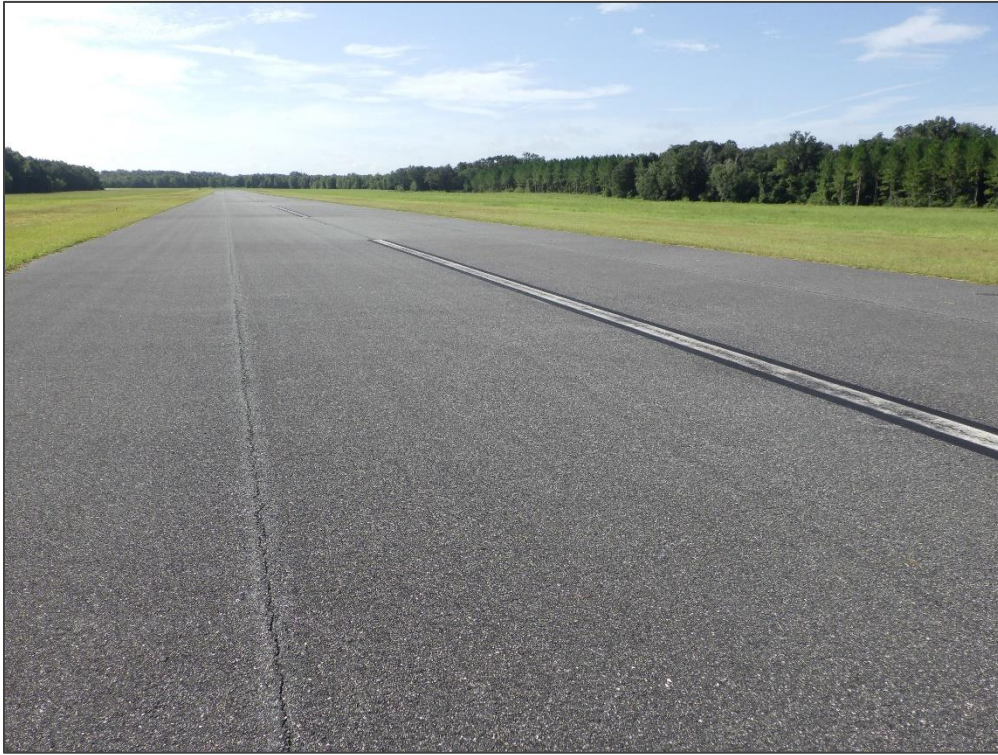
RW 14-32, Section 6215, Sample Unit 322 – Longitudinal & Transverse Cracking

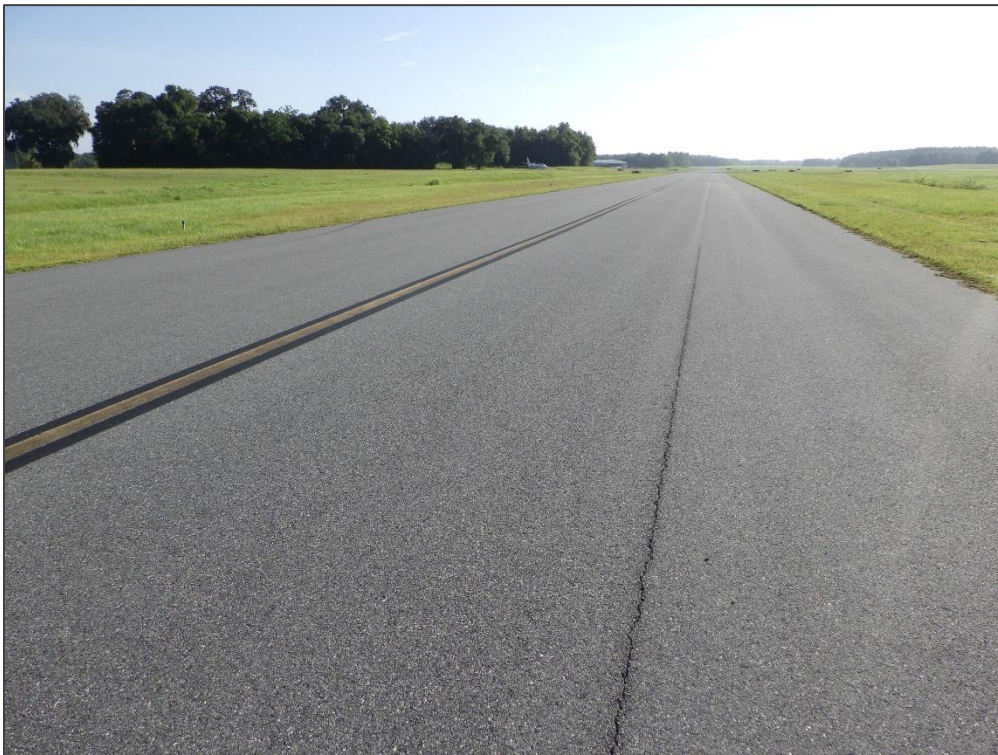
TW A, Section 205, Sample Unit 164 – Longitudinal & Transverse Cracking

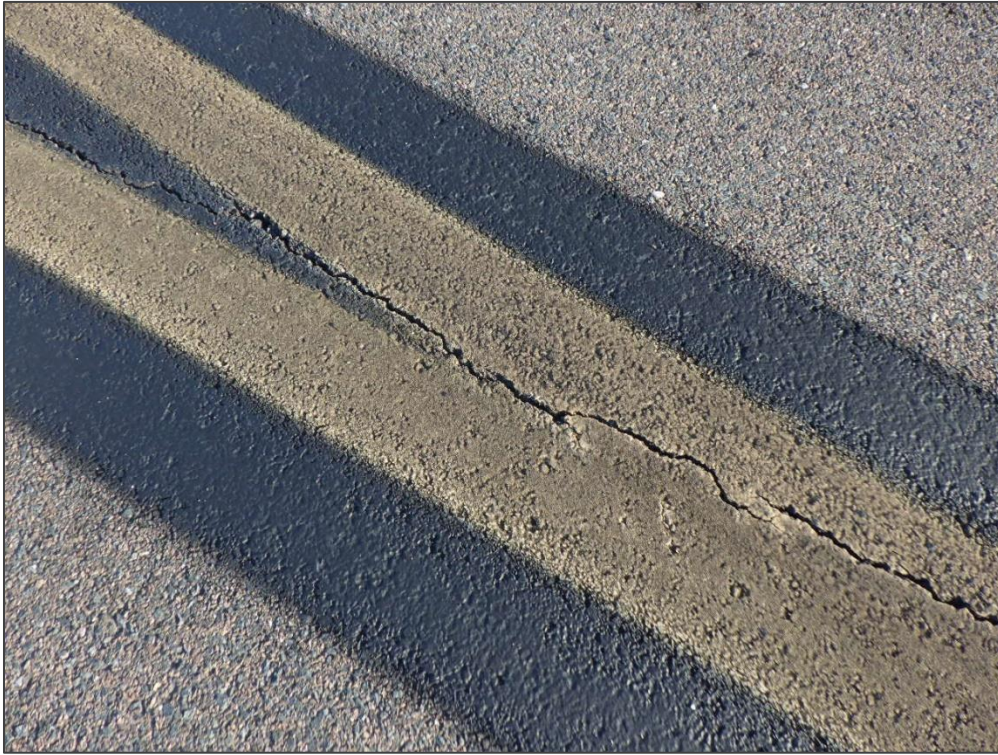
TW D, Section 505, Sample Unit 103 – Longitudinal & Transverse Cracking

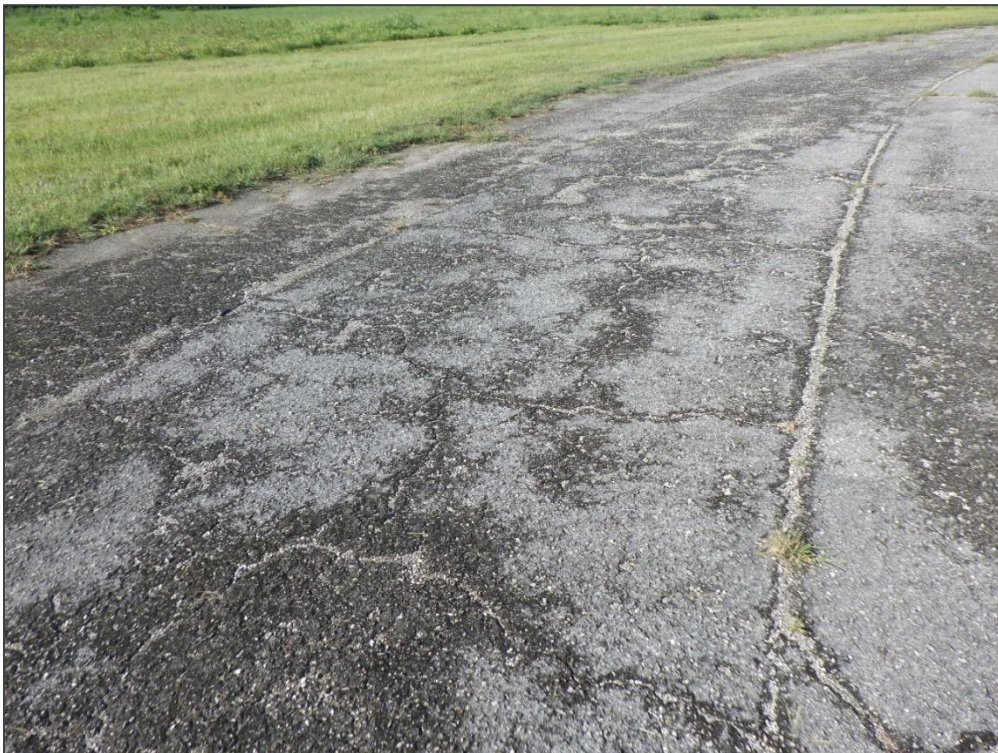
TW F, Section 550, Sample Unit 145 – Block Cracking and Raveling

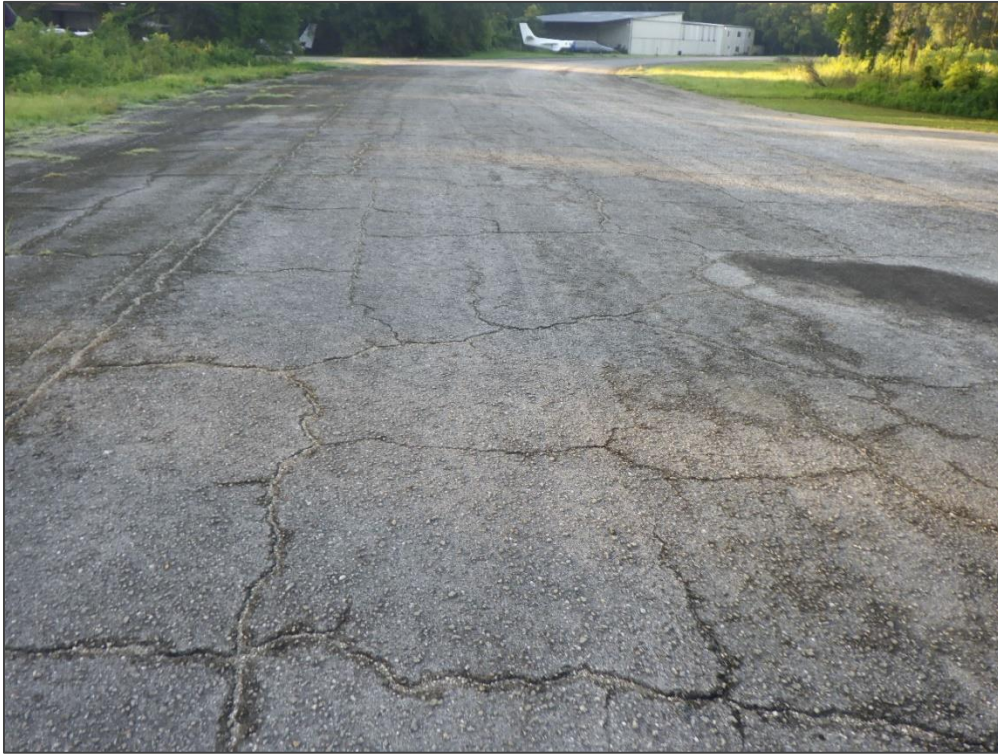
TW G, Section 450, Sample Unit 113 – Block Cracking

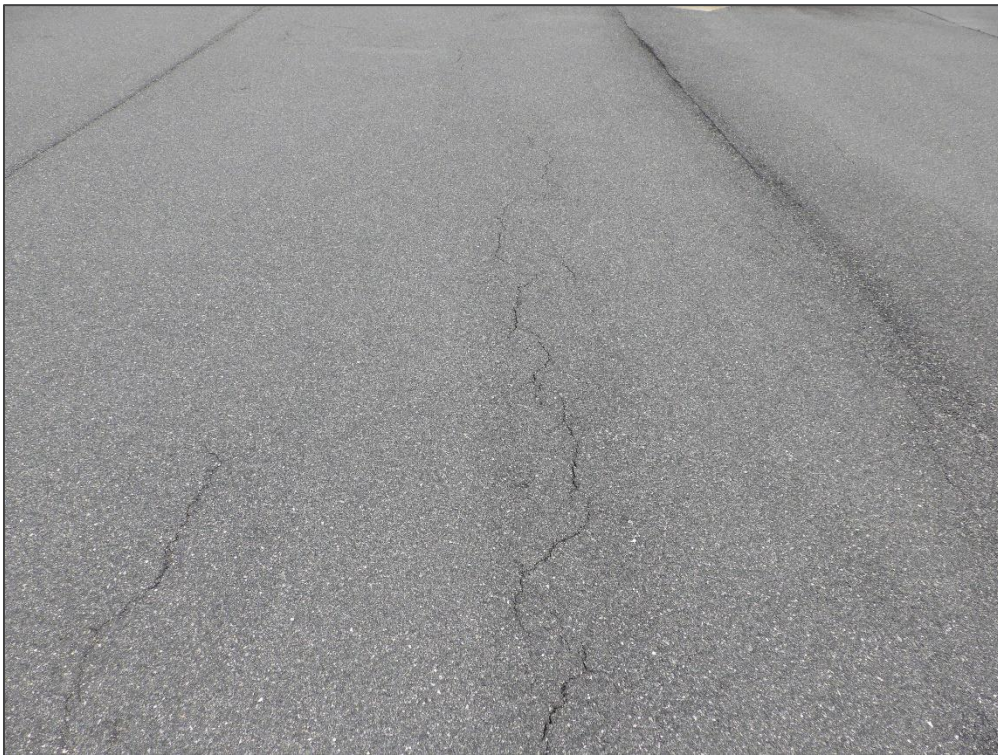
AP, Section 4110, Sample Unit 554 – Longitudinal & Transverse Cracking

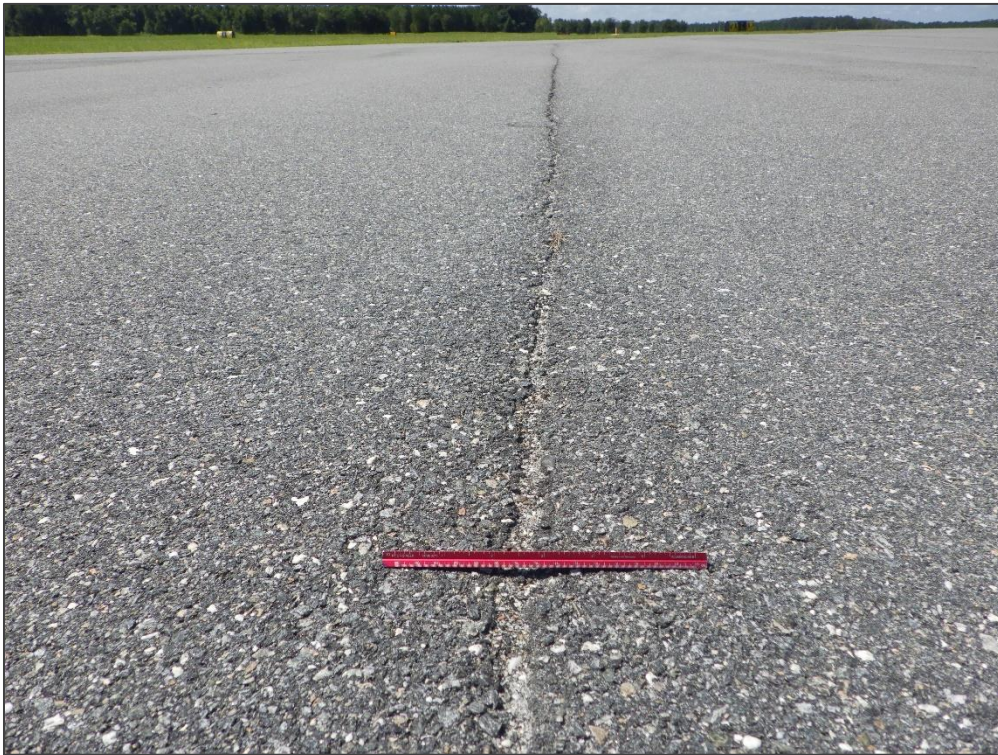
AP, Section 4110, Sample Unit 601 – Longitudinal & Transverse Cracking

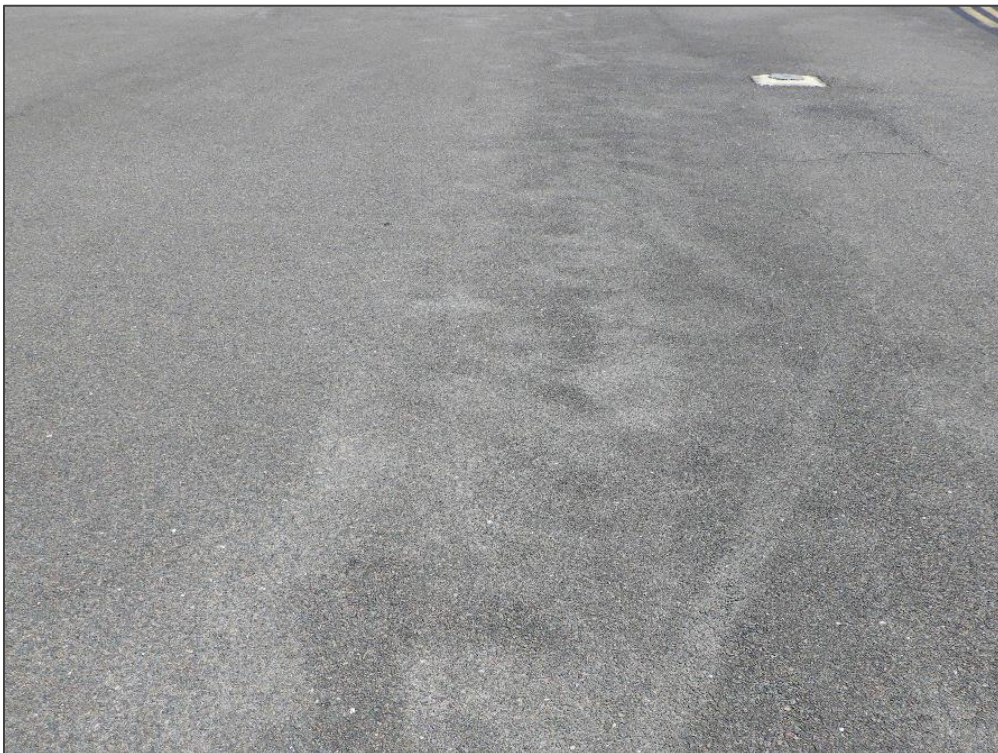
AP HANG, Section 4205, Sample Unit 100 – Swelling
