STATE OF FLORIDA DEPARTMENT OF TRANSPORTATION AVIATION OFFICE

Statewide Airfield Pavement Management Program North Palm Beach County General Aviation Airport – F45 (Regional Reliever) West Palm Beach, Florida (District 4)

February 8, 2008

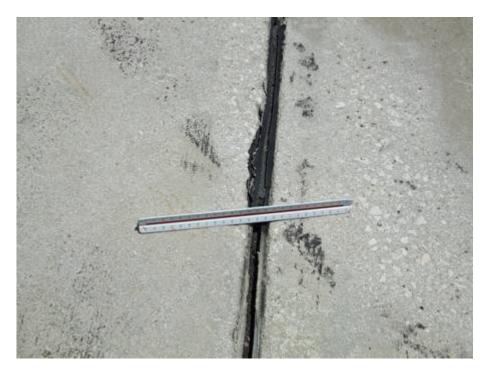
AP N Section 4110 SU 99: High Severity Joint Seal Damage (September 17, 2007)

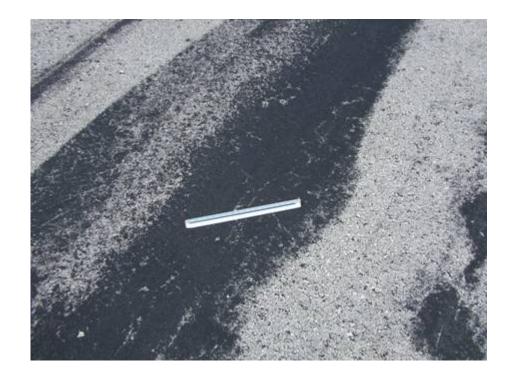
AP N Section 4120 SU 206: Low Severity Weathering (September 17, 2007)

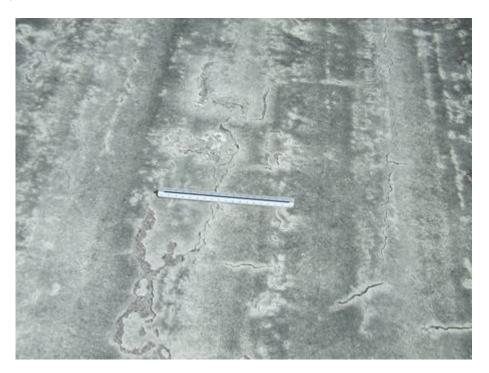
RW 13-31 Section 6205 SU 102: Low Severity Weathering (September 17, 2007)

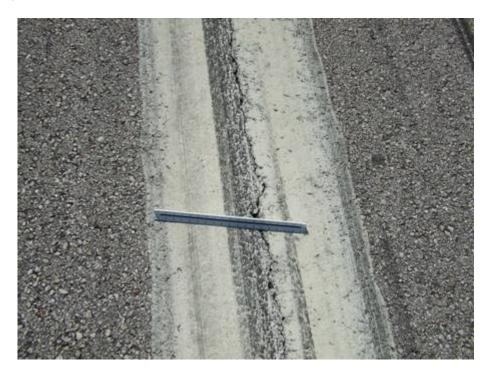
RW 8-26 Section 6105 SU 116: Low Severity L/T Cracking (September 17, 2007)

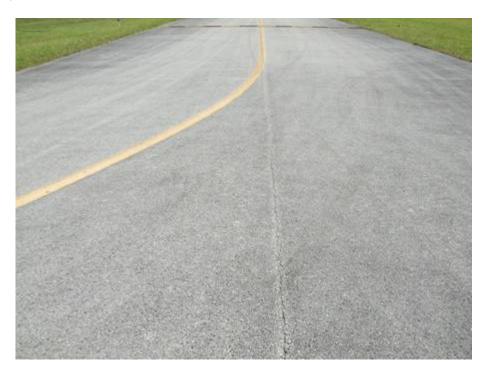
TW M Section 1305 SU 200: Low Severity L/T Cracking (September 17, 2007)

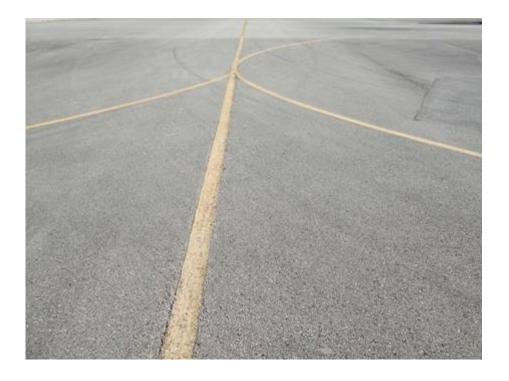
TW J Section 1010 SU 100: Low Severity L/T Cracking (September 17, 2007)
