**STATE OF FLORIDA  
DEPARTMENT OF TRANSPORTATION  
AVIATION OFFICE**

**Statewide Airfield Pavement Management Program  
Marianna Municipal Airport  
(General Aviation)  
Marianna, Florida  
(District 3)**

**March 31, 2008**

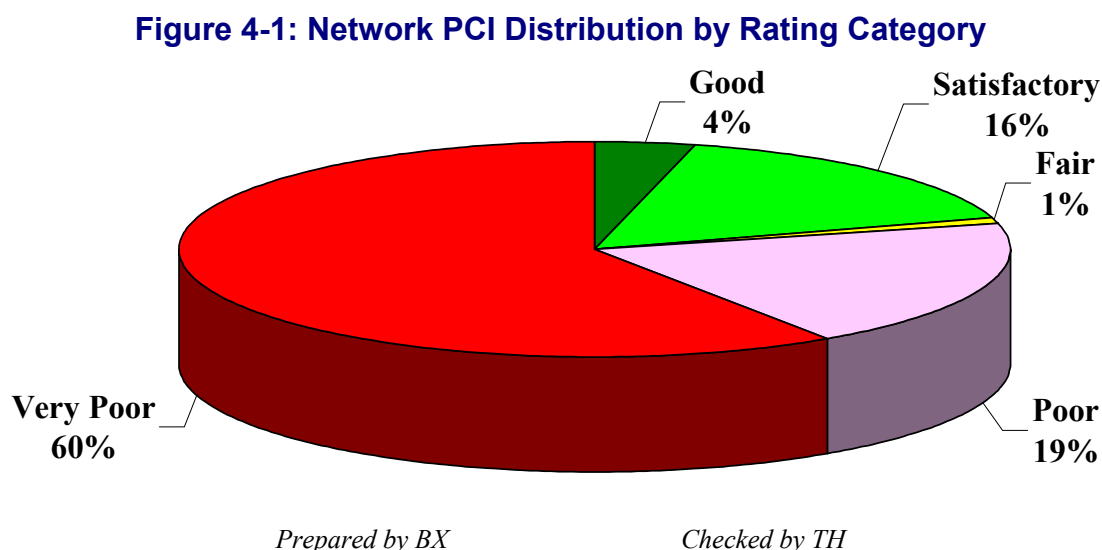
According to the 2006 survey, the overall area-weighted PCI at Marianna Municipal Airport is 42, representing a Poor overall network condition.

Approximately 20% of the network is in Good and Satisfactory condition while 79% of the network is in Poor to Very Poor condition. Table 4-1 illustrates the area-weighted PCI computed individually for each pavement use.

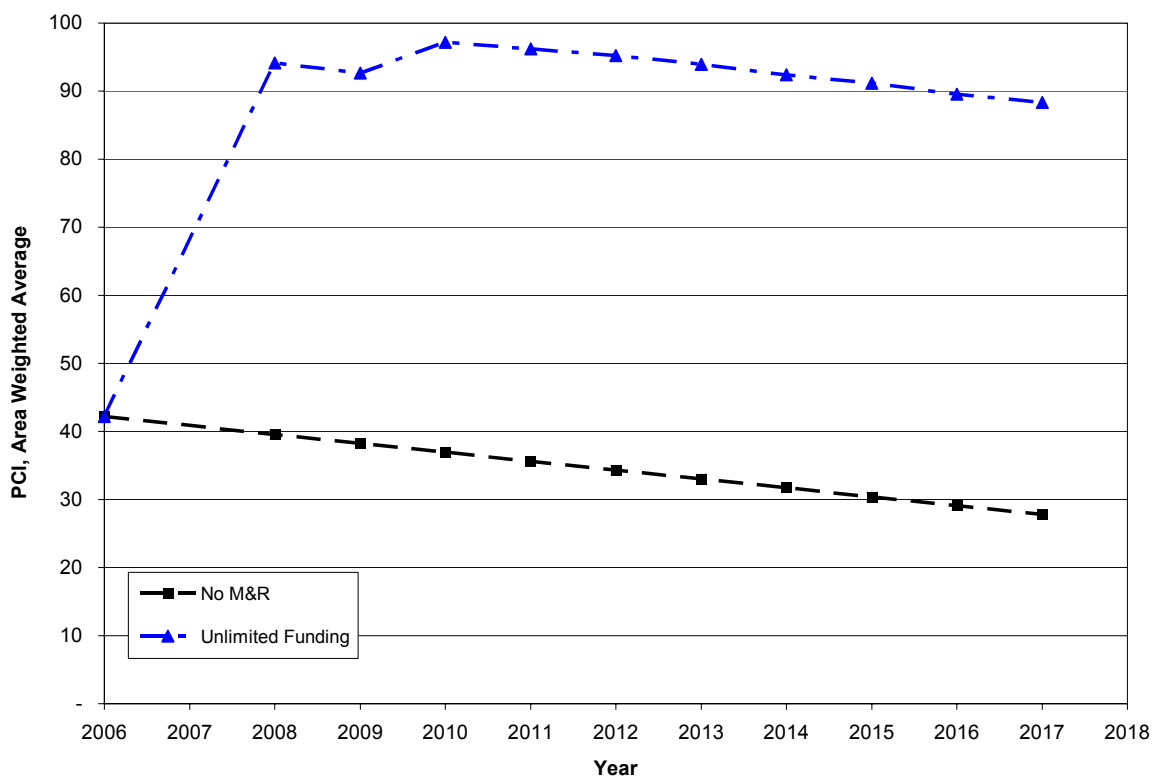
**Figure 7-1: Budget Scenario Analysis**

- The PCI will deteriorate from 42 in 2006 to 28 in 2017 if no M&R activities are performed.
- The PCI will remain at or above 88 through the 10-year analysis period under the unlimited budget scenario. A 2017 PCI of 88 with this scenario is 60 PCI points higher than a “No M&R” scenario. The total cost for Major M&R over this 10-year period is about \$30 million.

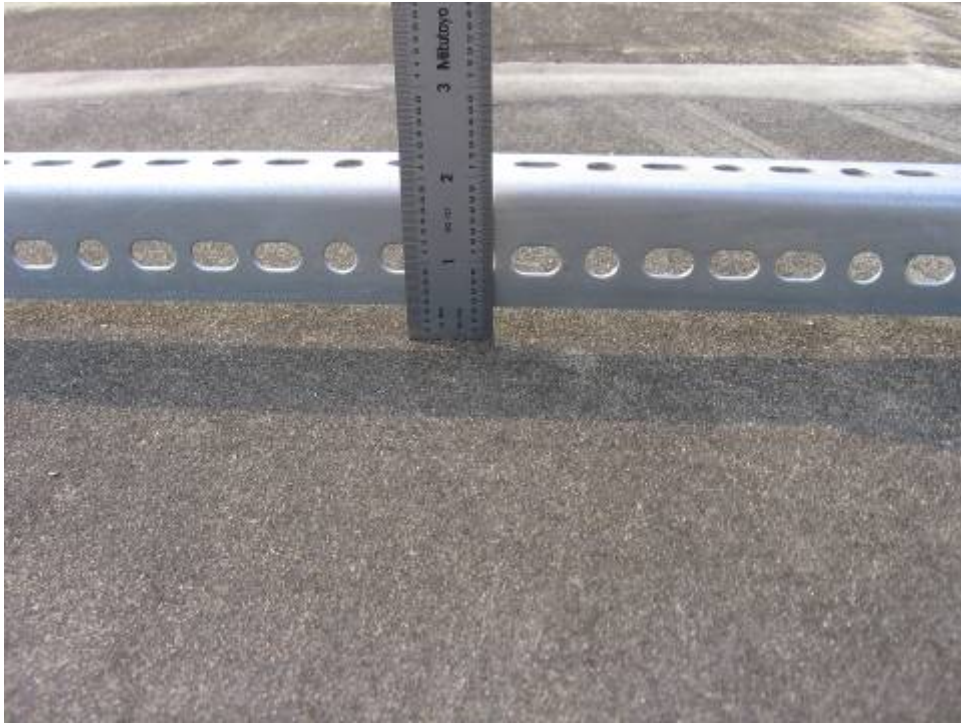
RW 8L-26R Section 6105 SU 300: Low Severity Swelling (October 3, 2006)

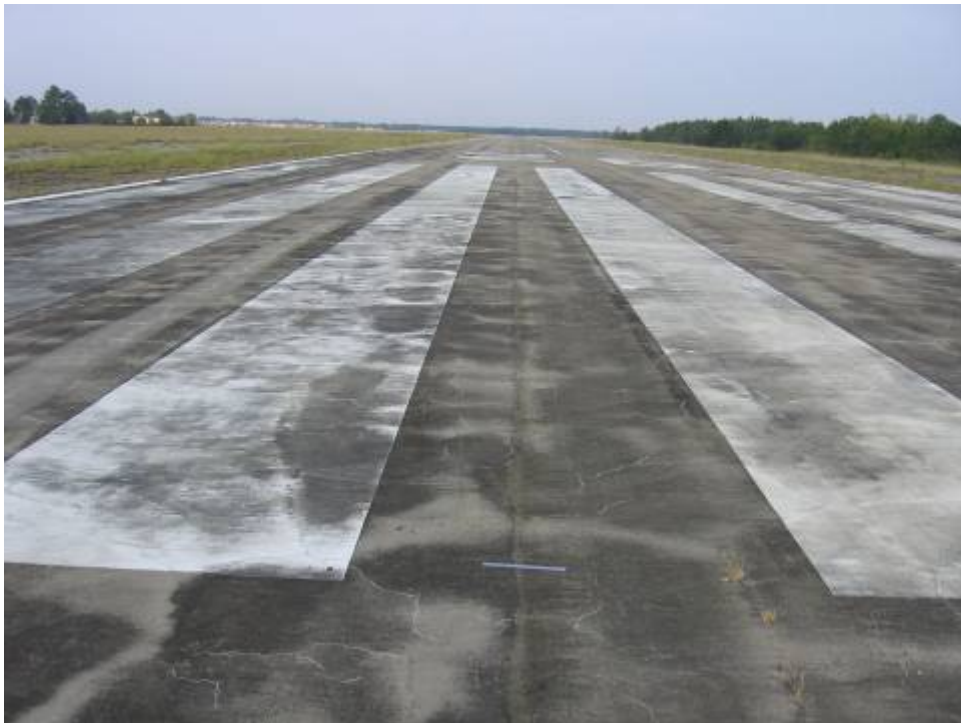
RW 8L-26R Section 6105 SU 300: Low Severity Block Cracking (October 3, 2006)

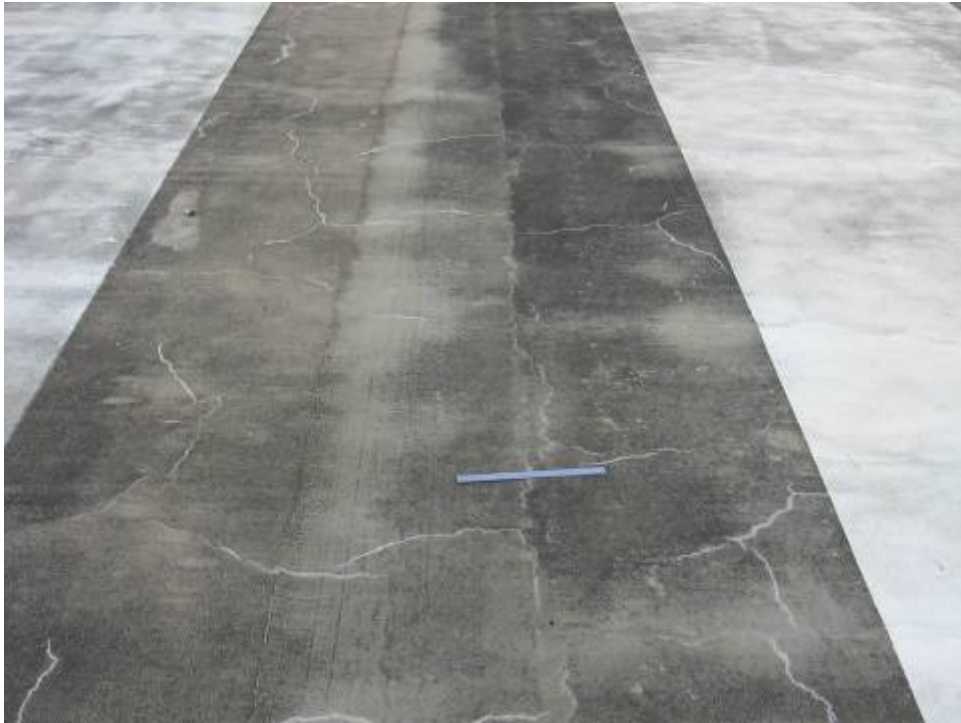
RW 8L-26R Section 6105 SU 301: Low Severity Block Cracking (October 3, 2006)

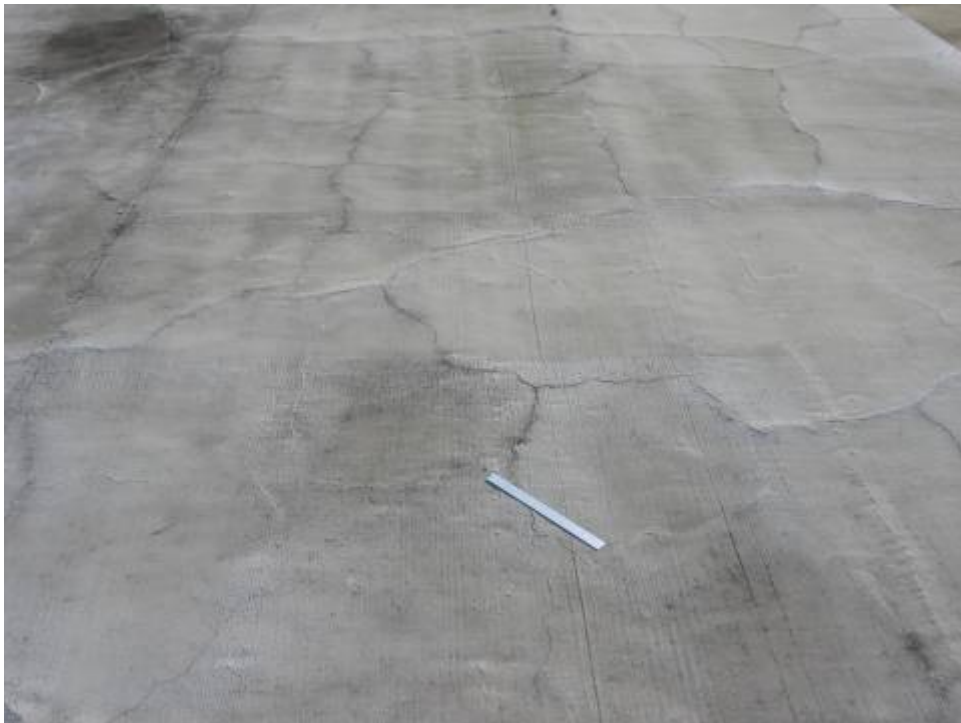
RW 8L-26R Section 6105 SU 322: Low Severity Block Cracking (October 3, 2006)

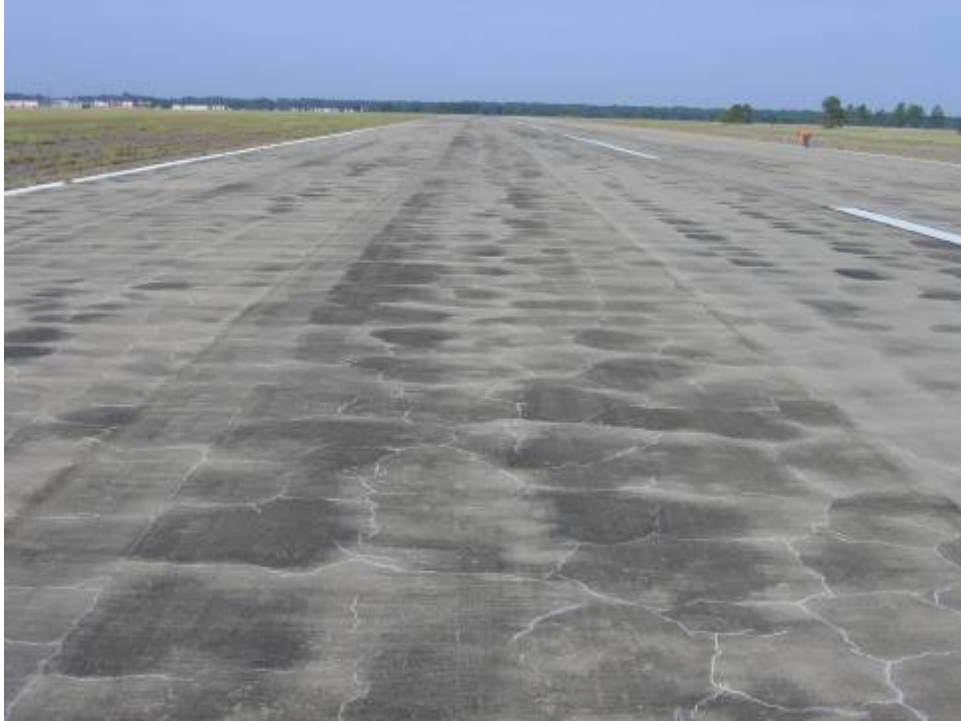
RW 8L-26R Section 6105 SU 343: Low Severity Block Cracking (October 3, 2006)

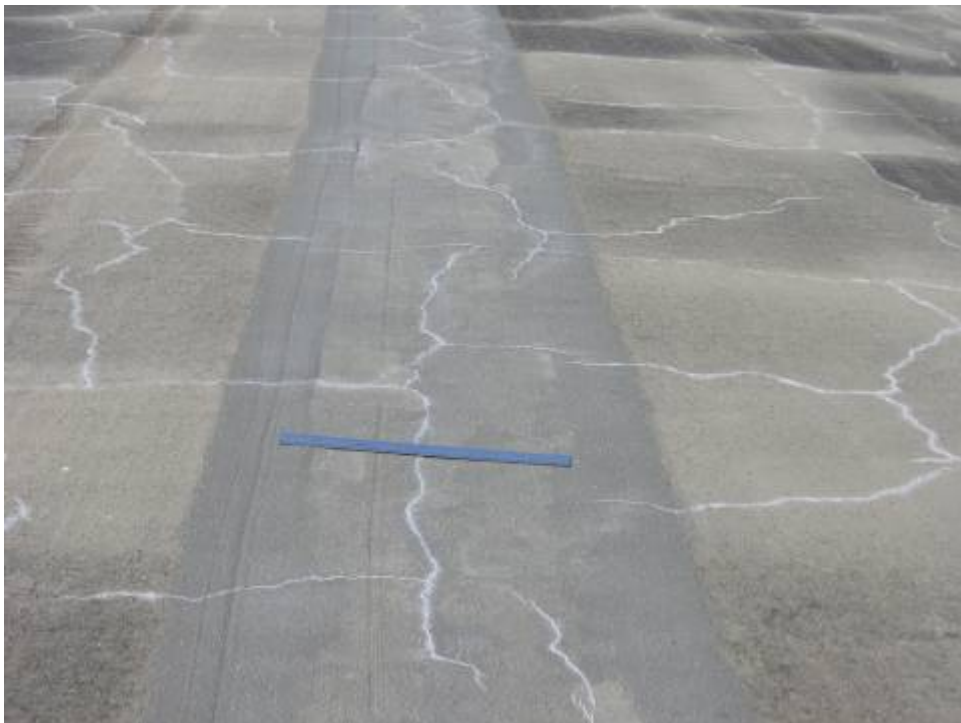
RW 8L-26R Section 6105 SU 378: Low Severity Block Cracking (October 3, 2006)

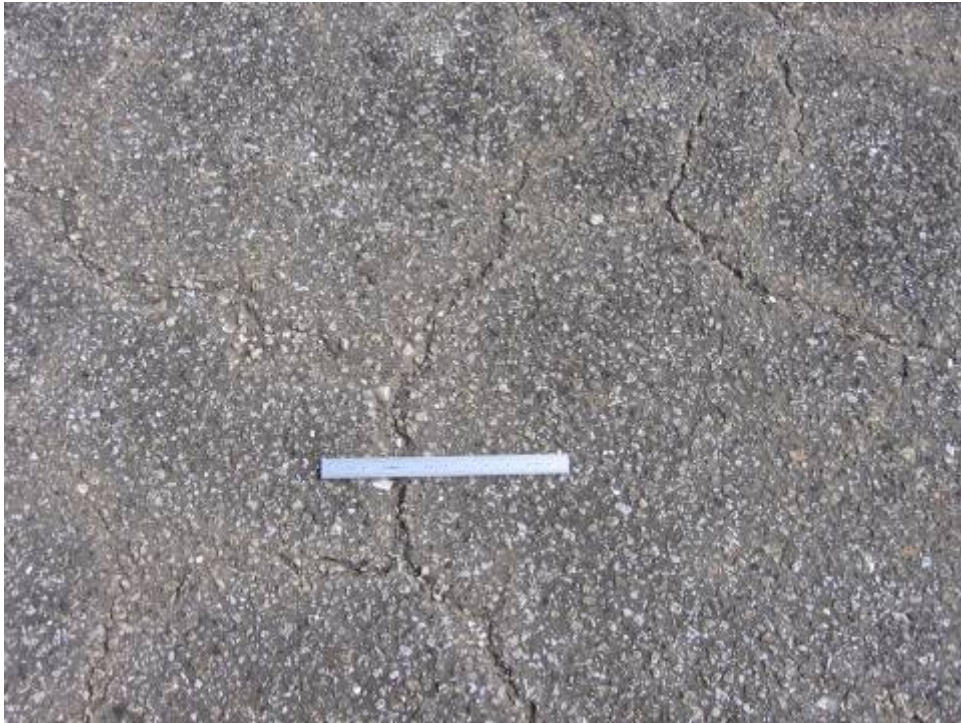
TW PARALL Section 105 SU 101: Low Severity Block Cracking (October 3, 2006)

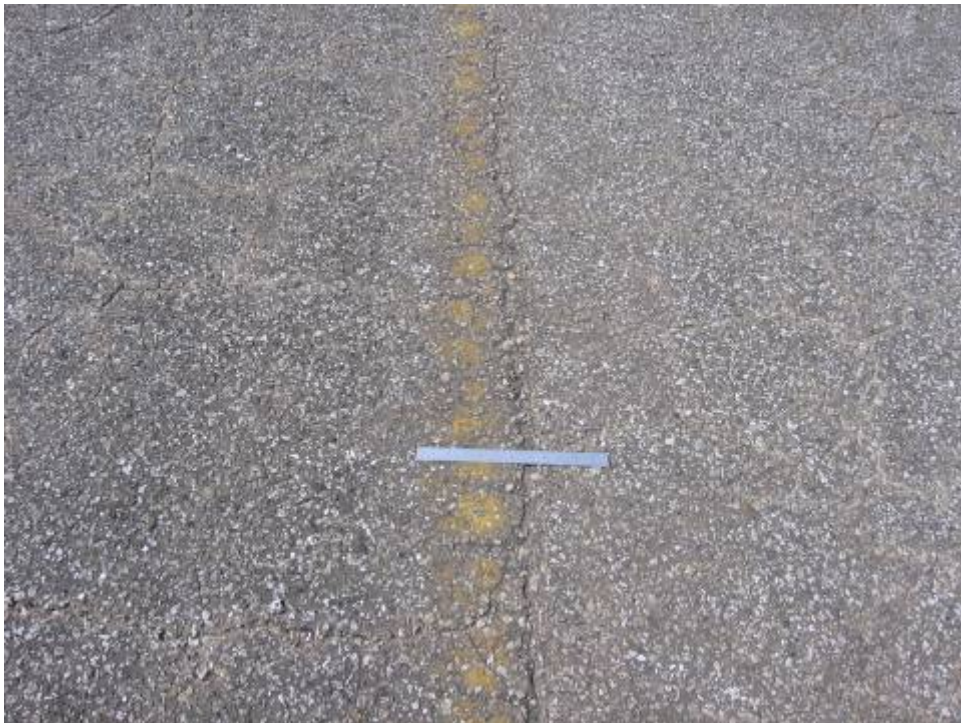
TW PARALL Section 105 SU 107: Low Severity L/T Cracking (October 3, 2006)

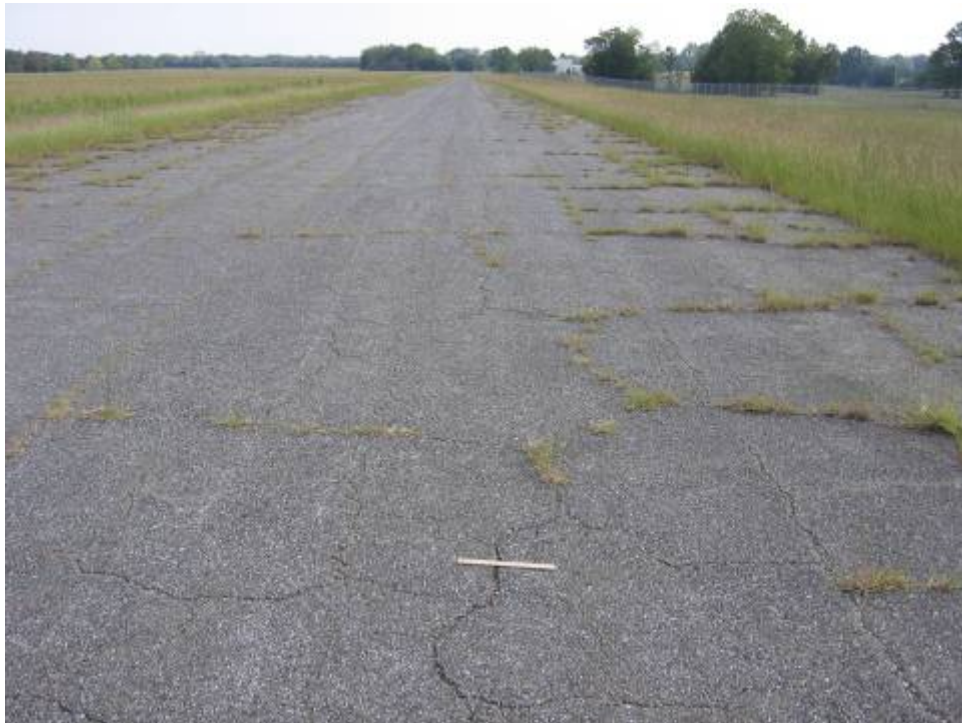
TW PARALL Section 105 SU 122: Medium Severity Block Cracking  
(October 3, 2006)

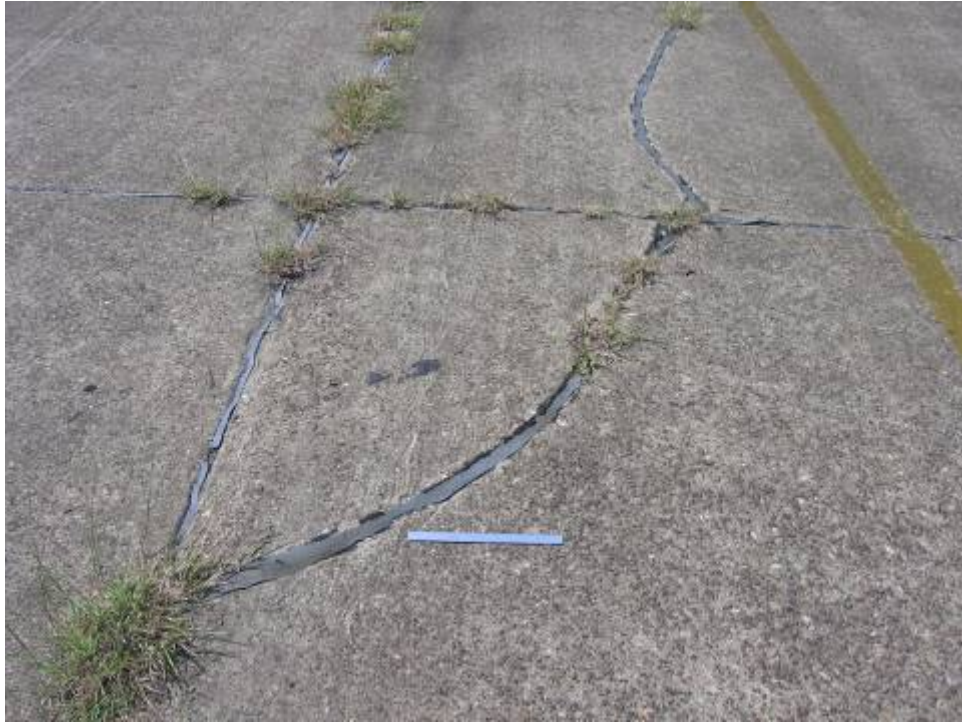
TW PARALL Section 150 SU 140: Medium Severity Corner Break  
(October 3, 2006)

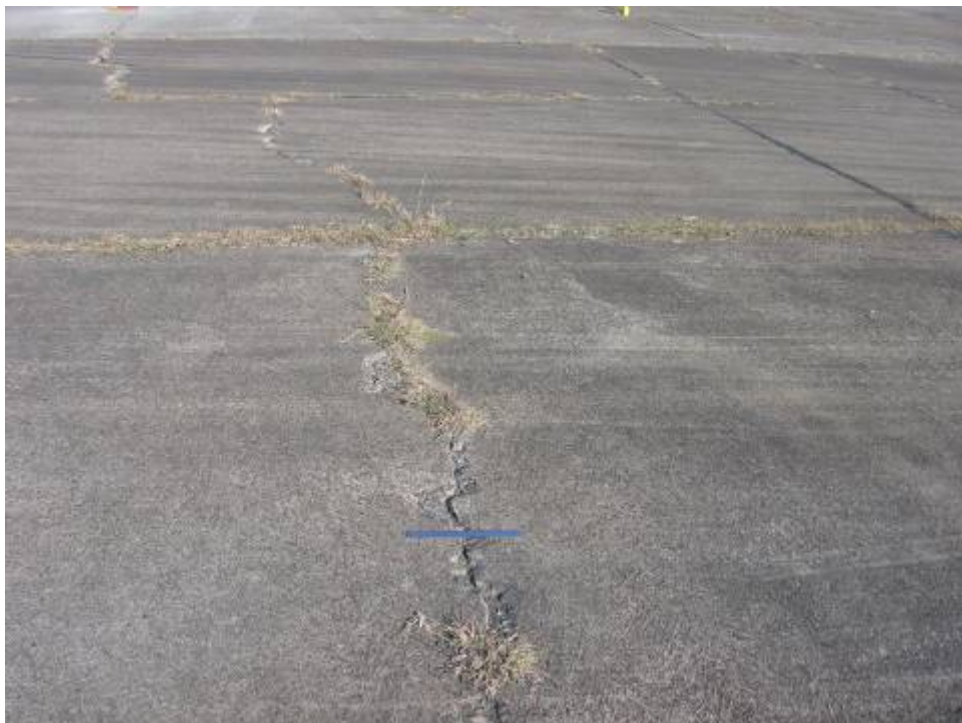
TW PARALL Section 150 SU 149: Medium Severity Linear Cracking  
(October 3, 2006)

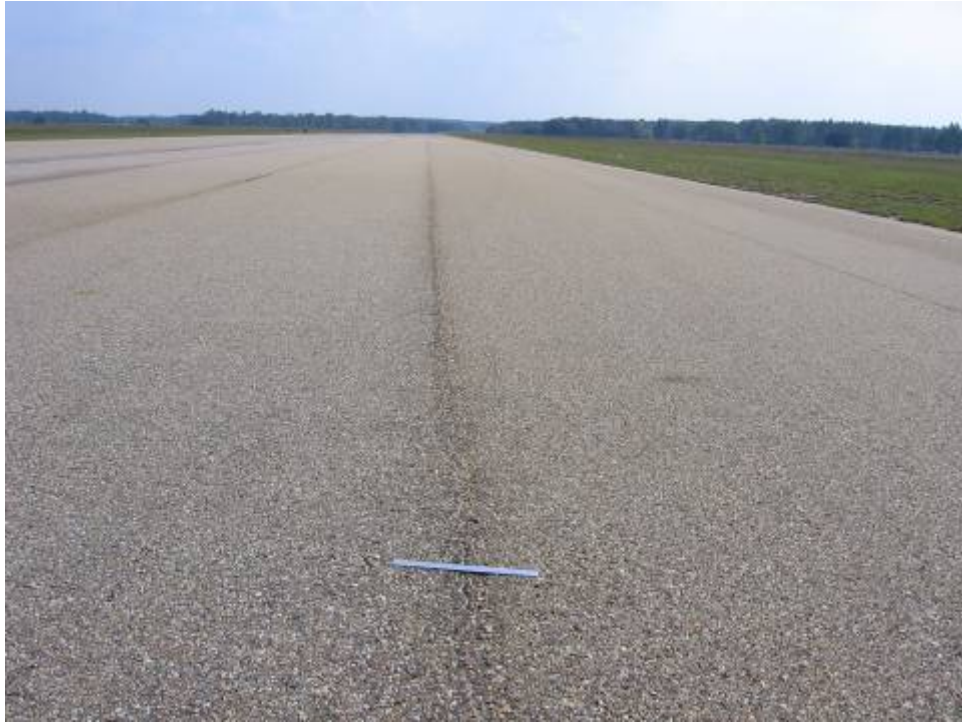
**RW 18L-36R Section 6205 SU 156: Low Severity L/T Cracking  
(October 3, 2006)**

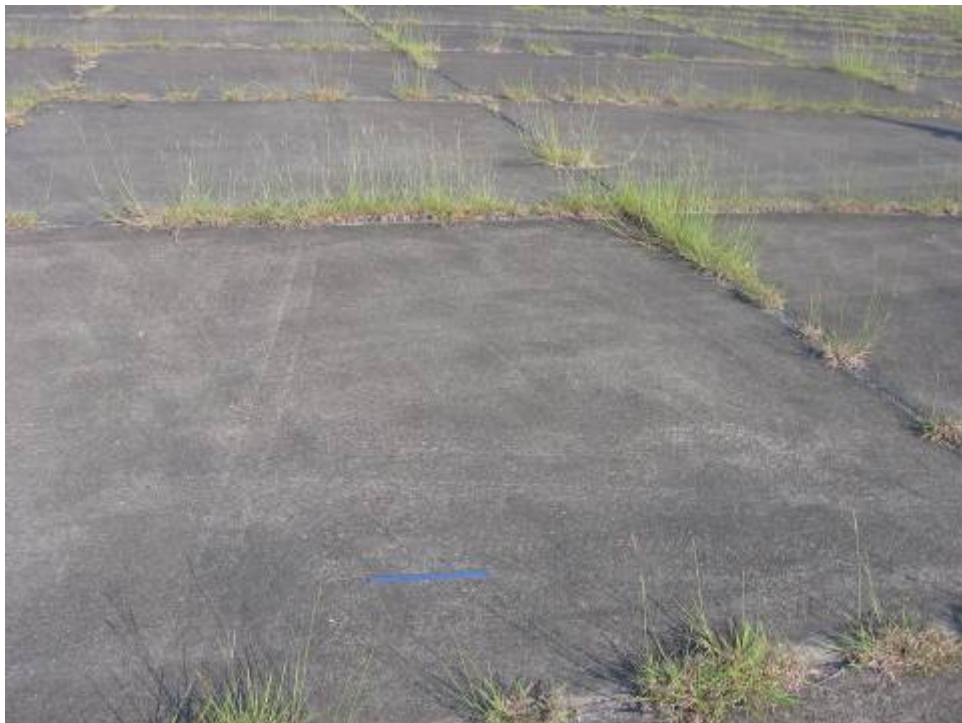
**APRON Section 4105 SU 506: High Severity Joint Seal Damage  
(October 3, 2006)**
