**STATE OF FLORIDA  
DEPARTMENT OF TRANSPORTATION  
AVIATION OFFICE**

**Statewide Airfield Pavement Management Program  
Merritt Island Airport  
(General Aviation)  
Merritt Island, Florida  
(District 5)**

February 1, 2008

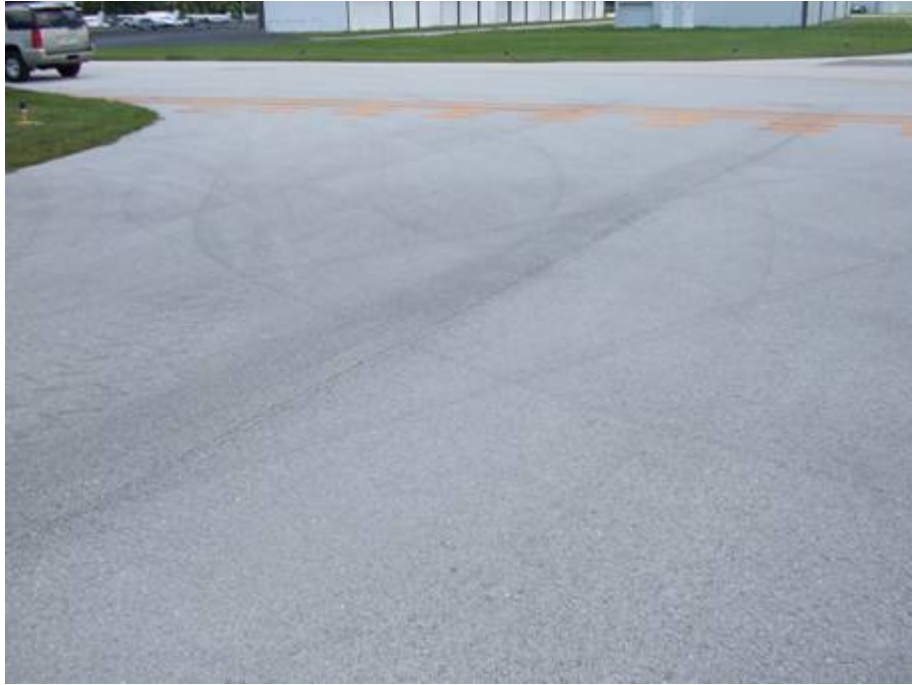
TW CA Section 310 SU 101: Low Severity L/T Cracking (July 9, 2007)

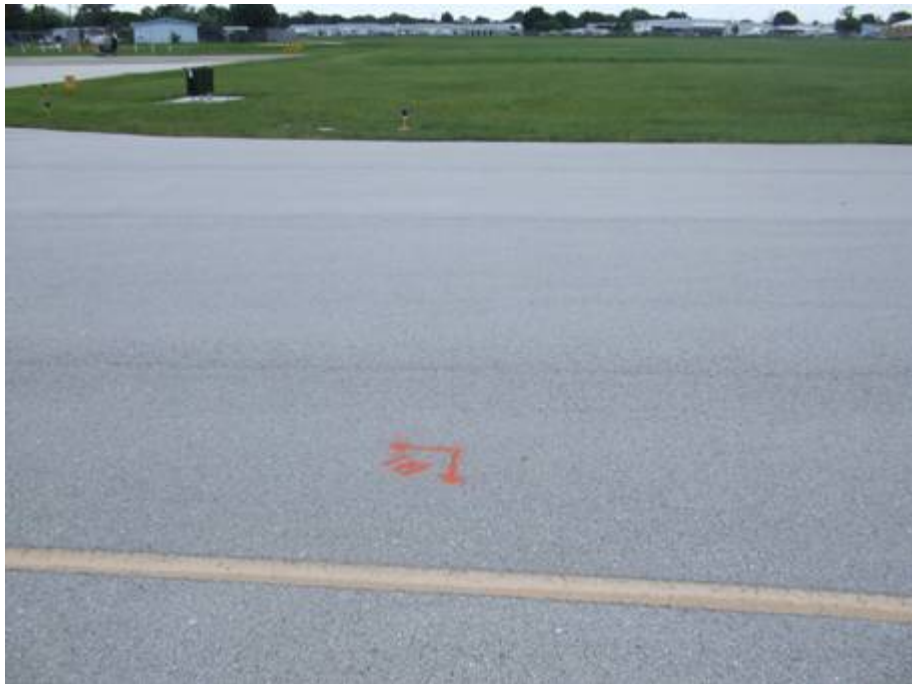
TW CA Section 305 SU 300: Low Severity L/T Cracking (July 9, 2007)

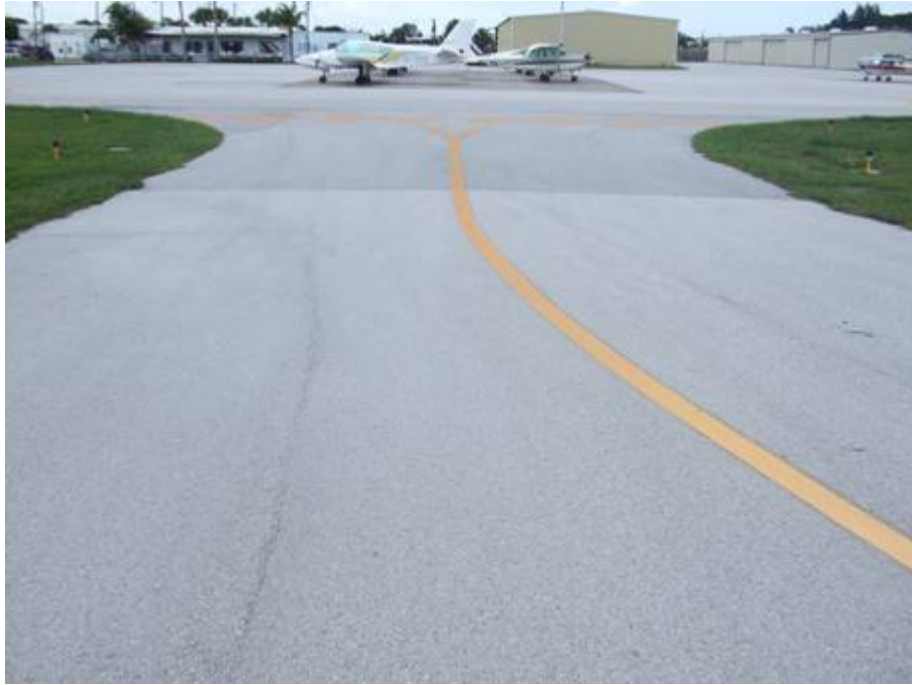
TW CB Section 315 SU 300: Low Severity L/T Cracking (July 9, 2007)

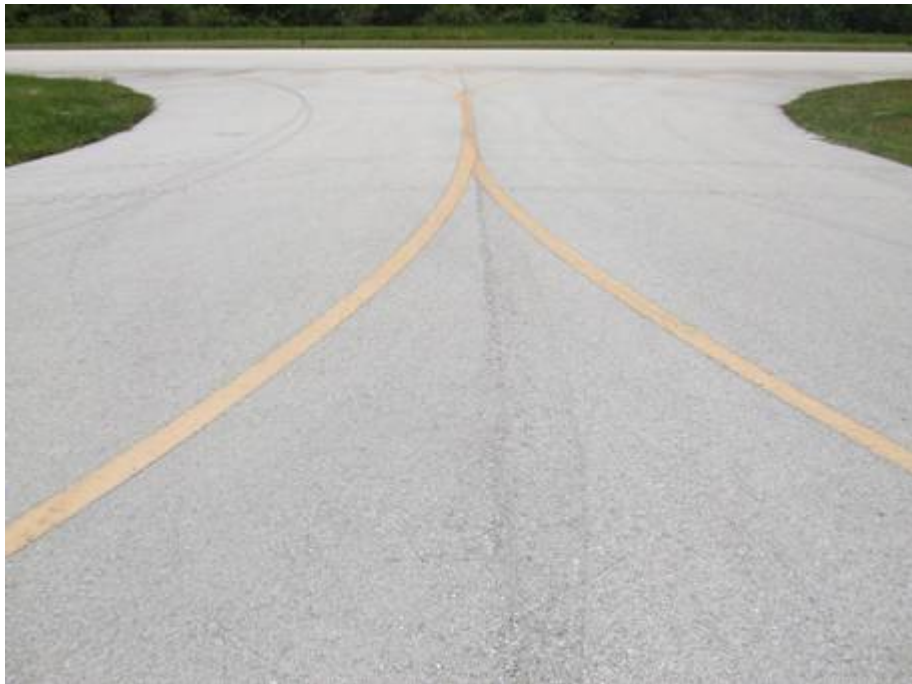
TW EA Section 505 SU 100: Section Overview (July 9, 2007)

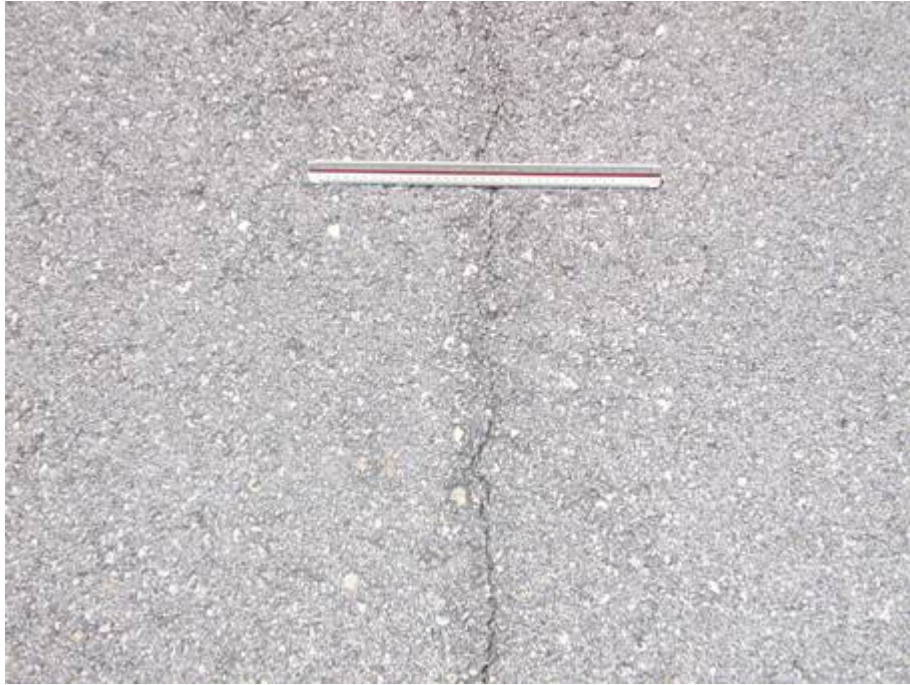
RW 11-29 Section 6105 SU 143: Low Severity L/T Cracking (July 9, 2007)

- Runway 11-29 is currently in Satisfactory condition with an average PCI value of 83. This runway has no immediate need for repair, but would have need for some repair by 2016.
- Several large areas of South Apron were identified that will require significant funding to improve them above Minimum PCI levels. Further evaluation of these features is necessary in order to develop repair plans and timing for future budgets. These needs can not be addressed with typical annual expenditures as they amount to close to half million dollars.

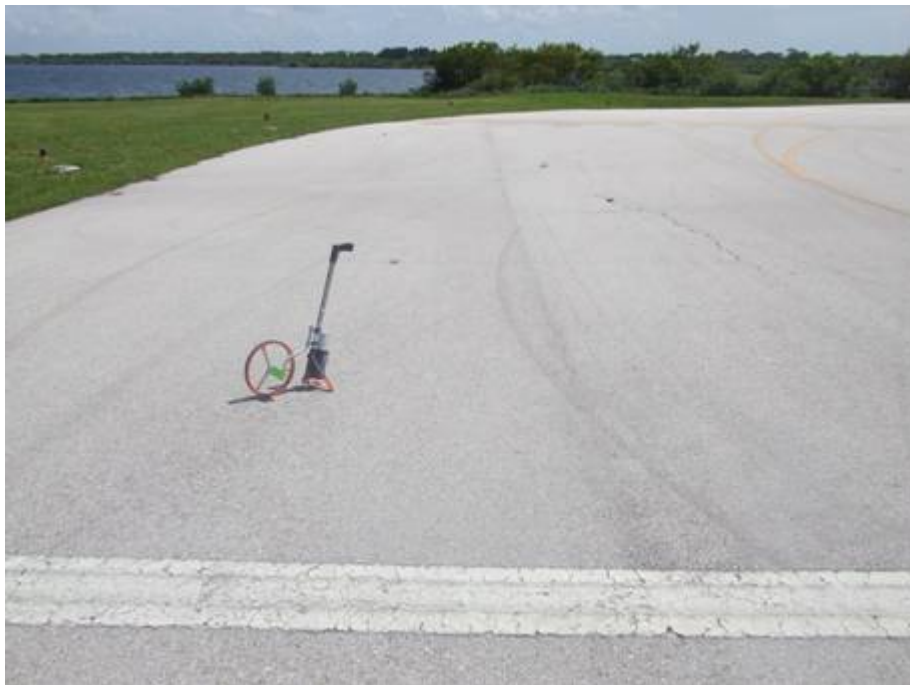
TW A Section 110 SU 100: Low Severity L/T Cracking (July 9, 2007)

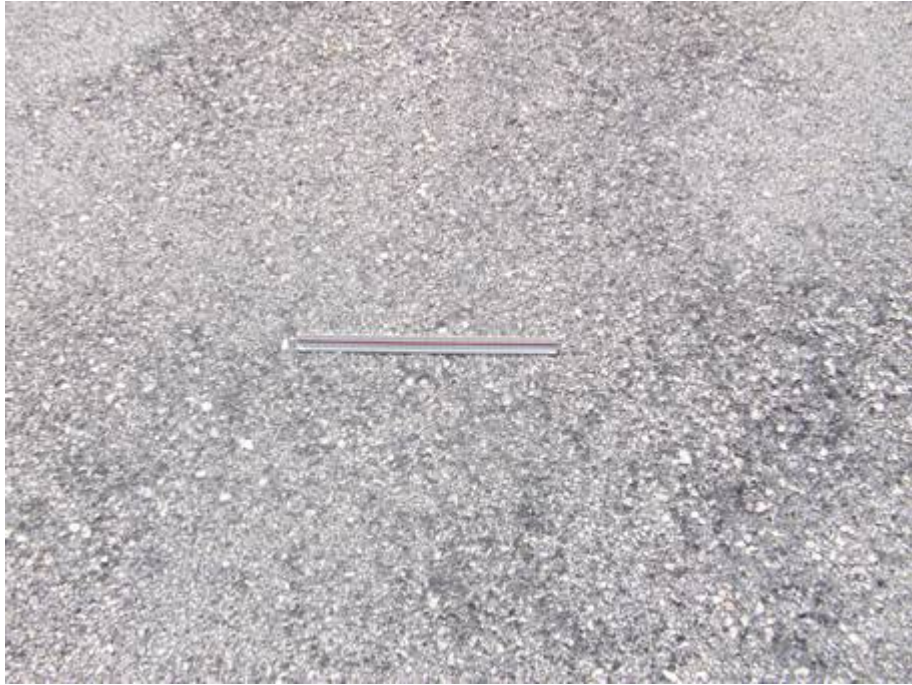
TW A Section 115 SU 300: Low Severity Weathering (July 9, 2007)

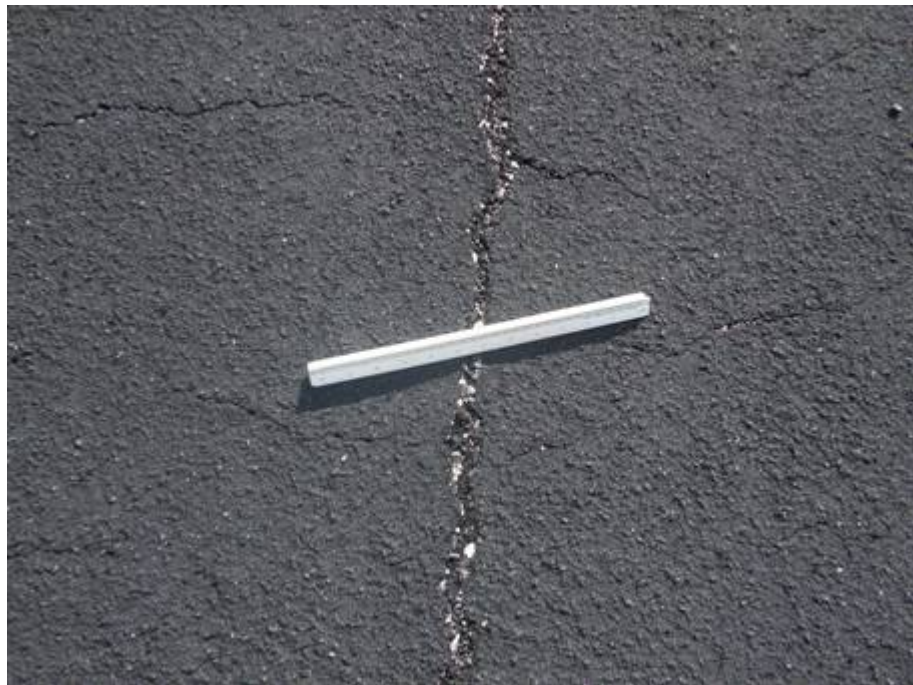
AP S Section 4106 SU 101: Medium Severity L/T Cracking (July 9, 2007)

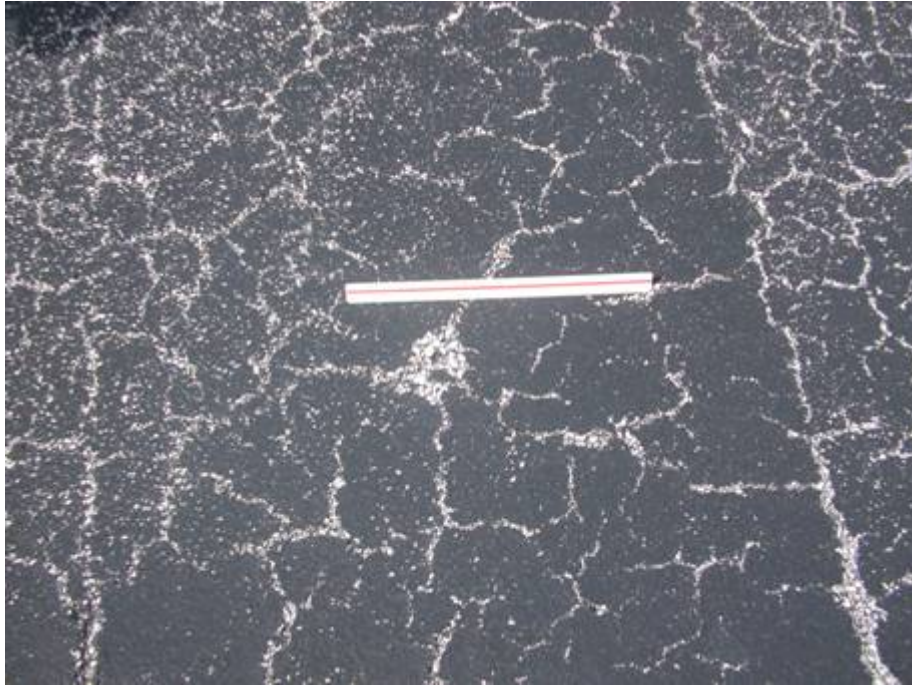
AP N Section 4205 SU 197: Medium Severity Weathering (July 9, 2007)

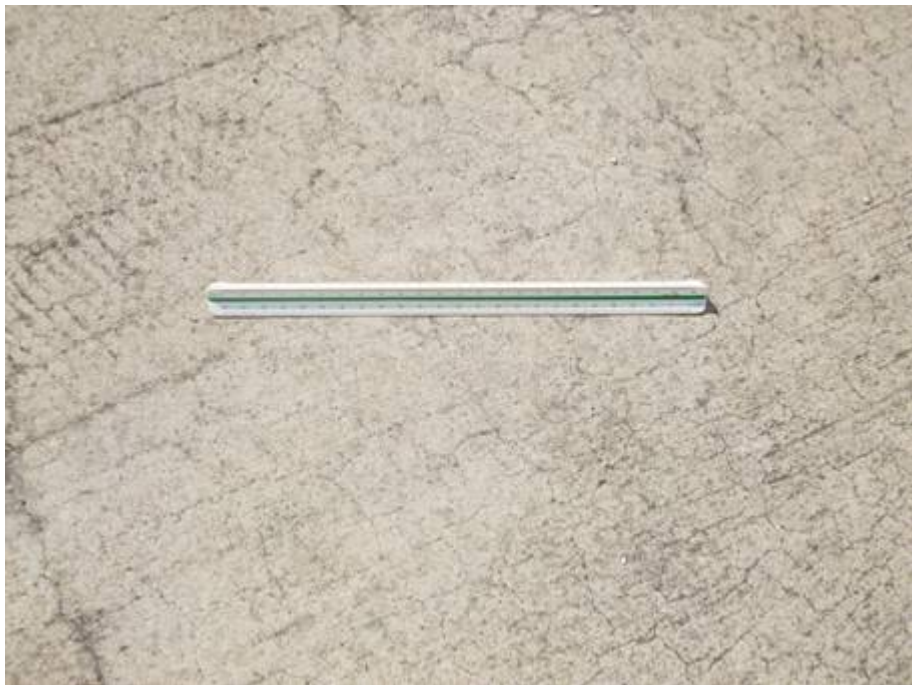
AP N Section 4203 SU 100: Low Severity Scaling (July 9, 2007)

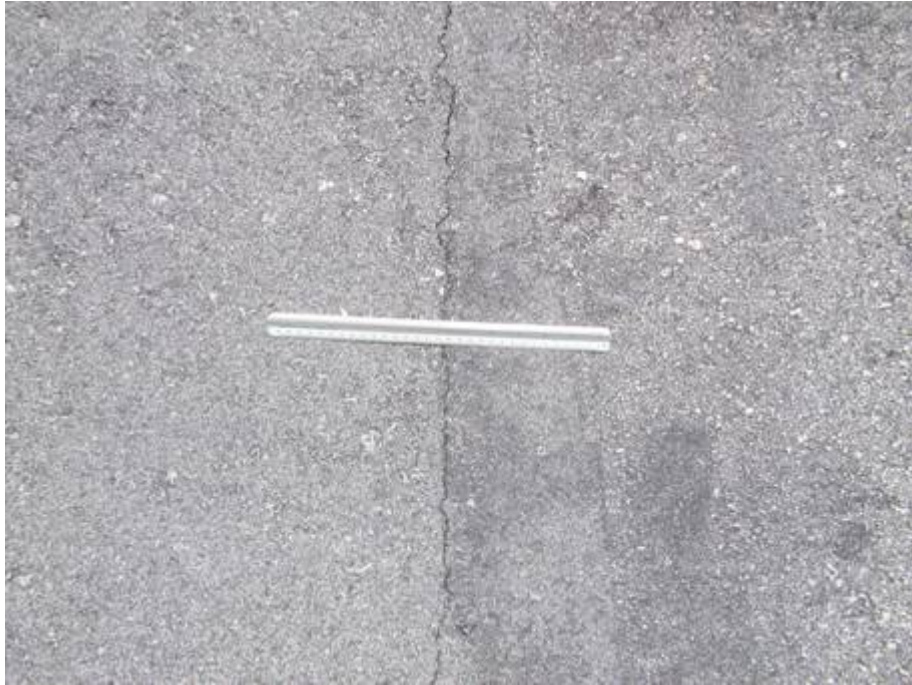
TW DB Section 410 SU 400: Low Severity L/T Cracking (July 9, 2007)
