**STATE OF FLORIDA
DEPARTMENT OF TRANSPORTATION
AVIATION OFFICE**

**Statewide Airfield Pavement Management Program
Dade-Collier Training and Transition Airport – TNT
(General Aviation)
Miami, Florida
(District 6)**

February 26, 2008

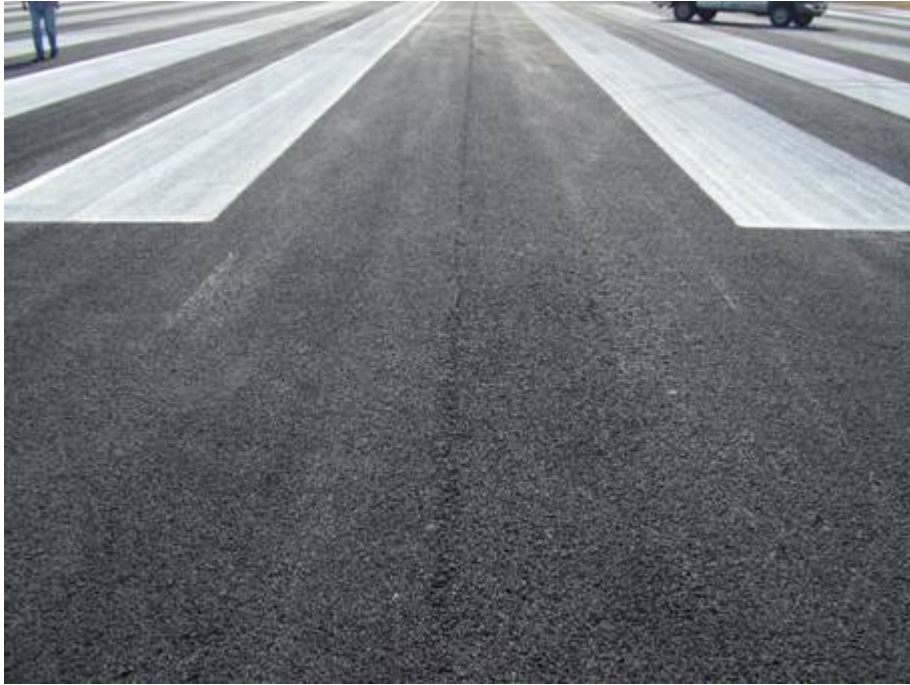
RW 9-27 Section 6105 SU 403: Low Severity Weathering (September 17, 2007)

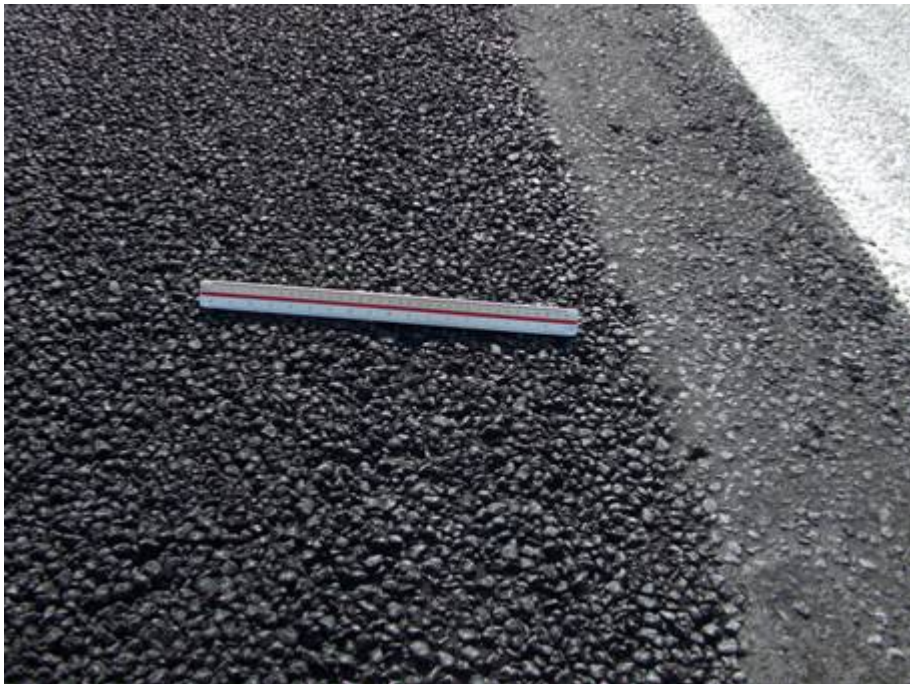
RW 9-27 Section 6105 SU 403: Medium Severity Weathering (September 17, 2007)

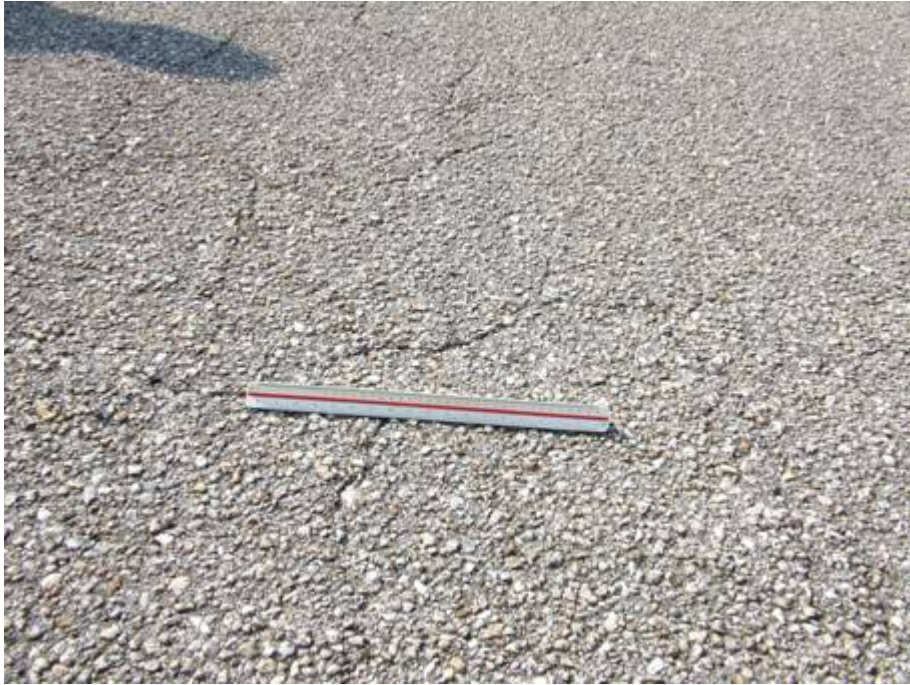
TW A6 Section 170 SU 602: Low Severity Block Cracking (September 17, 2007)

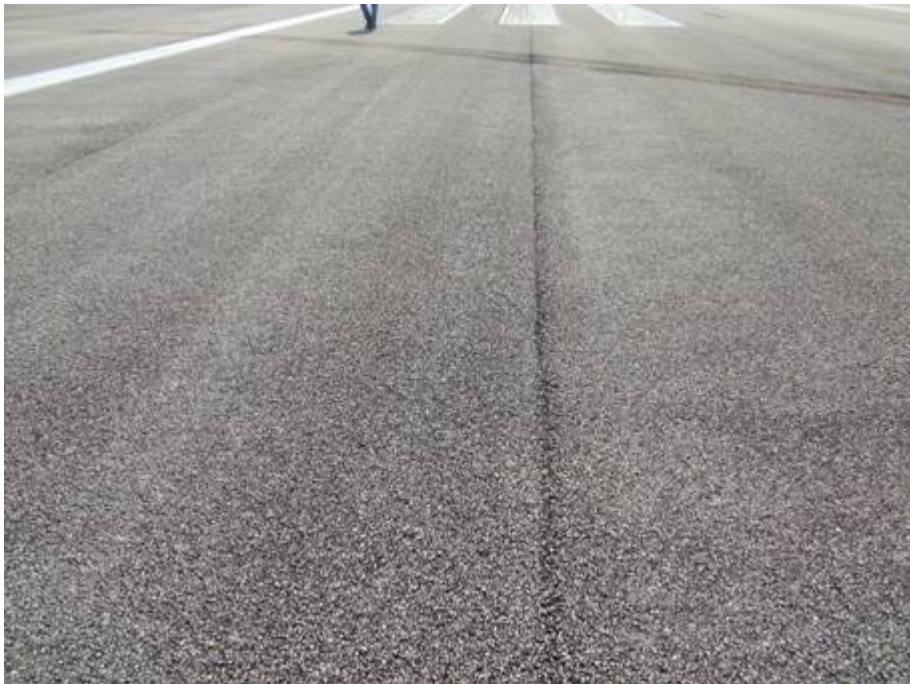
RW 9-27 Section 6110 SU 198: Construction Joint (September 17, 2007)

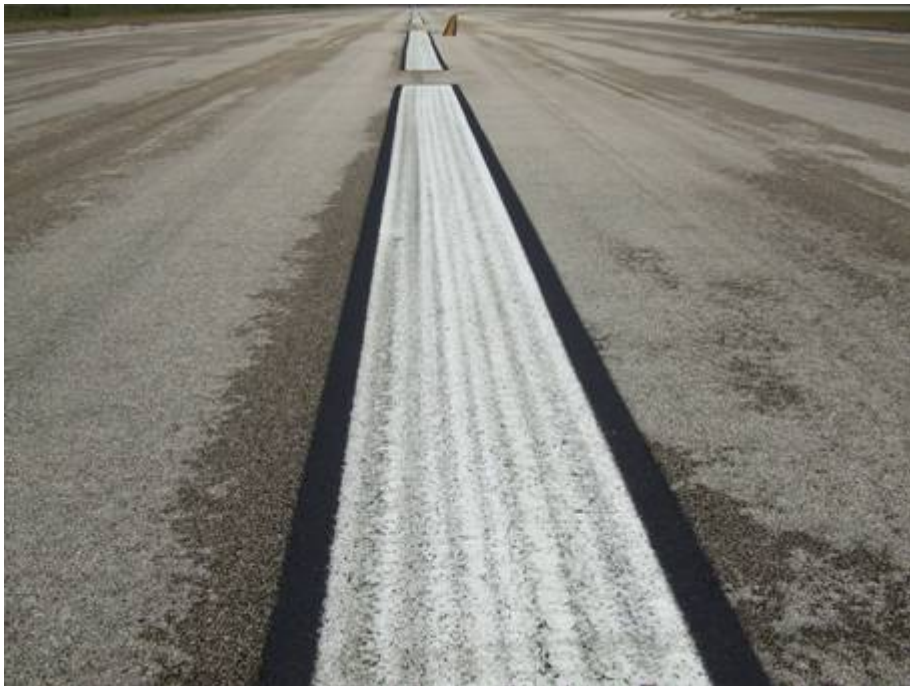
RW 9-27 Section 6105: Section Overview (September 17, 2007)

Runway 9-27 is currently in Fair condition with an average PCI value of 64. This runway has immediate need for repair. The unlimited budget scenario provides the basis for estimating the total repair cost. In reality, it is neither operationally nor fiscally prudent.

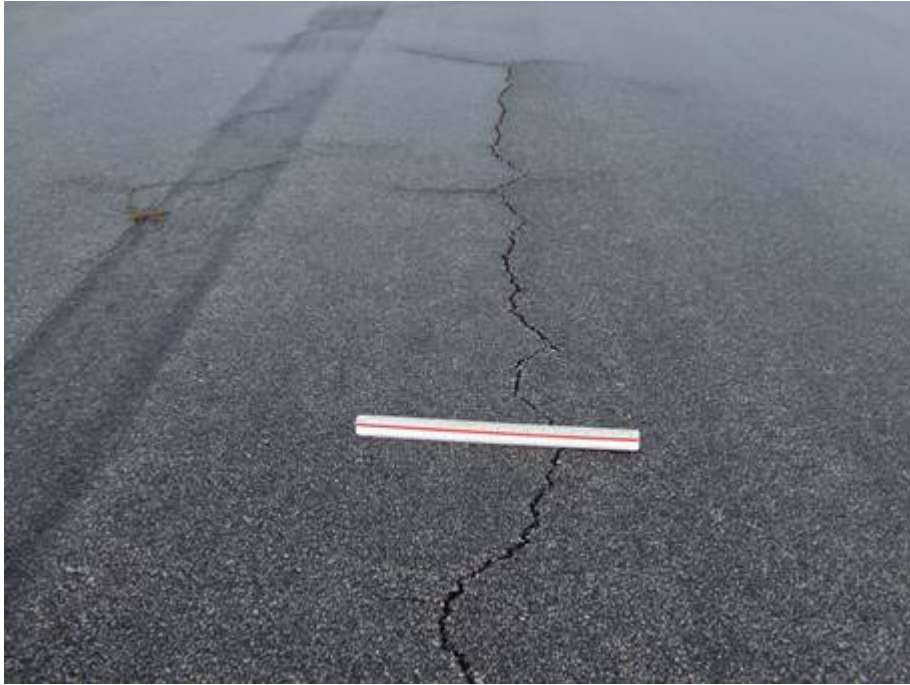
TW A Section 110 SU 106: Low Severity L/T Cracking (September 17, 2007)

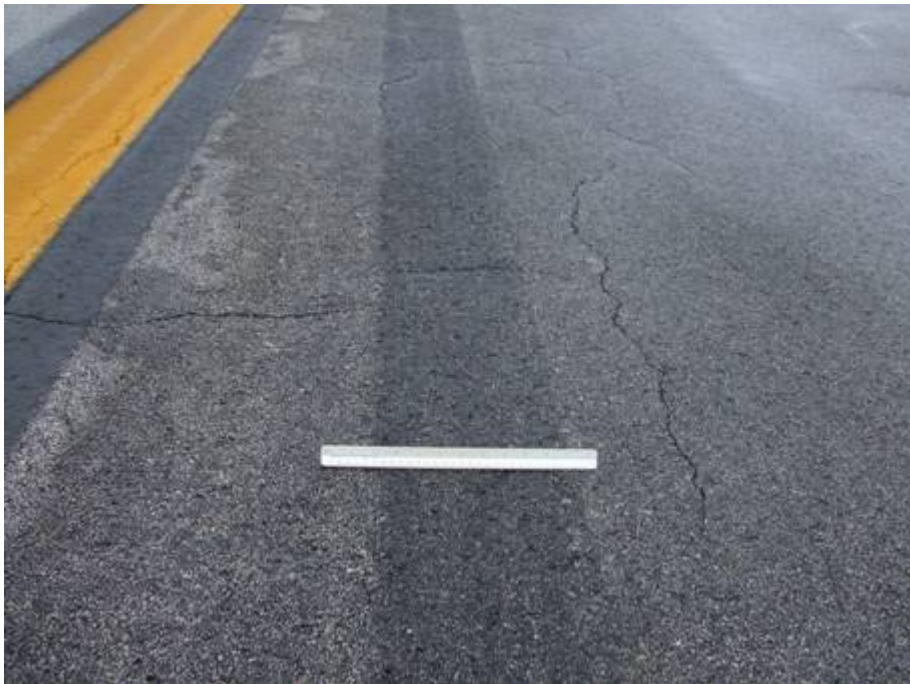
TW A Section 110 SU 111: Low Severity L/T Cracking (September 17, 2007)
