**STATE OF FLORIDA
DEPARTMENT OF TRANSPORTATION
AVIATION OFFICE**

**Statewide Airfield Pavement Management Program
Williston Municipal Airport – X60
(General Aviation)
Williston, Florida
(District 2)**

March 31, 2008

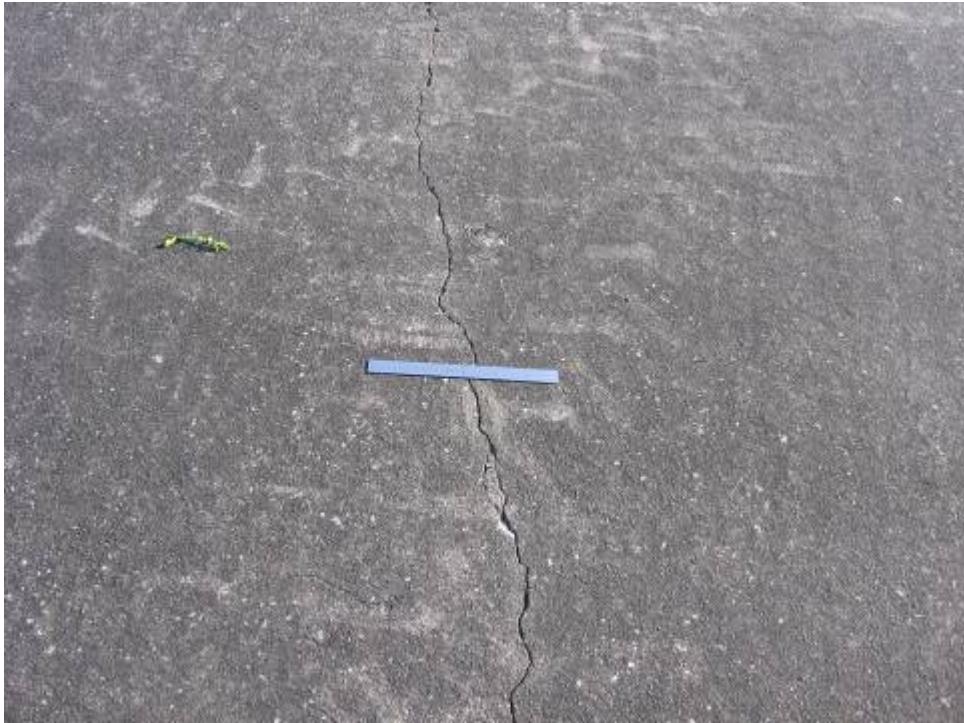
RW 14-32 Section 6240 SU 200: Low Severity Linear Cracking (October 10, 2006)

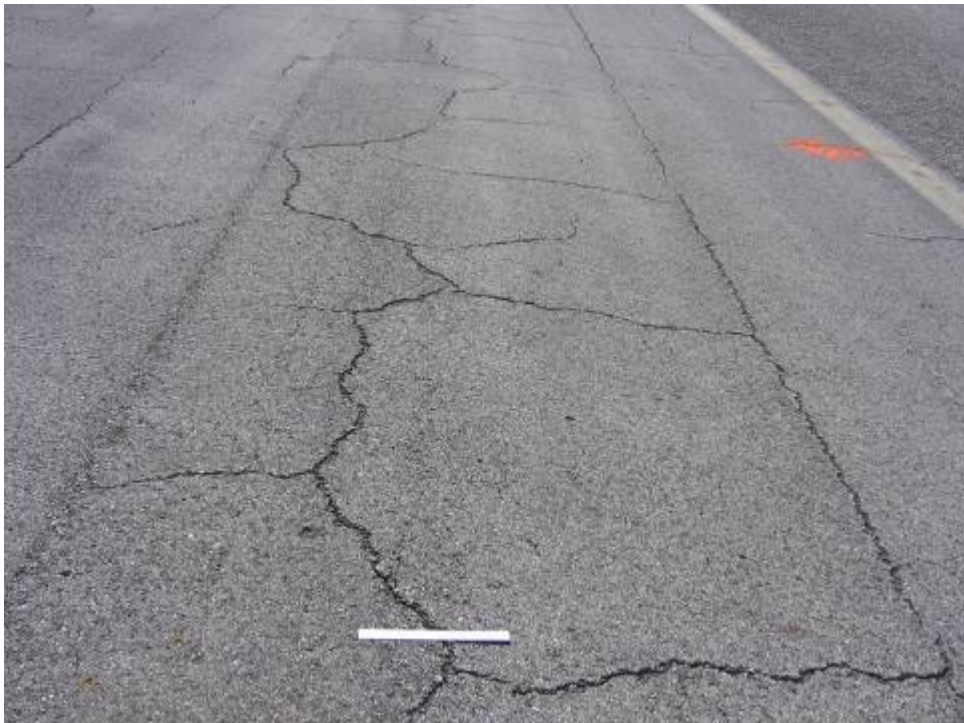
RW 14-32 Section 6215 SU 386: Low Severity Block Cracking (October 11, 2006)

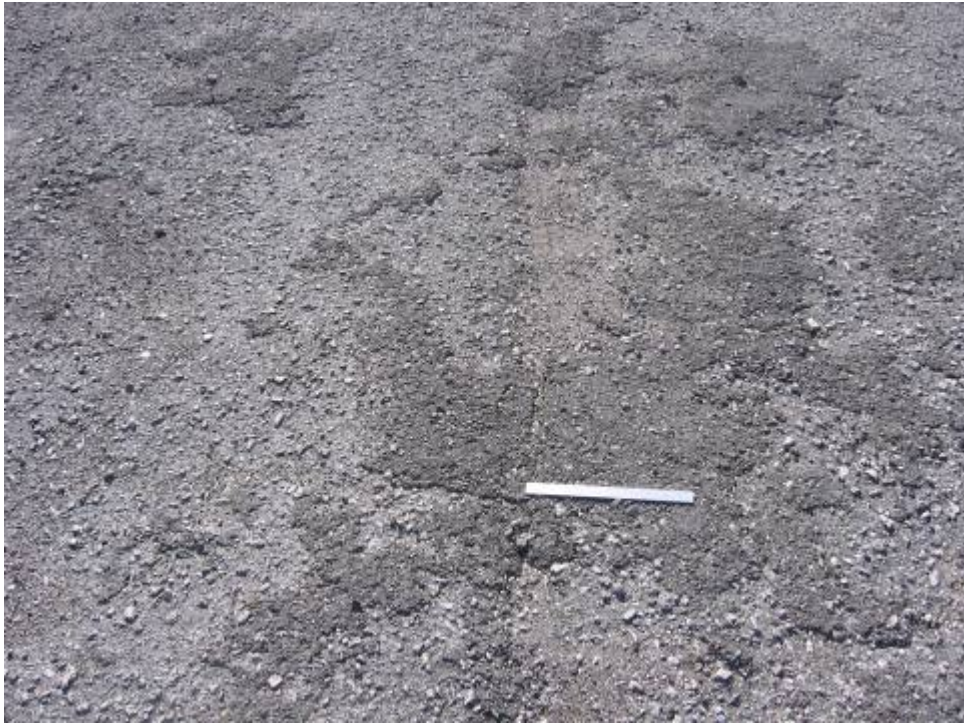
RW 14-32 Section 6220 SU 188: Medium Severity Weathering (October 11, 2006)

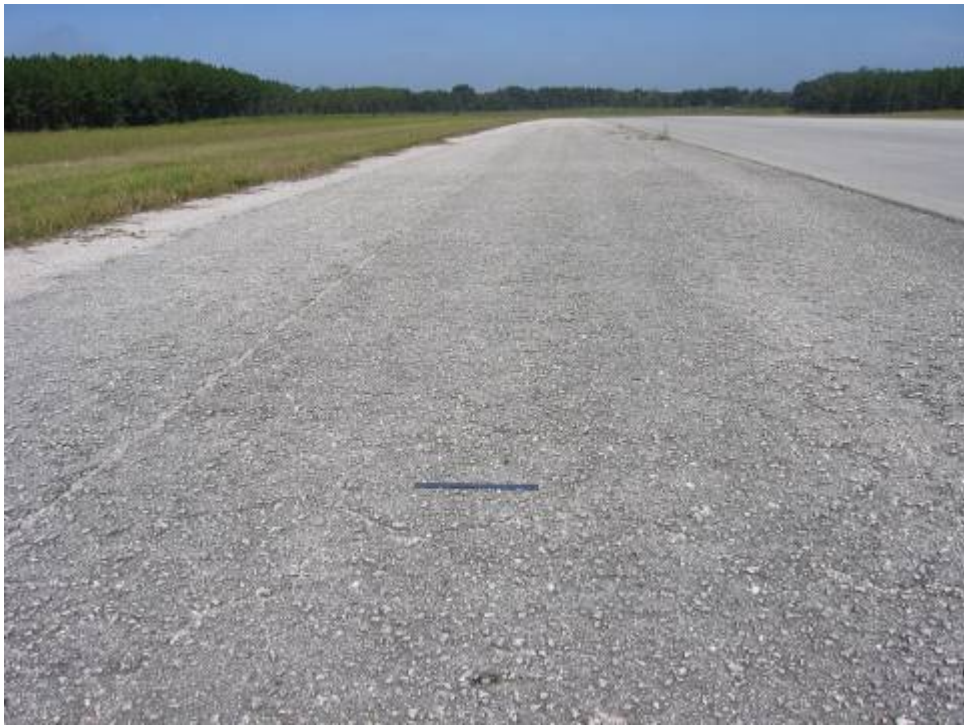
RW 14-32 Section 6220 SU 172: Low Severity Weathering (October 11, 2006)

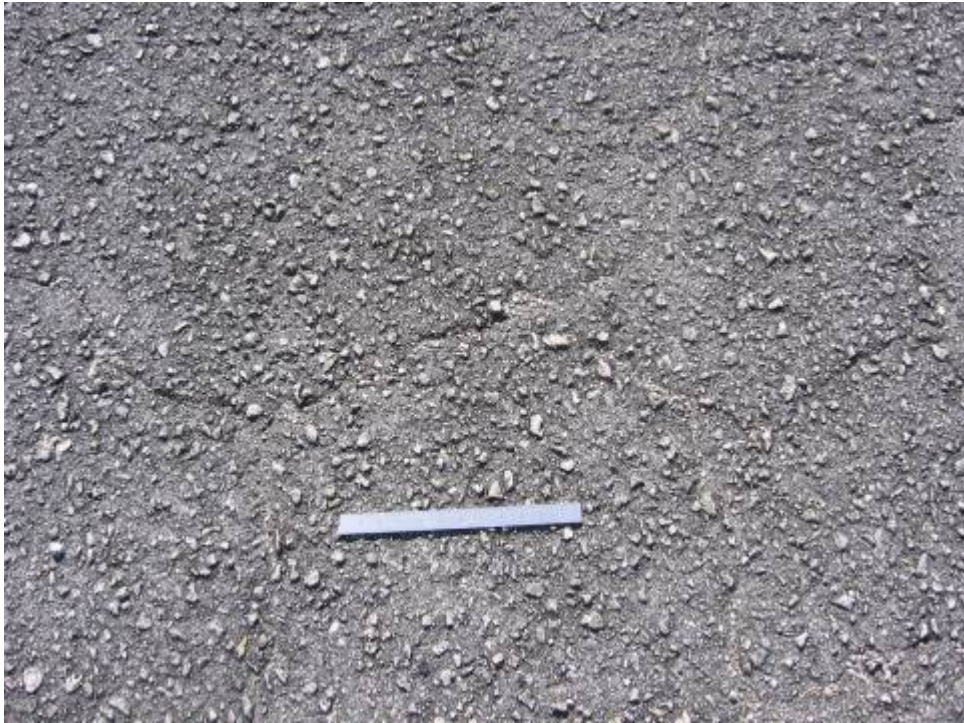
RW 14-32 Section 6220 SU 172: Low Severity Weathering
(October 11, 2006)

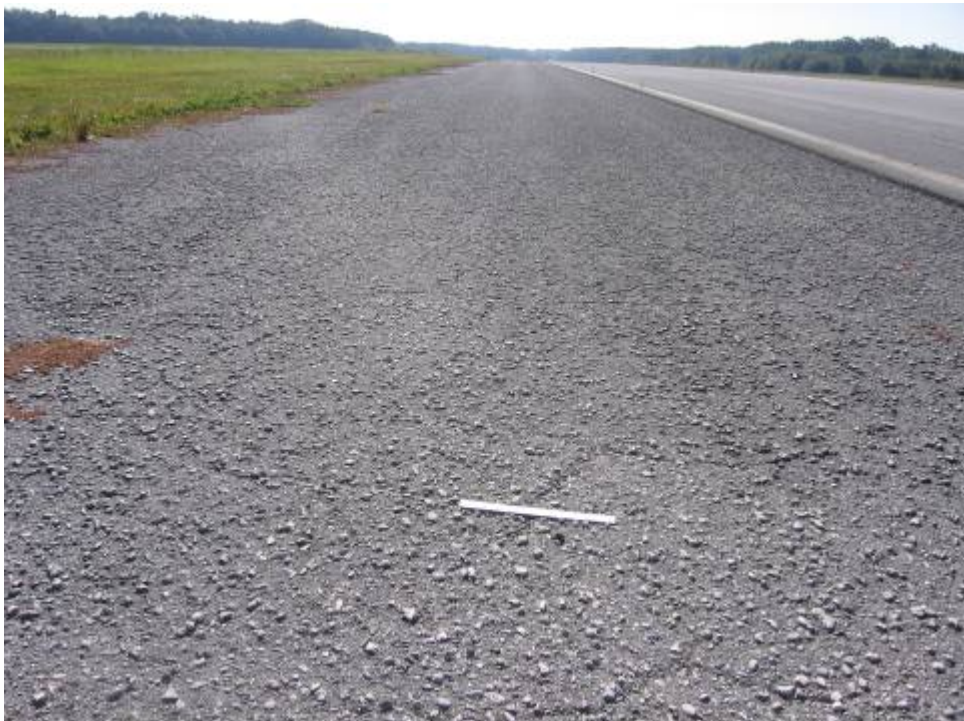
RW 14-32 Section 6220 SU 584: Medium Severity Weathering
(October 11, 2006)

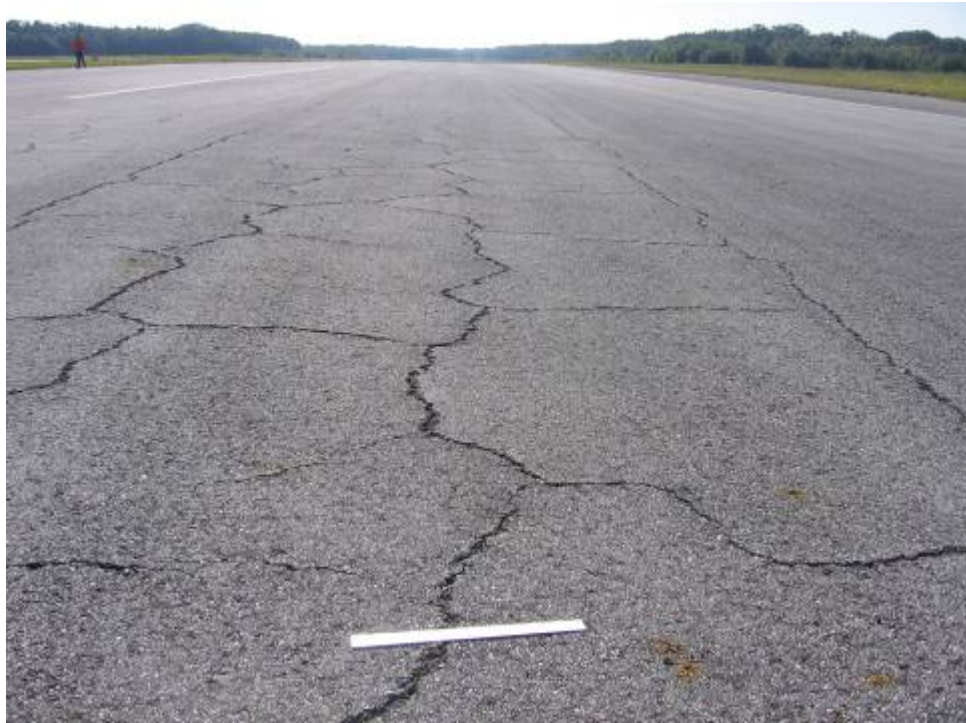
RW 14-32 Section 6215 SU 382: Medium Severity Block Cracking (October 11, 2006)

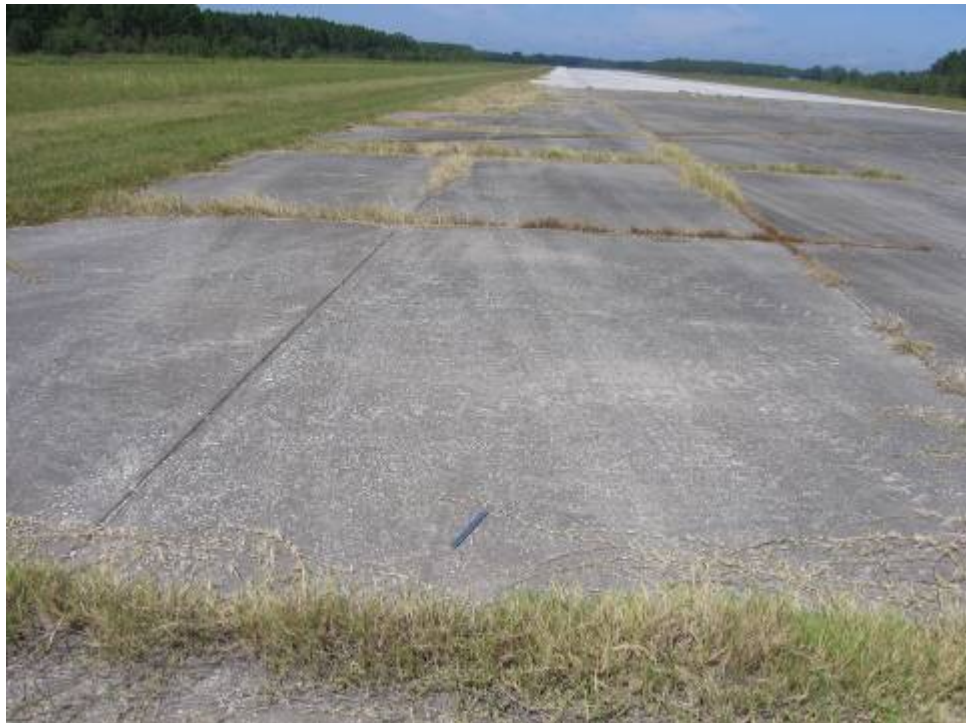
RW 14-32 Section 6210 SU 100: High Severity Joint Seal Damage
(October 11, 2006)

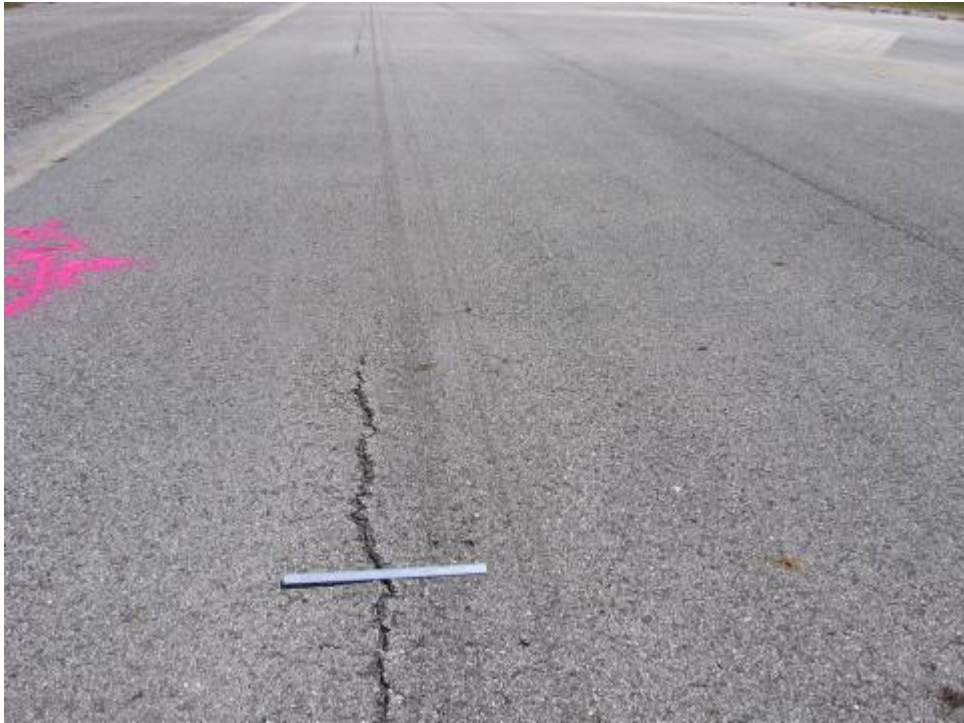
RW 14-32 Section 6215 SU 307: Medium Severity L/T Cracking (October 11, 2006)

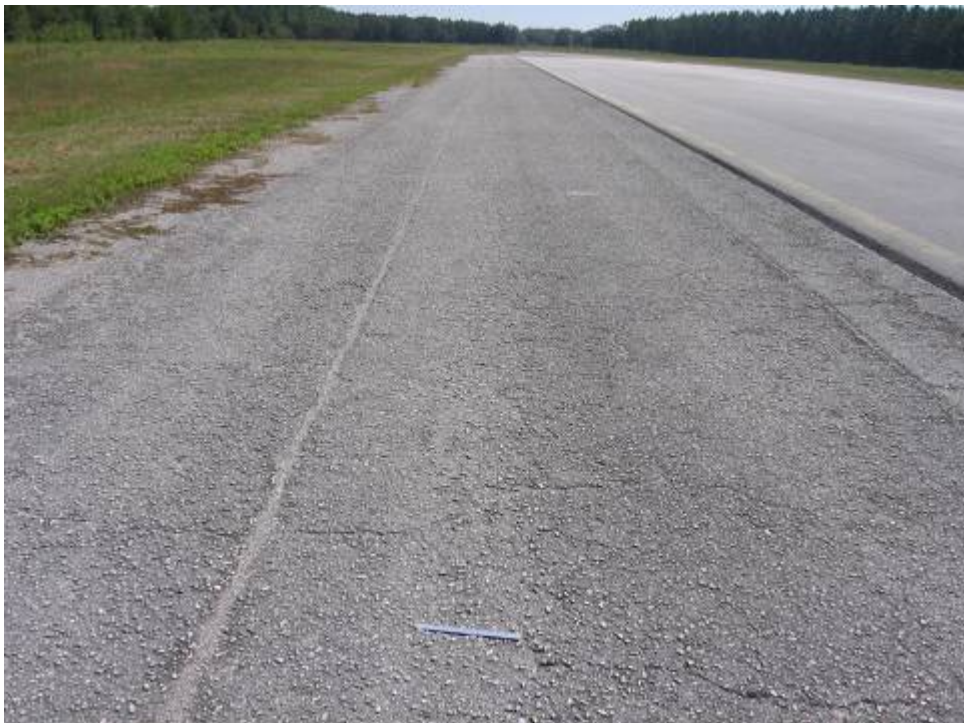
RW 14-32 Section 6220 SU 512: Low Severity Weathering (October 11, 2006)

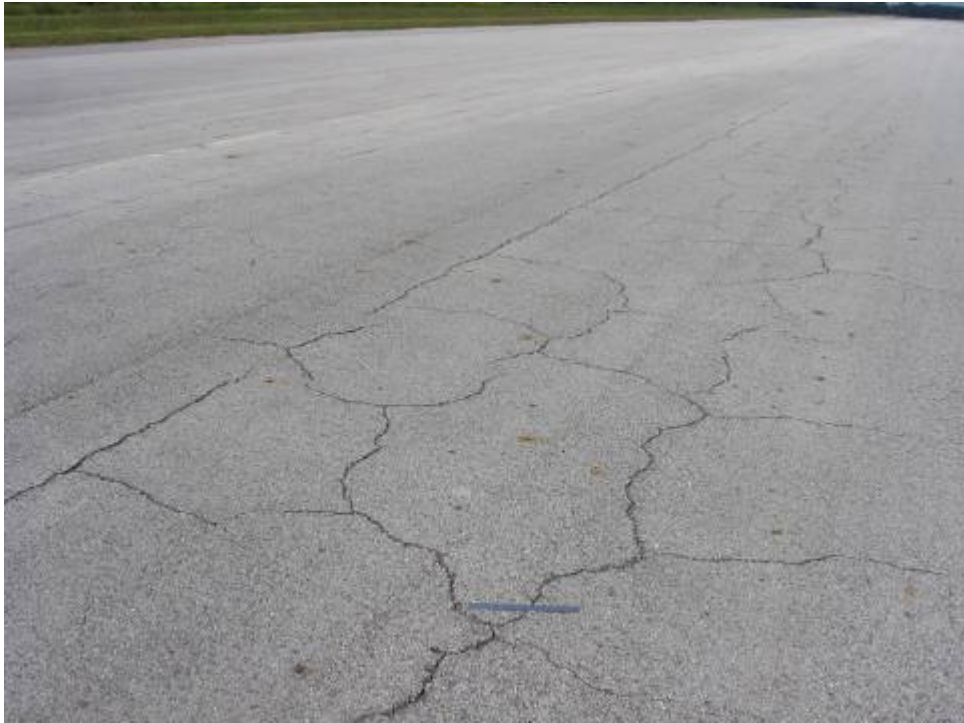
RW 14-32 Section 6220 SU 512: Low Severity Block Cracking (October 11, 2006)

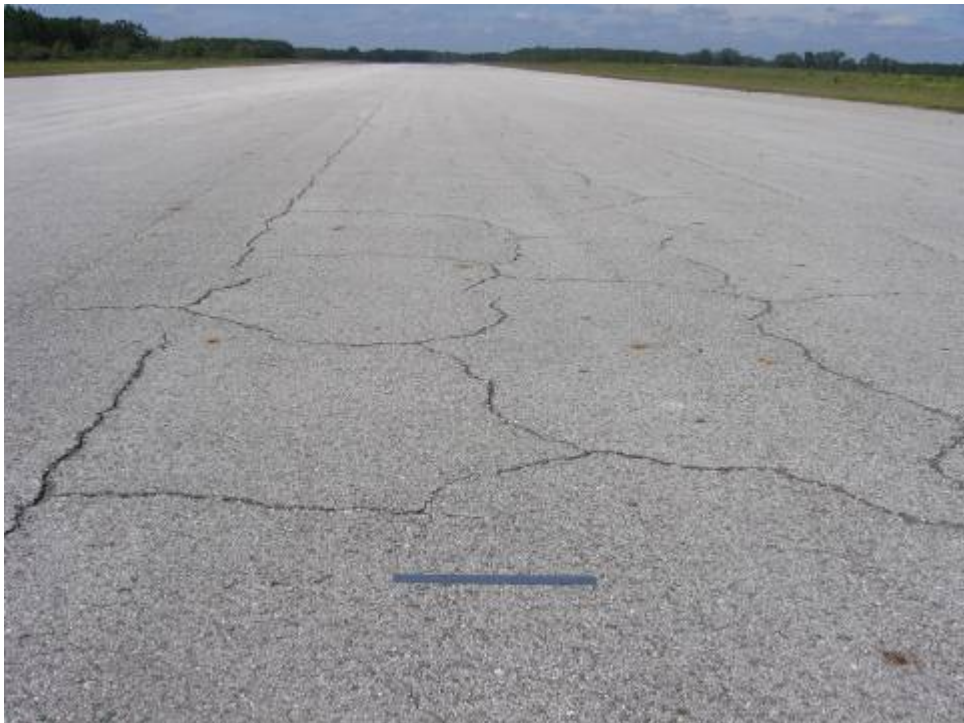
RW 14-32 Section 6215 SU 317: Low Severity Block Cracking (October 11, 2006)

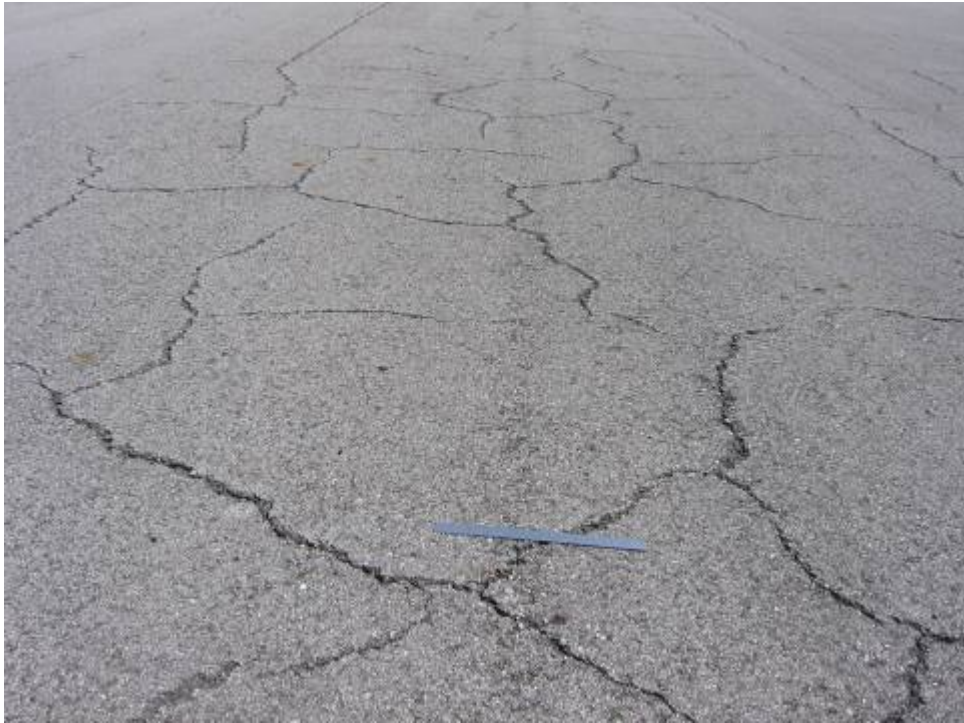
RW 14-32 Section 6215 SU 349: Medium Severity Block Cracking (October 11, 2006)

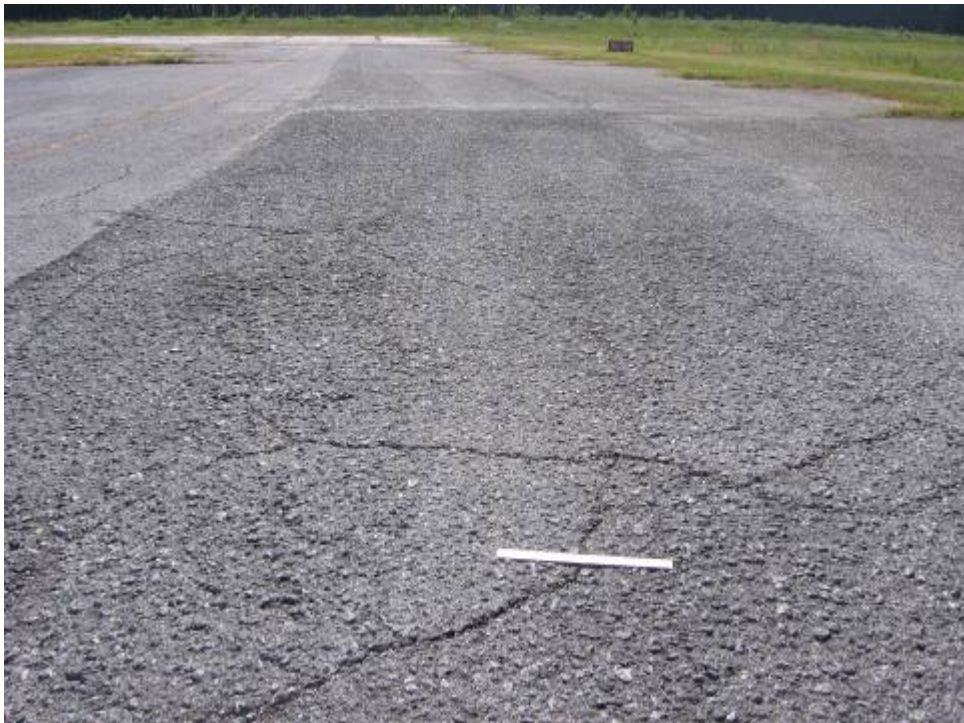
TW C Section 305 SU 104: Medium Severity Weathering (October 11, 2006)

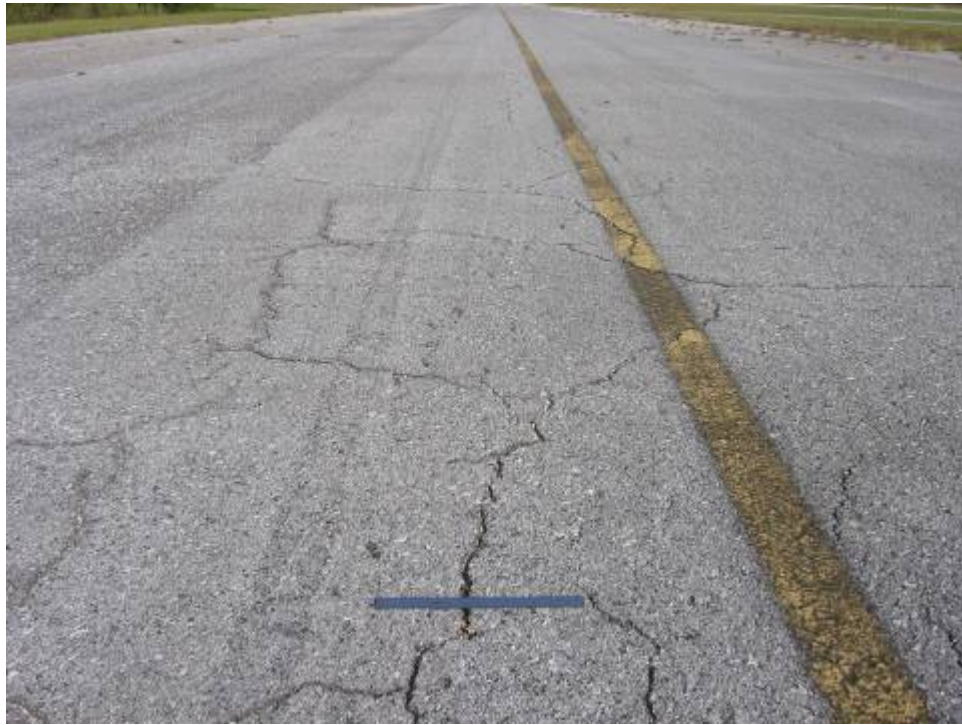
TW C Section 305 SU 131: Low Severity Block Cracking (October 11, 2006)

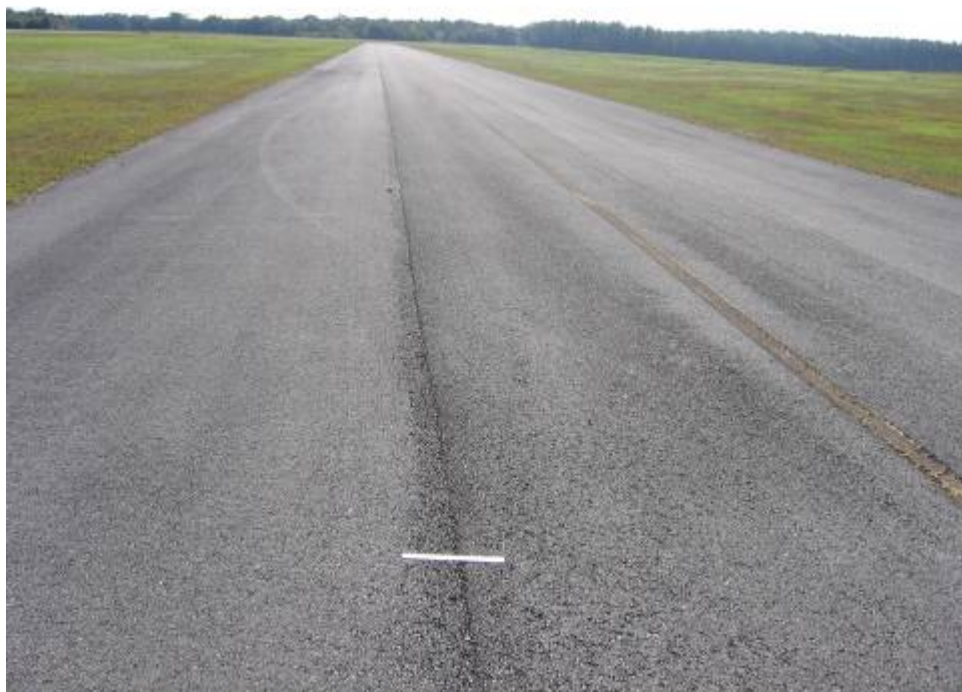
TW B Section 205 SU 115: Low Severity L/T Cracking (October 11, 2006)

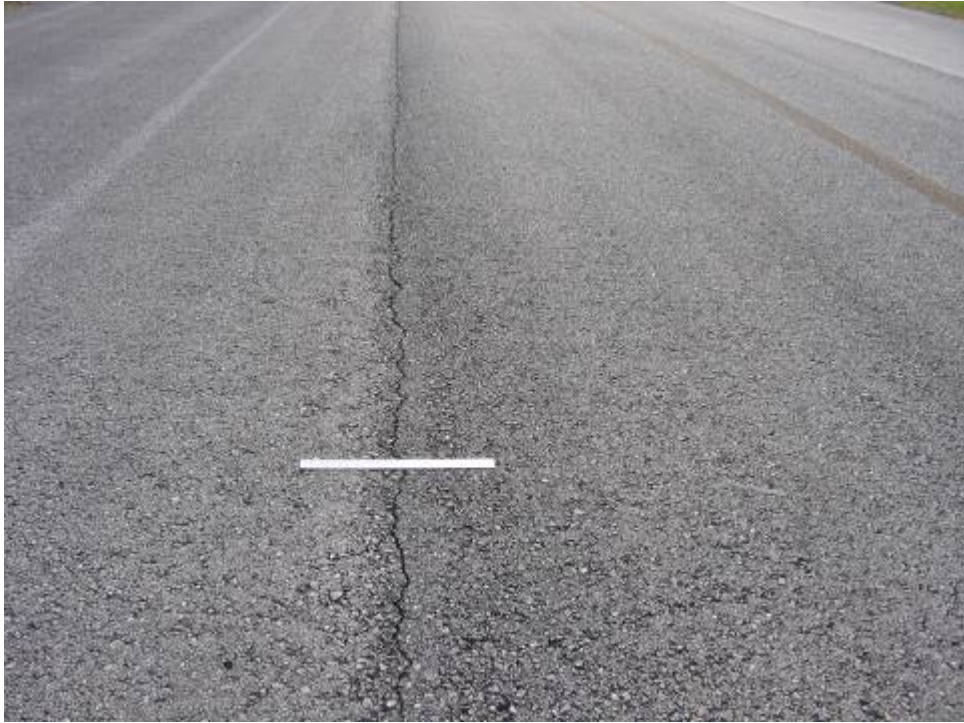
TW B Section 205 SU 104: Low Severity L/T Cracking (October 11, 2006)

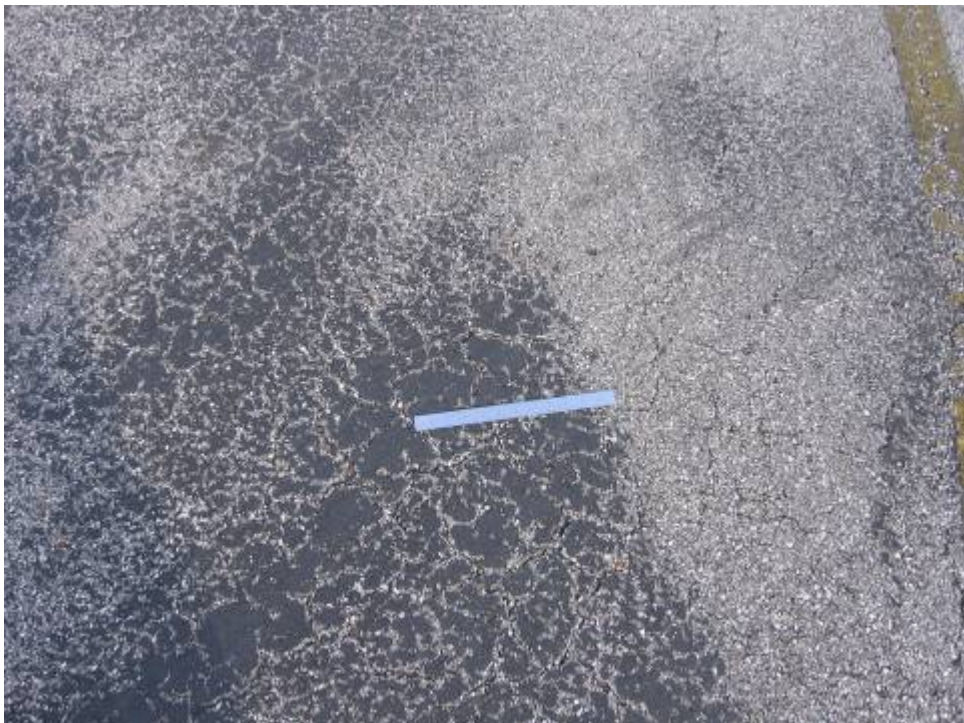
TW AP Section 405 SU 101: Medium Severity Weathering (October 11, 2006)
