**STATE OF FLORIDA
DEPARTMENT OF TRANSPORTATION
AVIATION OFFICE**

**Statewide Airfield Pavement Management Program
Herlong Airport
(Reliever)
Jacksonville, Florida
(District 2)**

January 15, 2008

Prepared for:
**Florida Department of Transportation
Aviation Office**

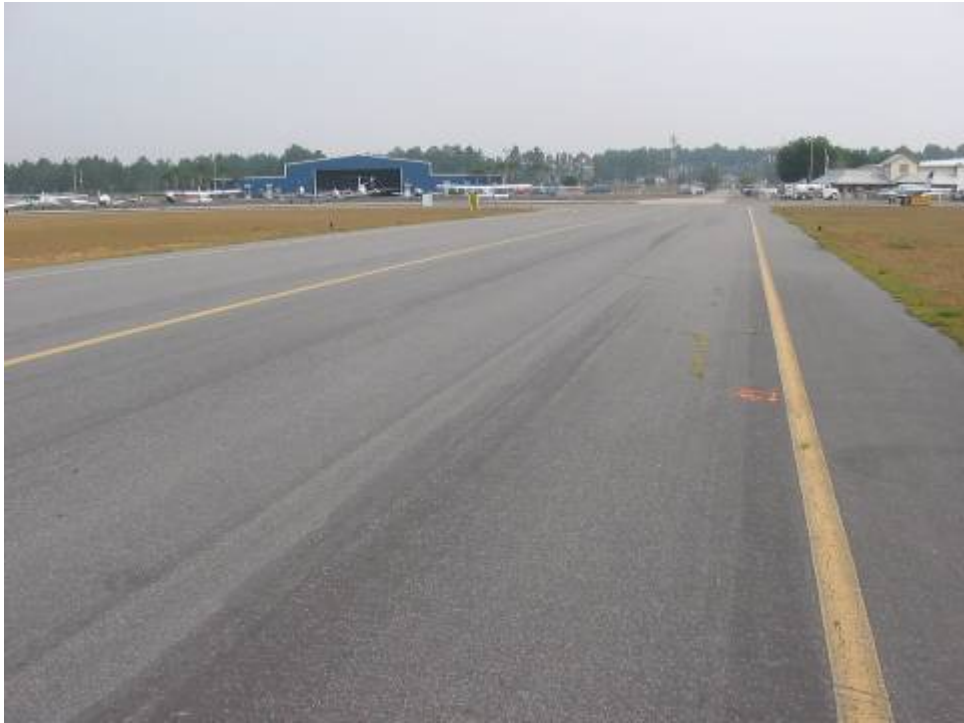
TW HS CONN Section 305 SU 101: Low Severity L/T Cracking (May 14, 2007)

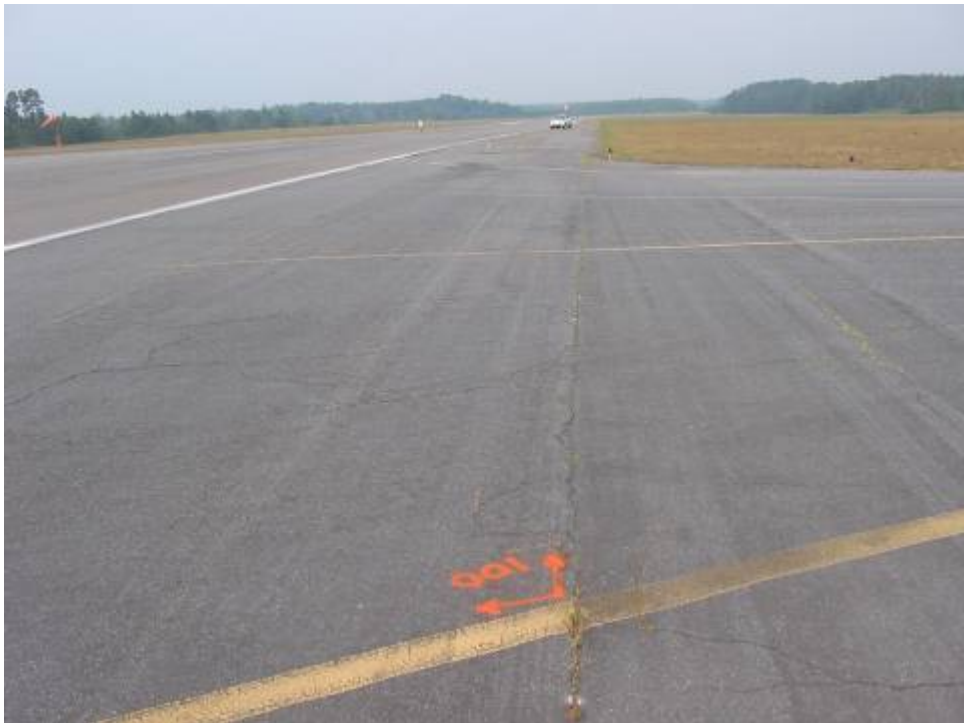
TW HS CONN Section 315 SU 100: Section Overview (May 14, 2007)

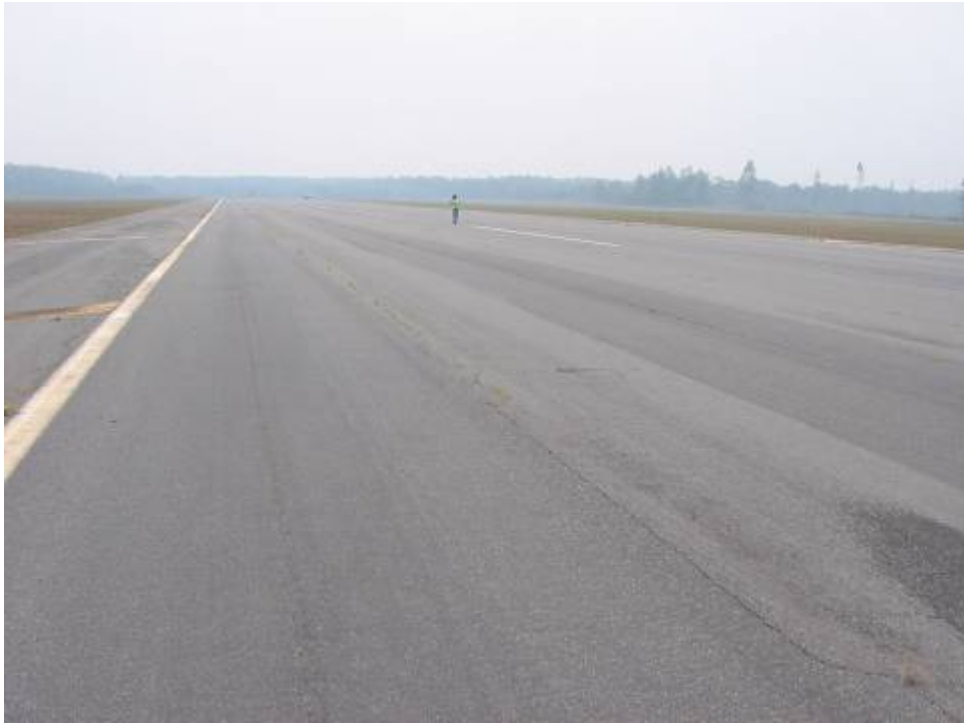
RW 11-29 Section 6205 SU 103: Low Severity L/T Cracking (May 14, 2007)

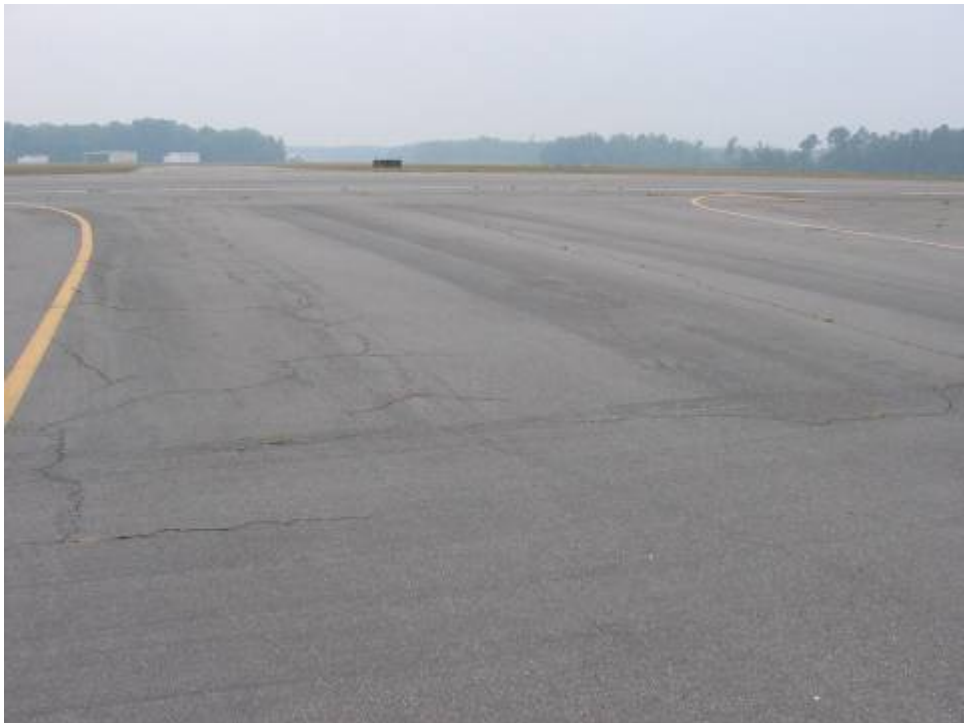
TW CONN RW Section 610 SU 100: Low Severity Block Cracking (May 14, 2007)

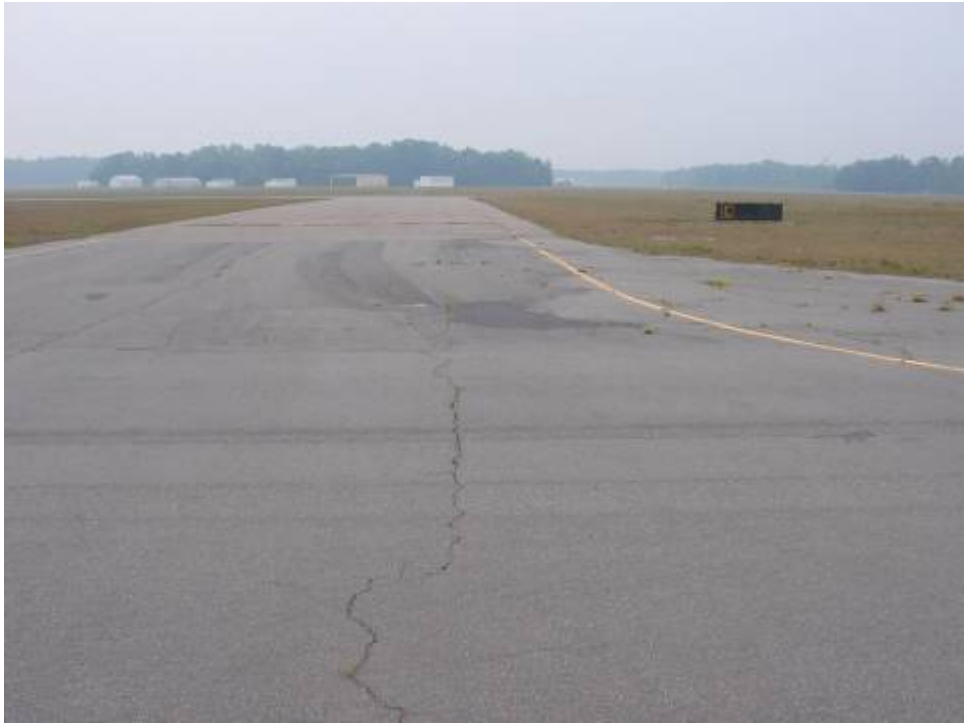
TW CONN RW Section 620 SU 100: Section Overview (May 14, 2007)

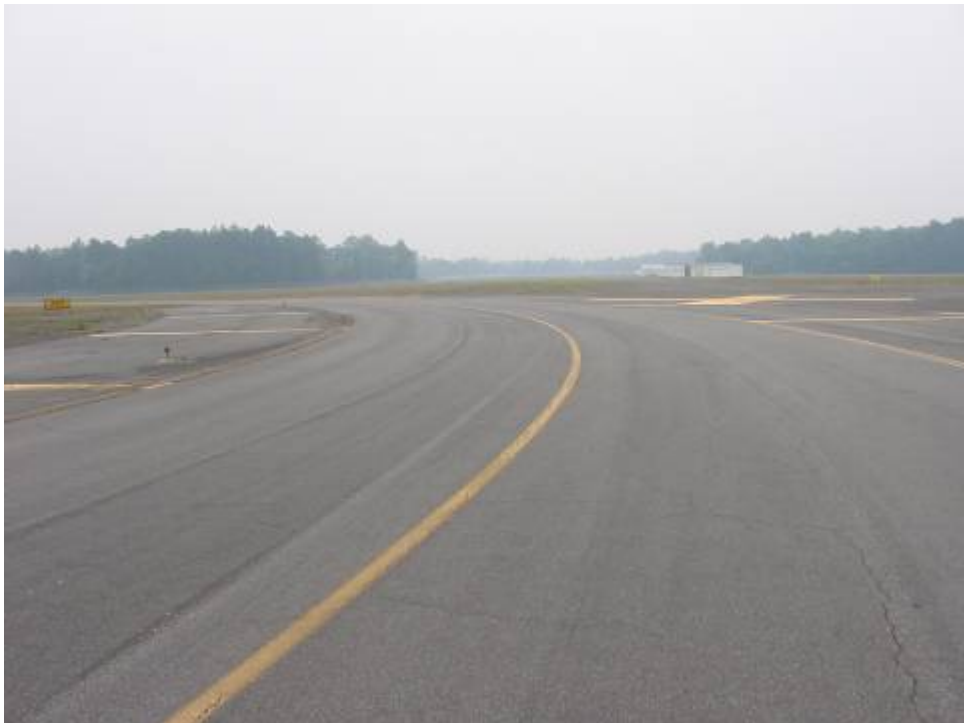
TW B Section 205 SU 102: Low Severity L/T Cracking (May 14, 2007)

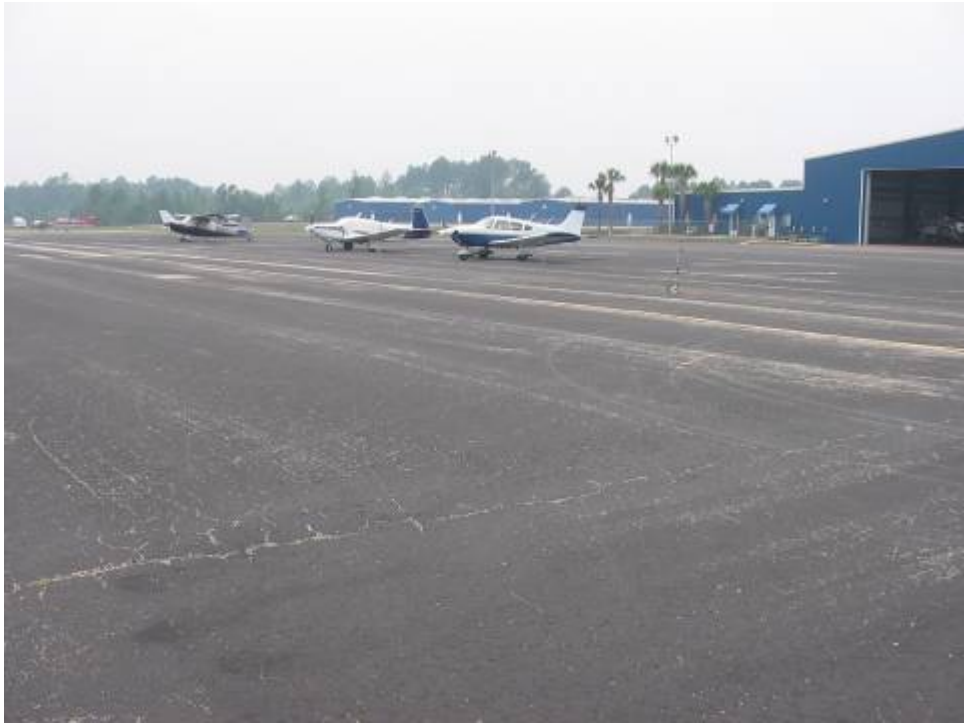
AP NW Section 4110 SU 353: Medium Severity Weathering (May 14, 2007)

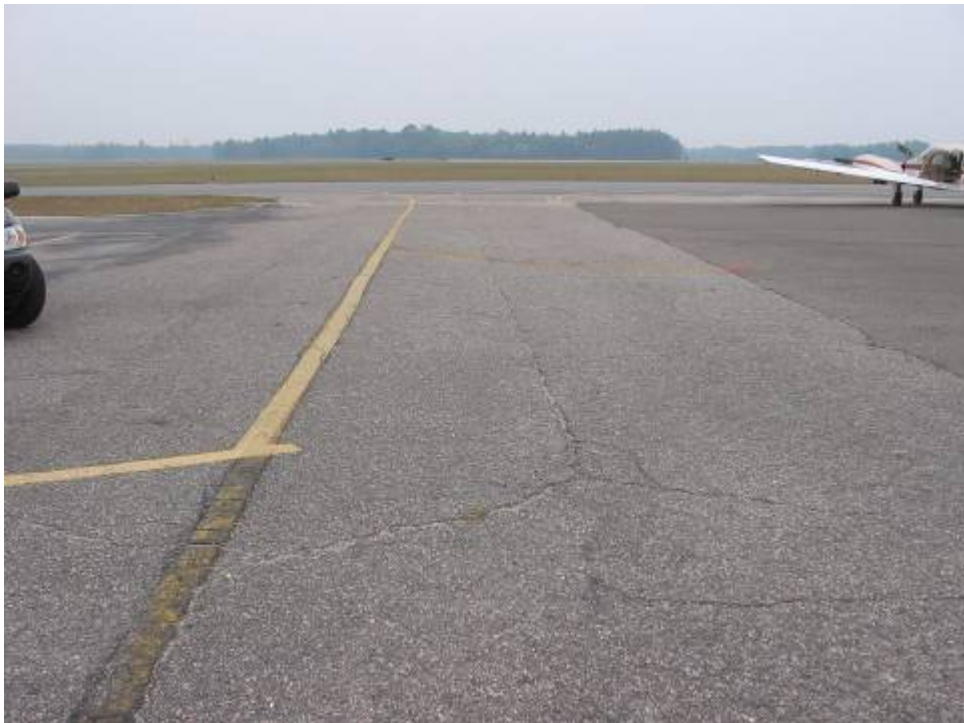
TW E FBO Section 710 SU 101: Medium Severity L/T Cracking

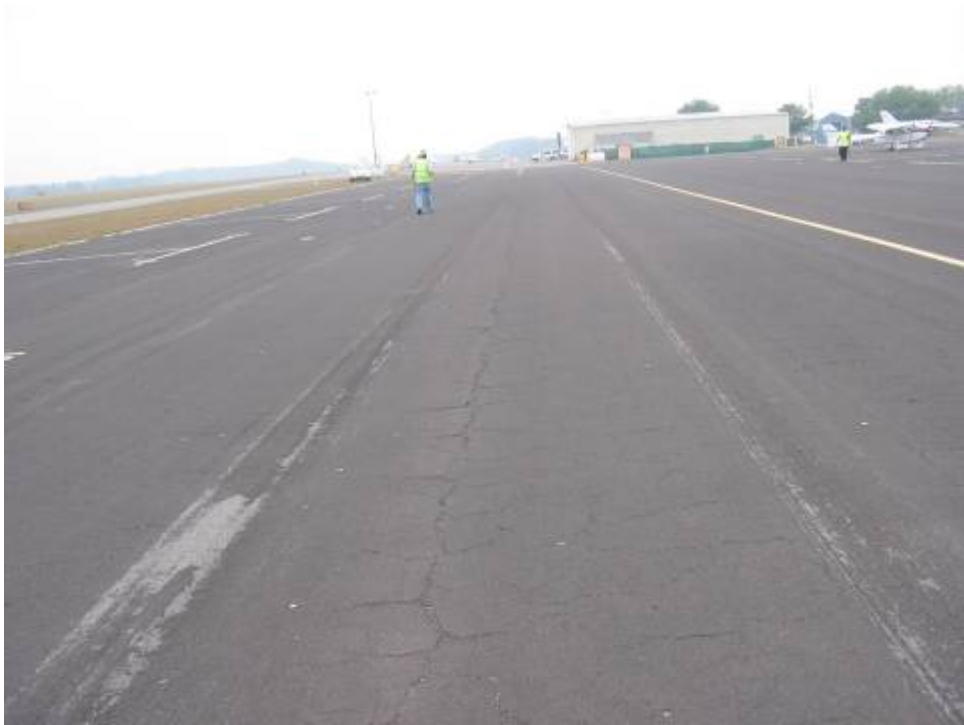
AP N Section 4305 SU 502: Medium Severity L/T Cracking (May 14, 2007)

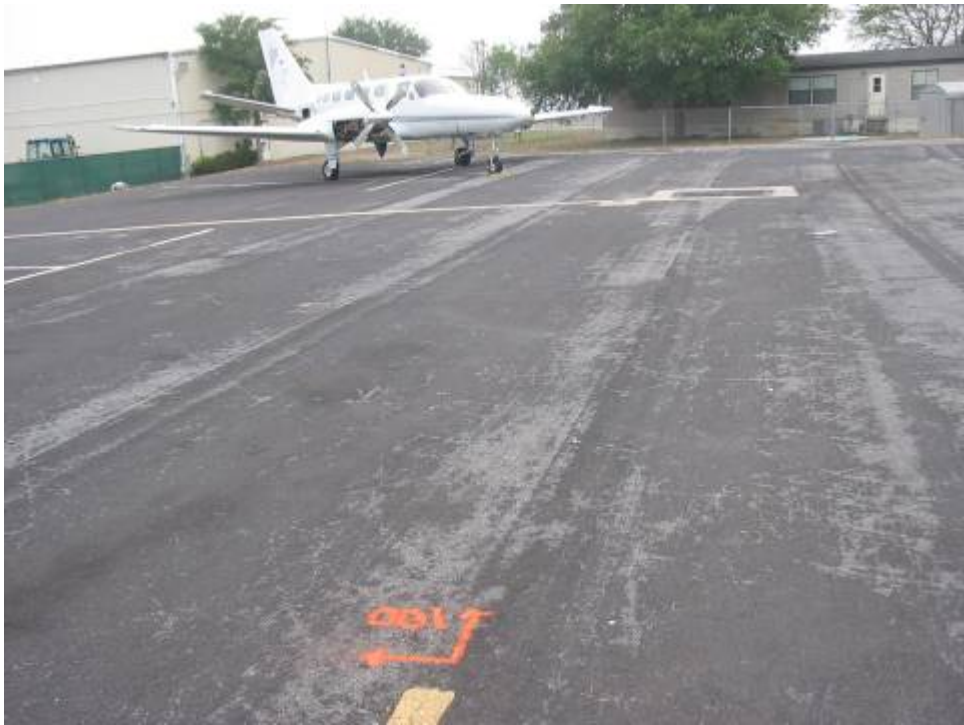
AP N Section 4310 SU 100: Medium Severity Weathering (May 14, 2007)
