**STATE OF FLORIDA
DEPARTMENT OF TRANSPORTATION
AVIATION OFFICE**

**Statewide Airfield Pavement Management Program
New Smyrna Beach Municipal Airport
(Regional Reliever)
New Smyrna Beach, Florida
(District 5)**

January 28, 2008

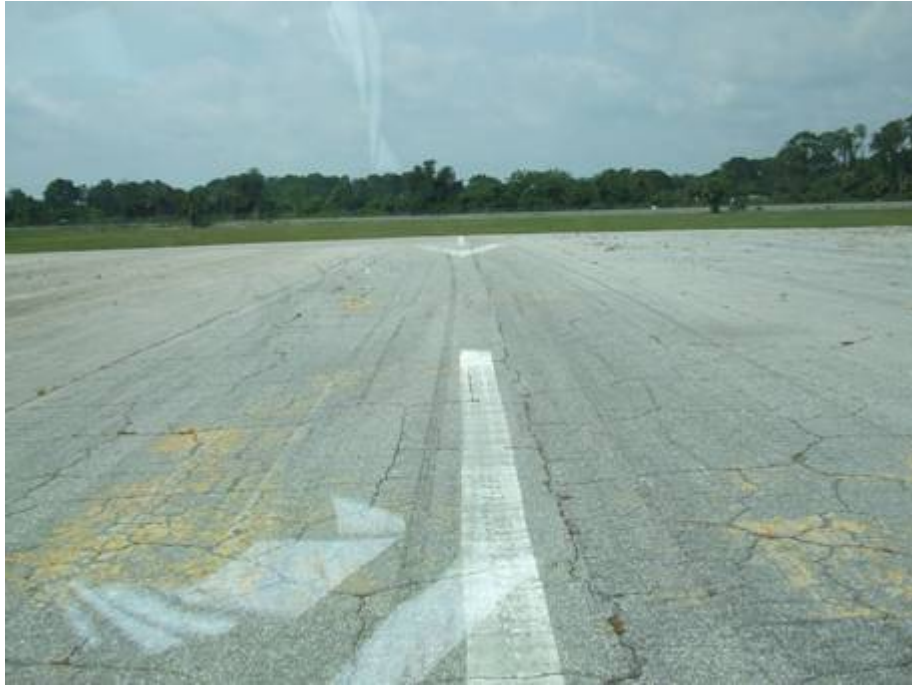
RW 2-20 Section 6405: Medium Severity Block Cracking (June 11, 2007)

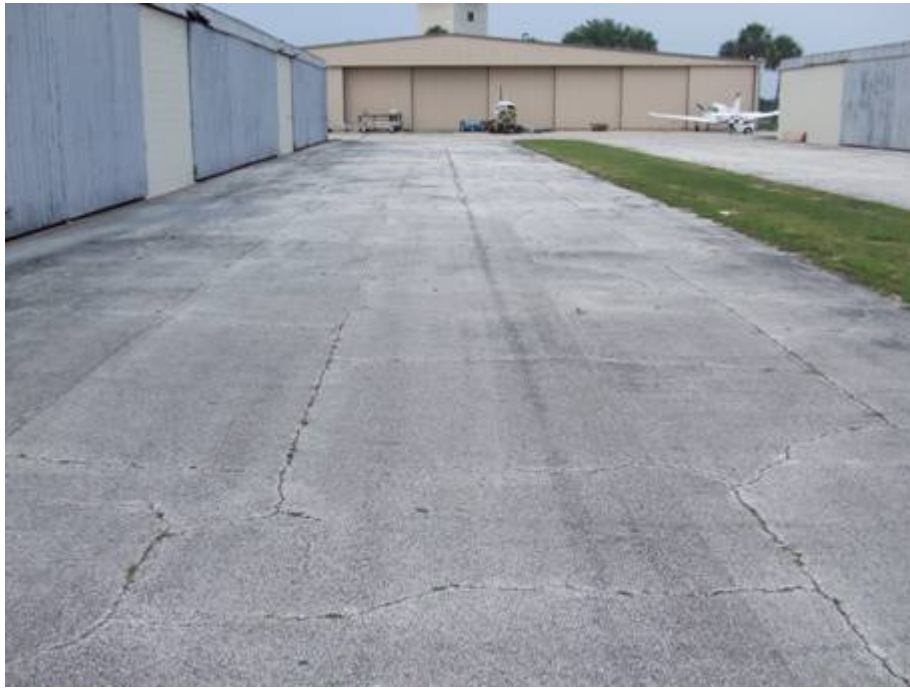
AP Section 4140: Medium Severity Block Cracking (June 11, 2007)

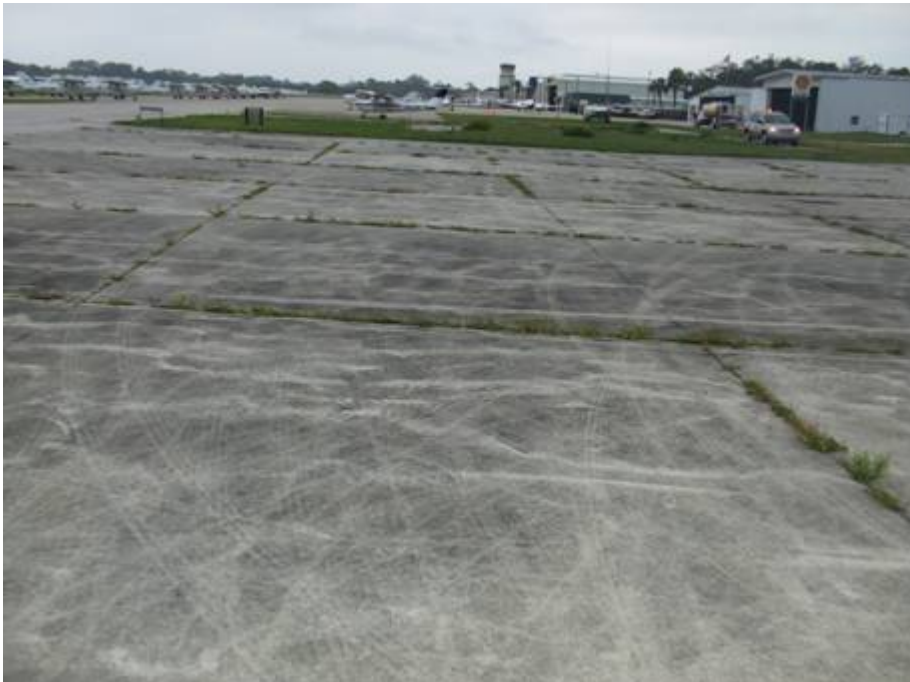
AP Section 4102: High Severity Joint Seal Damage (June 11, 2007)

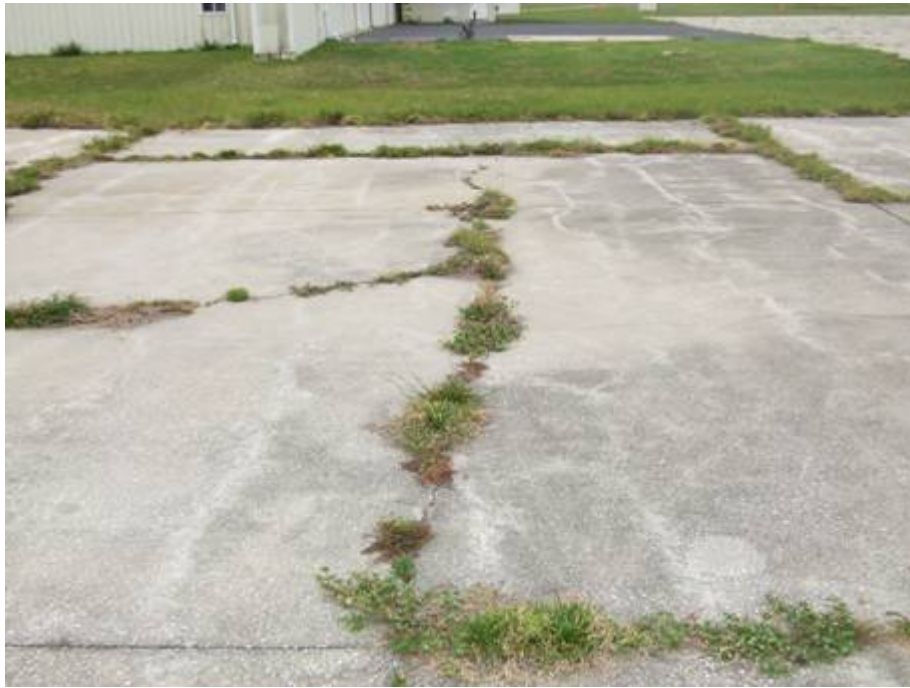
AP Section 4105: High Severity Jt Seal Damage, Medium Severity Cracking
(June 11, 2007)

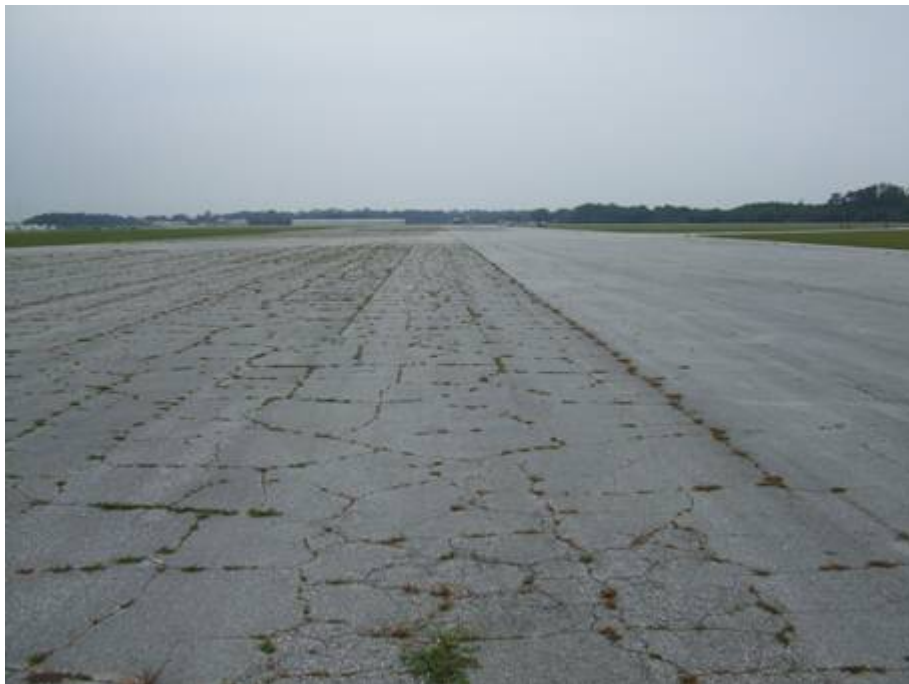
RW 15-33 Section 6305 SU 160, Medium Severity Block Cracking (June 11, 2007)

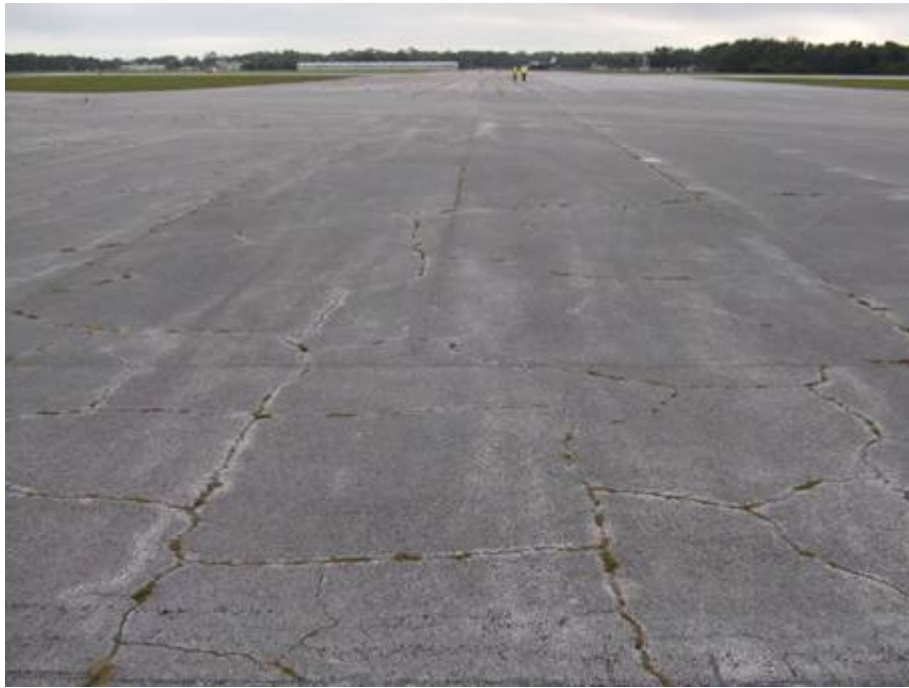
RW 15-33 Section 6320 SU 143, Medium Severity Block Cracking (June 11, 2007)

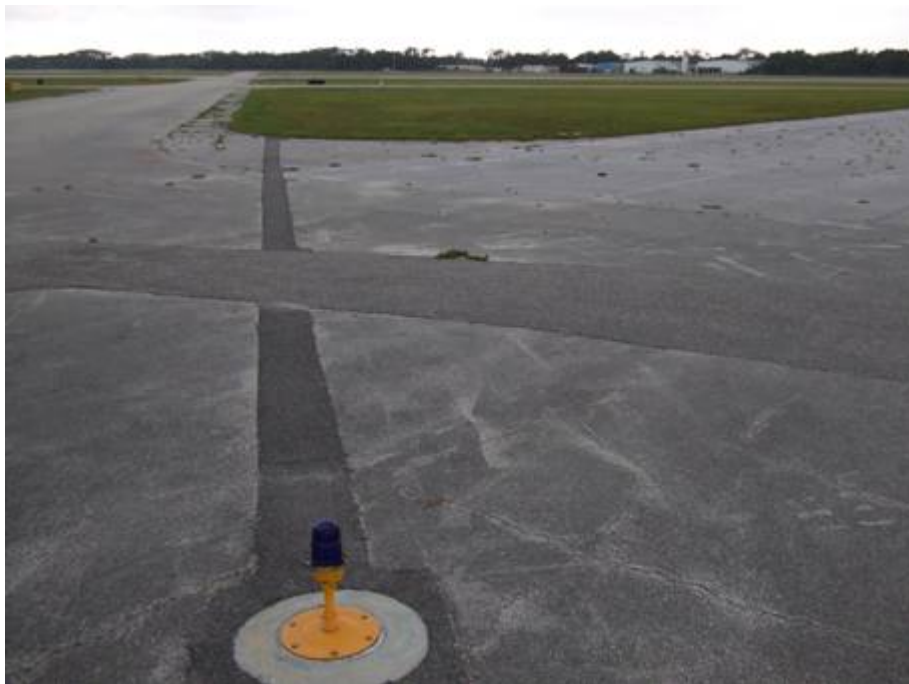
RW 15-33 Section 6330 SU 100, Low Severity Patching, Block Cracking (June 11, 2007)

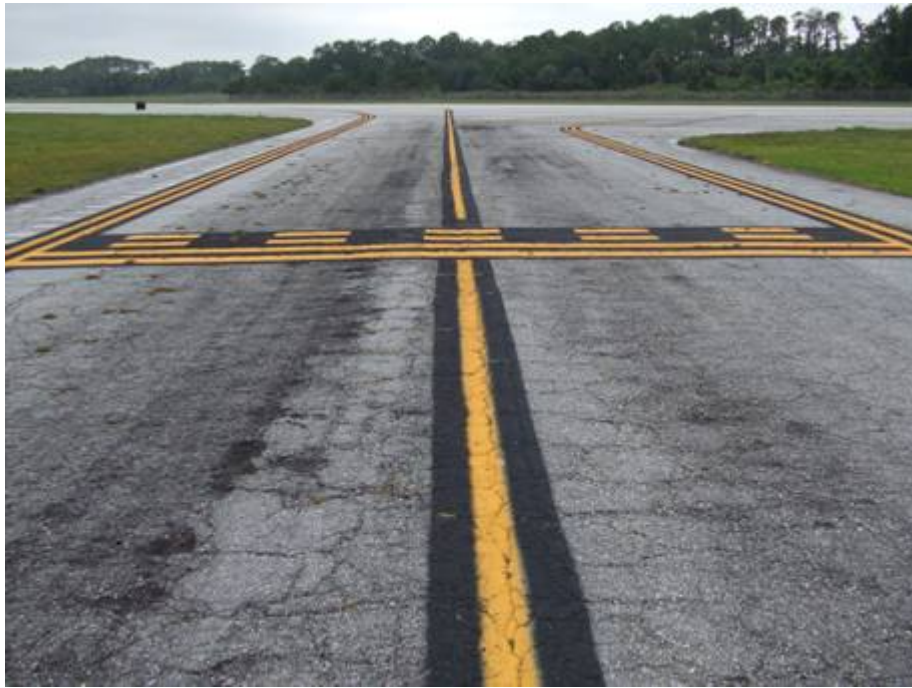
TW A Section 120 SU 101, Medium Severity Block Cracking (June 11, 2007)

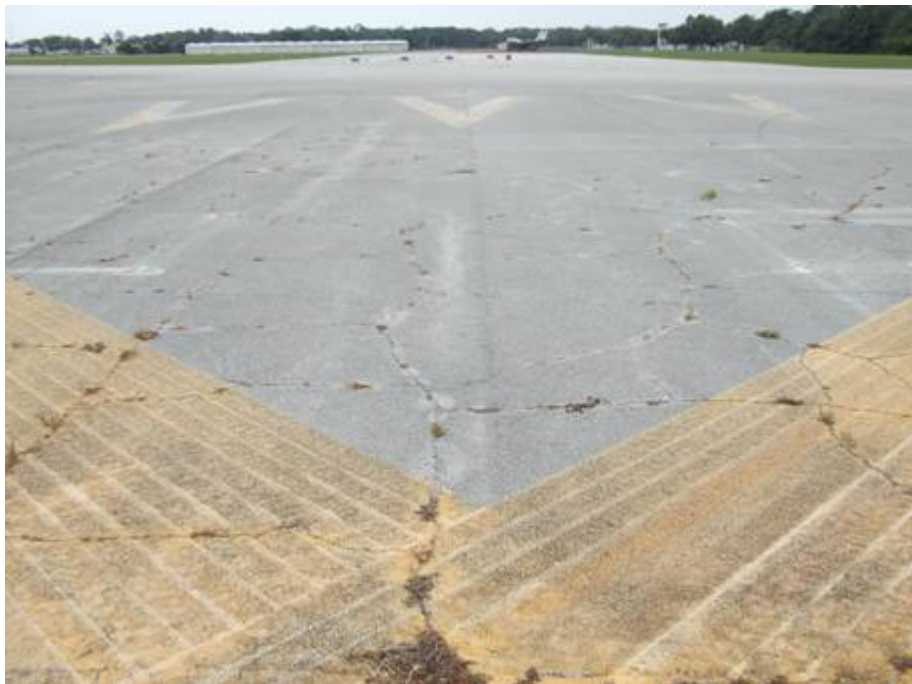
RW 15-33 Section 6310 SU 130, Medium Severity Block Cracking (June 11, 2007)

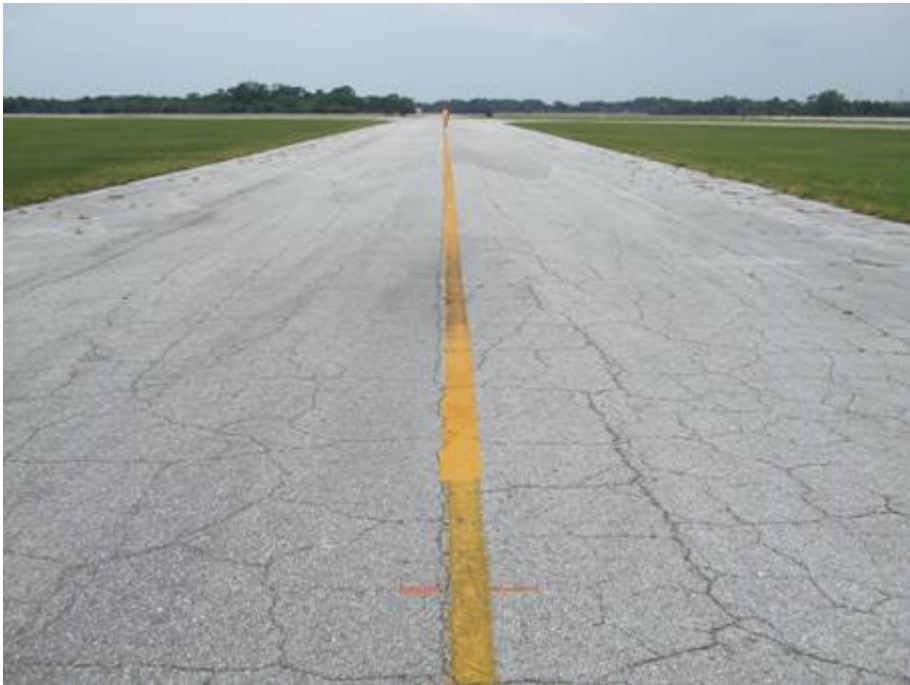
TW D Section 410 SU 305, Medium Severity Block Cracking (June 11, 2007)
