**STATE OF FLORIDA  
DEPARTMENT OF TRANSPORTATION  
AVIATION OFFICE**

**Statewide Airfield Pavement Management Program  
Flagler County Airport – X47  
(General Aviation)  
Bunnell, Florida  
(District 5)**

**June 11, 2008**

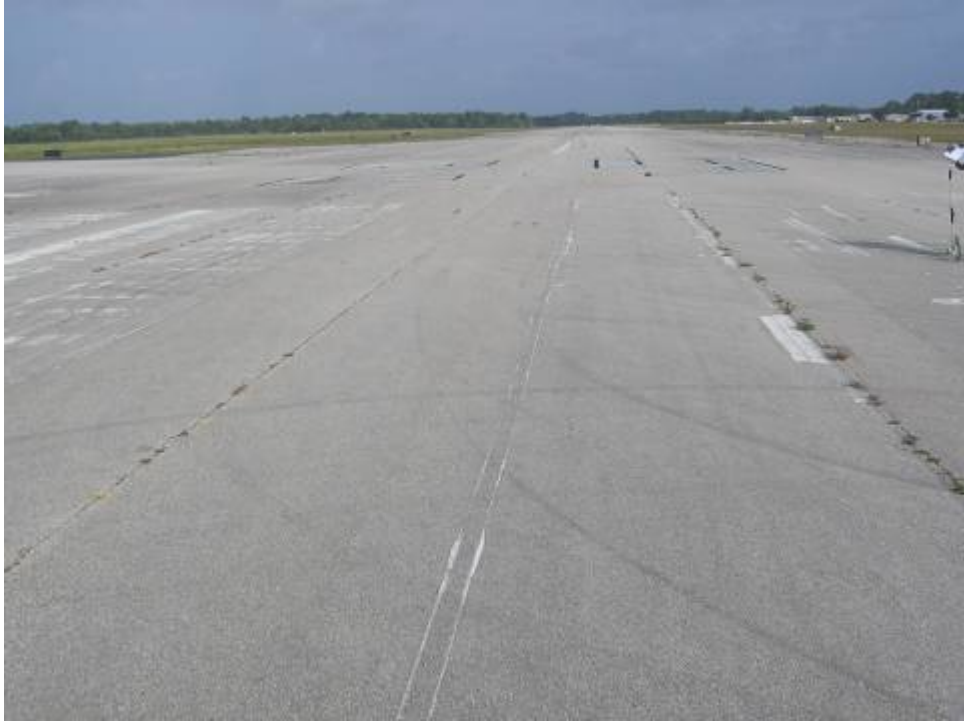
RW 11-29 Section 6105: Medium Severity Linear/Transverse Cracking (May 24, 2007)

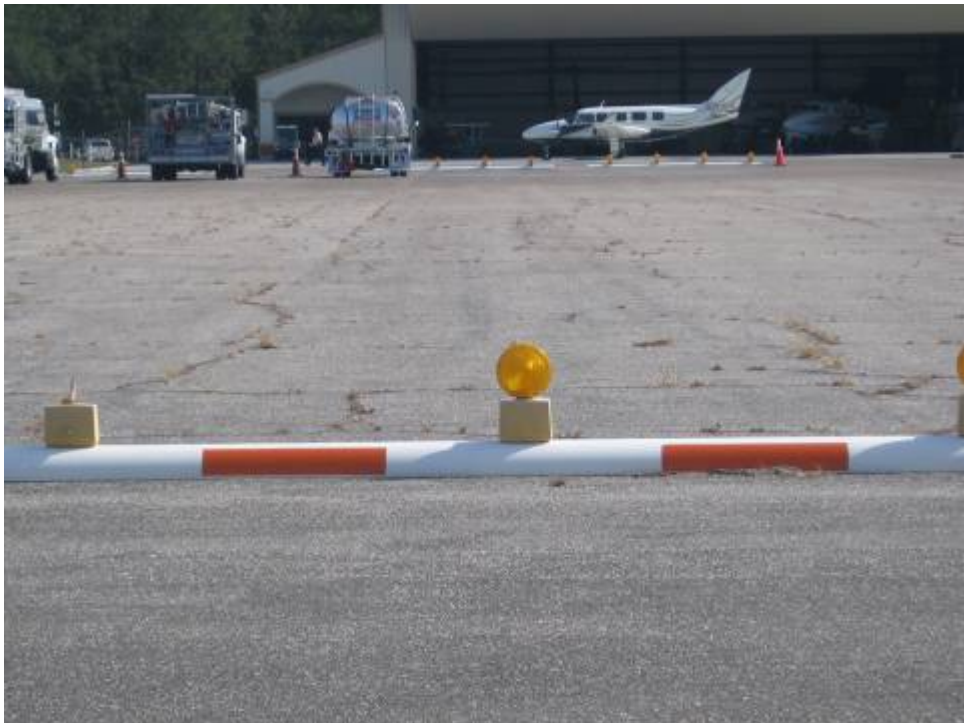
TW F Section 605: Medium Severity Block Cracking (May 24, 2007)

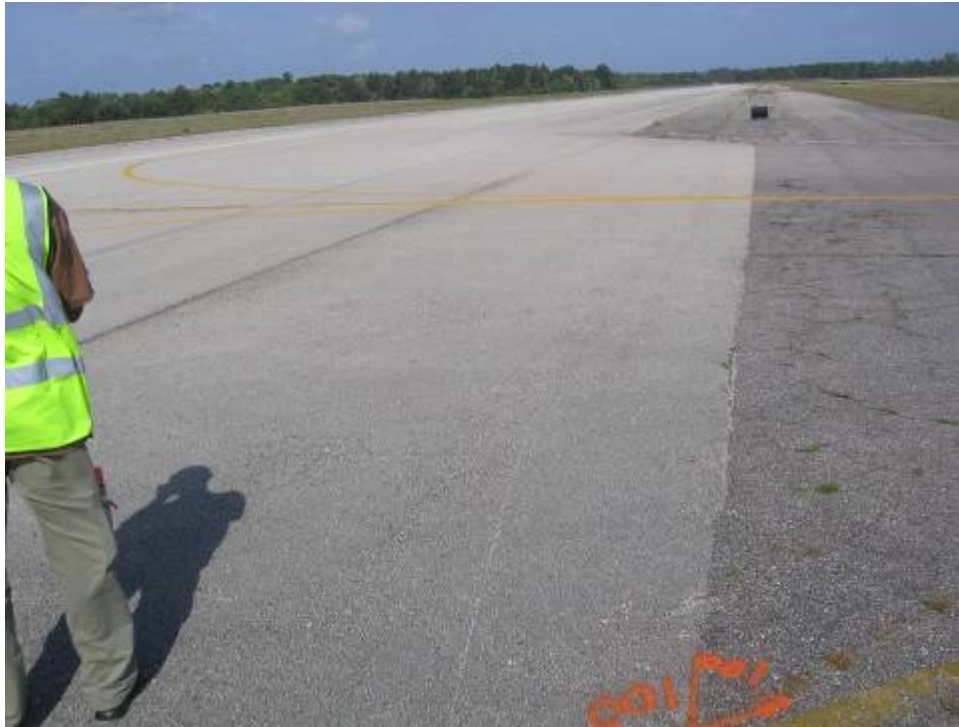
**TW D Section 415: Low Severity Weathering (May 24, 2007)**

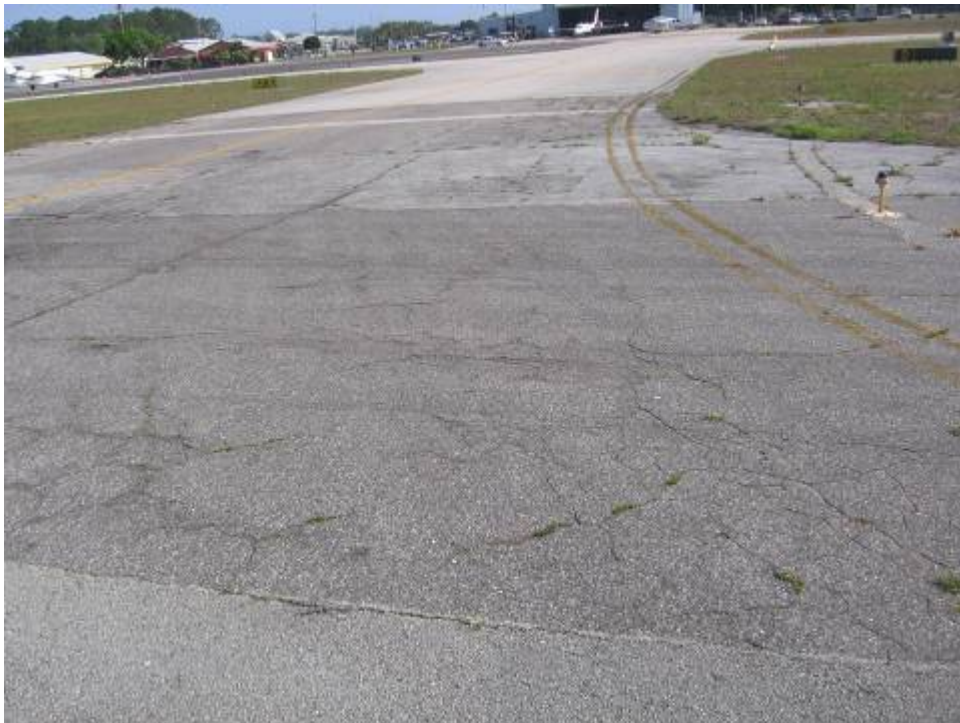
**TW D Section 414: Medium Severity Block Cracking (May 24, 2007)**

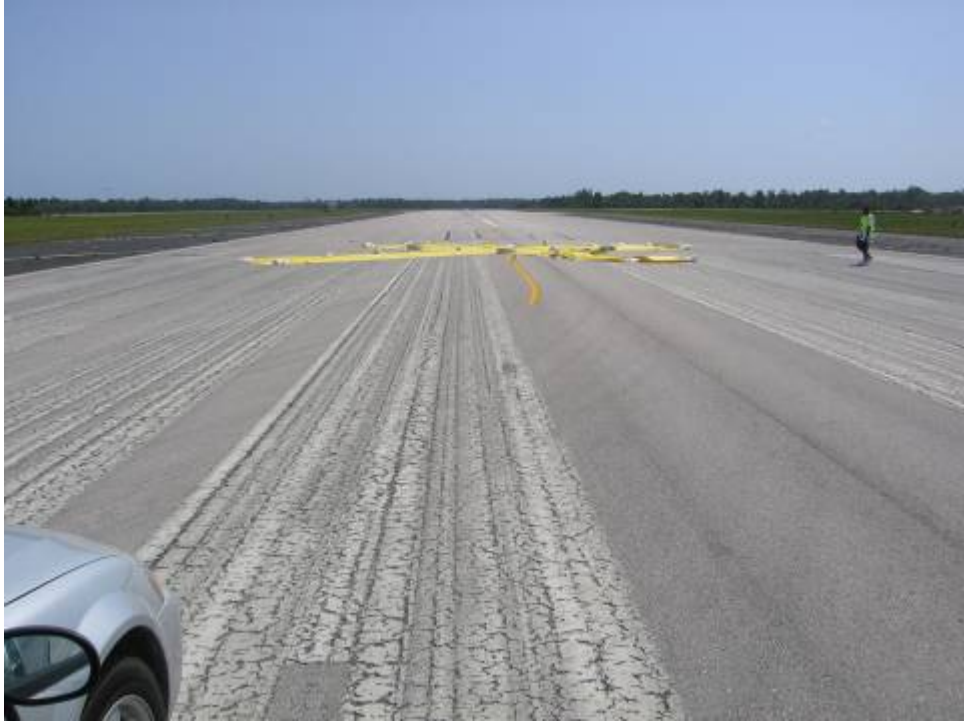
RW 6-24 Section 6205: Low Severity Weathering (May 24, 2007)

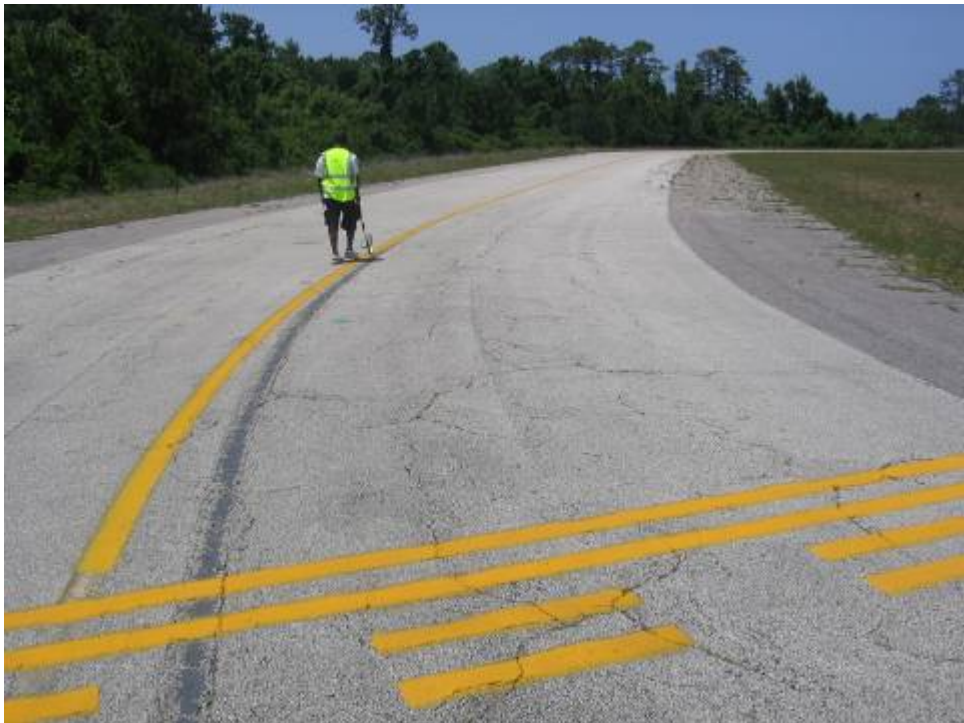
TW E Section 510: Low Severity Block Cracking (May 24, 2007)

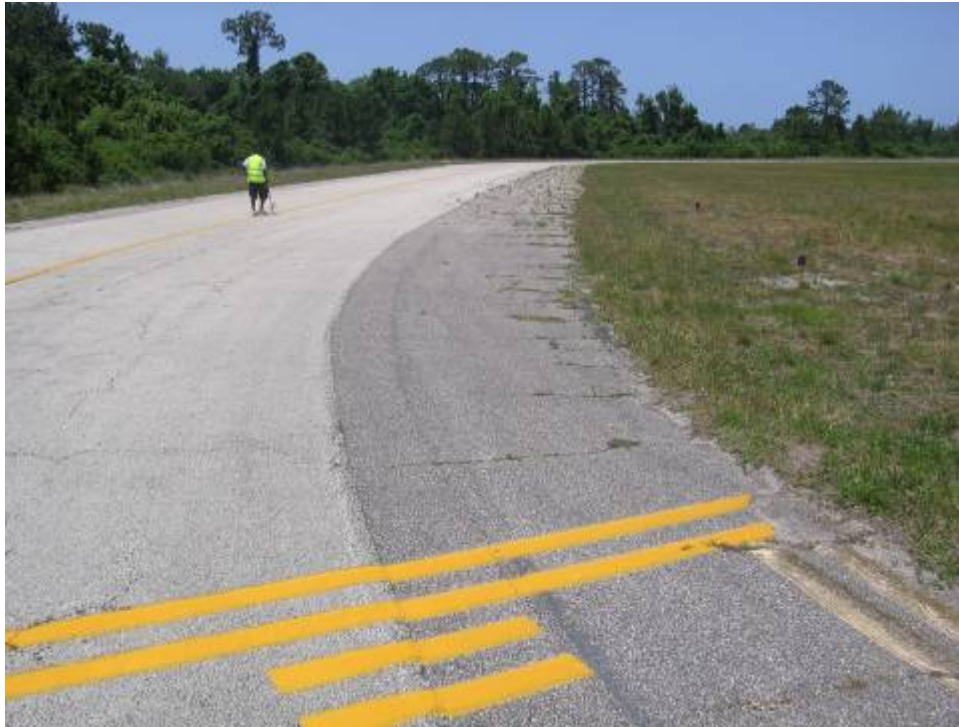
TW E Section 512: Low Severity Block Cracking (May 24, 2007)

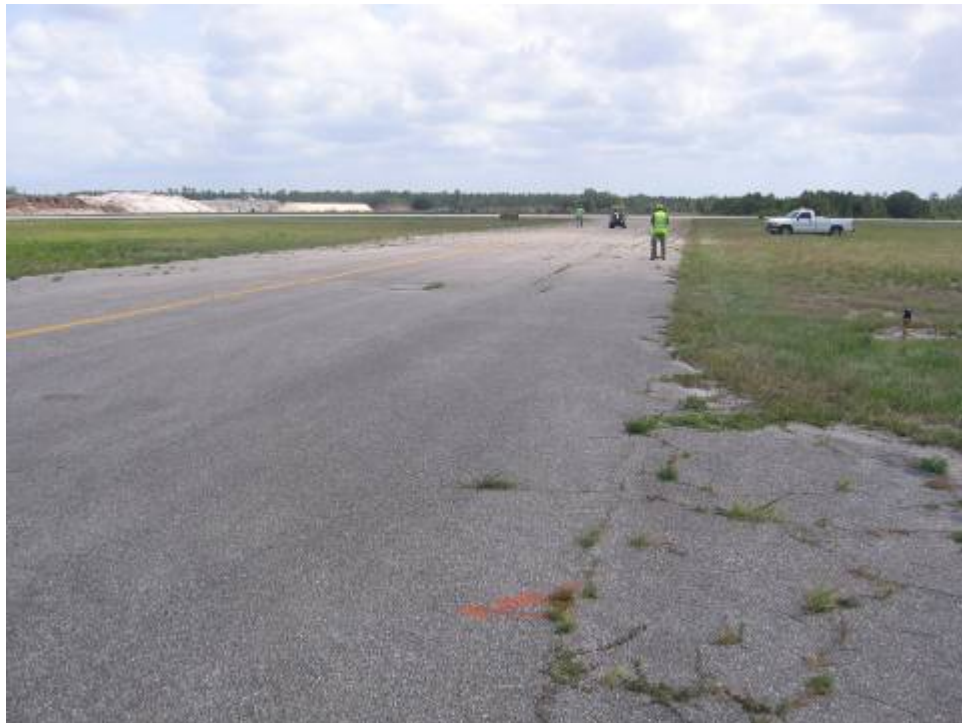
TW D Section 407: Low Severity Linear/Transverse Cracking (May 24, 2007)

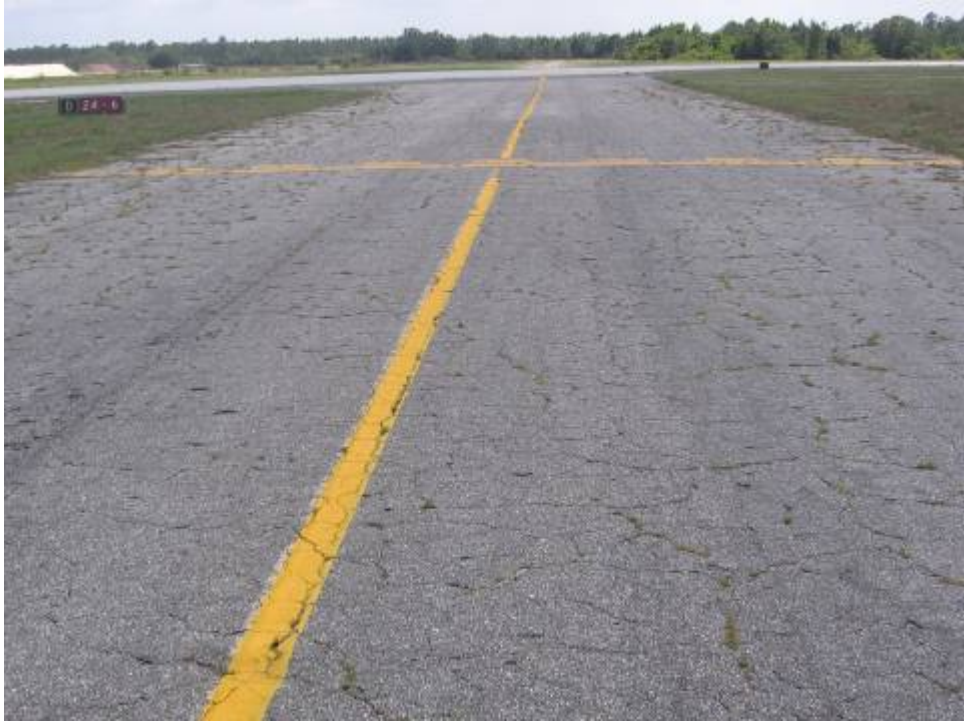
**TW D Section 405: Medium Severity Block Cracking (May 24, 2007)**

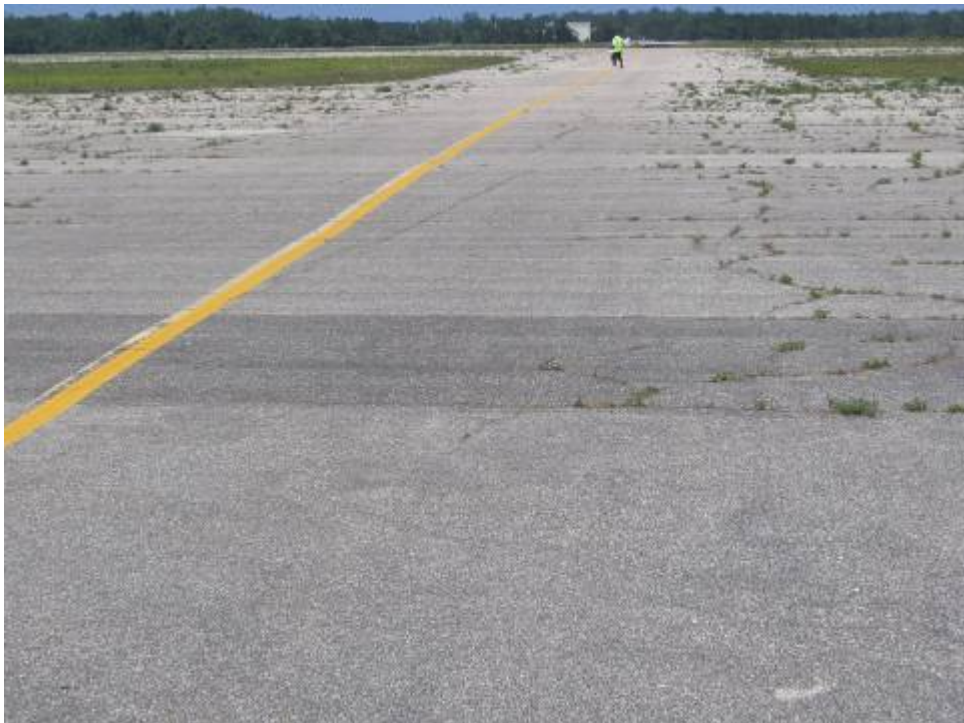
**TW E Section 515: Medium Severity Linear/Transverse Cracking (May 24, 2007)**

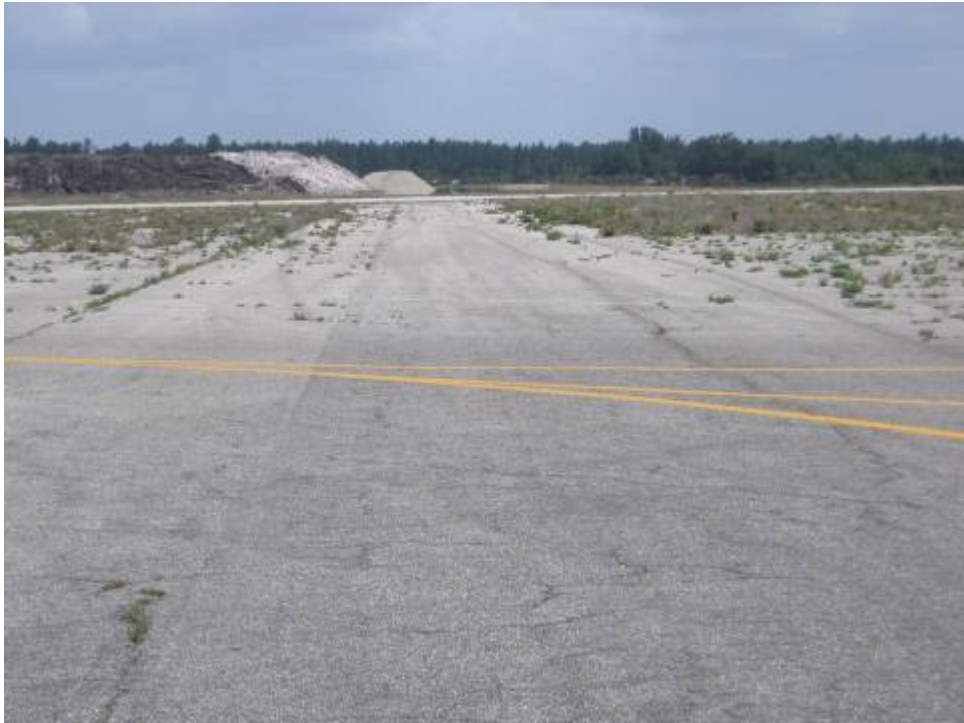
**TW C Section 310: Low Severity Weathering (May 24, 2007)**

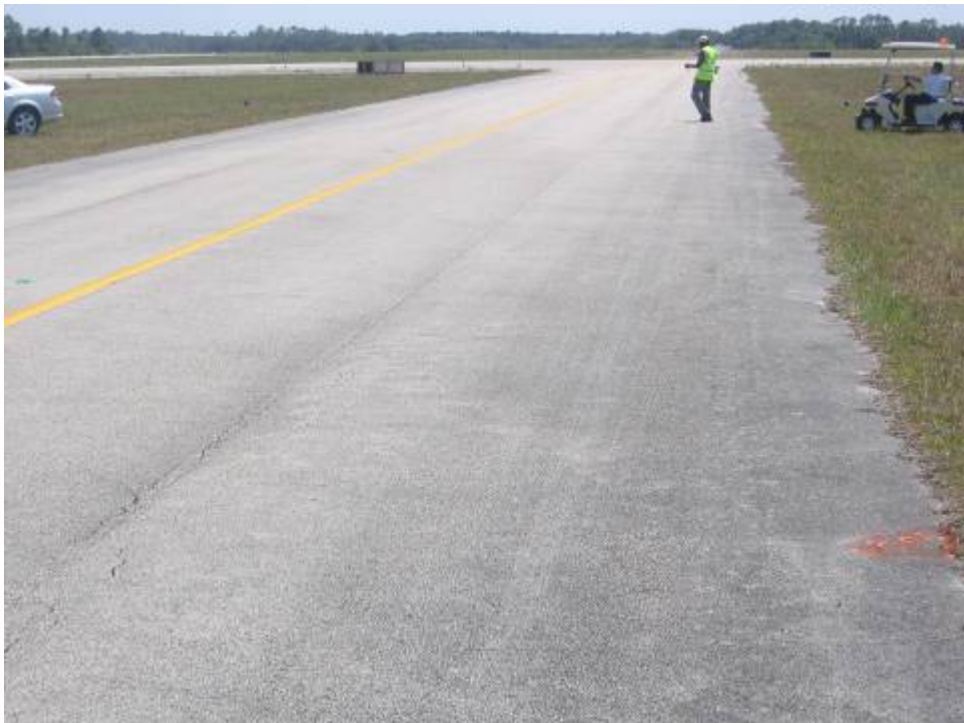
**TW E Section 505: Low Severity Linear/Transverse Cracking (May 24, 2007)**

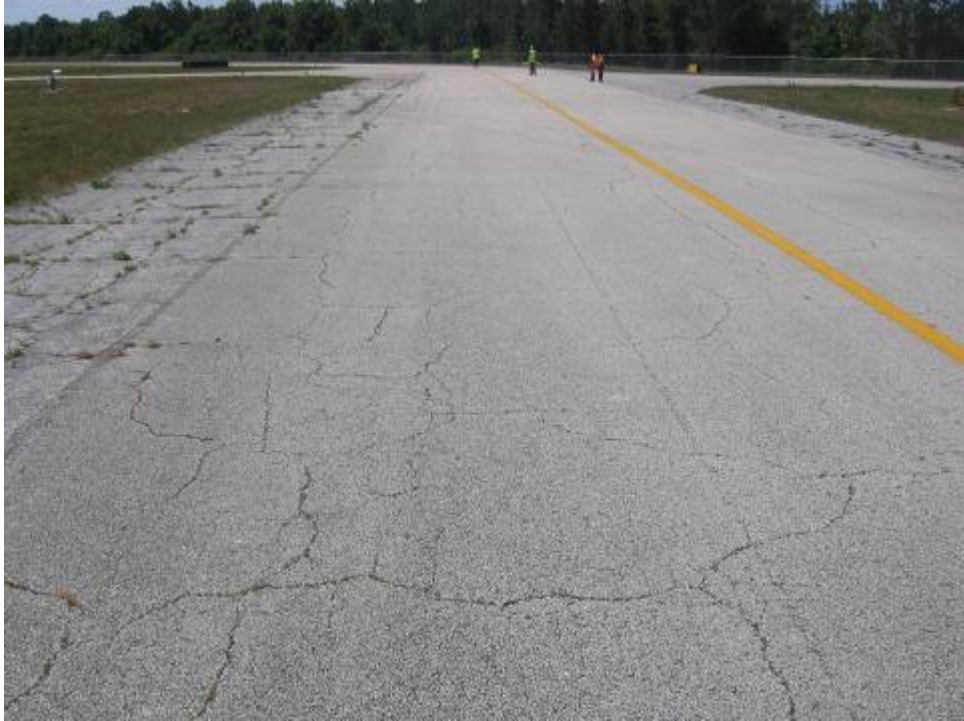
**TW A Section 110: Medium Severity Block Cracking (May 24, 2007)**

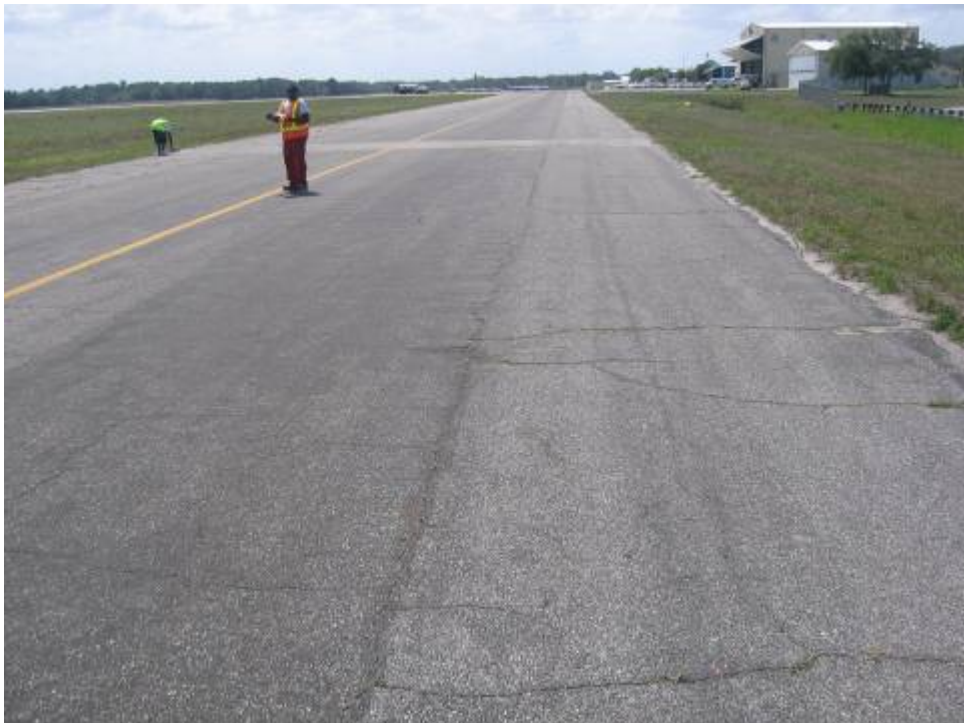
TW A Section 105: Low Severity Block Cracking (May 24, 2007)

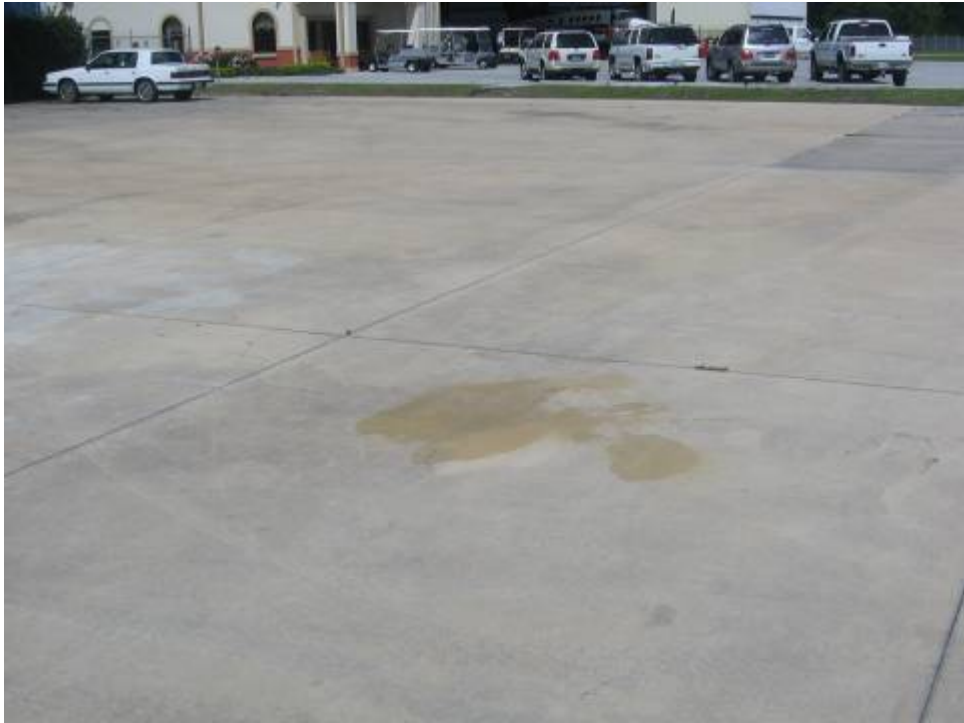
AP Section 4130: Low Severity Scaling (May 24, 2007)

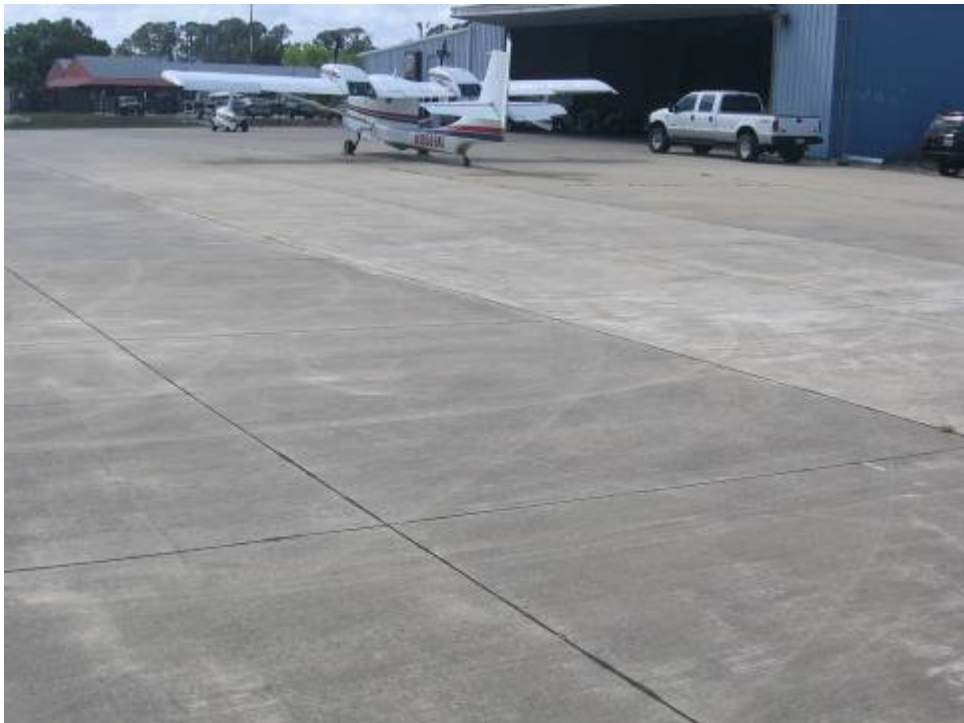
AP Section 4125: Low Severity Scaling (May 24, 2007)

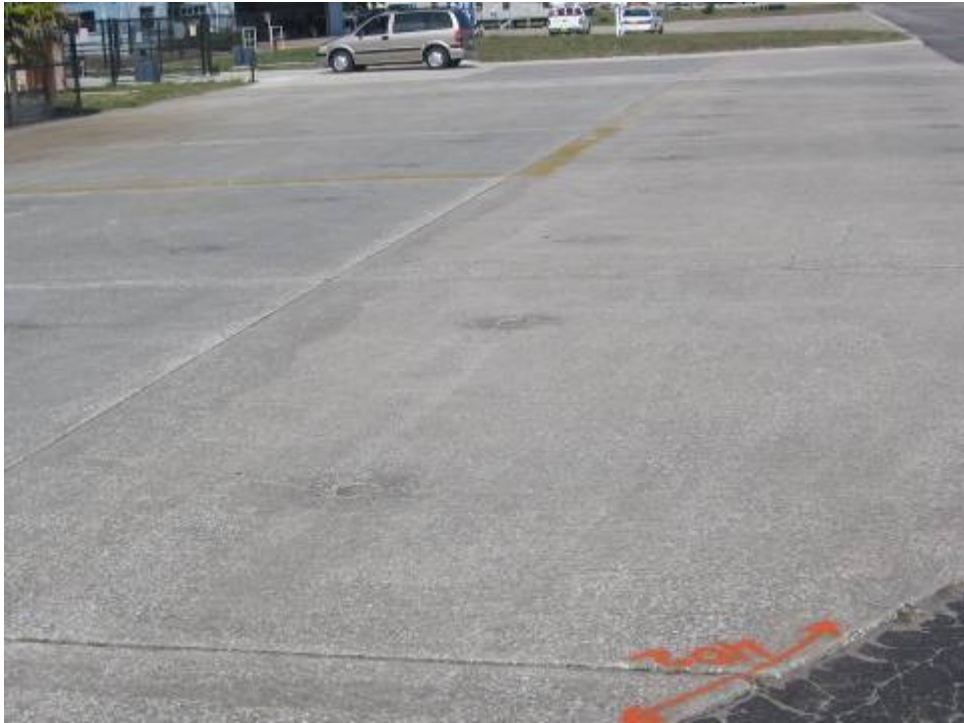
AP Section 4120: Low Severity Joint Seal Damage (May 24, 2007)

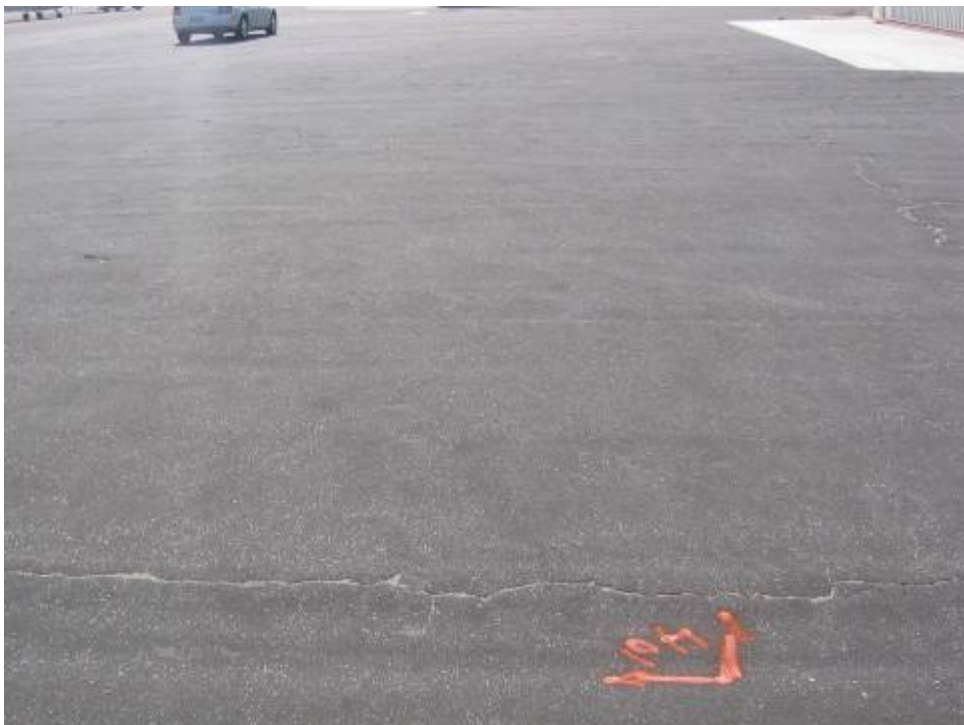
AP Section 4115: Medium Severity Block Cracking (May 24, 2007)

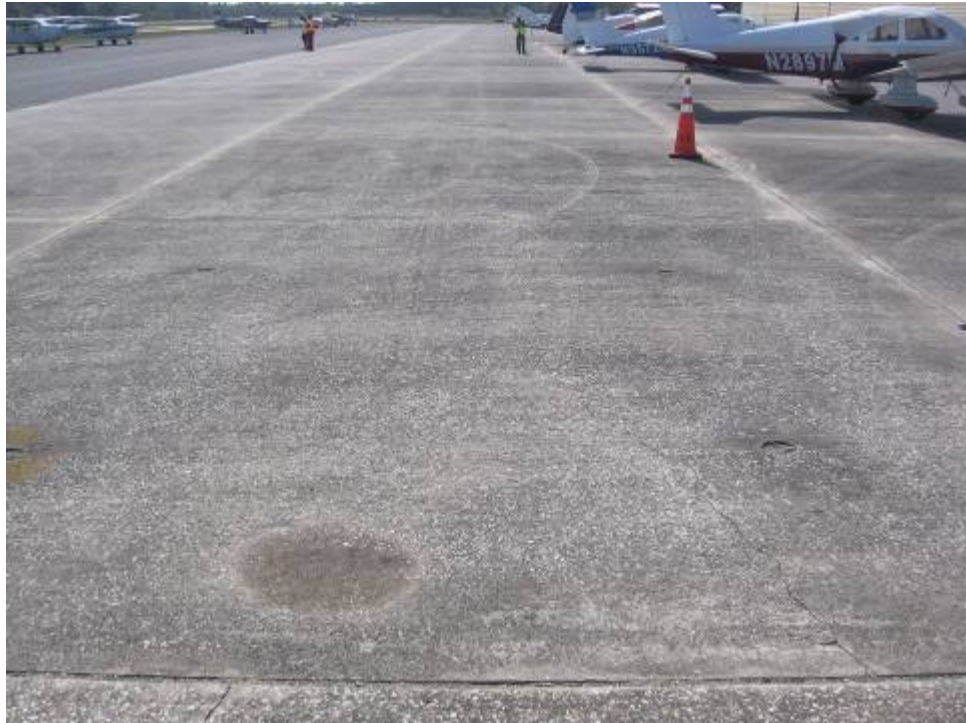
AP Section 4110: Low Severity Scaling (May 24, 2007)

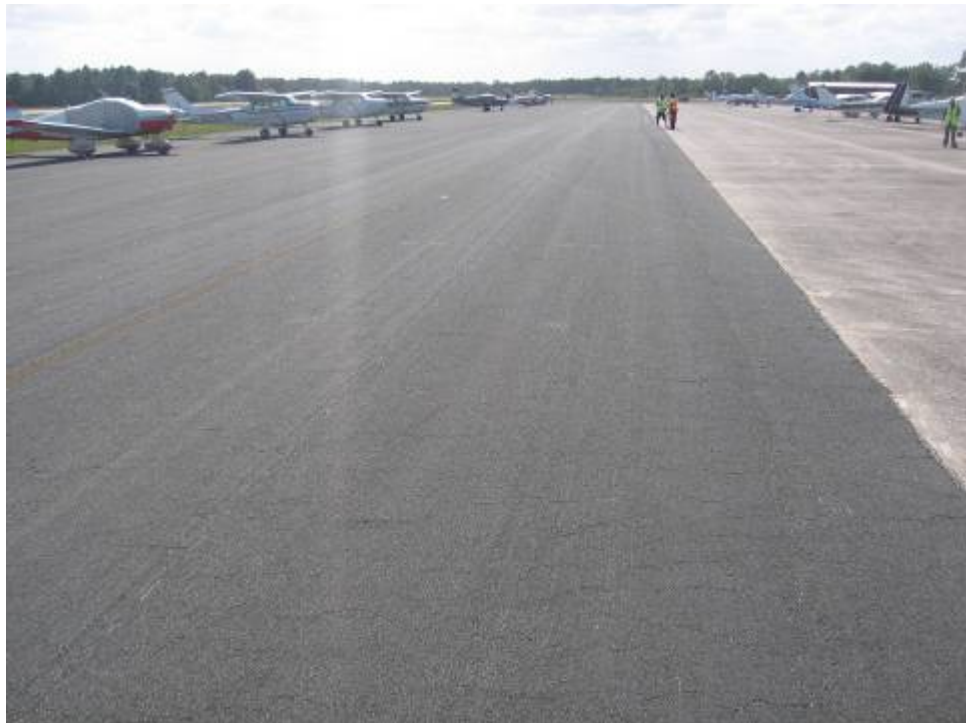
AP Section 4135: Low Severity Weathering (May 24, 2007)

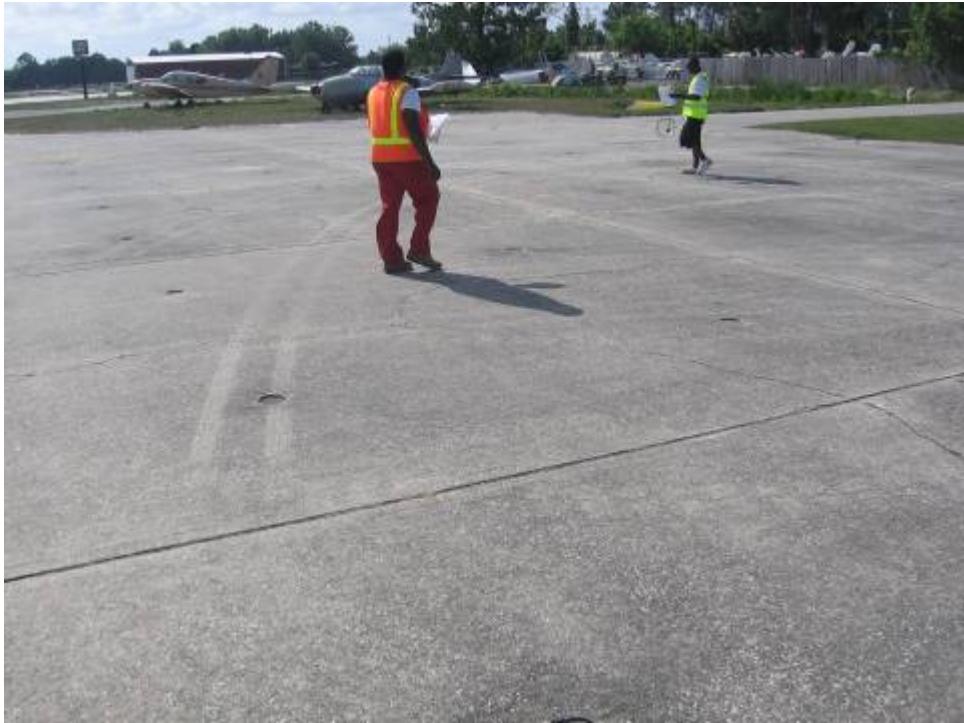
AP Section 4105: Low Severity Joint Seal Damage (May 24, 2007)

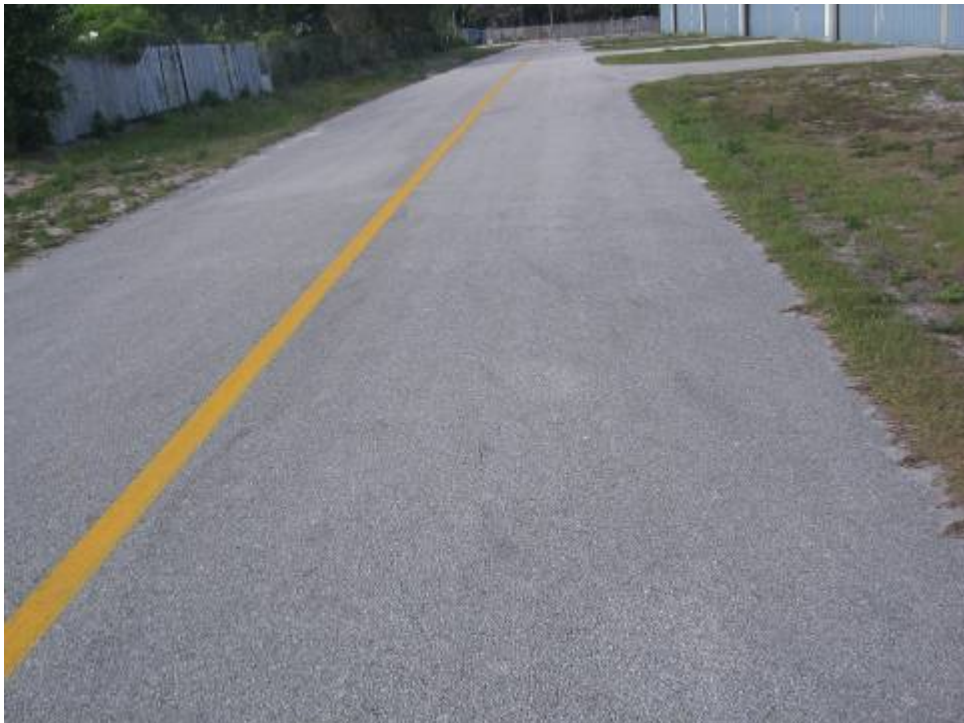
AP T-HANG Section 4310: Low Severity Weathering (May 24, 2007)

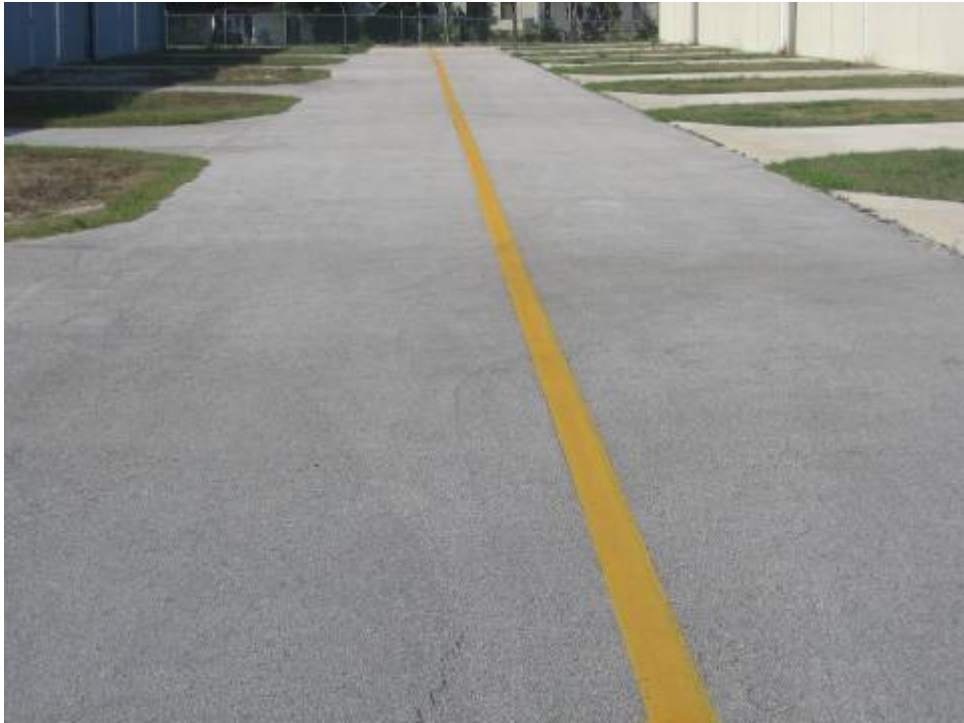
AP T-HANG Section 4315: Low Severity Weathering (May 24, 2007)

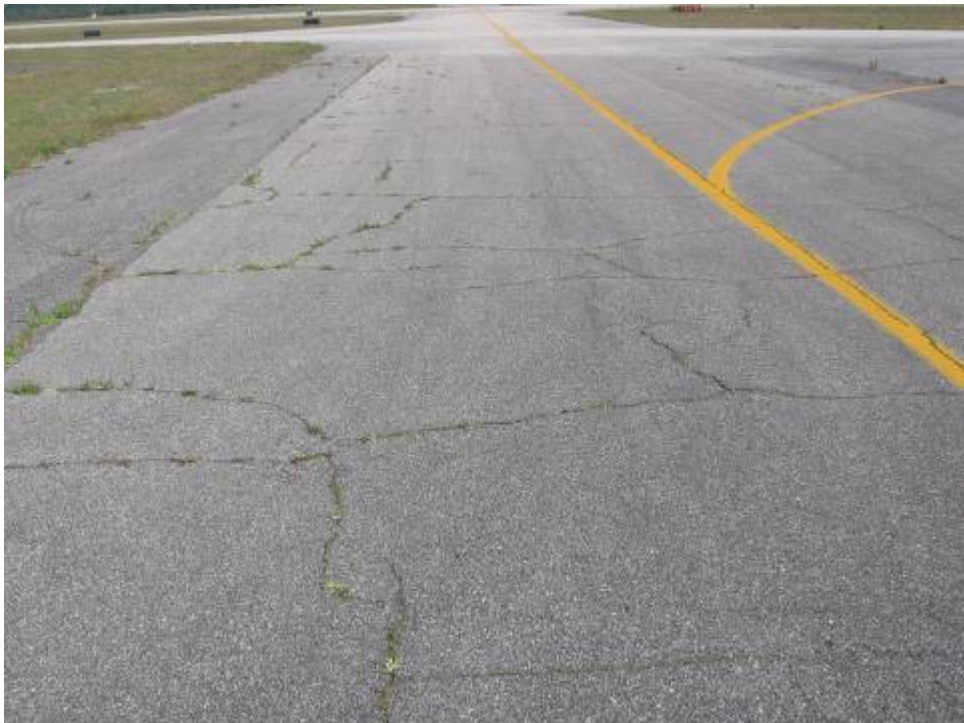
TW C Section 307: Low Severity Block Cracking (May 24, 2007)

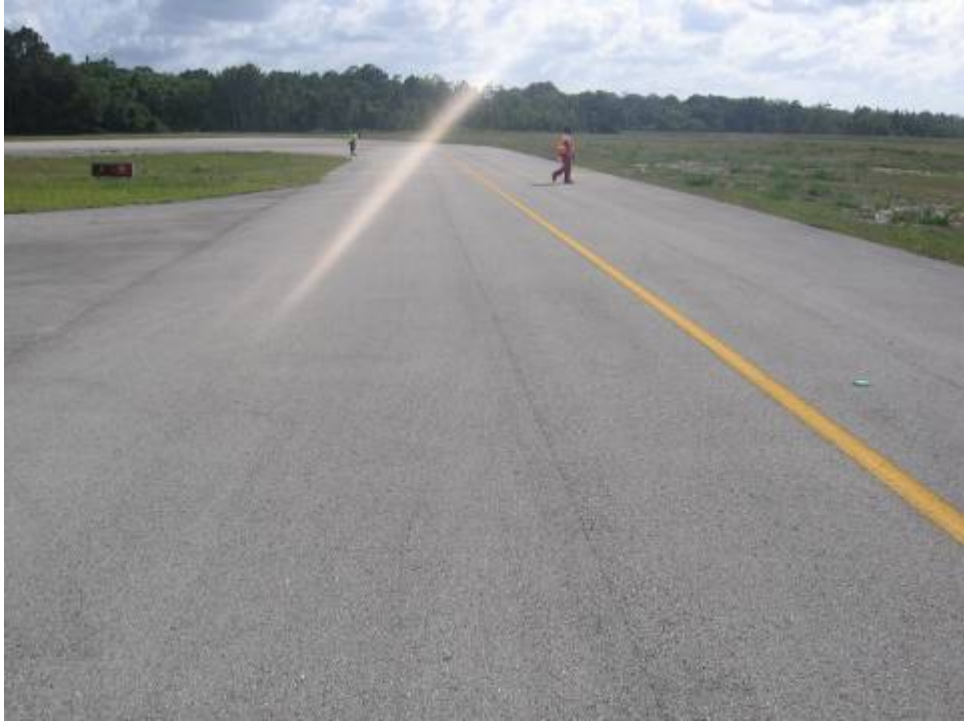
TW A Section 102: Low Severity Linear/Transverse Cracking (May 24, 2007)

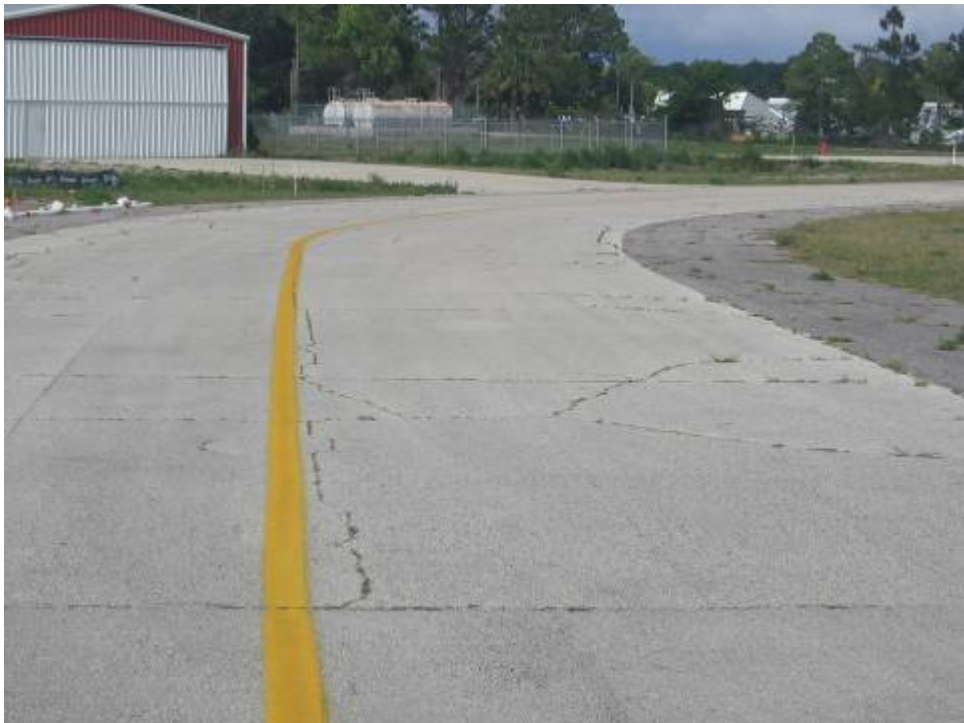
TW A Section 104: Medium Severity Block Cracking (May 24, 2007)

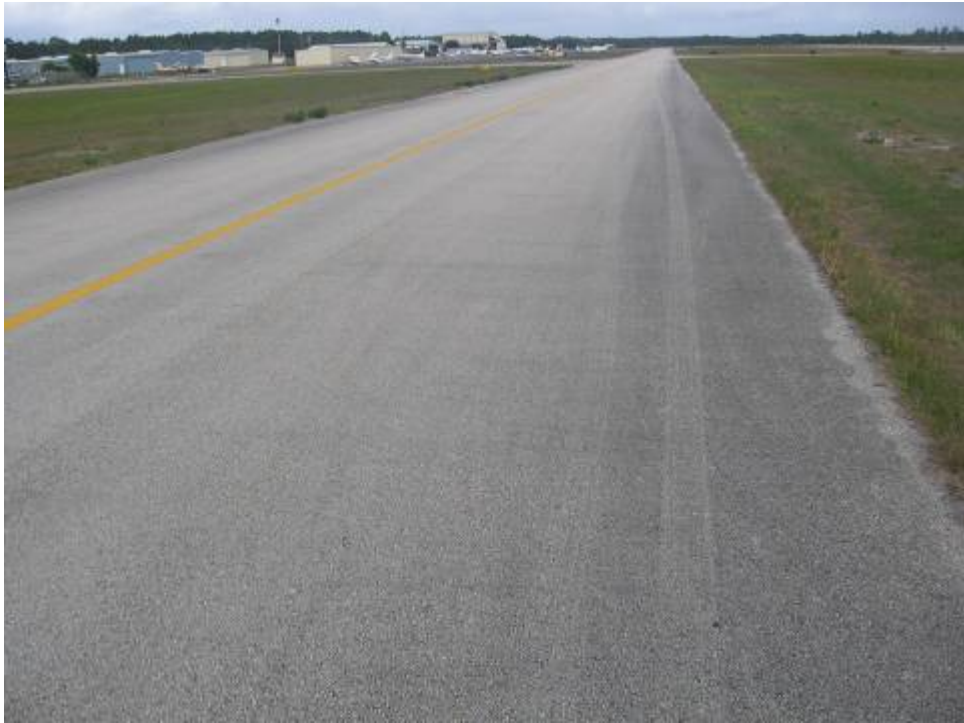
TW B Section 205: Low Severity Linear/Transverse Cracking (May 24, 2007)

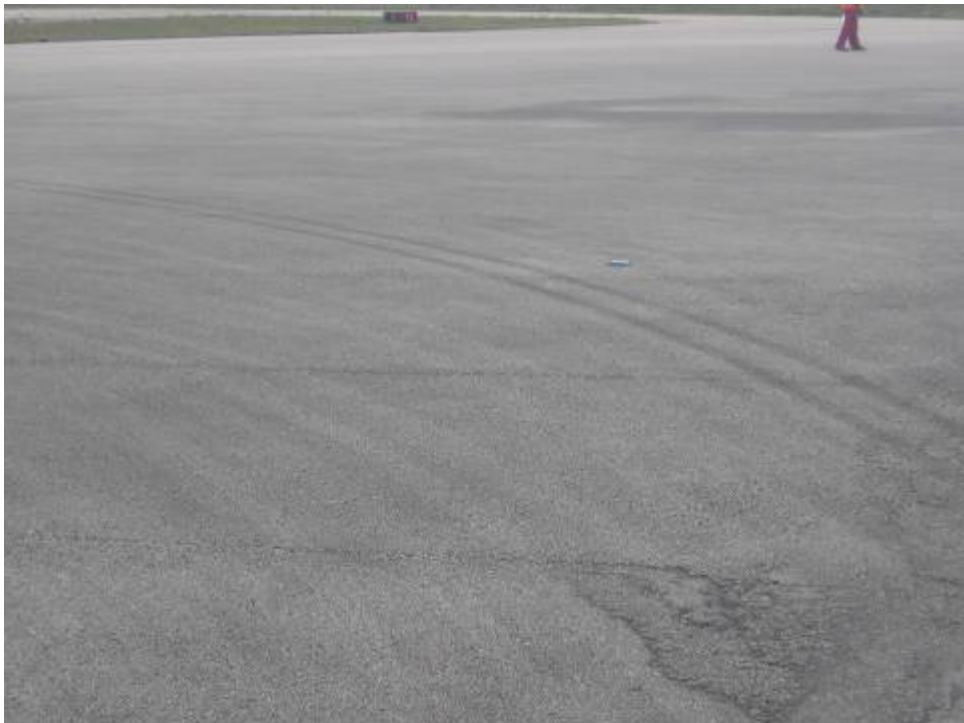
AP RU 11 Section 5105: Low Severity Weathering (May 24, 2007)

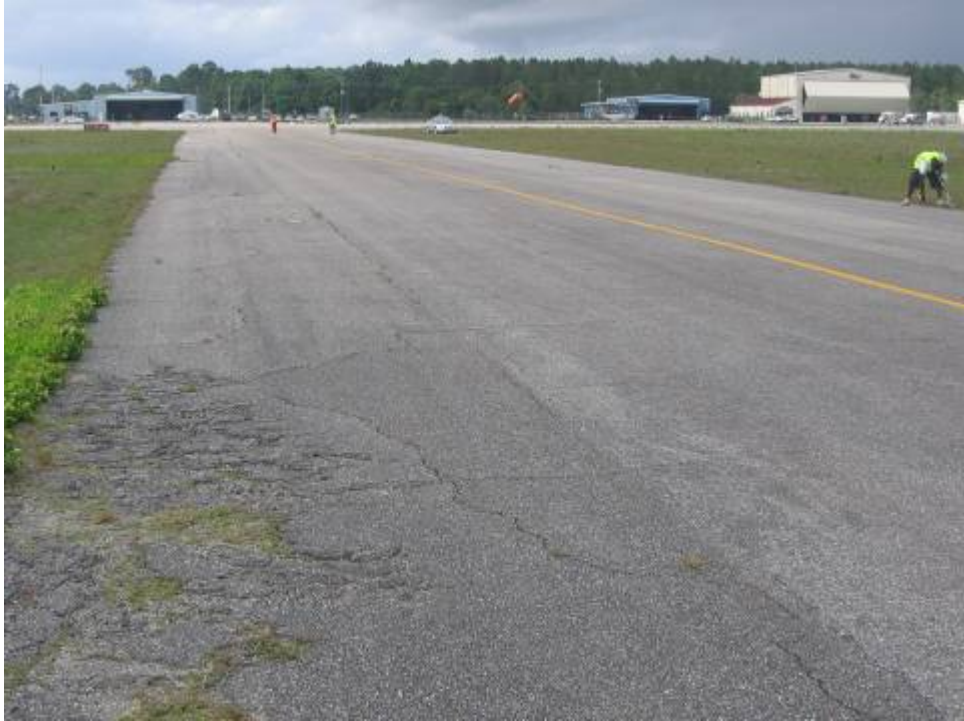
**TW D Section 410: High Severity Weathering (May 24, 2007)**
