**STATE OF FLORIDA  
DEPARTMENT OF TRANSPORTATION  
AVIATION OFFICE**

**Statewide Airfield Pavement Management Program  
Lake City Municipal Airport – LCQ  
(General Aviation)  
Lake City, Florida  
(District 2)**

**March 17, 2008**

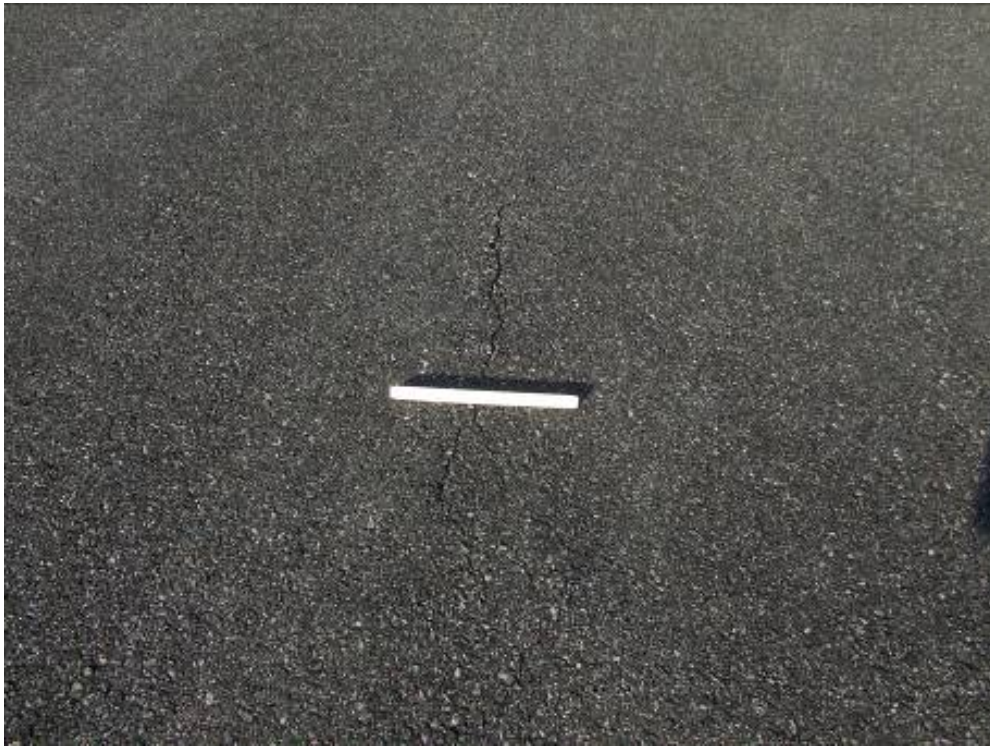
AP RW 10-28 Section 5125 SU 202: Low Severity L/T Cracking (December 19, 2007)

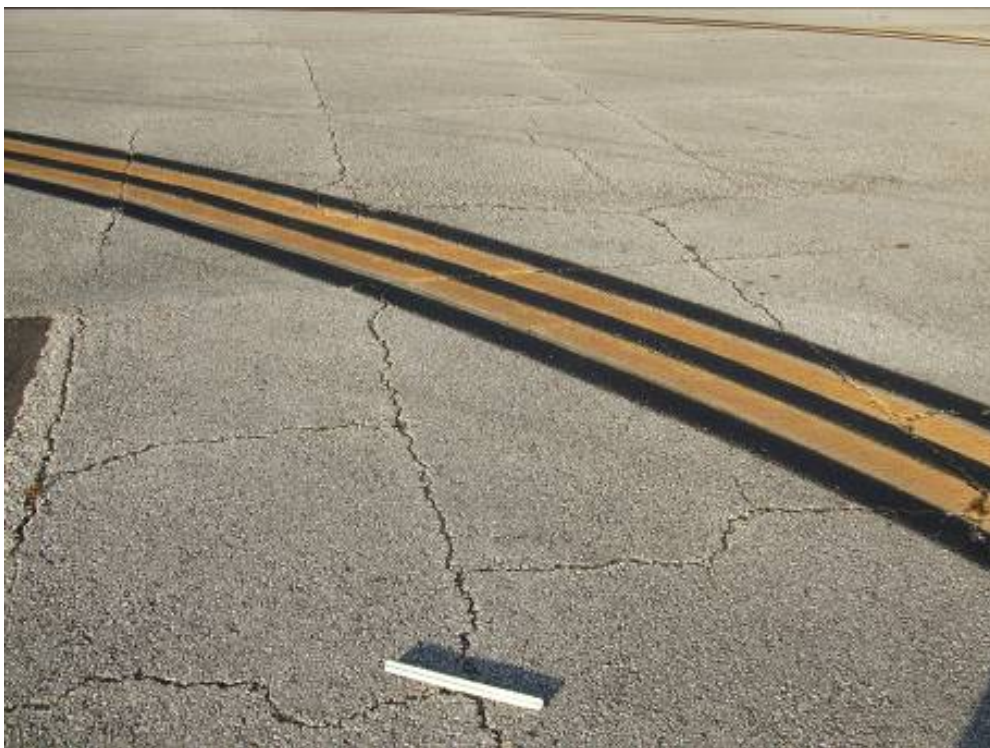
TW A6 Section 130 SU 605: Medium Severity Block Cracking (December 19, 2007)

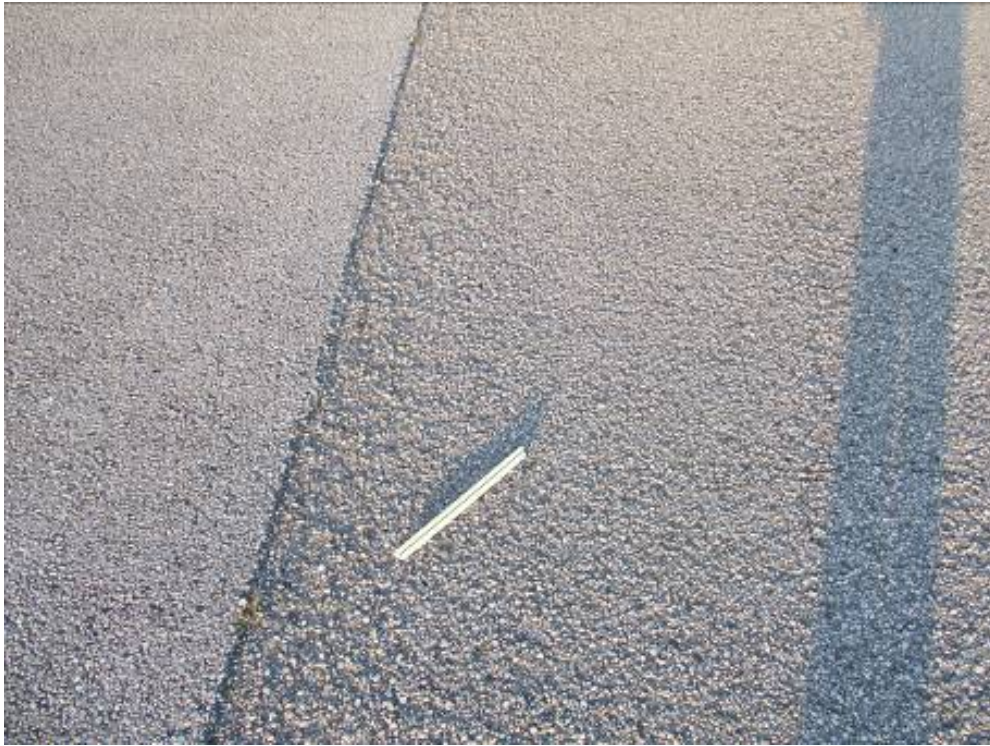
TW C Section 305 SU 102: Low Severity Weathering (December 19, 2007)

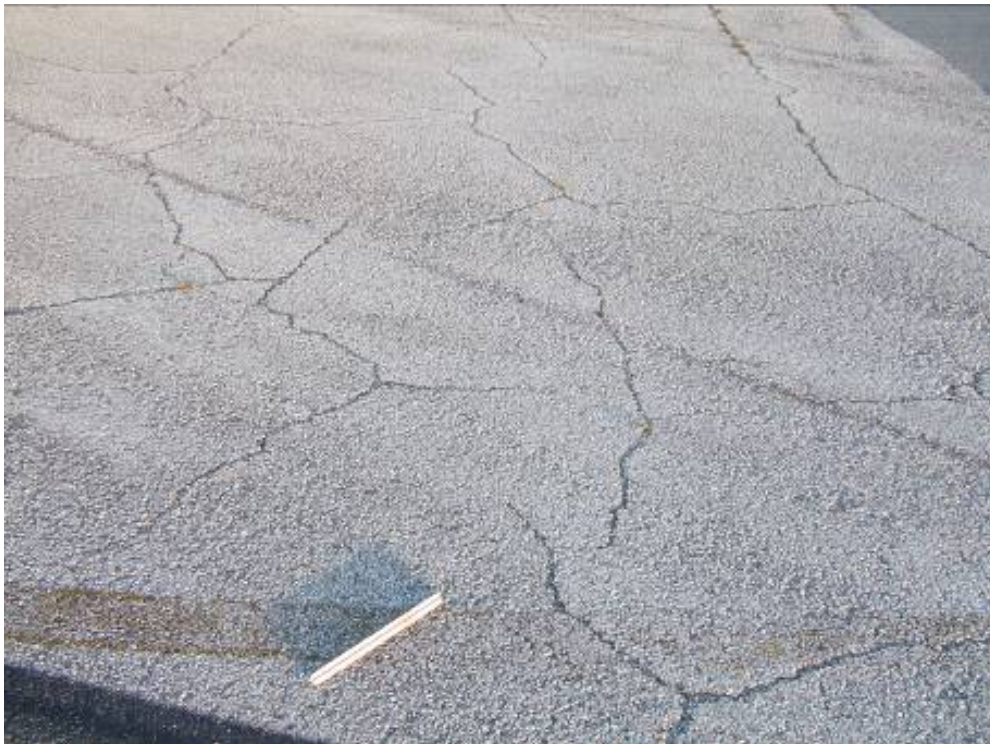
TW C Section 304 SU 100: Medium Severity Block Cracking (December 19, 2007)

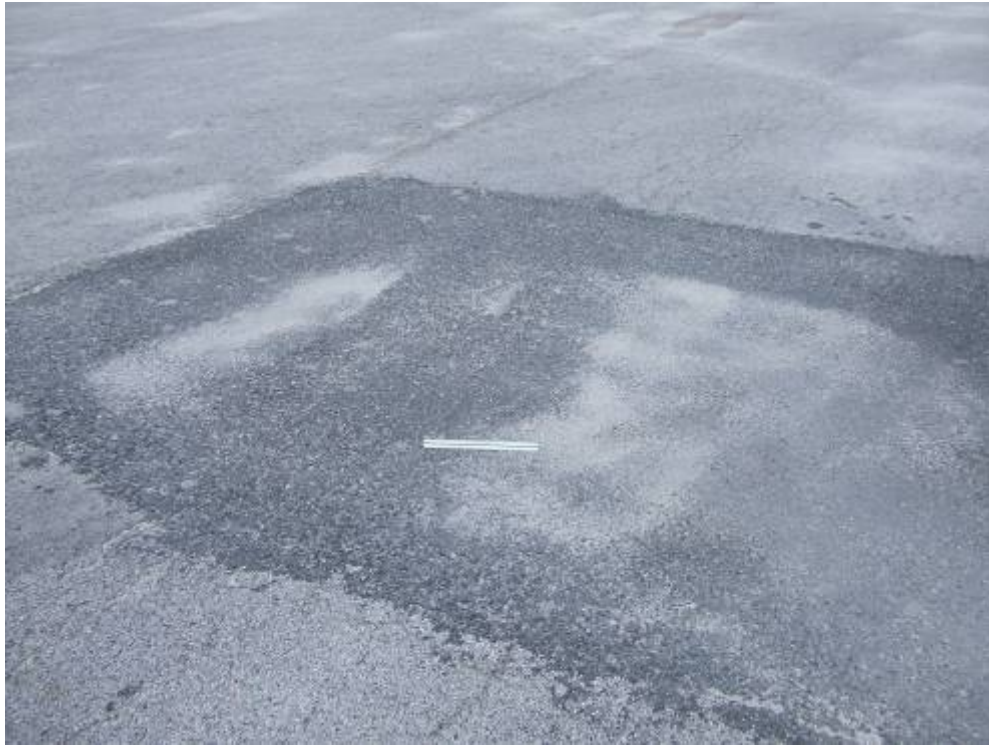
AP E Section 4228 SU 101: Medium Severity Patching (December 19, 2007)

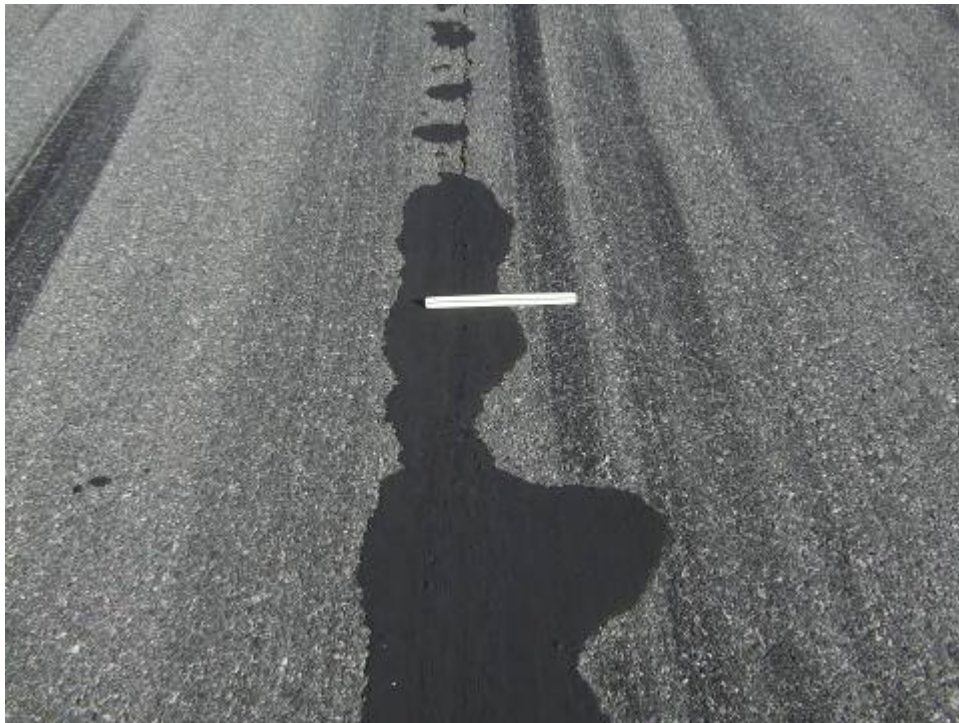
RW 10-28 Section 6114 SU 433: Bleeding (December 19, 2007)
