**STATE OF FLORIDA  
DEPARTMENT OF TRANSPORTATION  
AVIATION OFFICE**

**Statewide Airfield Pavement  
Management Program**

**Inverness Airport – X40  
(General Aviation)  
Inverness Airport, Florida  
(District 7)**

**May 2011**

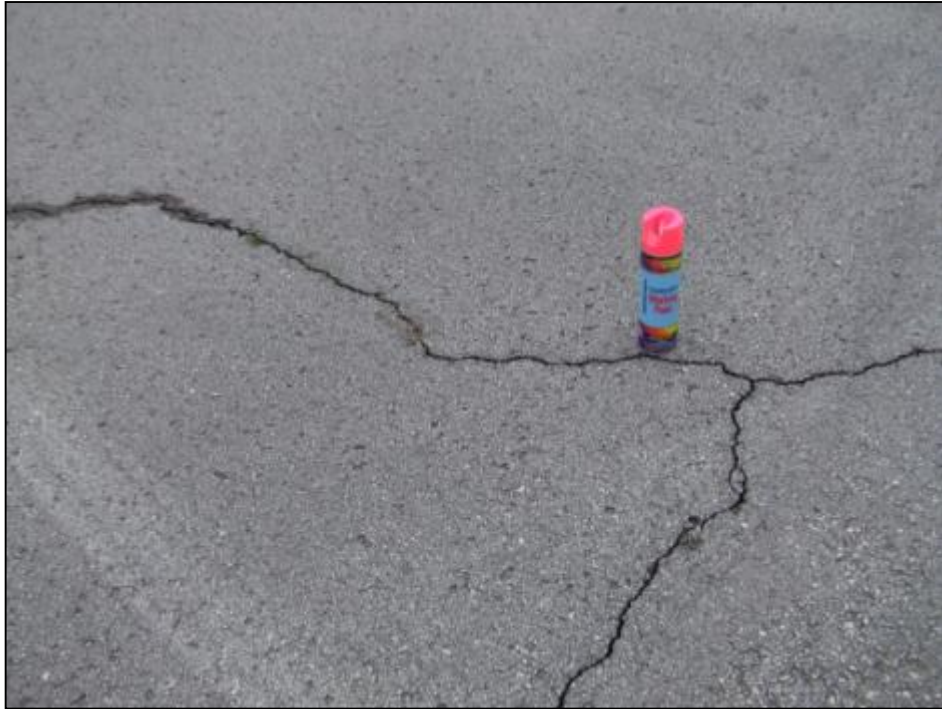
Apron General Aviation, Section 4005, Sample Unit 201 – Low severity (48) Longitudinal and Transverse Cracking, low severity (52) Weathering and Raveling.

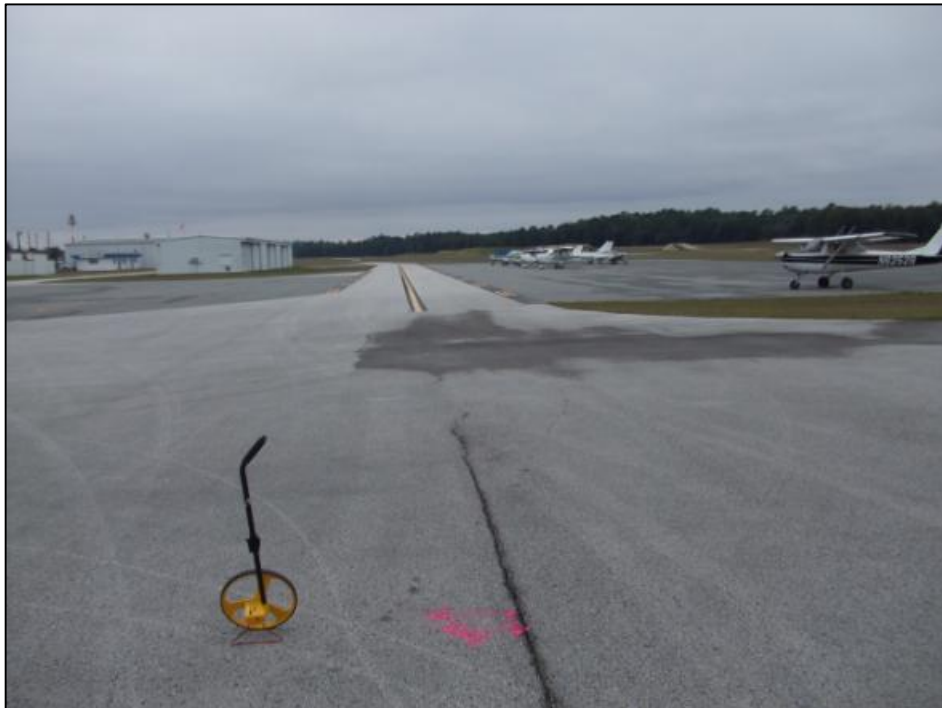
Apron General Aviation, Section 4005, Sample Unit 201 – Low severity (48) Longitudinal and Transverse Cracking, low severity (52) Weathering and Raveling.

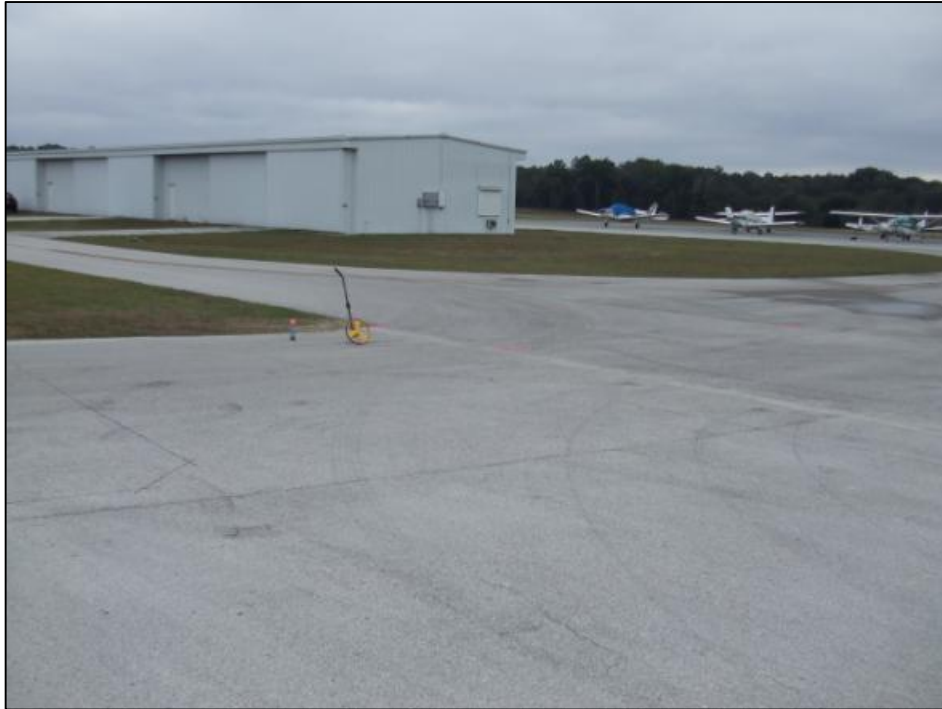
Apron General Aviation, Section 4010, Sample Unit 101 – Low severity (48) Longitudinal and Transverse Cracking, low severity (50) Patching, low severity (52) Weathering and Raveling.

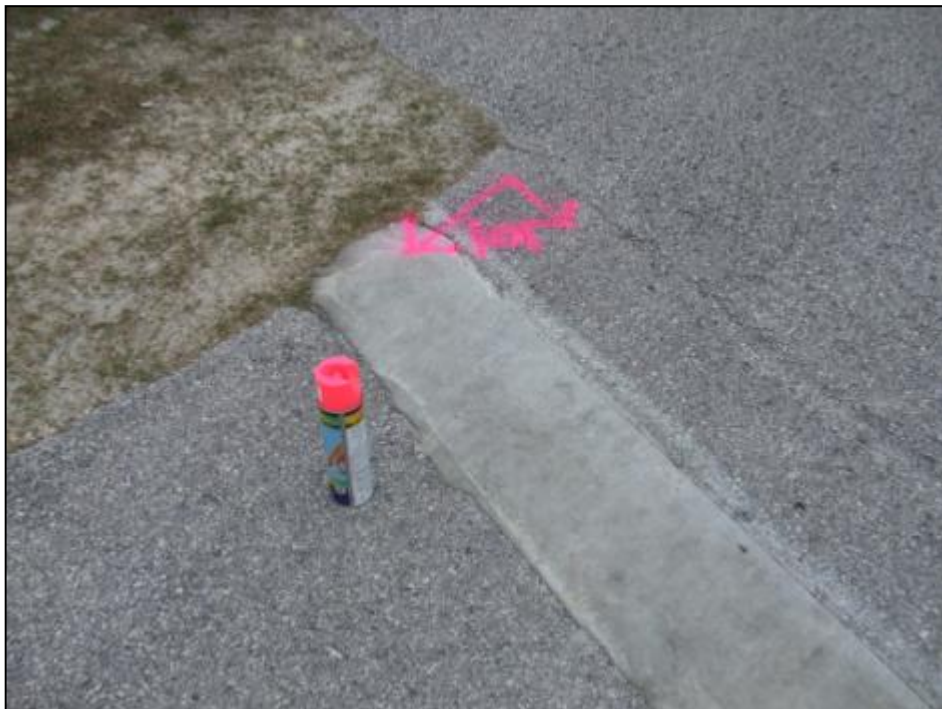
Apron General Aviation, Section 4010, Sample Unit 101 – Low severity (48) Longitudinal and Transverse Cracking, low severity (50) Patching, low severity (52) Weathering and Raveling.
