FLORIDA DEPARTMENT OF TRANSPORTATION
AVIATION AND SPACEPORTS OFFICE

**Statewide Airfield
Pavement Management Program**

DISTRICT

NOVEMBER 2019

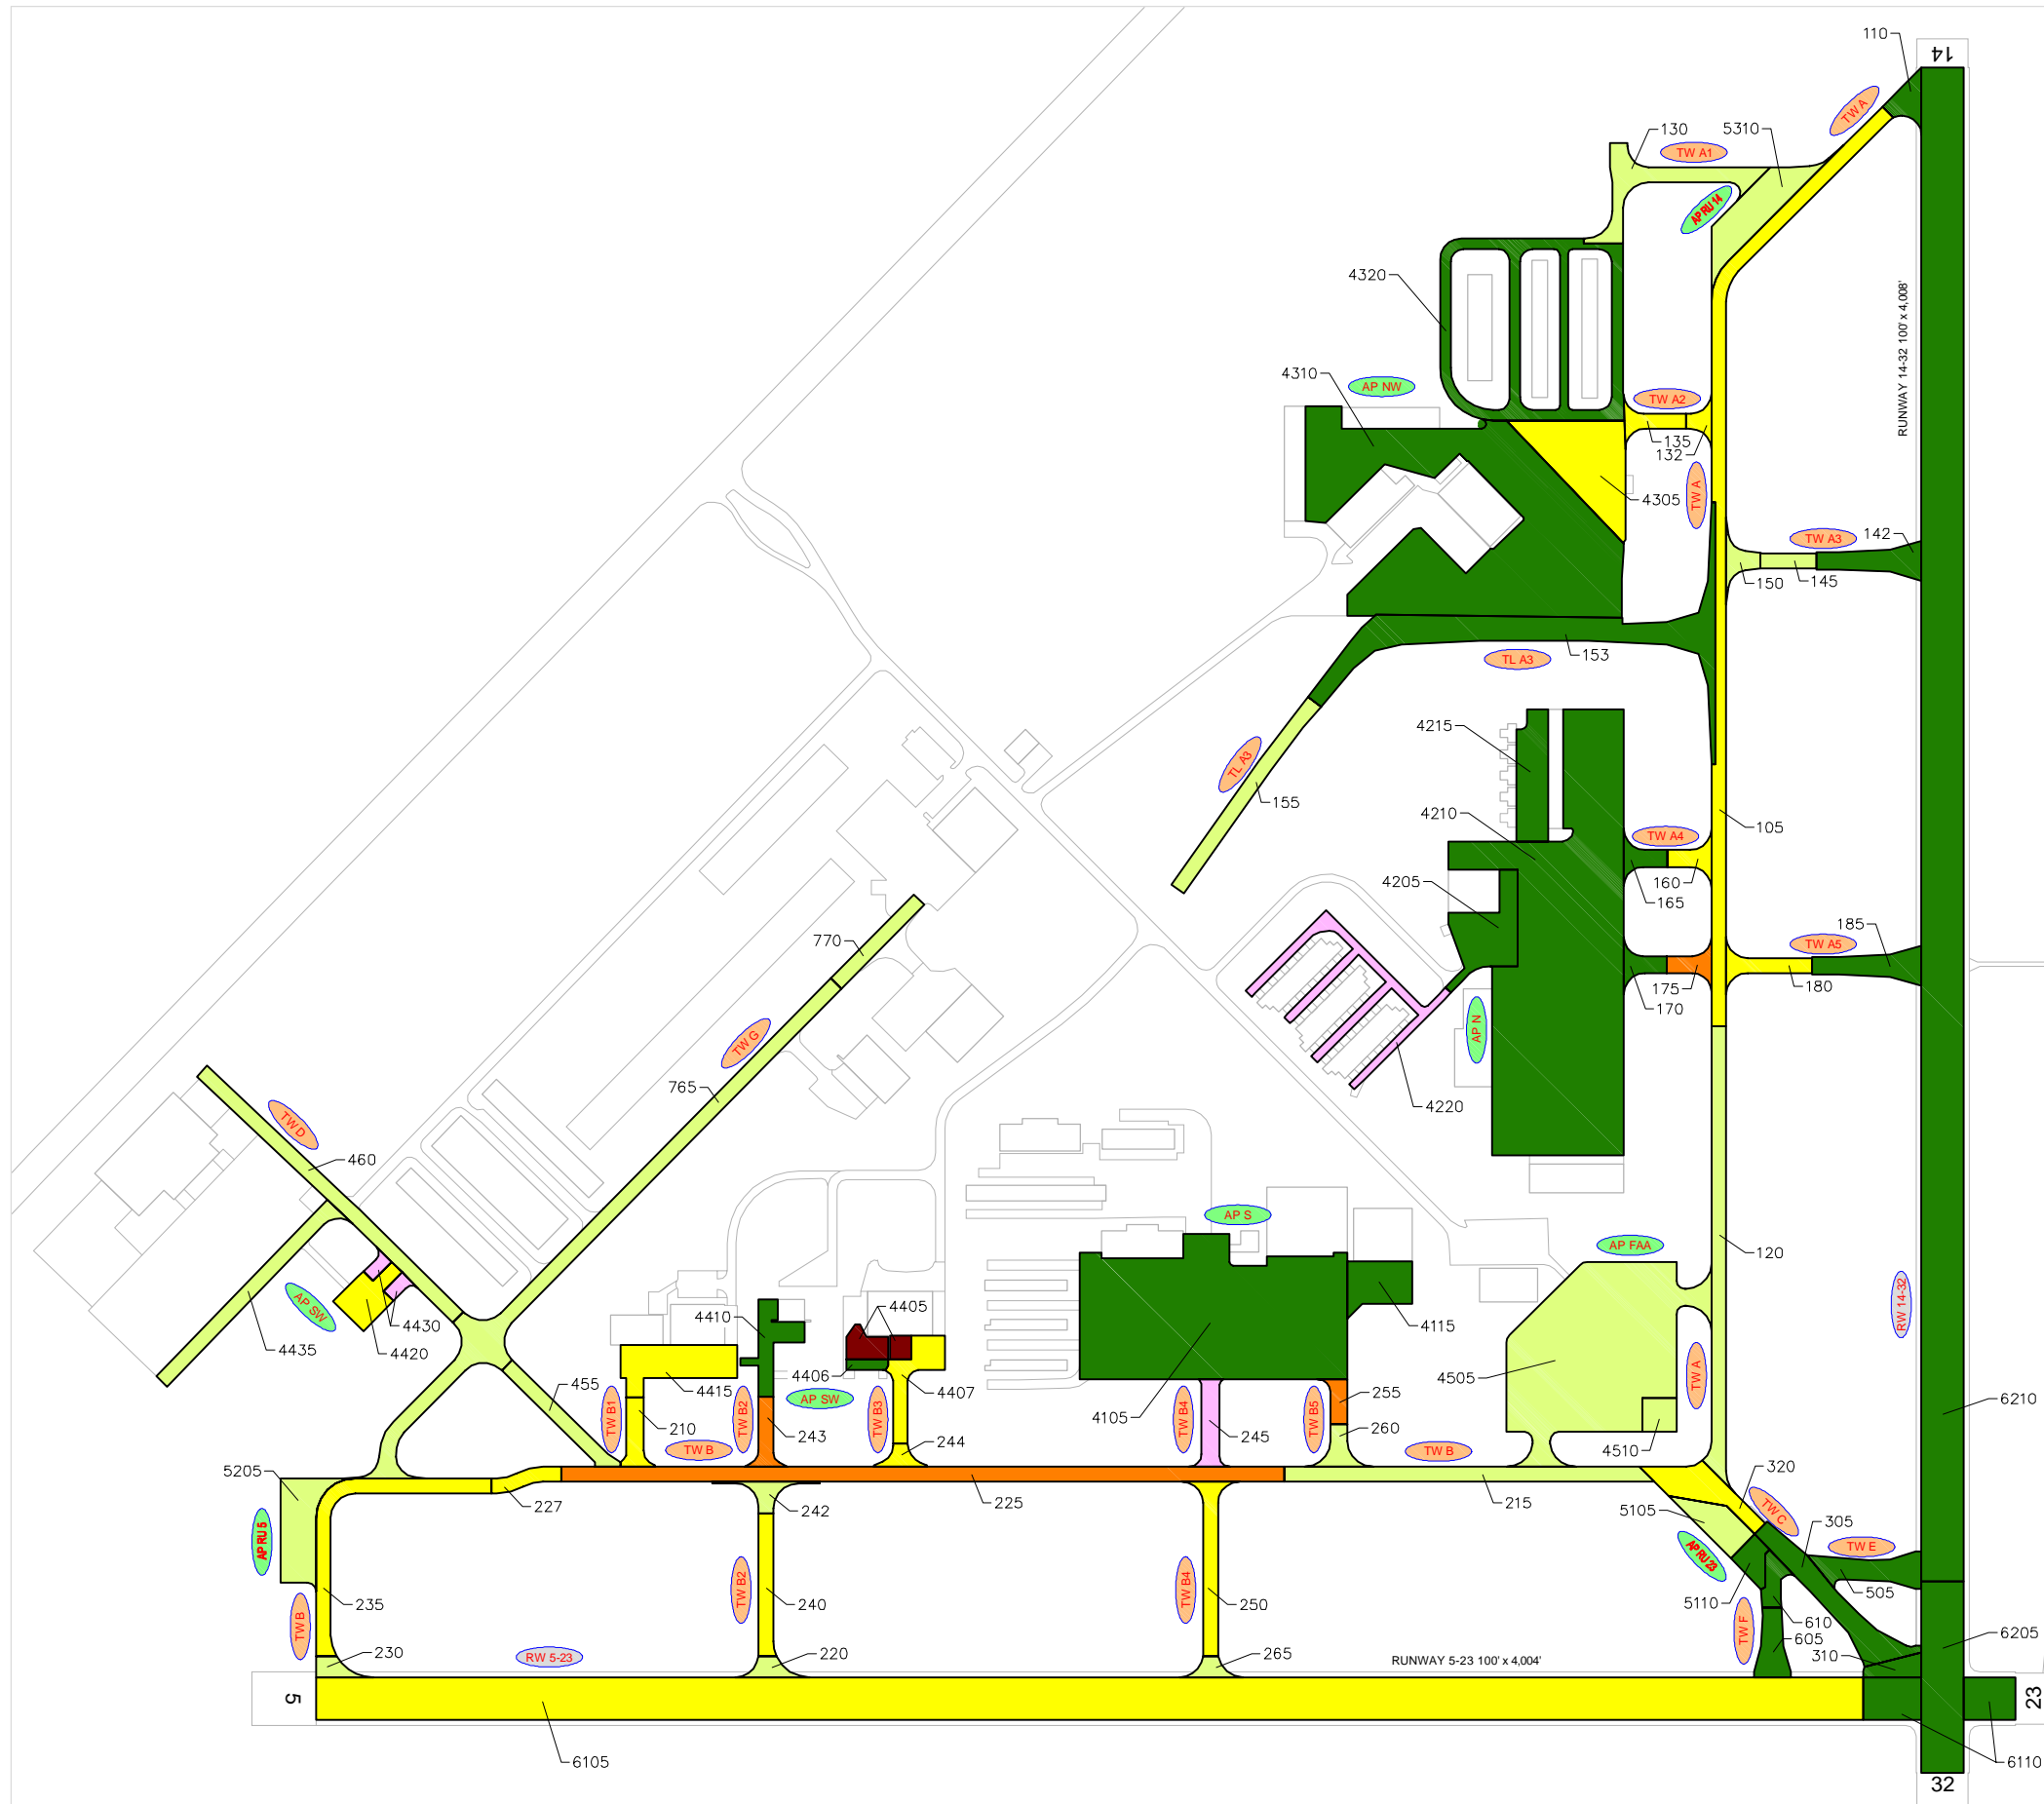
003 - AIRFIELD PAVEMENT
CONDITION INDEX EXHIBIT

| 105 PCI = 57 | 110 PCI = 100 | 120 PCI = 72 | 130 PCI = 84 | 132 PCI = 69 | 135 PCI = 57 | 142 PCI = 100 |
| 145 PCI = 72 | 150 PCI = 81 | 153 PCI = 100 | 155 PCI = 79 | 160 PCI = 66 | 165 PCI = 100 | 170 PCI = 100 |

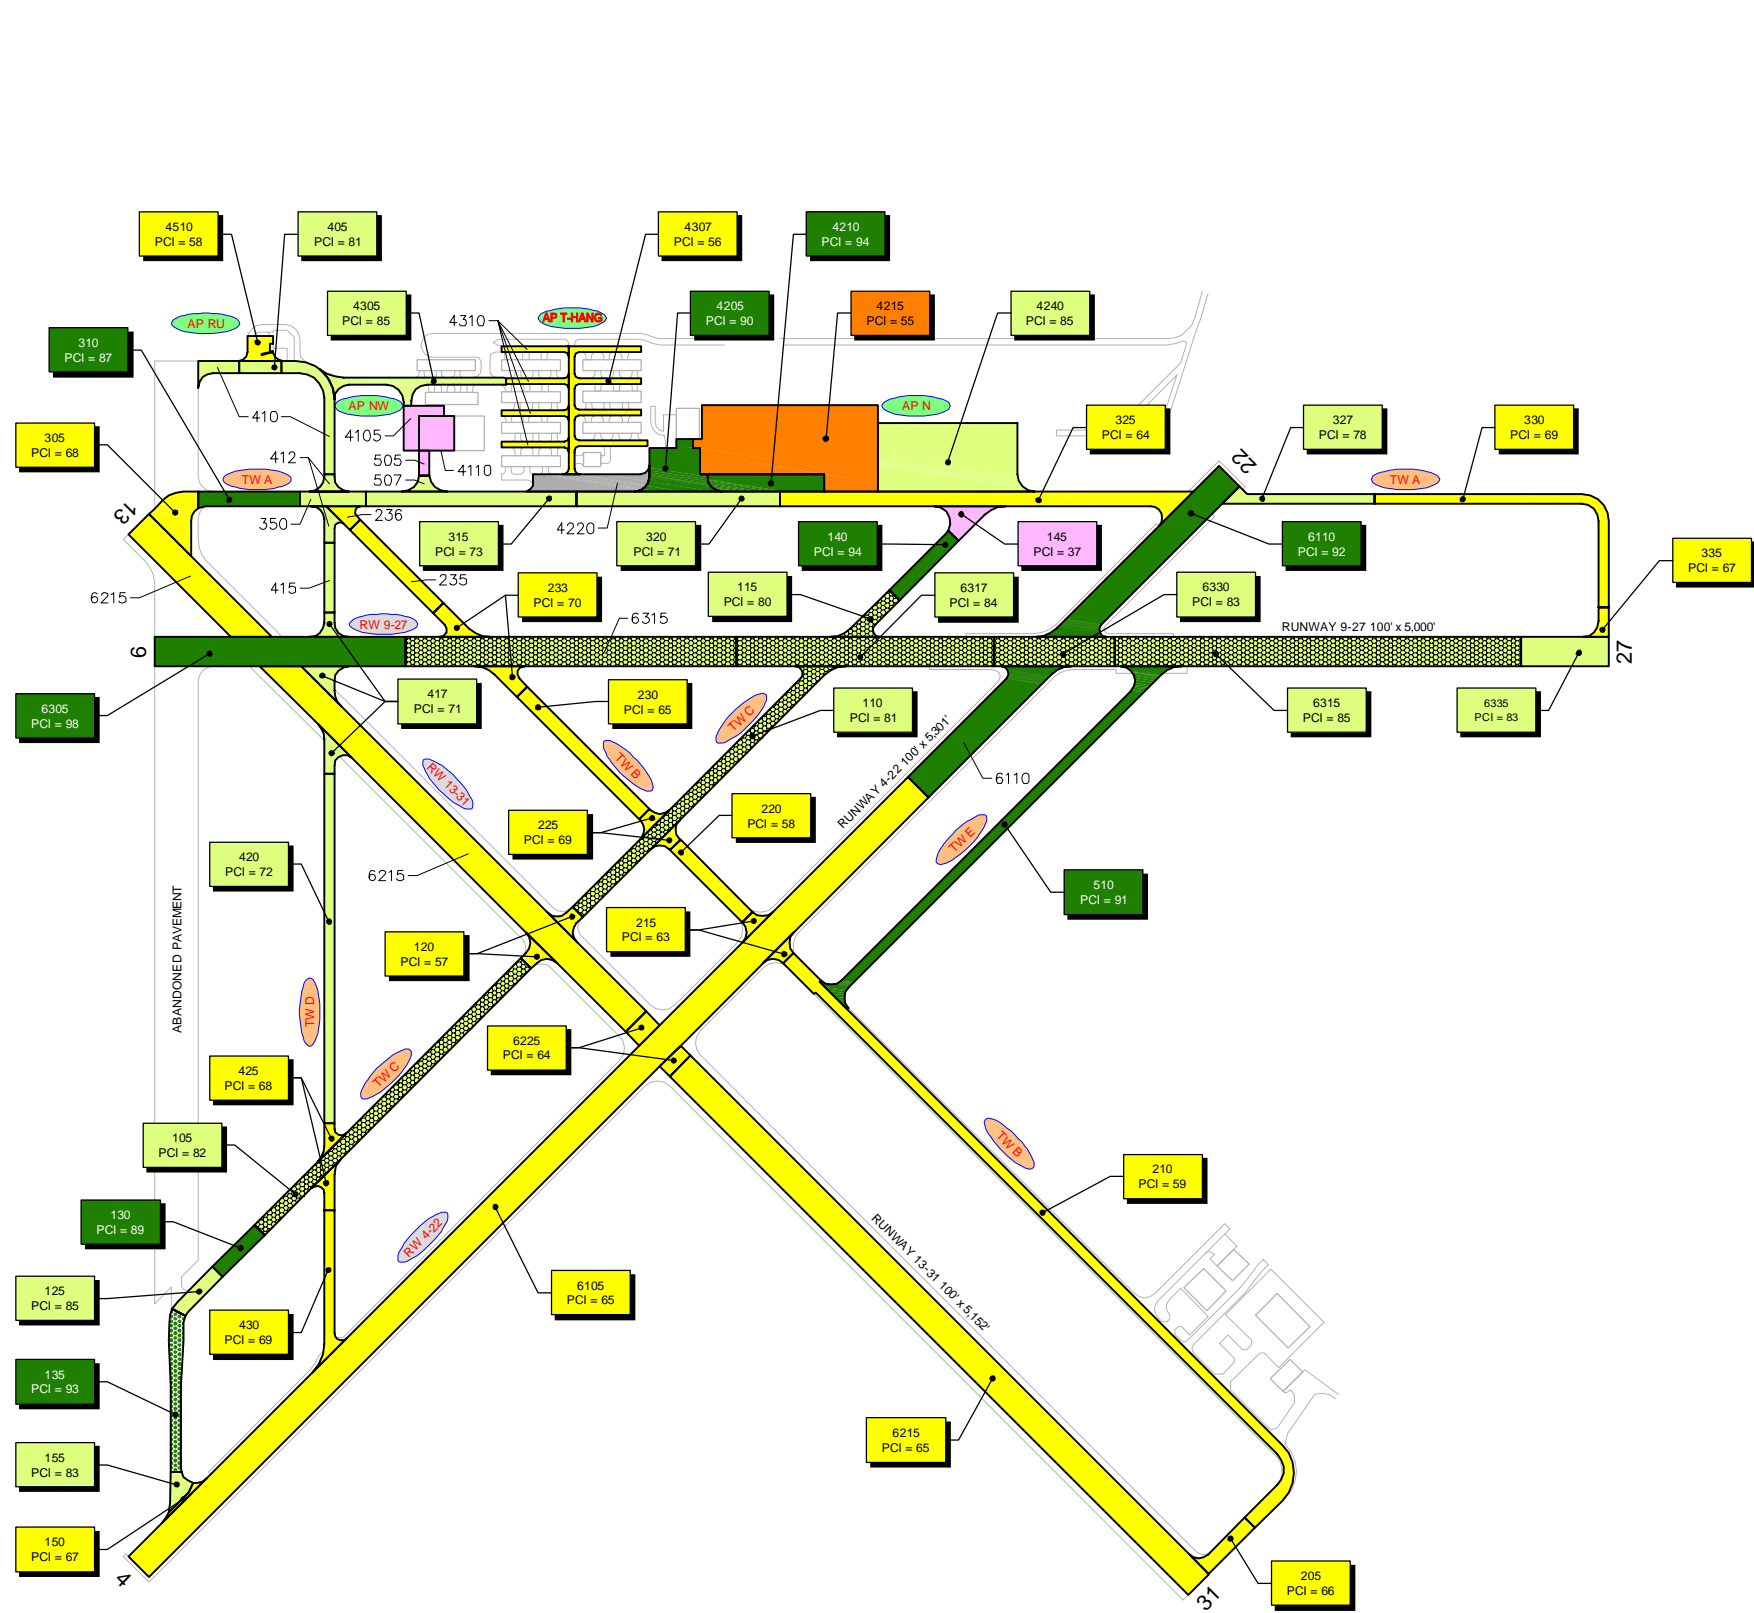
| 235 PCI = 63 | 236 PCI = 70 | 350 PCI = 71 | 410 PCI = 71 |
| 412 PCI = 71 | 415 PCI = 77 | 505 PCI = 33 | 507 PCI = 74 |

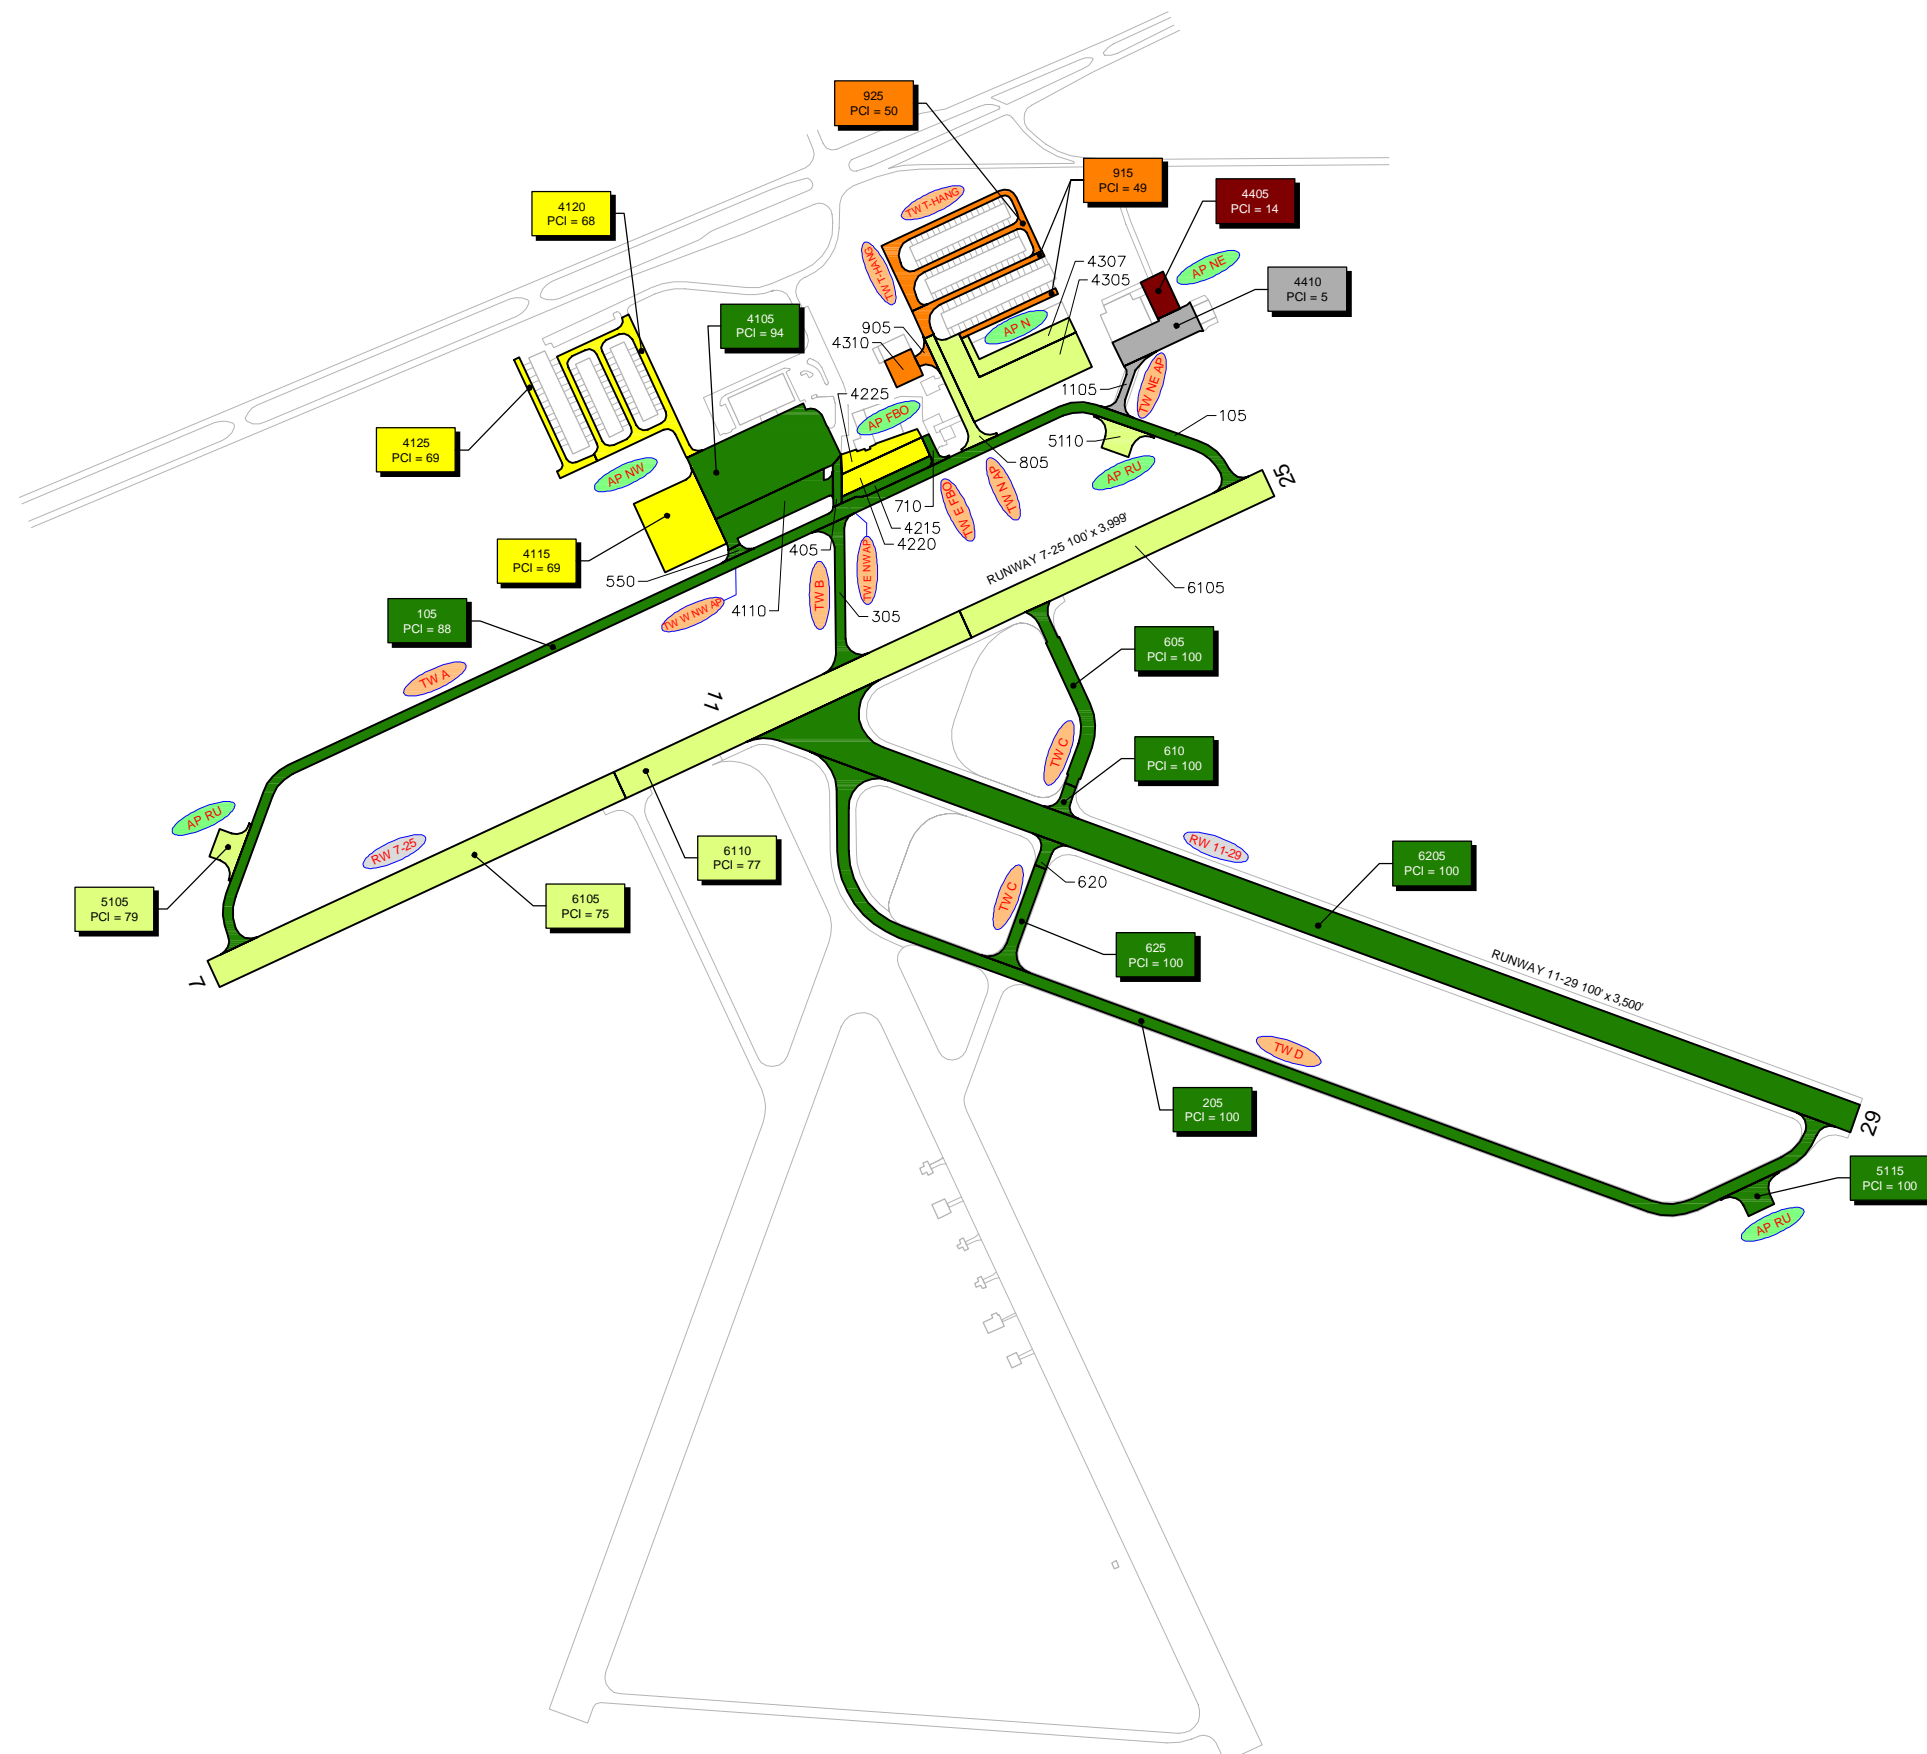
| 305 PCI = 92 | 405 PCI = 94 | 550 PCI = 90 | 620 PCI = 100 |
| 710 PCI = 94 | 805 PCI = 79 | 905 PCI = 46 | 1105 PCI = 9 |

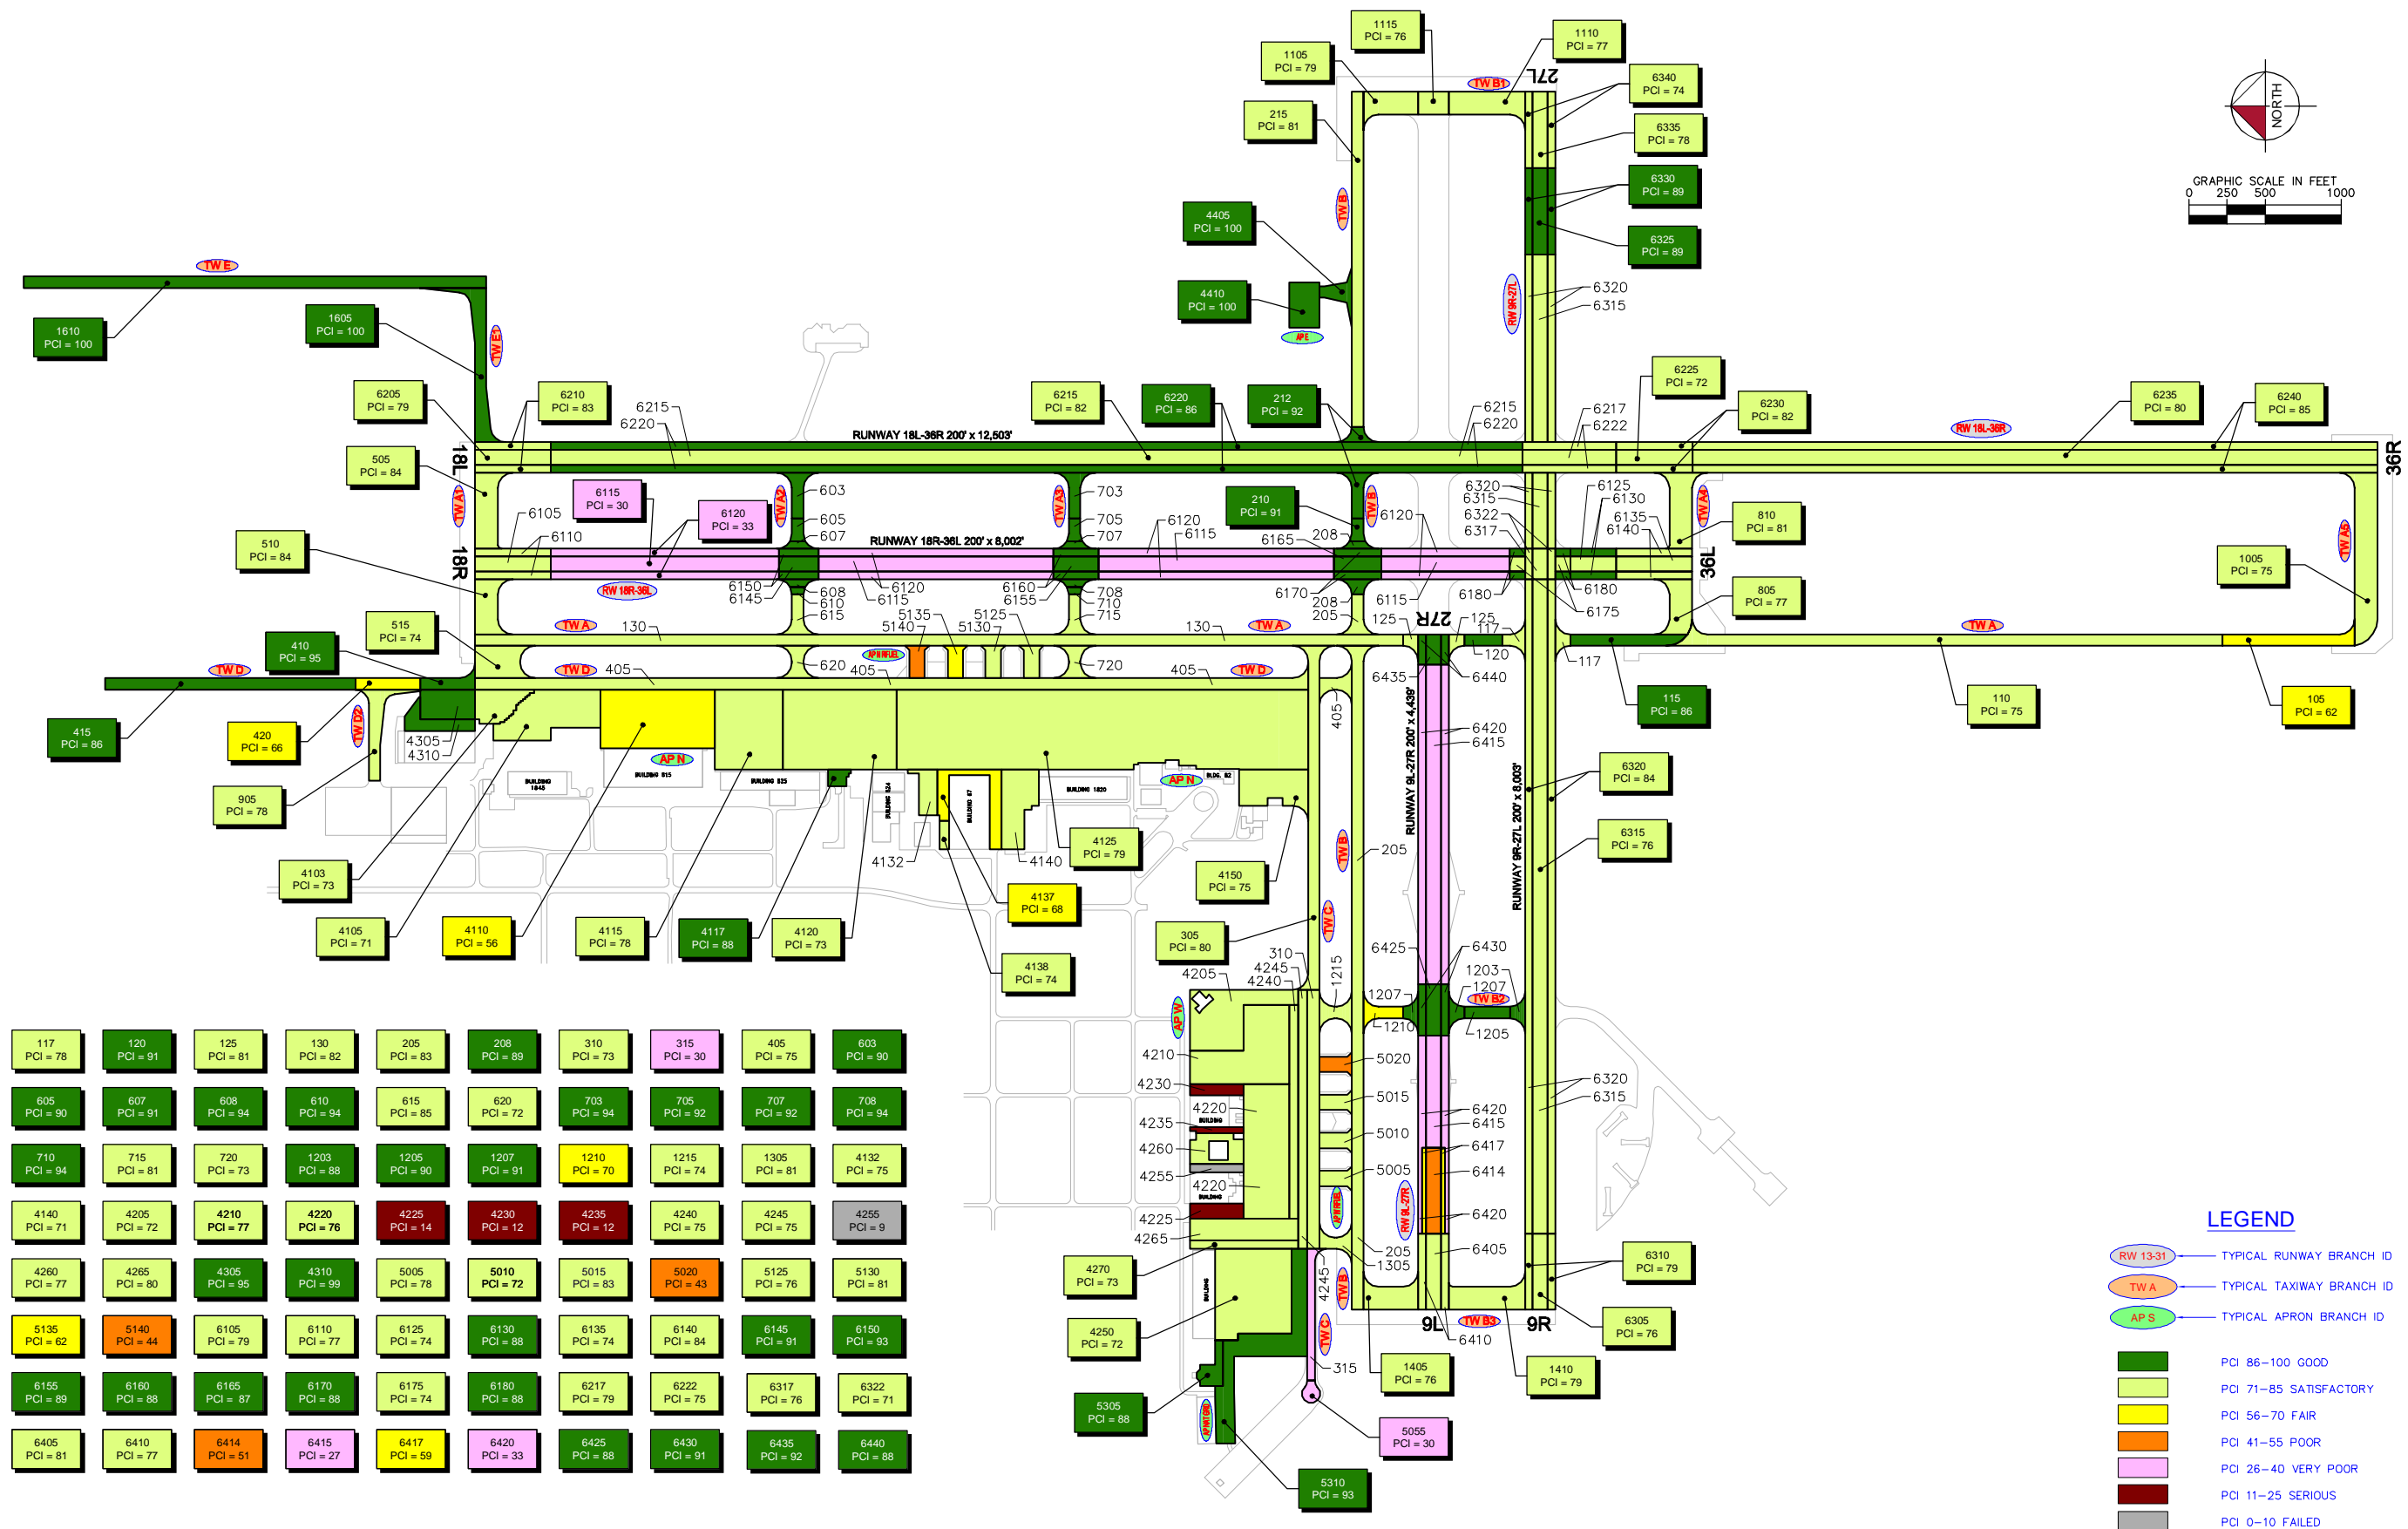
| 117 PCI = 78 | 120 PCI = 91 | 125 PCI = 81 | 130 PCI = 82 | 205 PCI = 83 | 208 PCI = 89 | 310 PCI = 73 | 315 PCI = 30 | 405 PCI = 75 | 603 PCI = 90 |
| 605 PCI = 90 | 607 PCI = 91 | 608 PCI = 94 | 610 PCI = 94 | 615 PCI = 85 | 620 PCI = 72 | 703 PCI = 94 | 705 PCI = 92 | 707 PCI = 92 | 708 PCI = 94 |
