**FLORIDA DEPARTMENT OF TRANSPORTATION
AVIATION AND SPACEPORTS OFFICE**

**Statewide Airfield
Pavement Management Program**

DISTRICT

NOVEMBER 2019

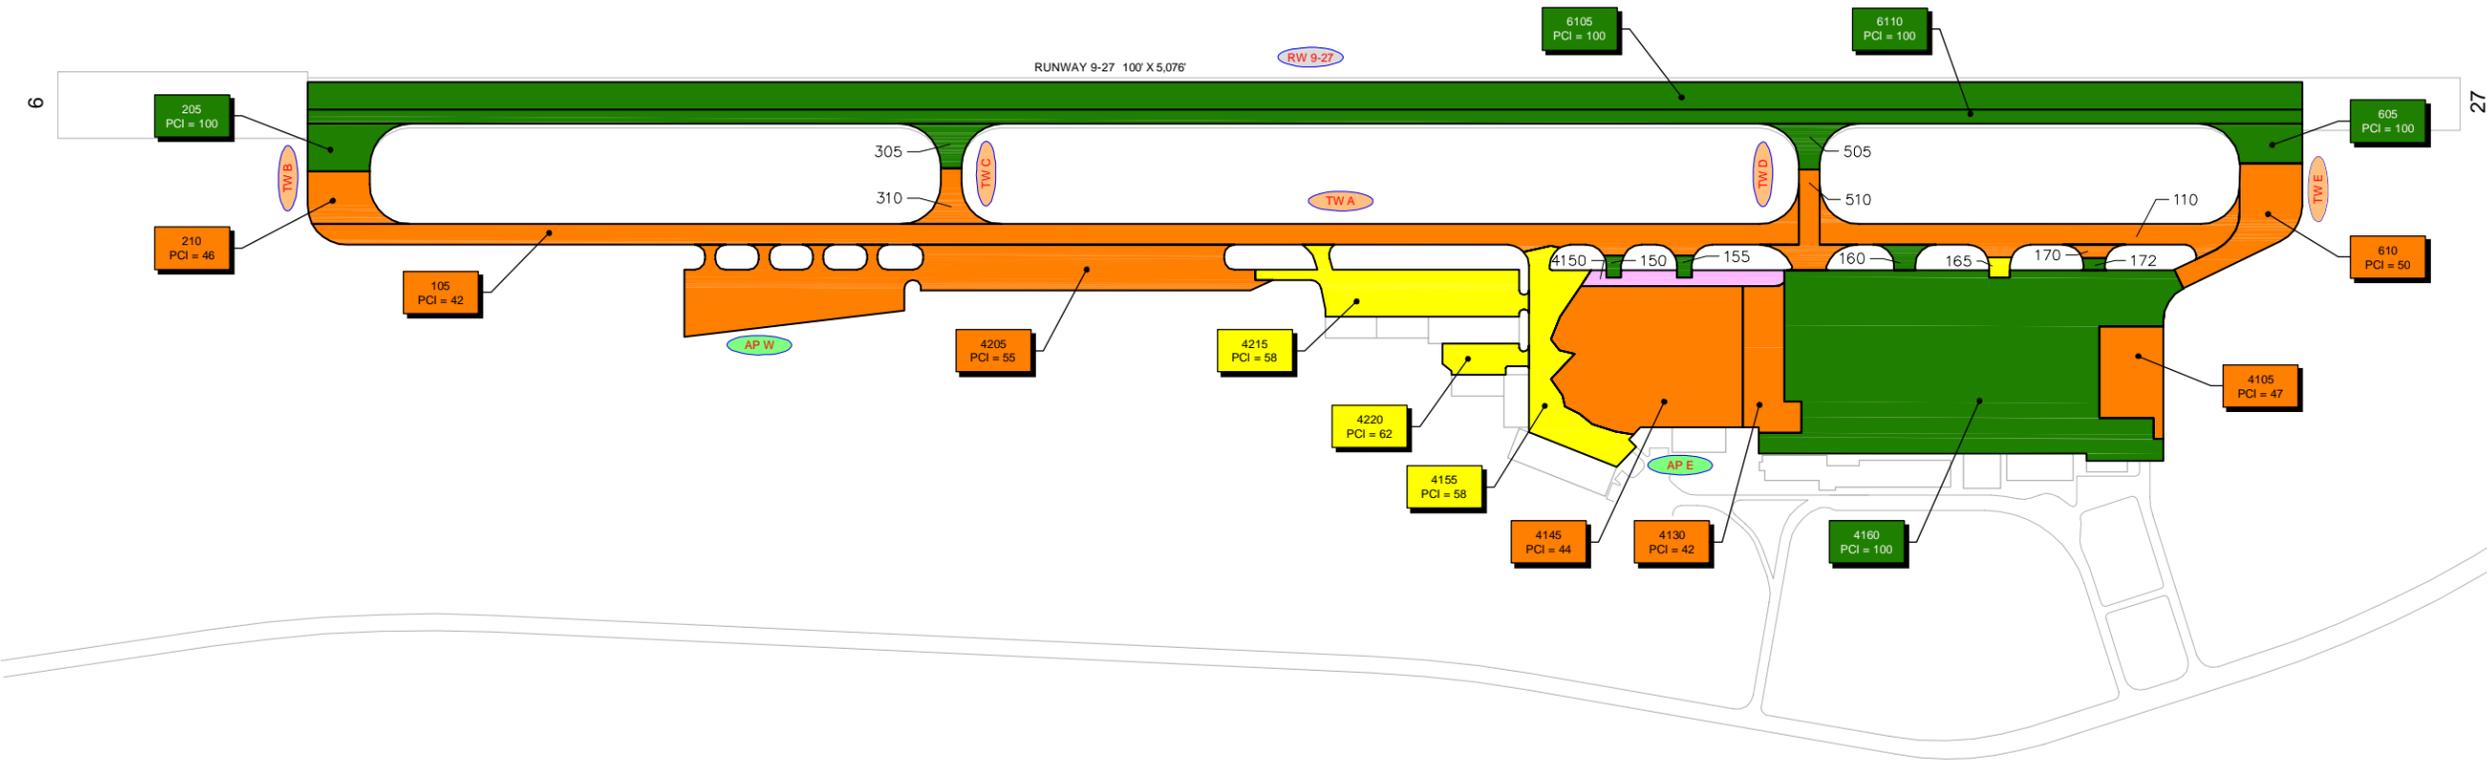
| 110 PCI = 42 | 150 PCI = 88 | 155 PCI = 88 | 160 PCI = 100 |
| 165 PCI = 61 | 170 PCI = 43 | 172 PCI = 100 | 305 PCI = 100 |

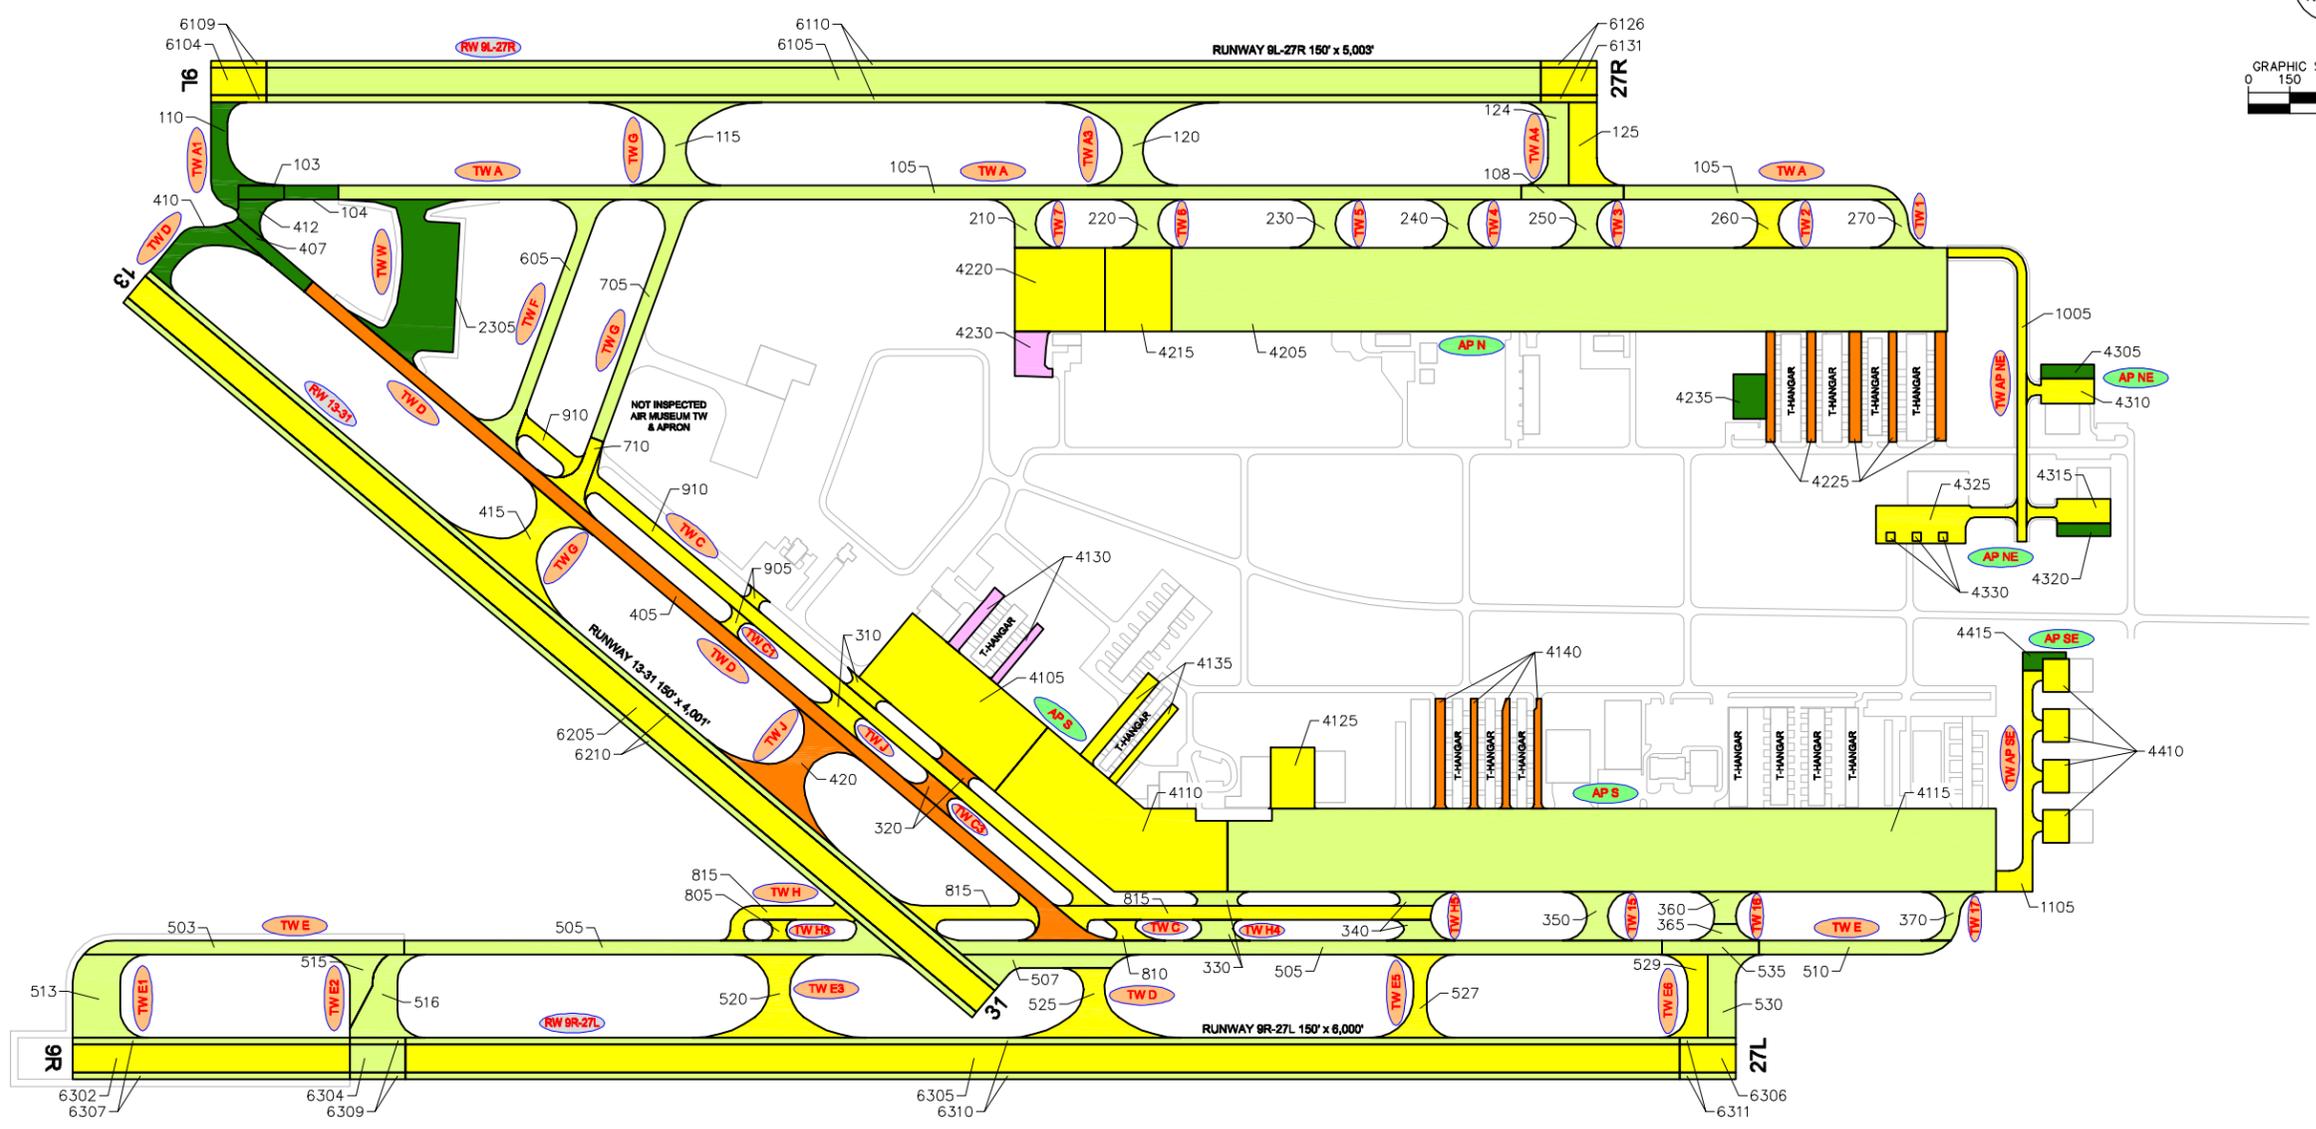
| 103 PCI = 100 | 104 PCI = 100 | 105 PCI = 79 | 108 PCI = 71 | 110 PCI = 100 | 115 PCI = 82 | 120 PCI = 83 | 124 PCI = 72 | 125 PCI = 68 | 210 PCI = 74 | 220 PCI = 77 | 230 PCI = 79 | 240 PCI = 74 |
| 250 PCI = 71 | 260 PCI = 67 | 270 PCI = 79 | 310 PCI = 62 | 320 PCI = 54 | 330 PCI = 74 | 340 PCI = 81 | 350 PCI = 78 | 360 PCI = 84 | 365 PCI = 78 | 370 PCI = 81 | 405 PCI = 51 | 407 PCI = 100 |

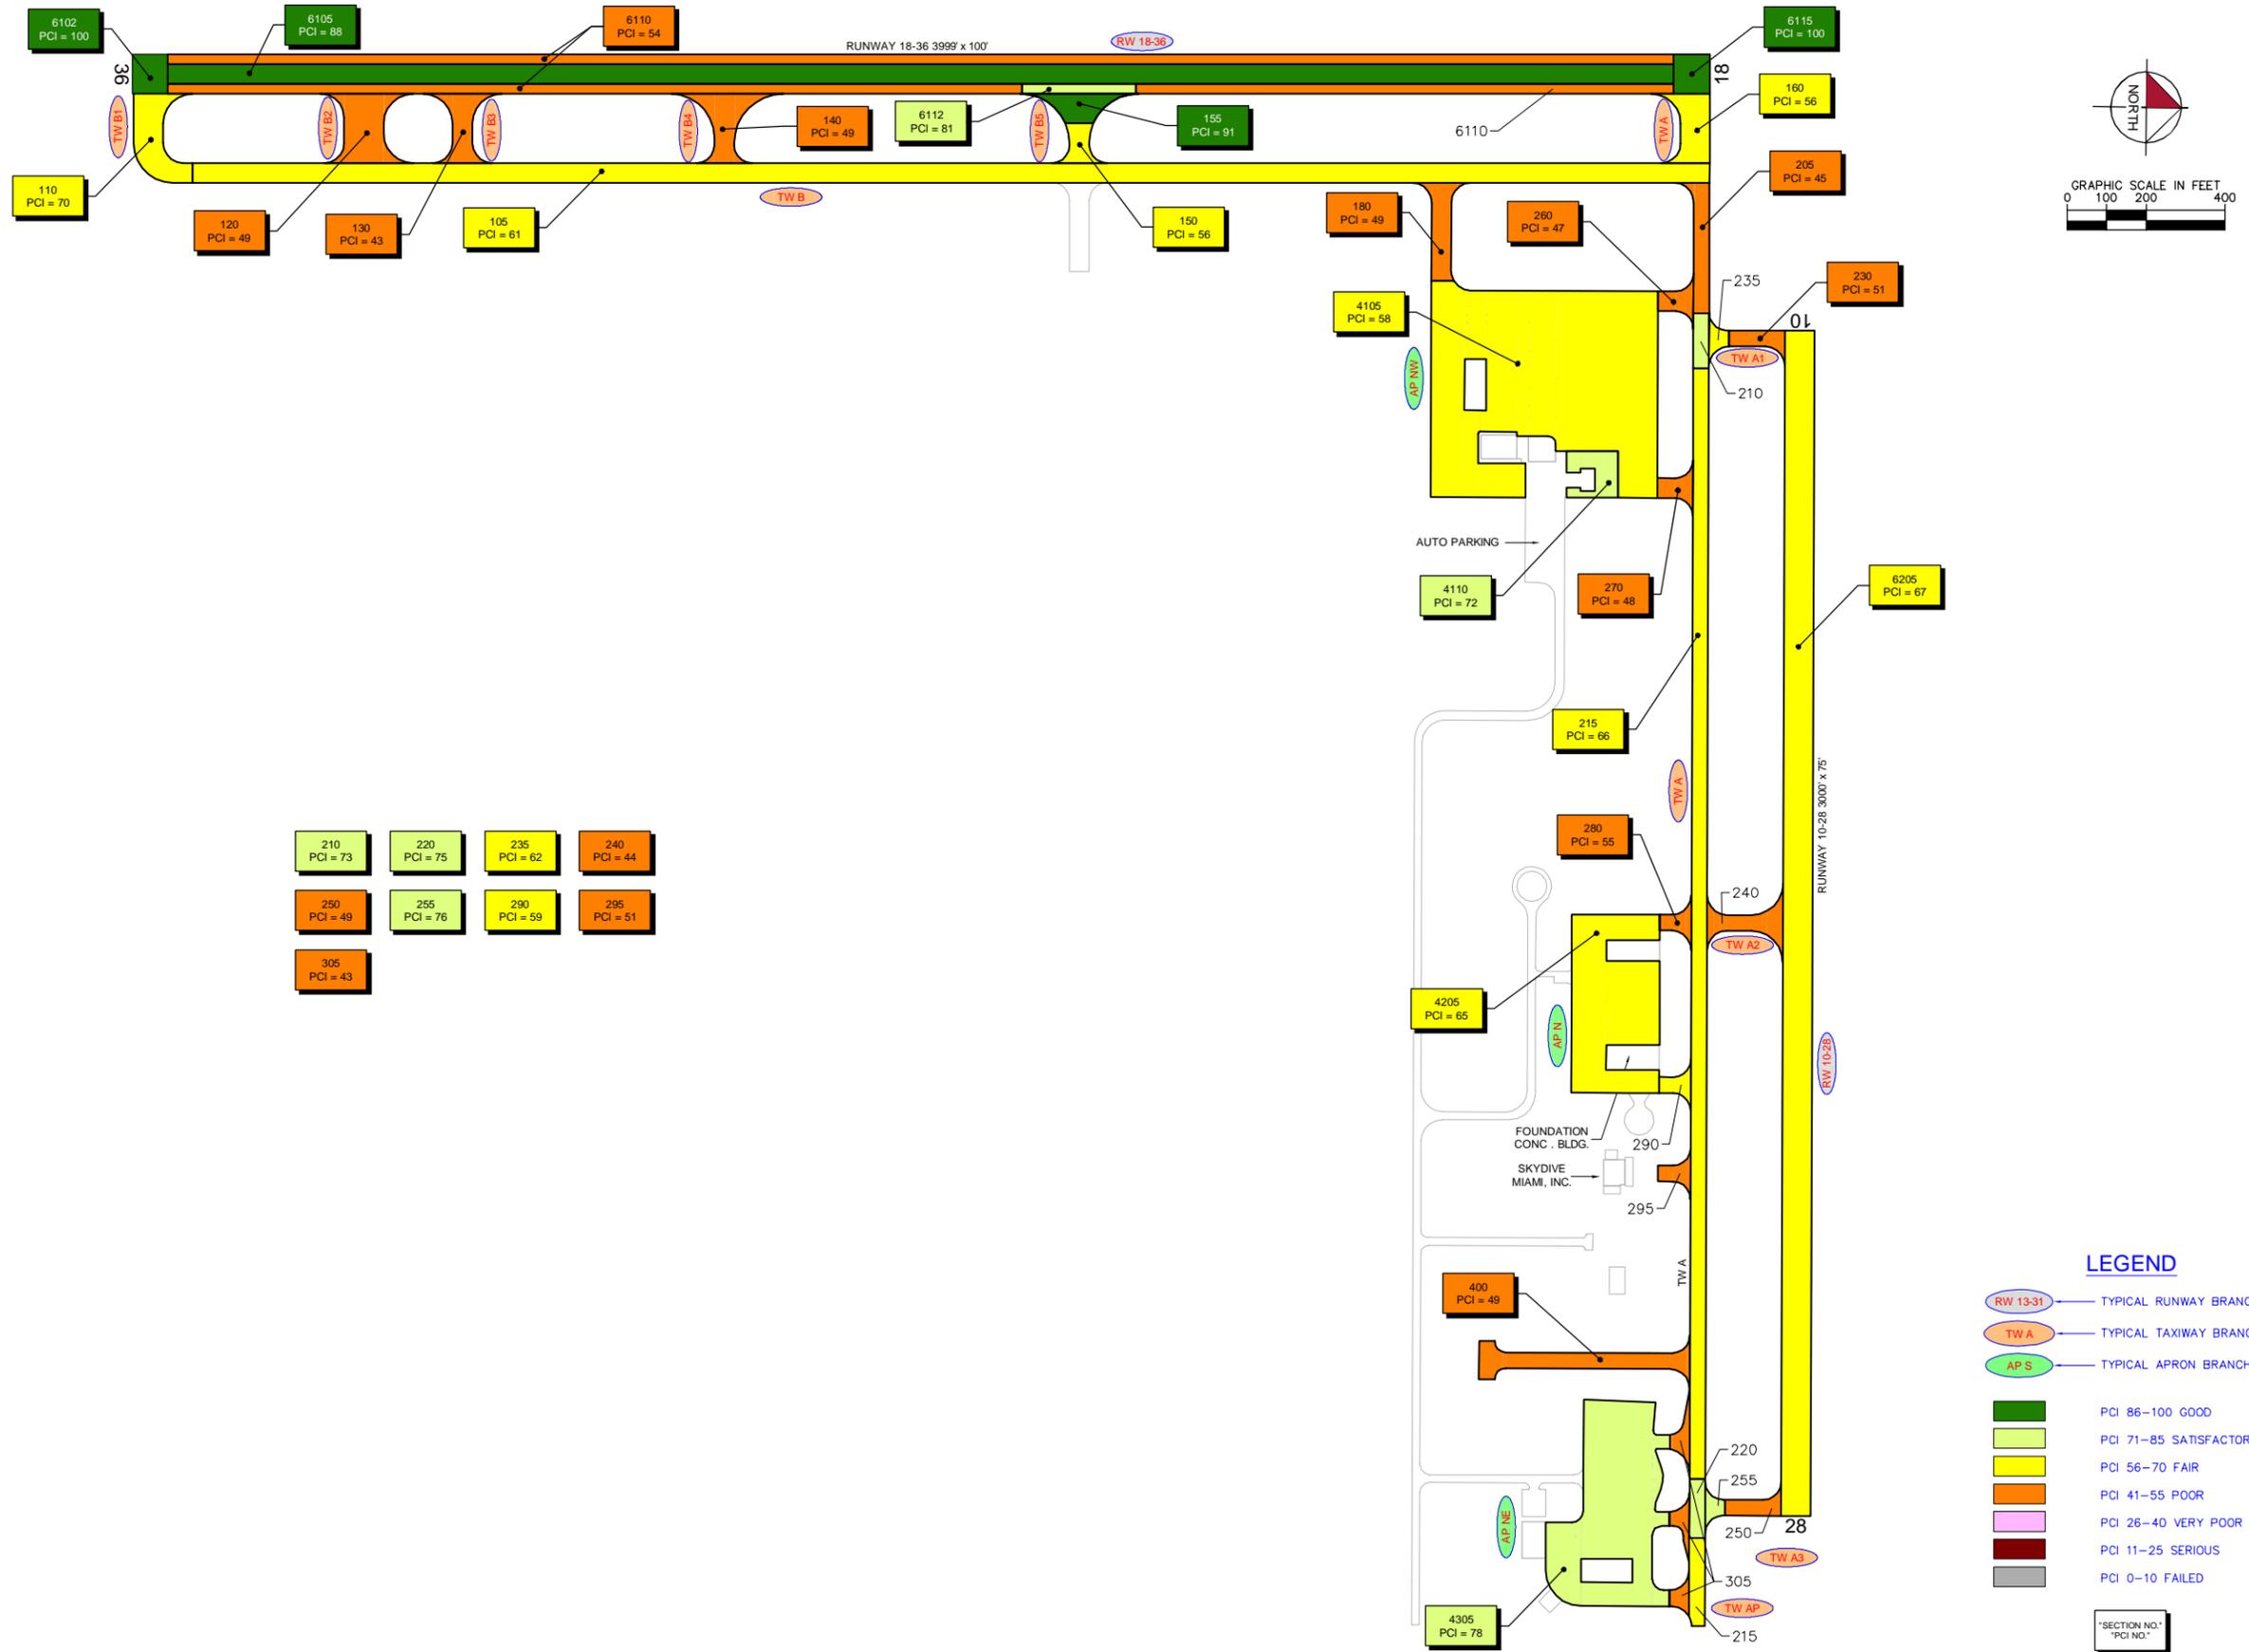
003 - AIRFIELD PAVEMENT
CONDITION INDEX EXHIBIT

| 210 PCI = 73 | 220 PCI = 75 | 235 PCI = 62 | 240 PCI = 44 |
| 250 PCI = 49 | 255 PCI = 76 | 290 PCI = 59 | 295 PCI = 51 |
