STATE OF FLORIDA DEPARTMENT OF TRANSPORTATION AVIATION OFFICE

Statewide Airfield Pavement Management Program

Tri-County Airport – 1J0 (General Aviation) Bonifay, Florida (District 3)

May 2011

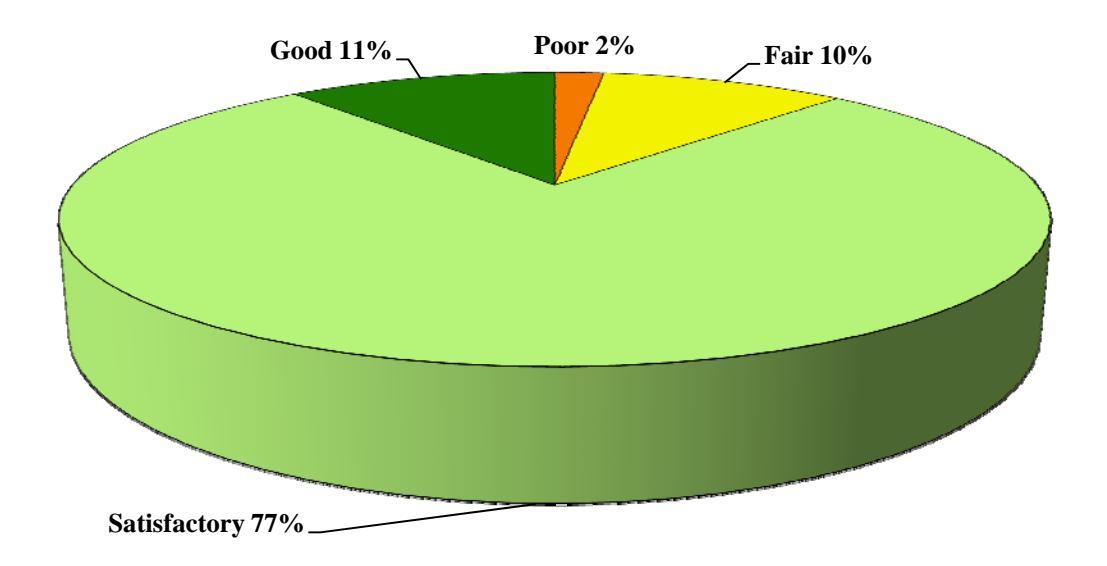
Figure 3-1: Network PCI Distribution by Rating Category

Approximately 88% of the network is in Satisfactory to Good condition, with 12% in Fair to Poor condition. Table 3-3 illustrates the area-weighted PCI computed individually for each pavement use.

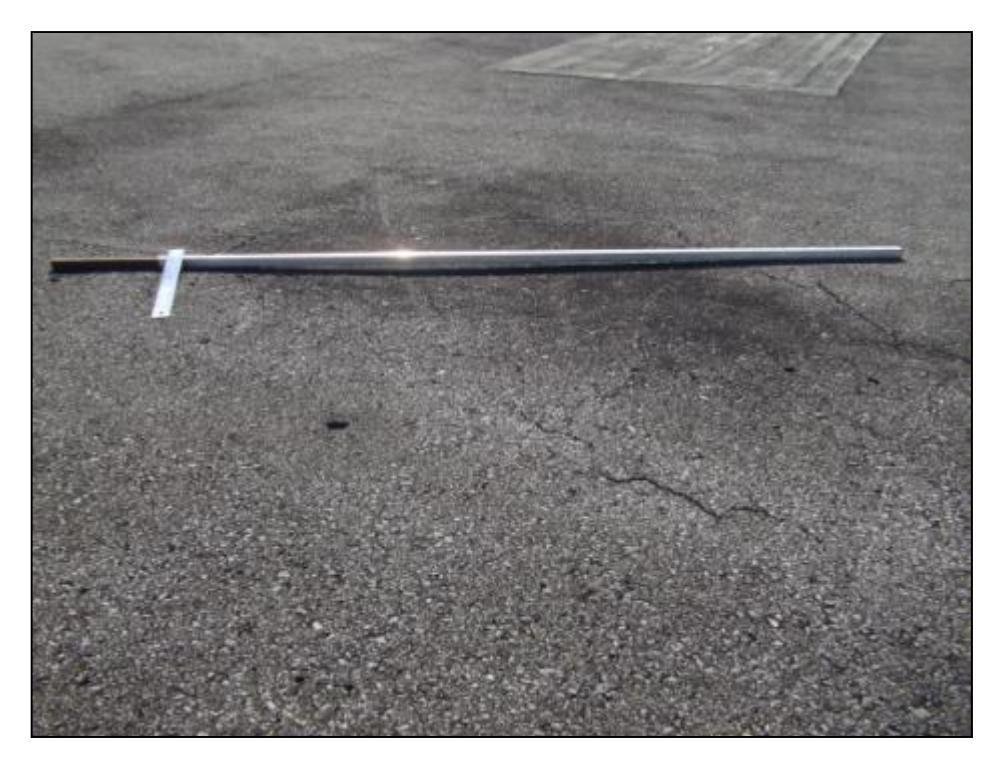
Runway 1-19, Section 6105, Sample Unit 179 - Low severity (45) Depression, low and medium (48) Longitudinal and Transverse Cracking, low severity (52) Weathering and Raveling, low severity (56) Swelling.

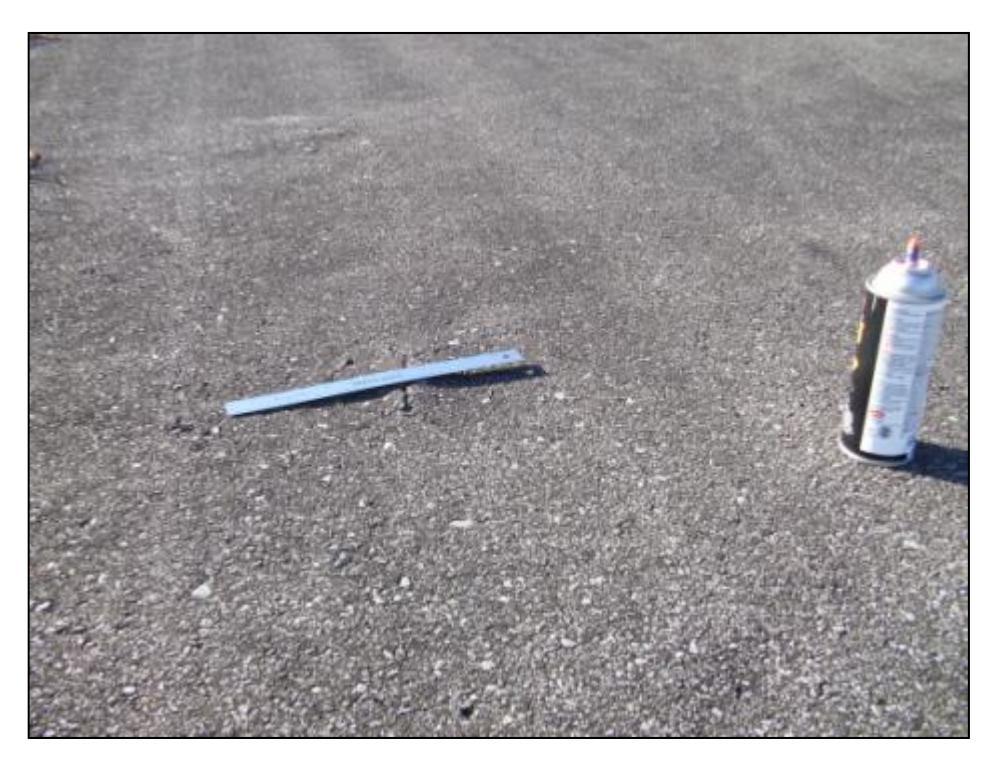
Runway 1-19, Section 6105, Sample Unit 113 - Low Severity (48) Longitudinal and Transverse Cracking, low severity (52) Weathering and Raveling, low severity (56) Swelling.

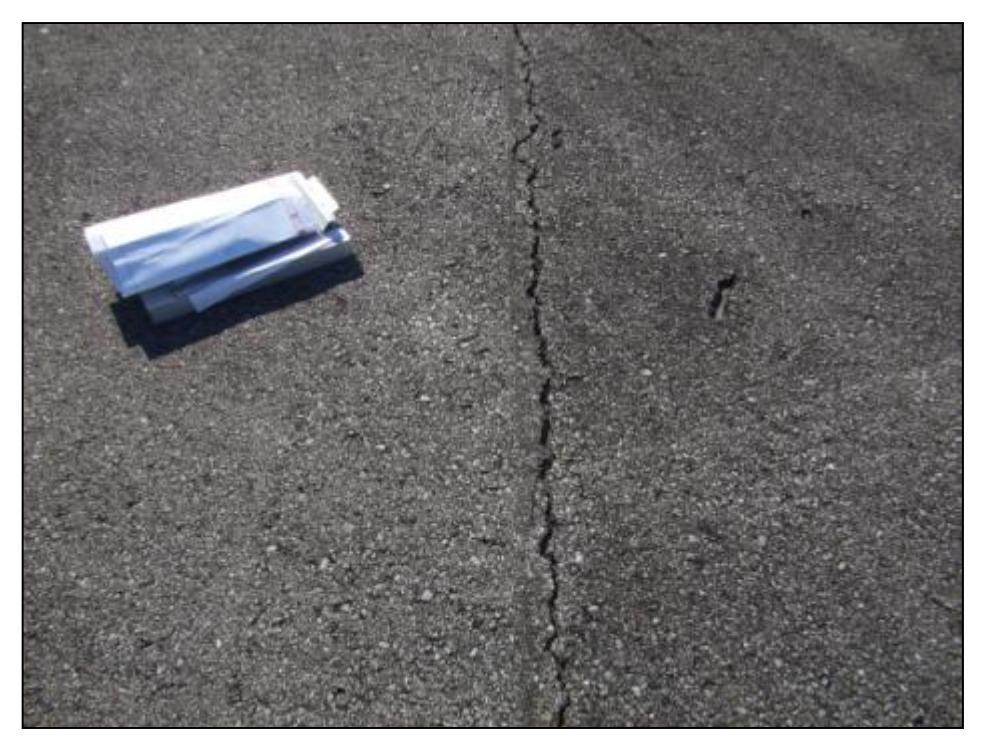
Runway 1-19, Section 6105, Sample Unit 179 - Low severity (45) Depression, low and medium (48) Longitudinal and Transverse Cracking, low severity (52) Weathering and Raveling, low severity (56) Swelling.

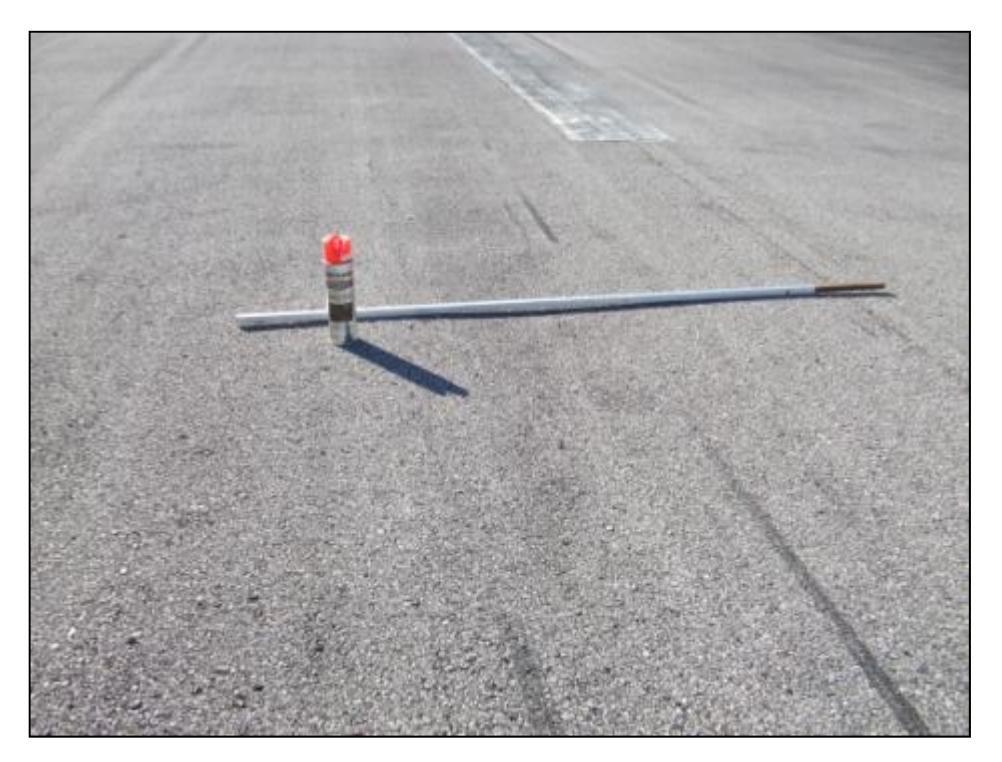
Runway 1-19, Section 6105, Sample Unit 161 - Low Severity (48) Longitudinal and Transverse Cracking, low severity (52) Weathering and Raveling, low severity (53) Rutting.

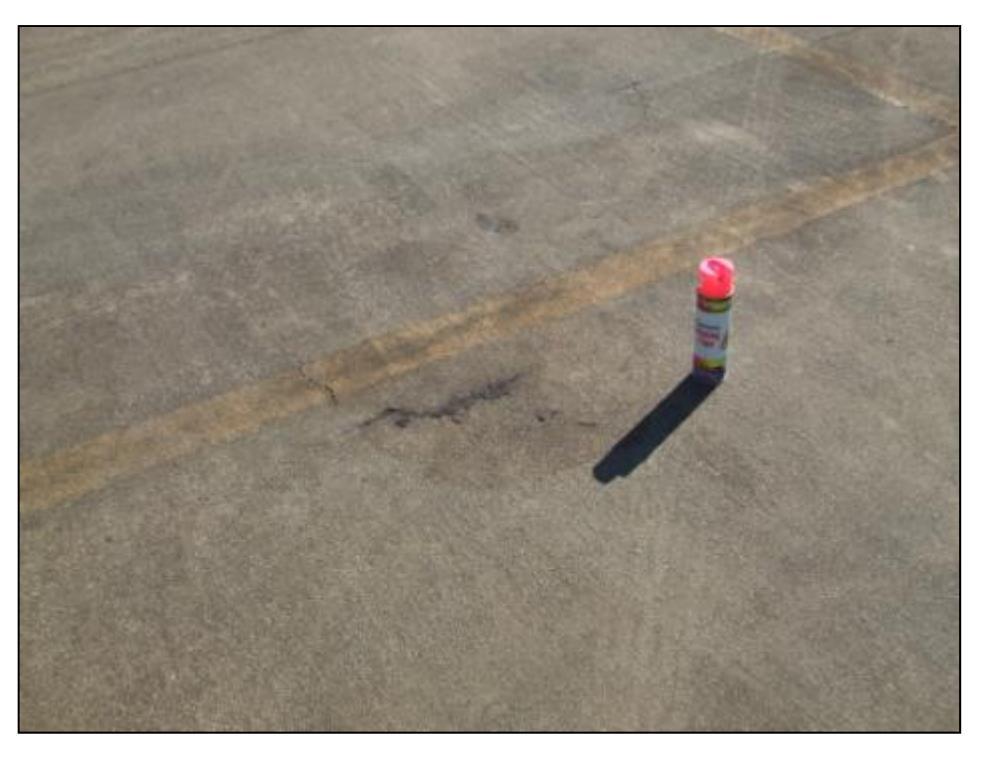
Apron Section 4105, Sample Unit 100 - Low severity (42) Bleeding, low and medium severity (45) Depression, low severity (48) Longitudinal and Transverse Cracking, low severity (49) Oil Spillage, low severity (52) Weathering and Raveling, low severity (56) Swelling.

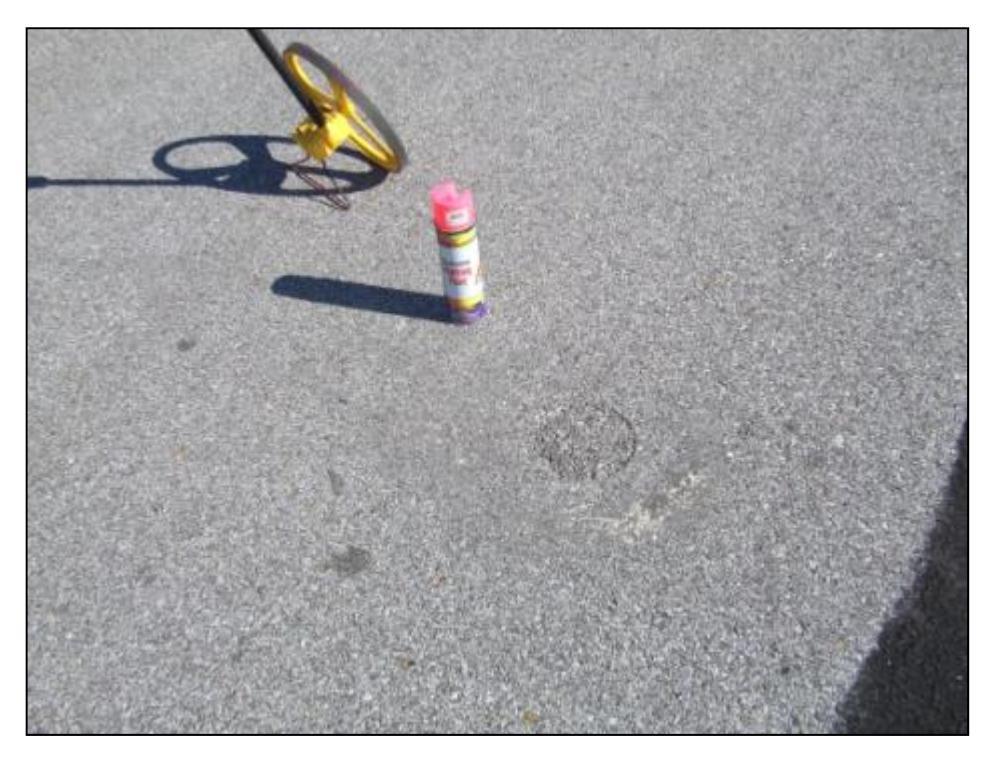
Apron, Section 4115, Sample Unit 405 - Low severity (45) Depression, low severity (50) Patching, low severity (52) Weathering and Raveling.
