**STATE OF FLORIDA
DEPARTMENT OF TRANSPORTATION
AVIATION OFFICE**

**Statewide Airfield Pavement
Management Program**

**George T. Lewis Airport – CDK
(General Aviation)
Cedar Key, Florida
(District 2)**

May 2011

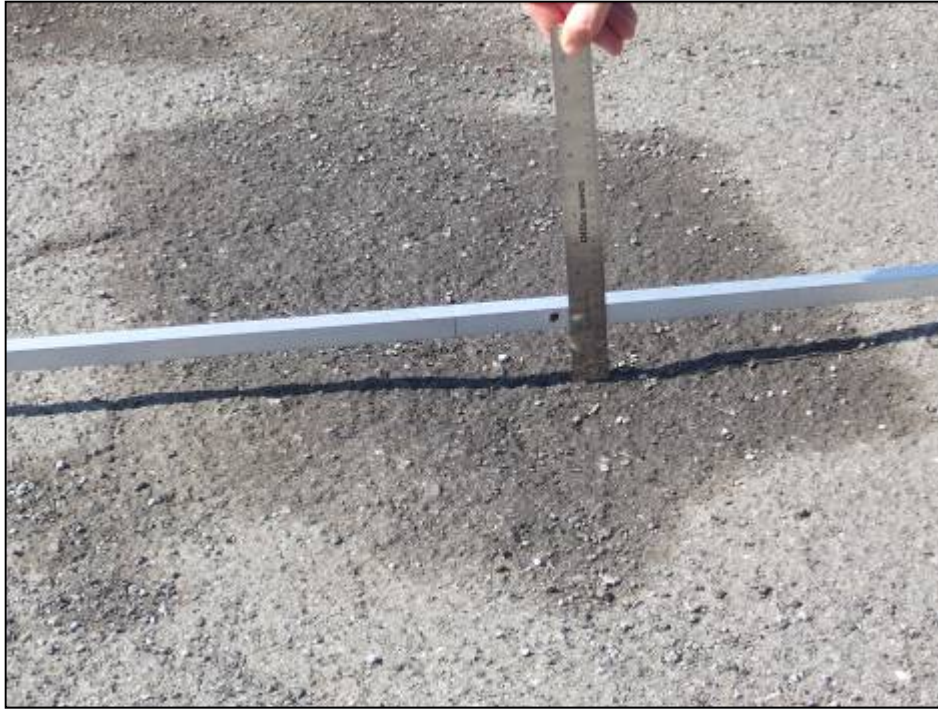
Apron, Section 4105, Sample Unit 100 – Low severity (43) Block Cracking, low and medium severity (45) Depression, medium severity (50) Patching, medium and high severity (52) Weathering and Raveling, low severity (56) Swelling.

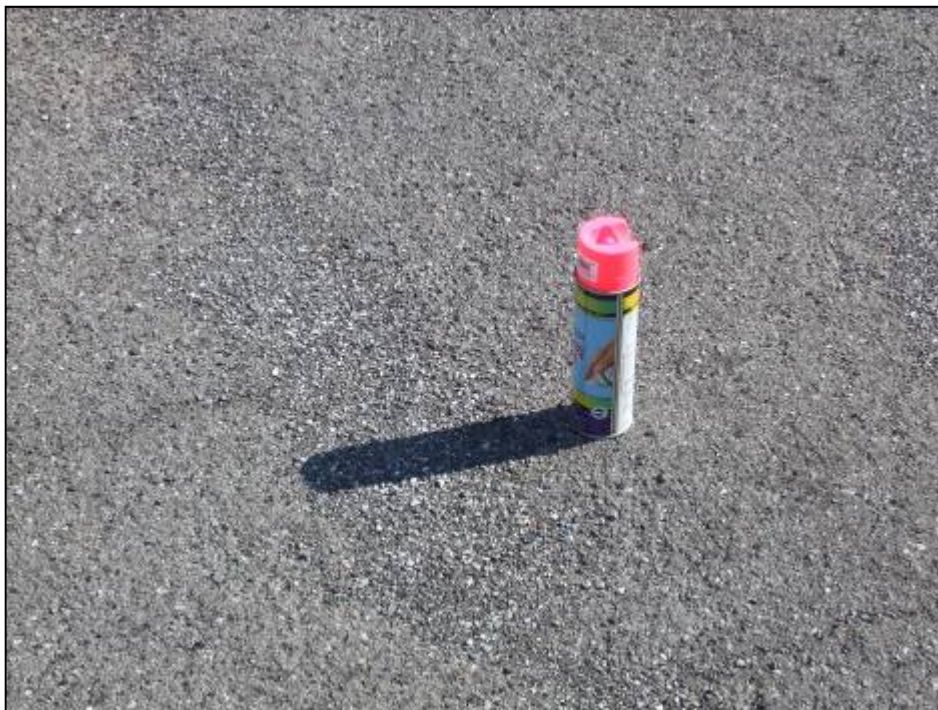
Apron, Section 4105, Sample Unit 100 – Low severity (43) Block Cracking, low and medium severity (45) Depression, medium severity (50) Patching, medium and high severity (52) Weathering and Raveling, low severity (56) Swelling.

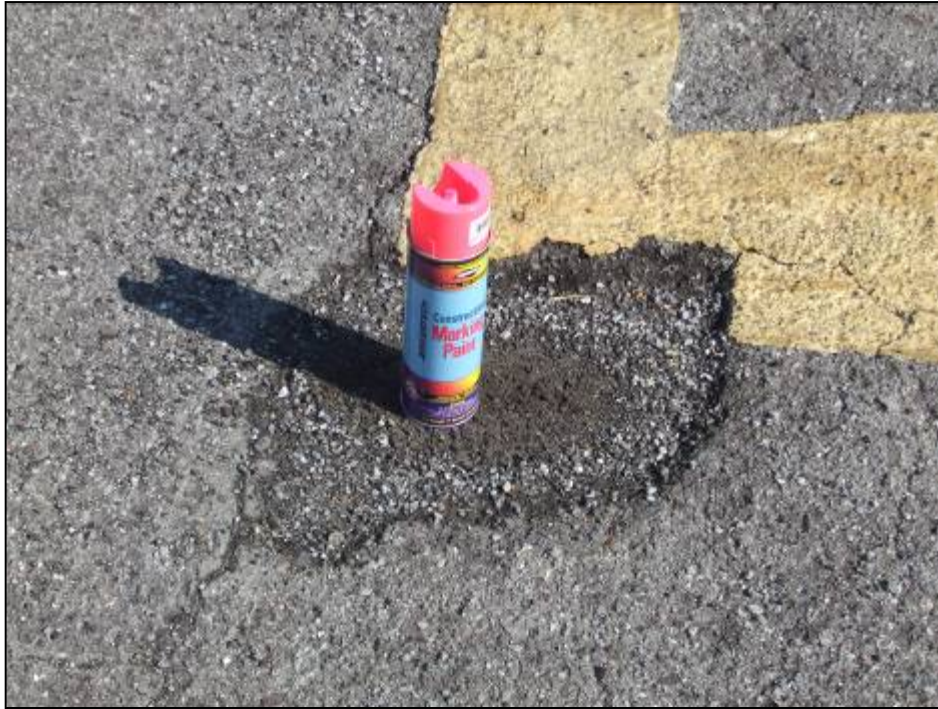
Apron, Section 4105, Sample Unit 100 – Low severity (43) Block Cracking, low and medium severity (45) Depression, medium severity (50) Patching, medium and high severity (52) Weathering and Raveling, low severity (56) Swelling.

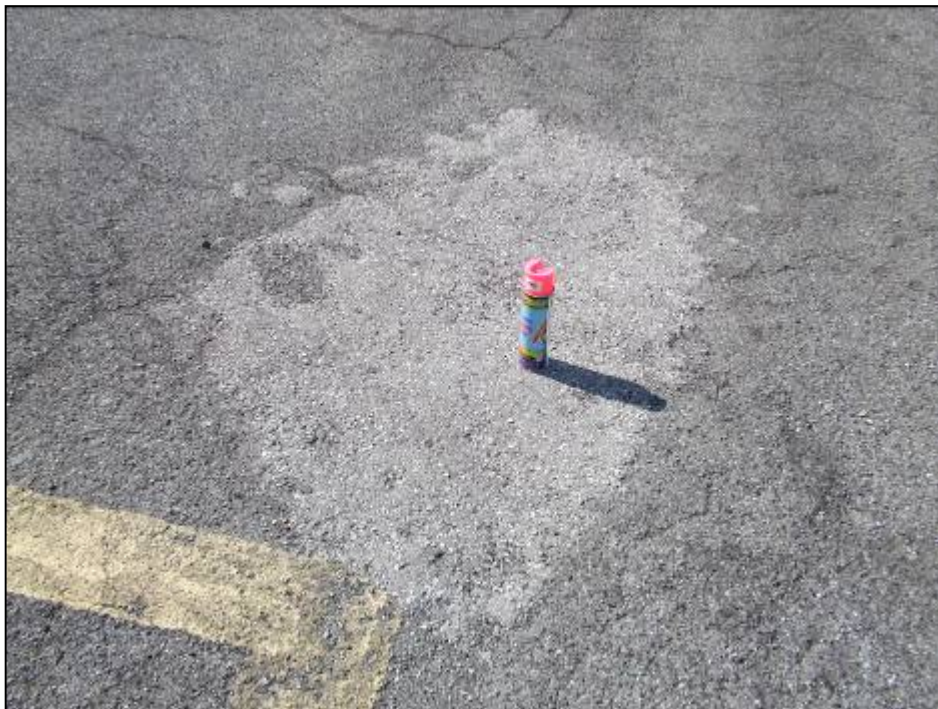
Apron, Section 4105, Sample Unit 100 – Low severity (43) Block Cracking, low and medium severity (45) Depression, medium severity (50) Patching, medium and high severity (52) Weathering and Raveling, low severity (56) Swelling.

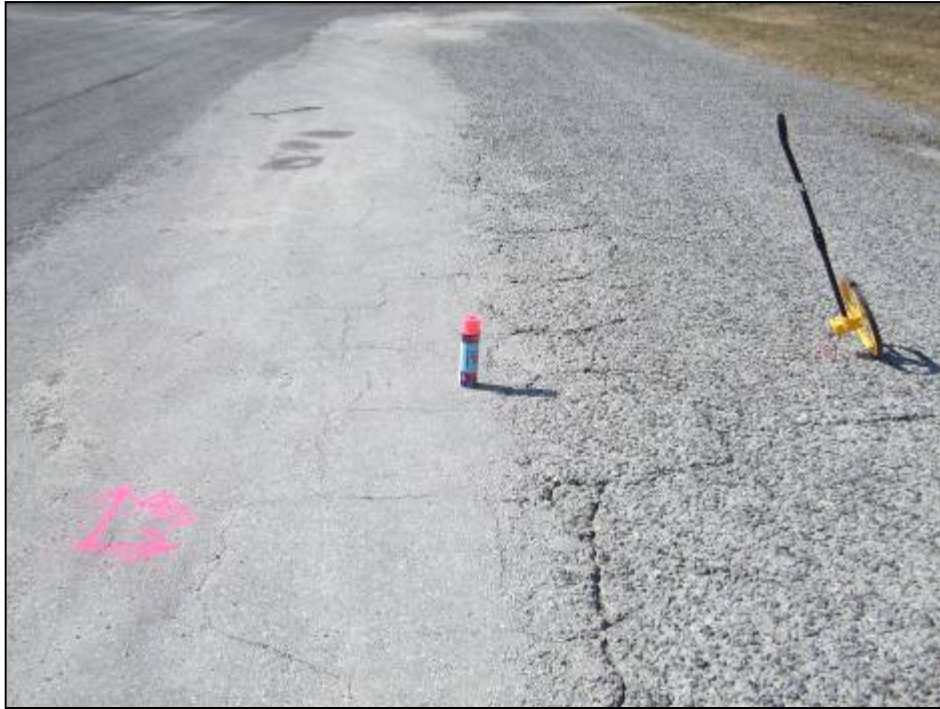
Taxiway Alpha, Section 105 Sample Unit 100 – Low severity (43) Block Cracking, low and medium severity (45) Depression, low severity (48) Longitudinal and Transverse Cracking, medium severity (50) Patching, high severity (52) Weathering and Raveling, low severity (56) Swelling.

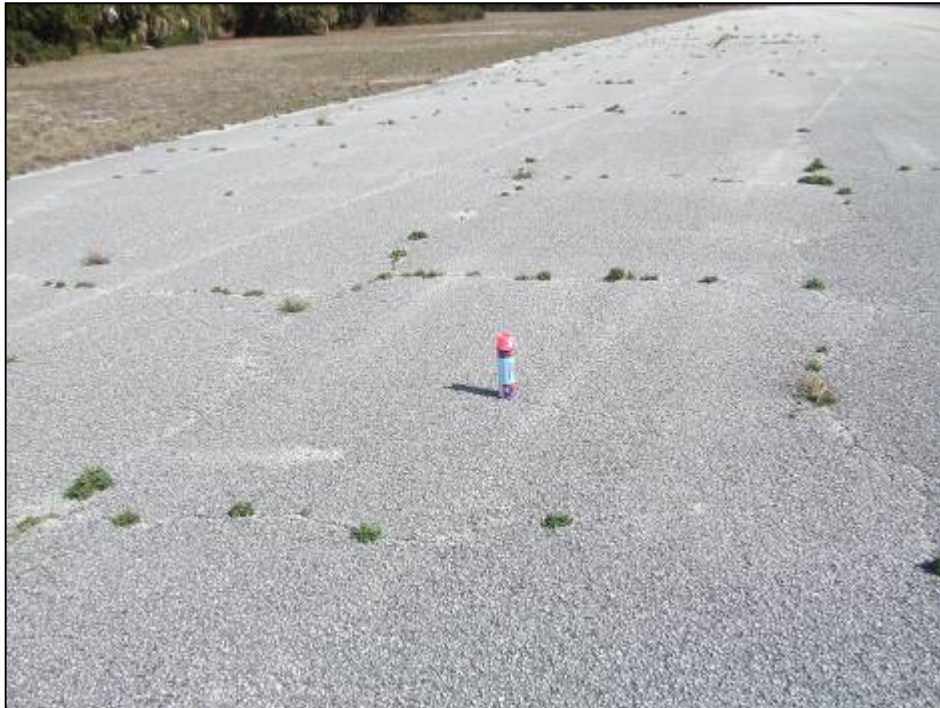
Runway 5-25, Section 6105, Sample Unit 105 – Low severity (43) Block Cracking, low severity (52) Weathering and Raveling, low severity (56) Swelling.
