**STATE OF FLORIDA
DEPARTMENT OF TRANSPORTATION
AVIATION OFFICE**

**Statewide Airfield Pavement
Management Program**

**Immokalee Regional Airport– IMM
(General Aviation)
Immokalee, Florida
(District 1)**

May 2011

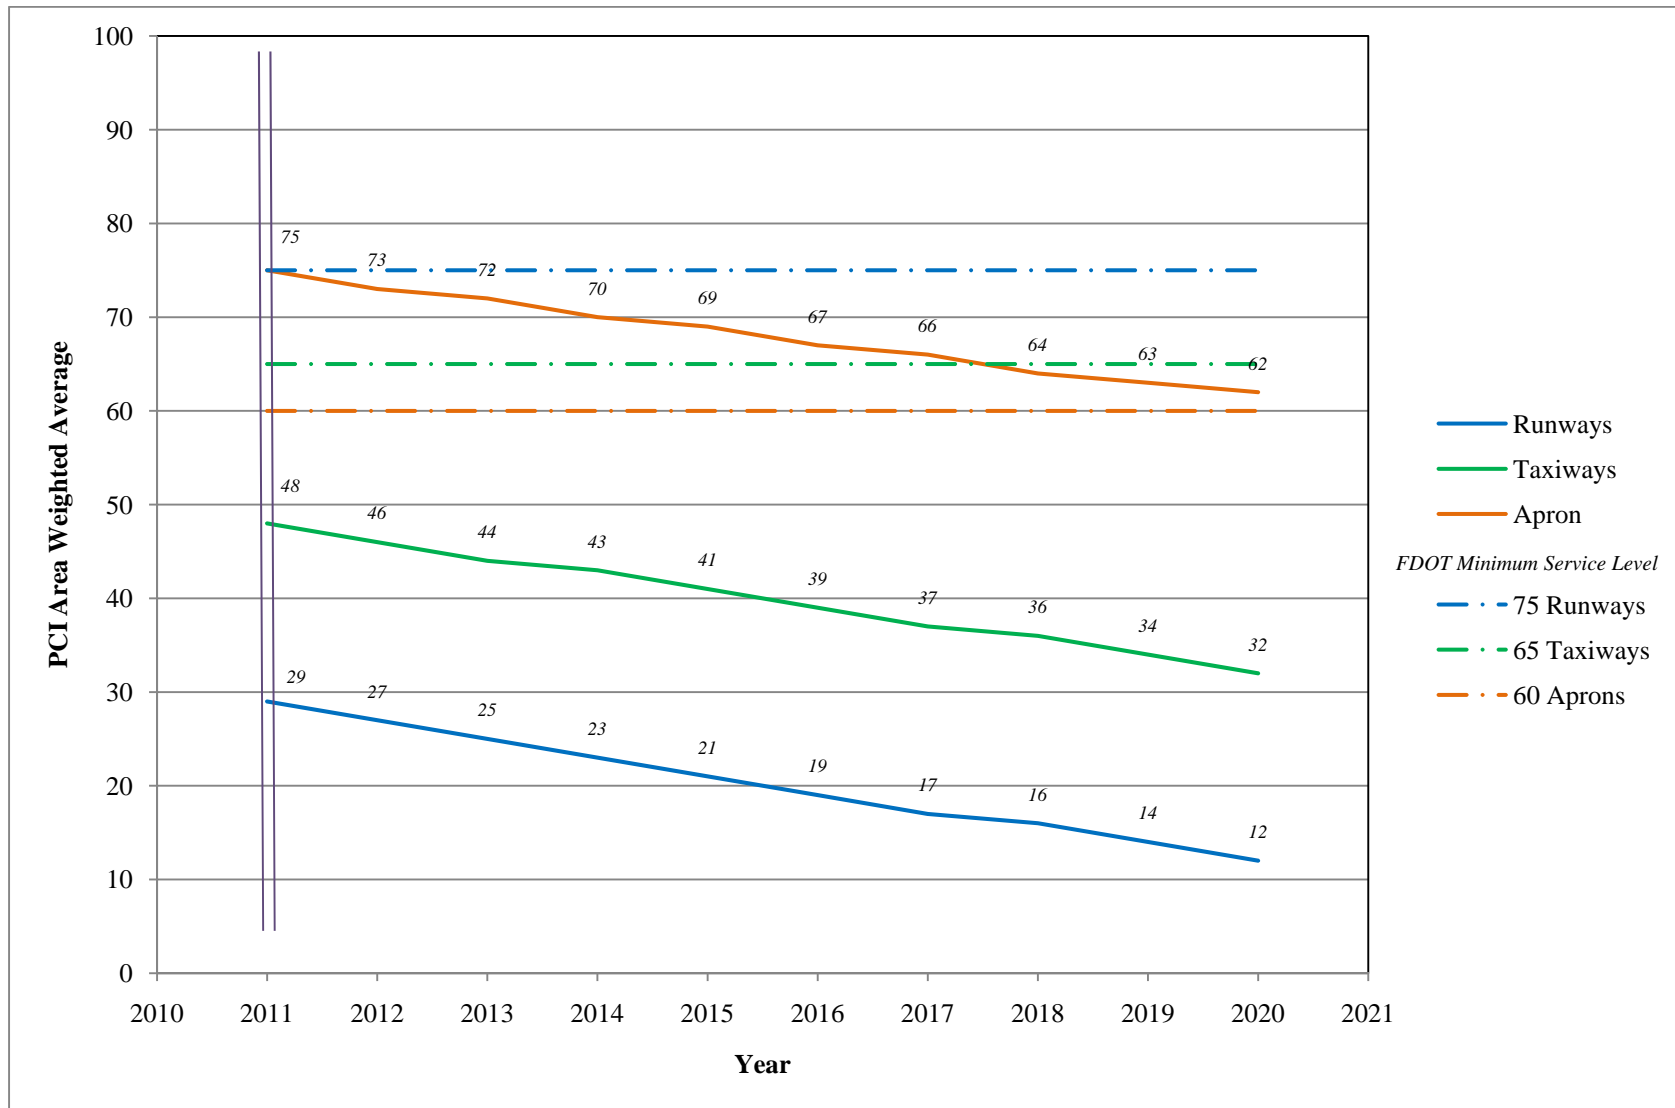
Figure D-1: Predicted PCI by Pavement Use

Branch Name	Branch ID	Section ID	Current PCI	PCI Forecast									
				2011	2012	2013	2014	2015	2016	2017	2018	2019	2020
Runway 9-27	RW 9-27	6230	5	4	2	0	0	0	0	0	0	0	0
Taxiway Alpha	TW A	205	25	25	23	21	19	18	16	14	13	11	9
Taxiway Alpha 1	TW A1	210	26	26	24	22	20	19	17	15	14	12	10
Taxiway Alpha 2	TW A2	220	22	22	20	18	16	15	13	11	10	8	6
Taxiway Bravo	TW B	105	26	26	24	22	20	19	17	15	14	12	10
Taxiway Bravo	TW B	110	34	34	32	30	28	27	25	23	22	20	18
Taxiway Bravo	TW B	115	33	33	31	29	27	26	24	22	21	19	17
Taxiway Bravo 1	TW B1	405	34	34	32	30	28	27	25	23	22	20	18
Taxiway Bravo 1	TW B1	410	28	28	26	24	22	21	19	17	16	14	12
Taxiway Charlie	TW C	310	89	89	87	85	83	82	80	78	77	75	73
Taxiway Charlie	TW C	315	94	94	92	90	88	87	85	83	82	80	78
Taxiway to Crop Apron	TW TO AP	305	67	67	65	63	61	60	58	56	55	53	51

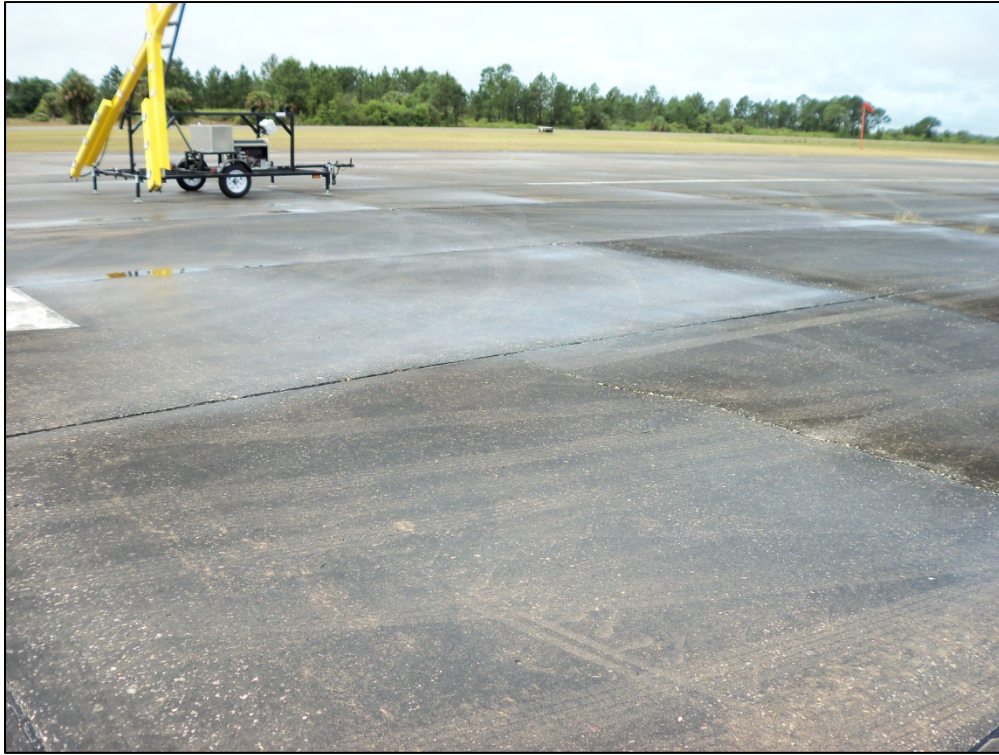
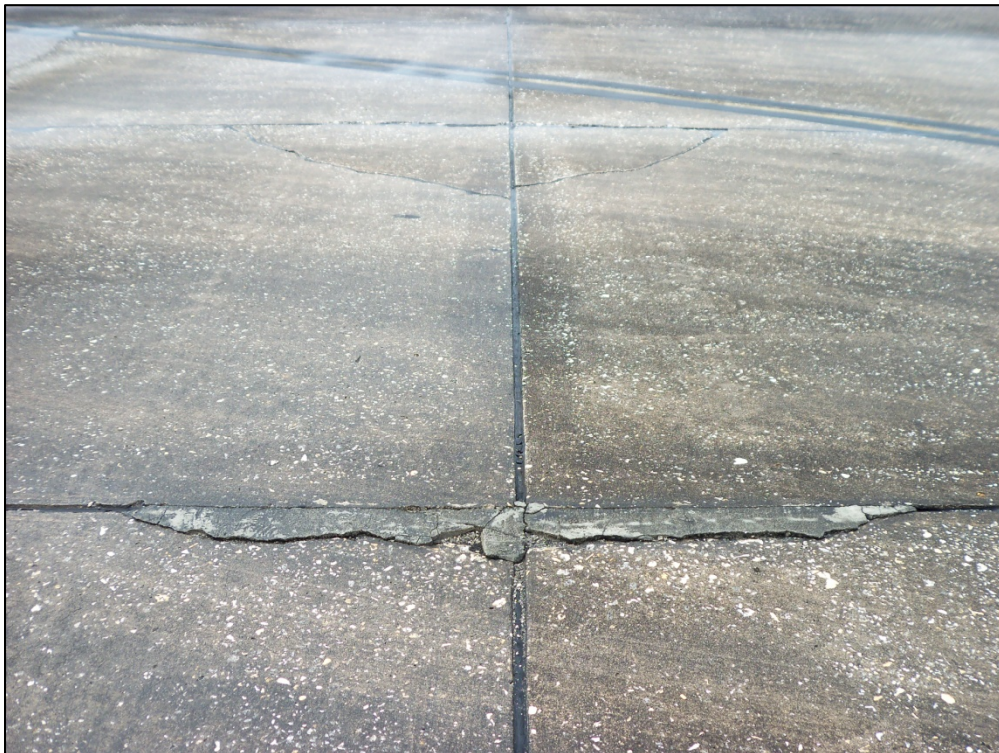
The Asphalt Concrete pavement on RW 9-27 exhibited low and medium severity block cracking along with medium severity weathering and raveling. Portland Cement Concrete pavement distresses were very similar throughout the airport and consisted of; corner breaks, LTD cracking, joint seal damage, scaling/map cracking, shrinkage cracks, joint and corner spalling. All of these distresses were typically of low to medium severity.

Runway 9-27, Section 6225, Sample Unit 388 – Low, medium and high severity (62) Corner Break, (63) LTD Cracking, (65) Joint Seal Damage, (70) Scaling/Map Cracking, (72) Shattered Slabs, (73) Shrinkage Cracks, (74) Joint Spalling, (75) Corner Spalling

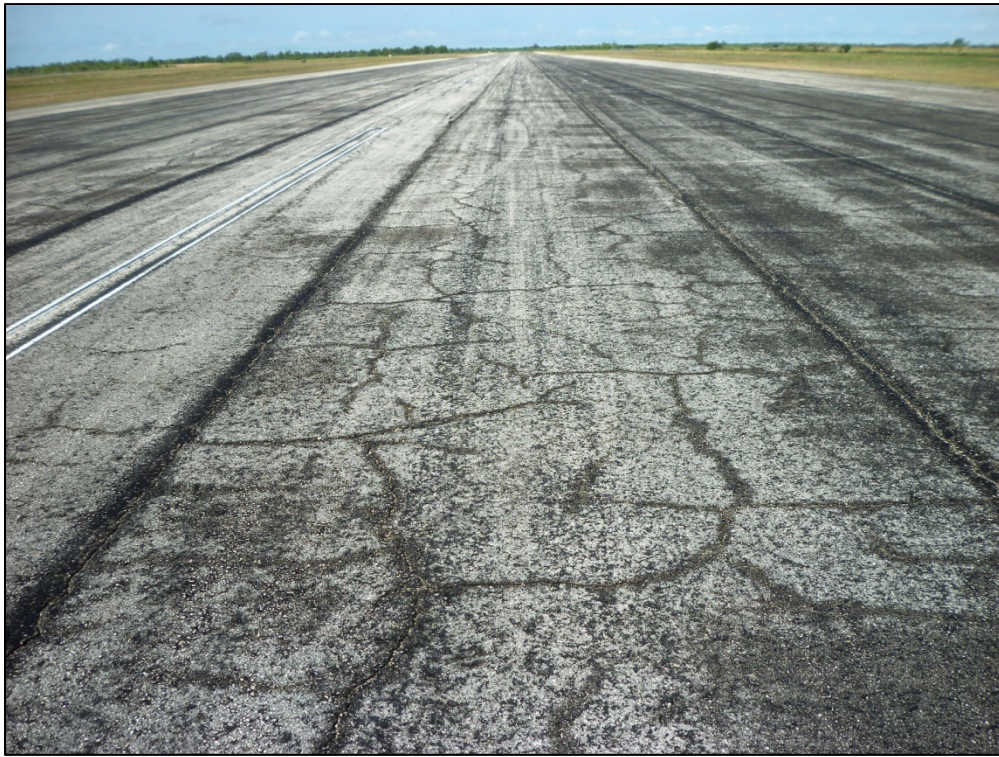
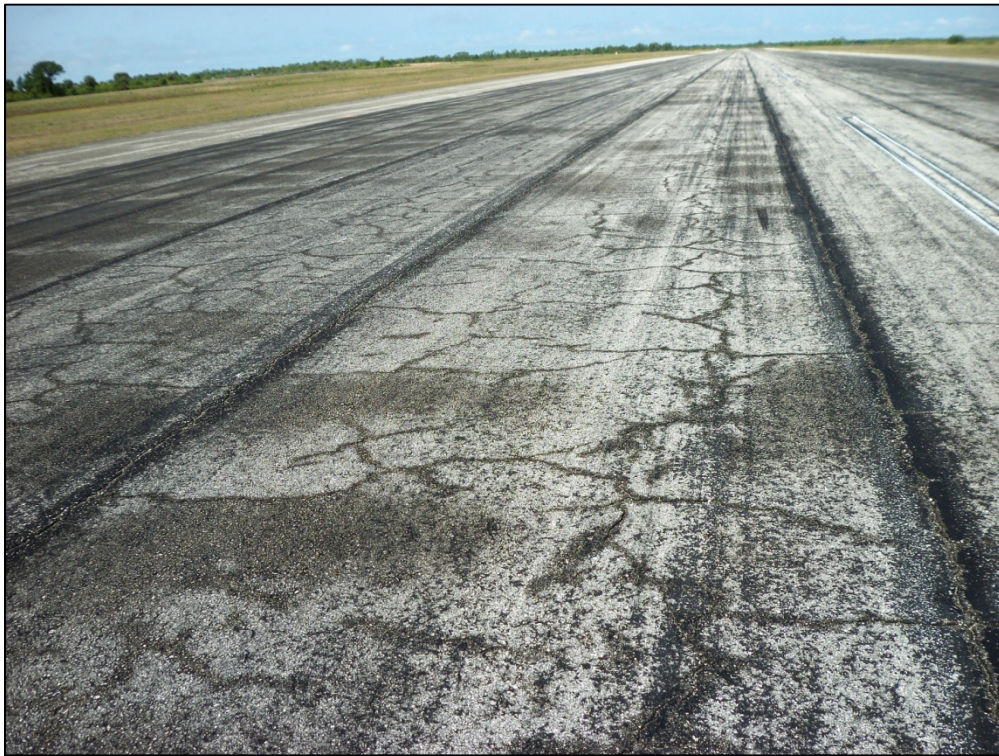
Runway 9-27, Section 6215, Sample Unit 380 – Low and medium severity (43) Block Cracking, medium severity (52) Weathering and Raveling

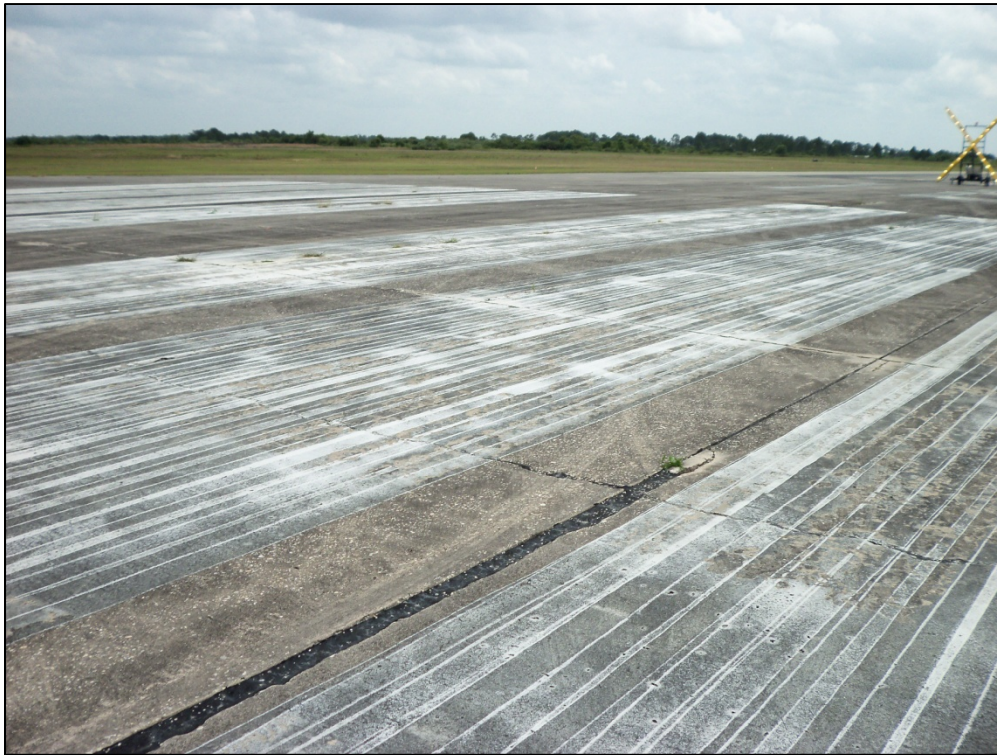
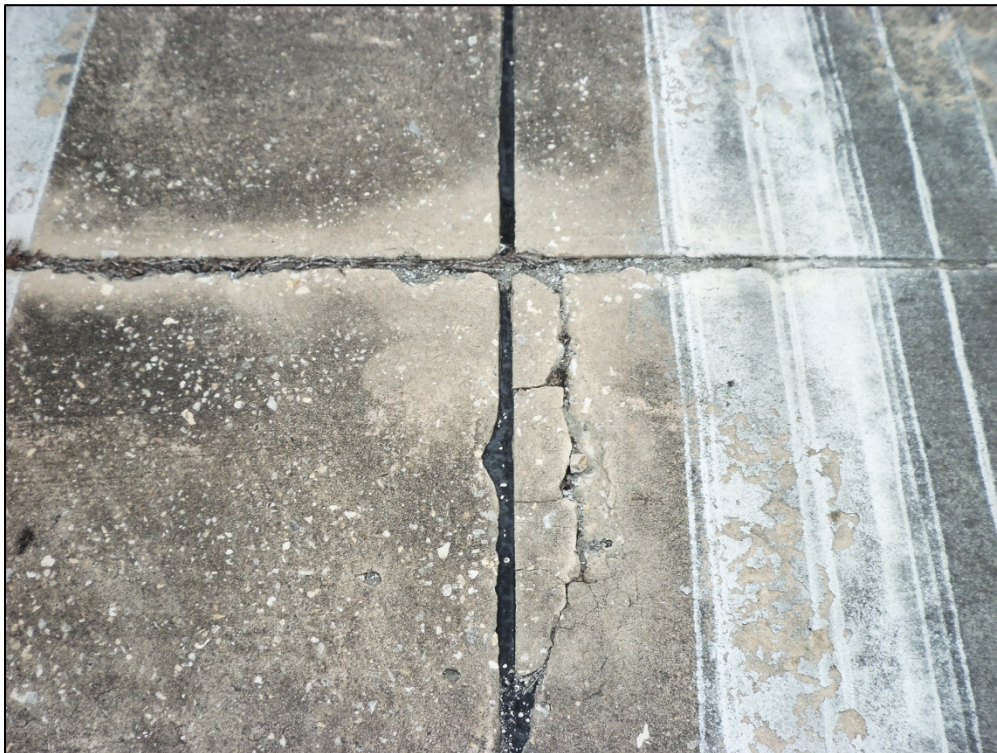
Runway 18-36, Section 6125, Sample Unit 392 – Low, medium and high severity (62) Corner Break, (63) LTD Cracking, (65) Joint Seal Damage, (70) Scaling/Map Cracking, (72) Shattered Slabs, (73) Shrinkage Cracks, (74) Joint Spalling, (75) Corner Spalling

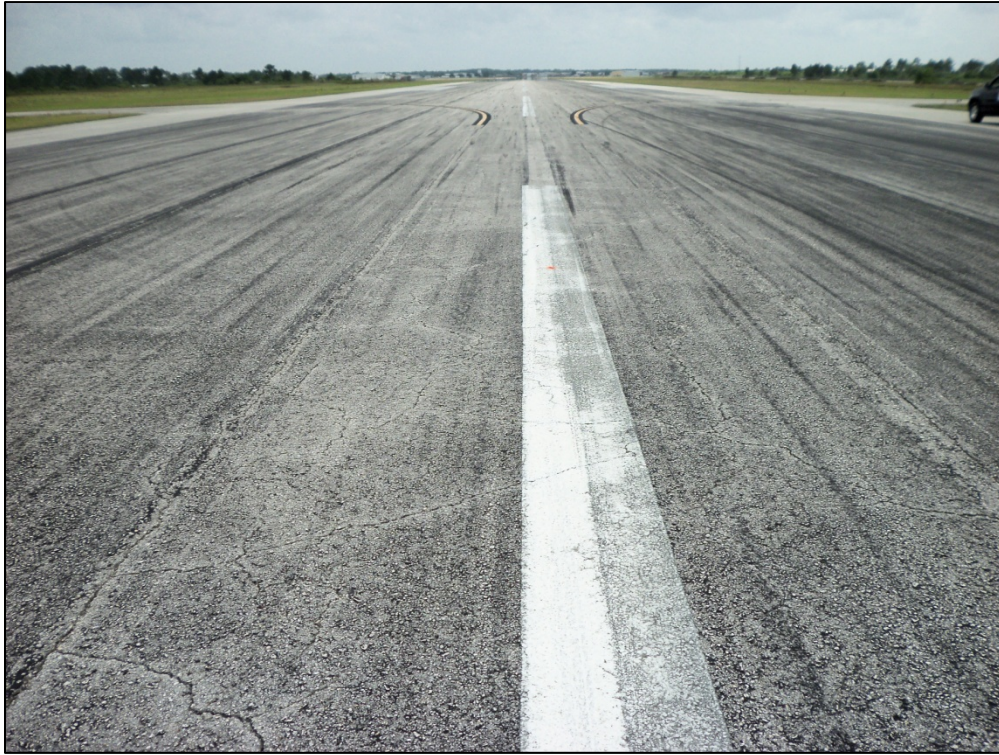
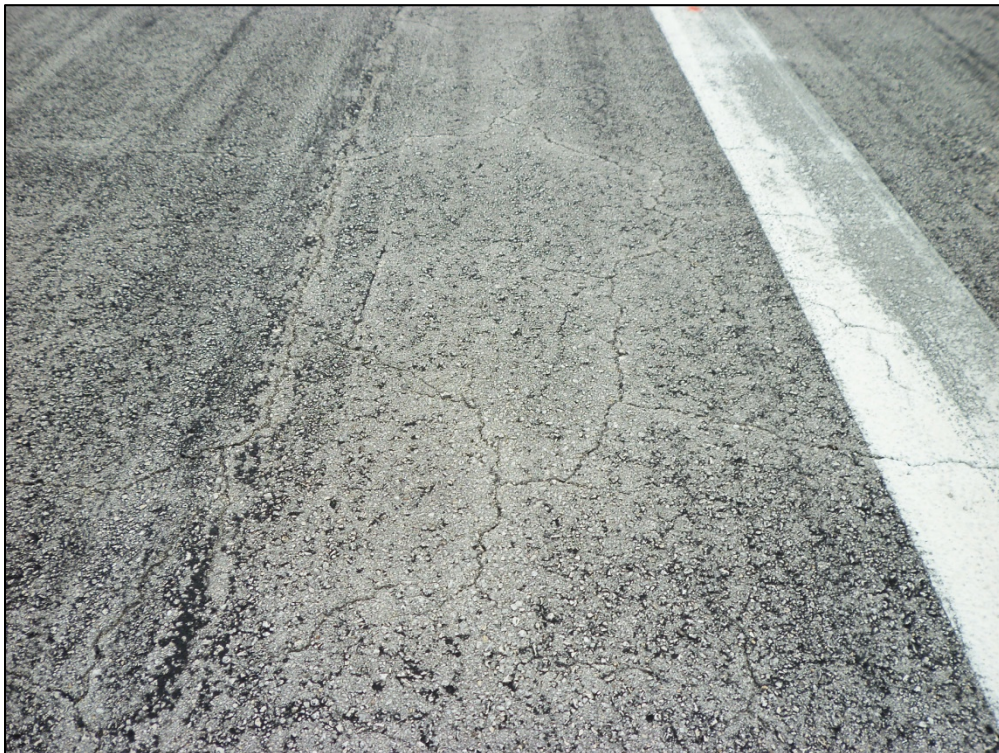
RW 18-36 exhibited low and medium severity block cracking along with medium severity weathering and raveling. Low and medium severity longitudinal and transverse cracking was also observed throughout the runway pavement section.

Runway 18-36, Section 6115, Sample Unit 383 – Medium severity (43) Block Cracking, medium severity (48) Longitudinal and Transverse Cracking, medium severity (52) Weathering and Raveling

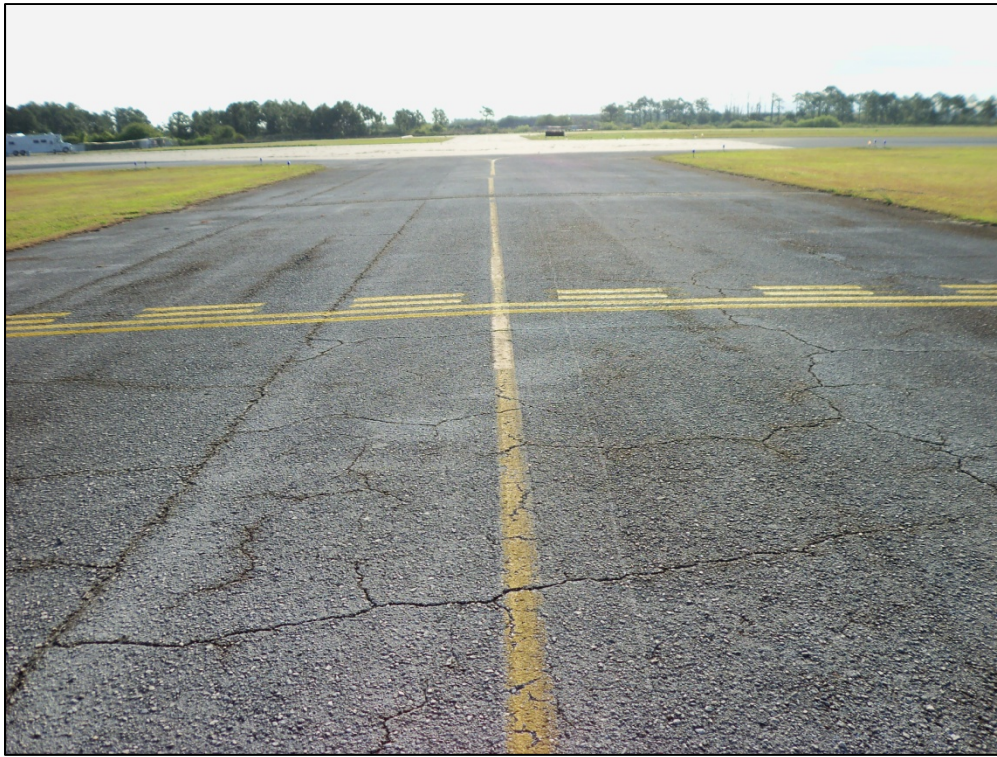
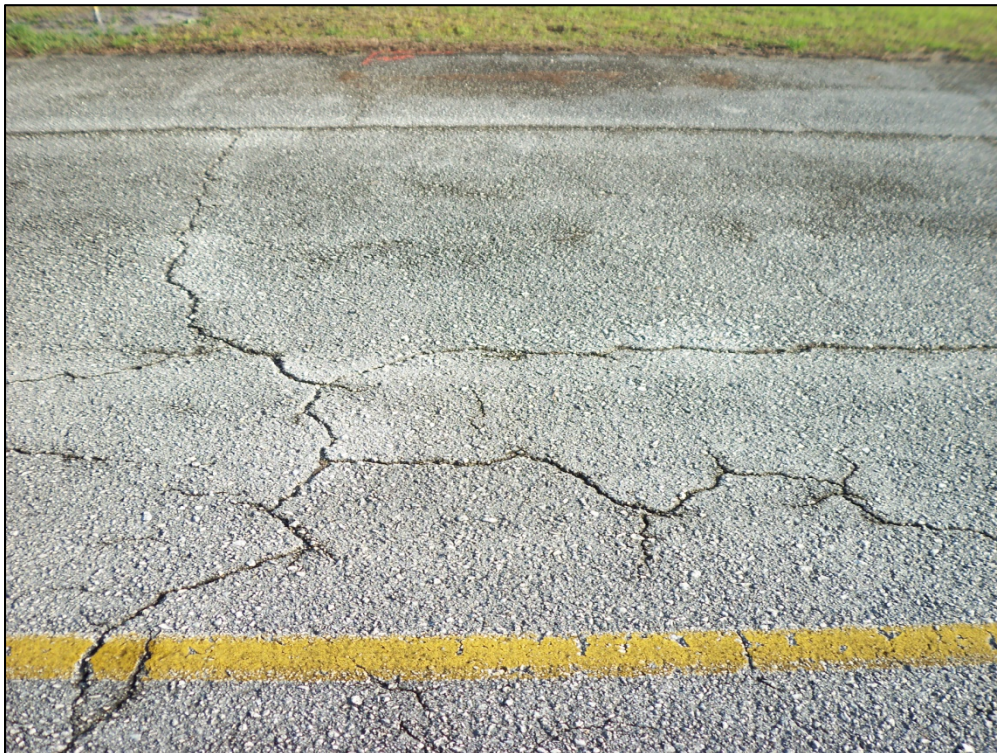
Taxiway A-1, Section 210, Sample Unit 201 – Medium severity (43) Block Cracking, medium severity (50) Patch, medium severity (52) Weathering and Raveling

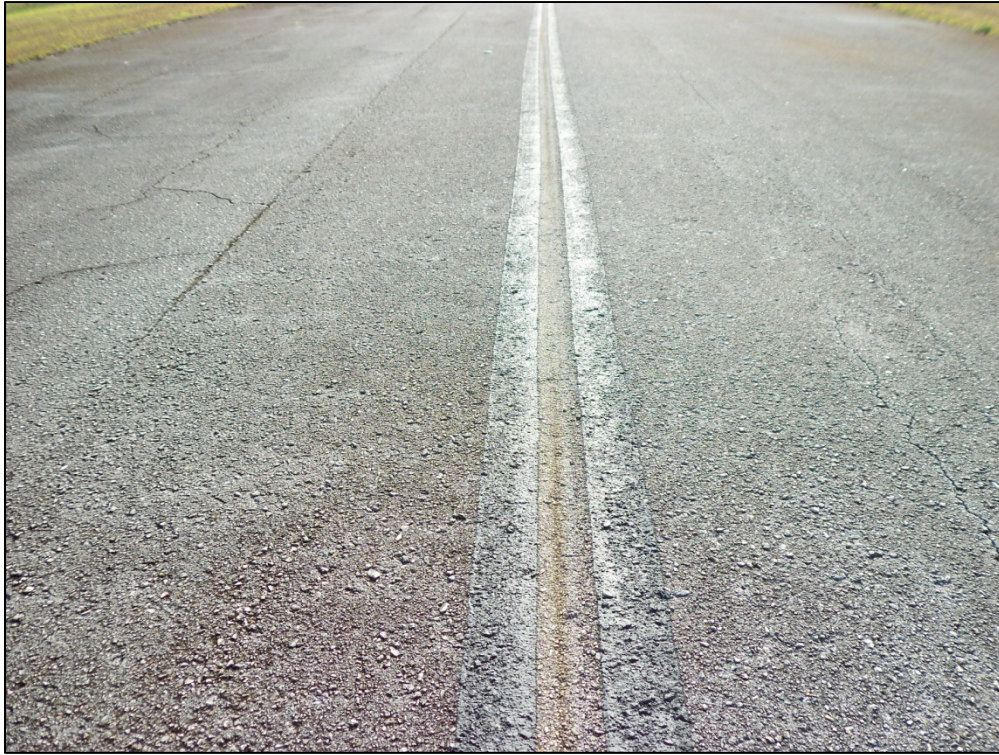
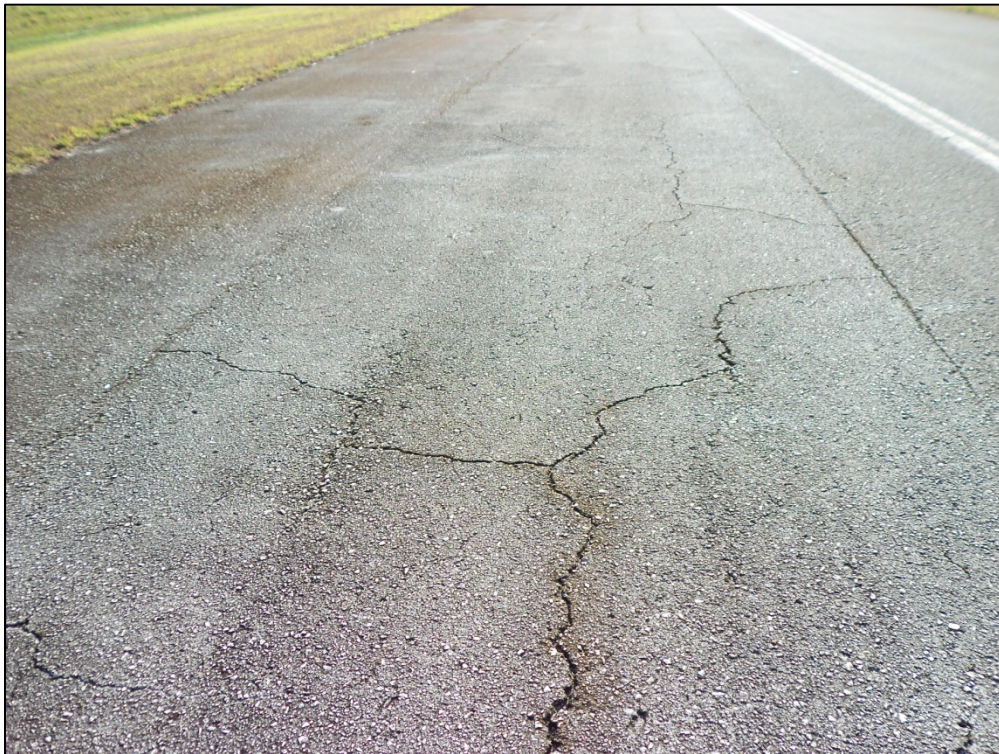
Taxiways Alpha and Bravo exhibited very similar distresses to the runways, with low and medium severity longitudinal and transverse cracking in addition to medium severity weathering and raveling. Block cracking with low and medium severity was also a very prevalent distress throughout the two main taxiways. Taxiway Charlie was recently reconstructed in 2006 and appeared to be in a good overall condition. Small amounts of low severity longitudinal cracking were observed along the pavement joints which is a common distress due to the pavement being the weakest at this location.

Taxiway Bravo, Section 105, Sample Unit 108 – Low and medium severity (43) Block Cracking, medium severity (52) Weathering and Raveling

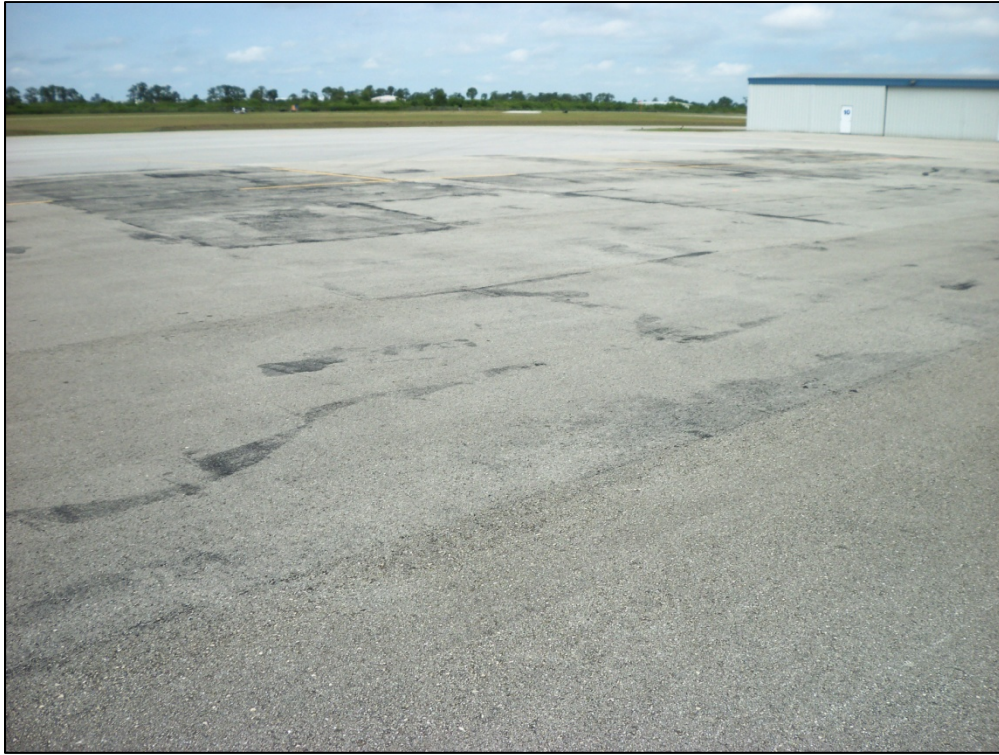
Apron, Section 4210, Sample Unit 203 – Low severity (48) Longitudinal and Transverse Cracking, low severity (50) Patch ,low severity (52) Weathering and Raveling
