**STATE OF FLORIDA
DEPARTMENT OF TRANSPORTATION
AVIATION OFFICE**

**Statewide Airfield Pavement
Management Program**

**Winter Haven's Gilbert Airport – GIF
(General Aviation)
Winter Haven, Florida
(District 1)**

May 2011

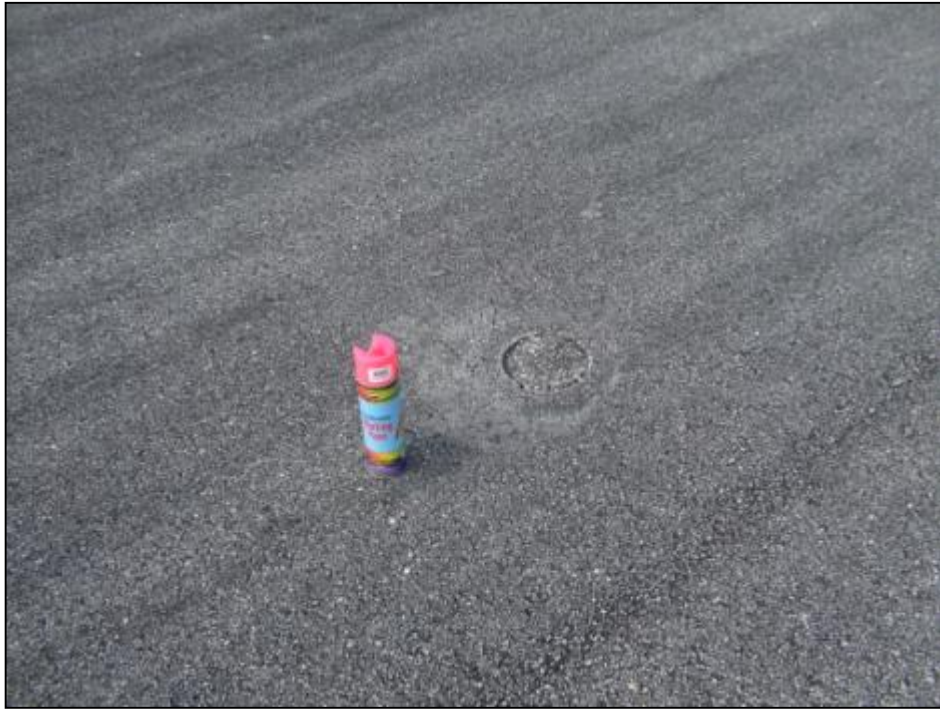
Runway 11-29, Section 6205, Sample Unit 103 – Low severity (48) Longitudinal and Transverse Cracking, low severity (50) Patching, low severity (52) Weathering and Raveling.

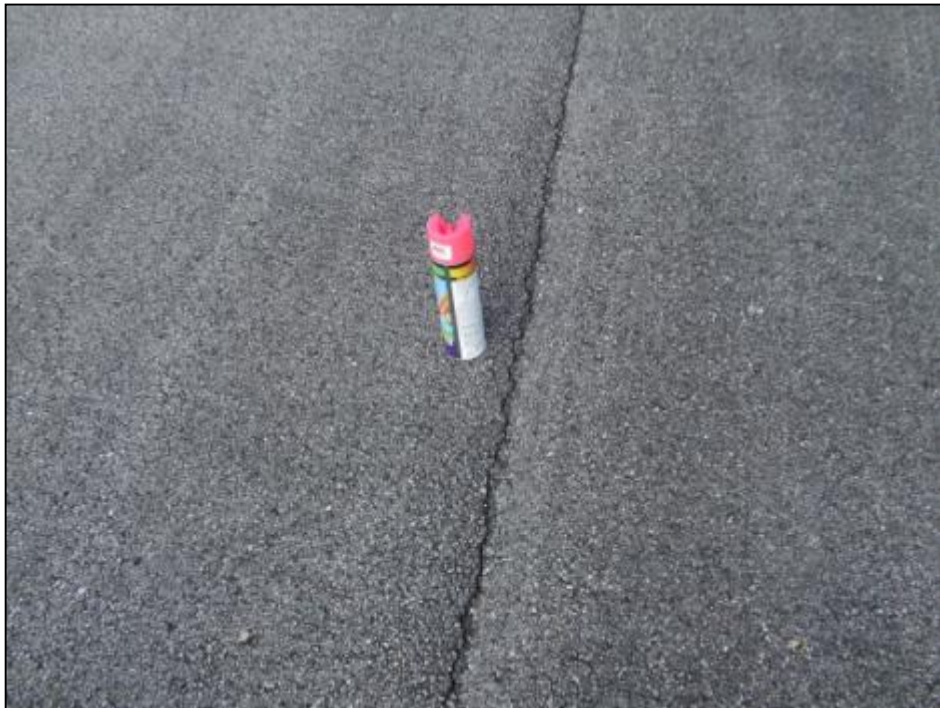
Runway 11-29, Section 6205, Sample Unit 103 – Low severity (48) Longitudinal and Transverse Cracking, low severity (50) Patching, low severity (52) Weathering and Raveling.

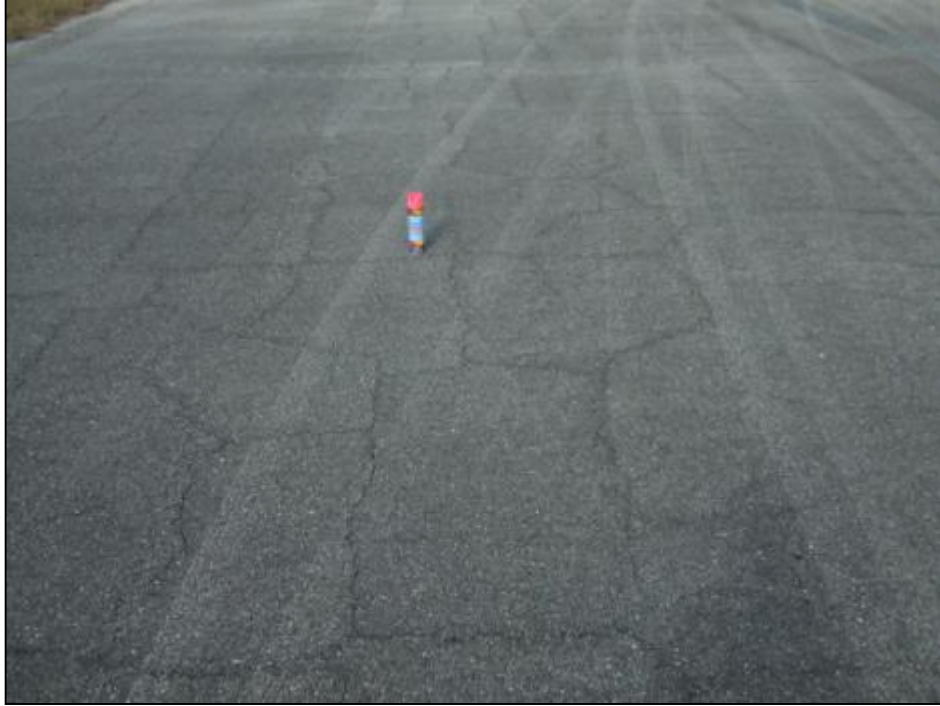
Runway 11-29, Section 5105, Sample Unit 183 – Low severity (43) Block Cracking, low severity (48) Longitudinal and Transverse Cracking, low severity (52) Weathering and Raveling, low severity (56) Swelling.

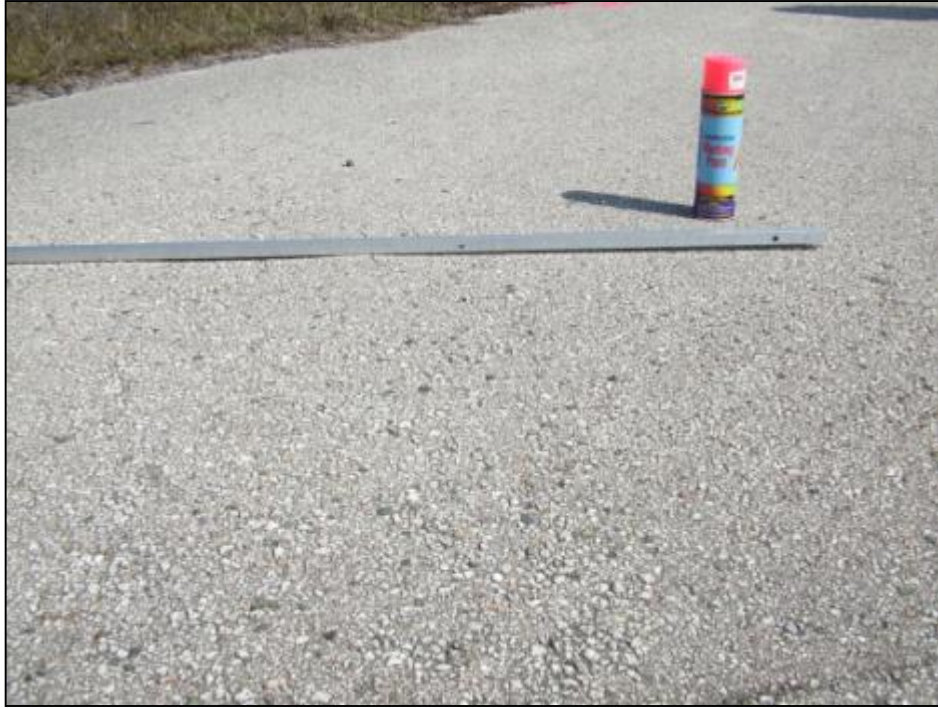
Taxiway Bravo, Section 220, Sample Unit 100 – Low severity (45) Depression, low severity (48) Longitudinal and Transverse Cracking, low severity (52) Weathering and Raveling, low severity (56) Swelling.

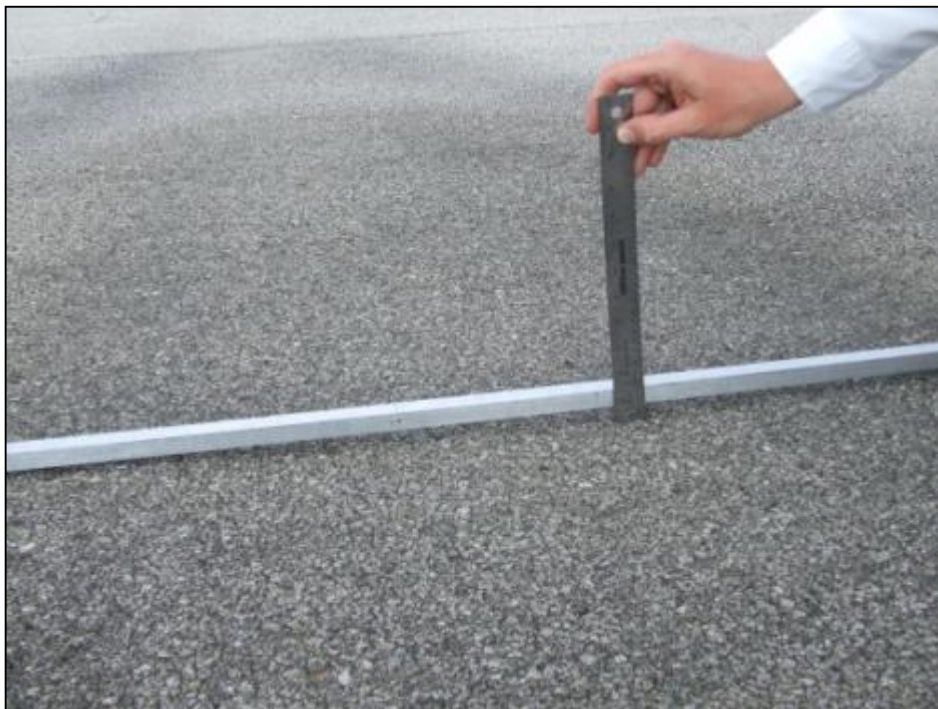
Taxiway Bravo 3, Section 260, Sample Unit 301 – Medium severity (45) Depression, low severity (48) Longitudinal and Transverse Cracking, low severity (50) Patching, low severity (52) Weathering and Raveling.

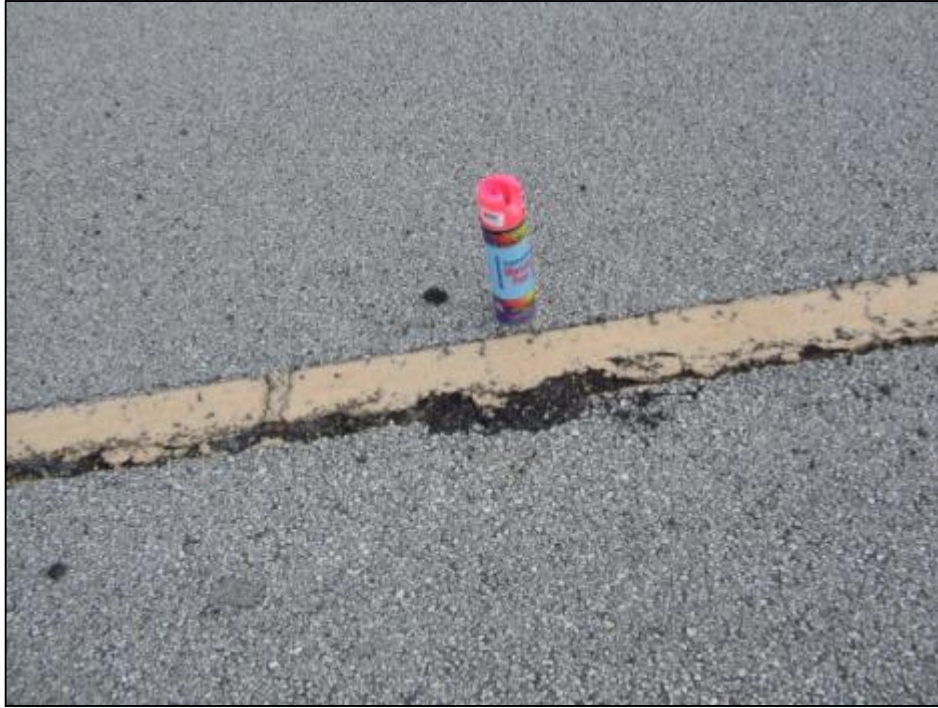
Taxiway Alpha, Section 110, Sample Unit 406 – Low and medium severity (48) Longitudinal and Transverse Cracking, low and medium severity (52) Weathering and Raveling.

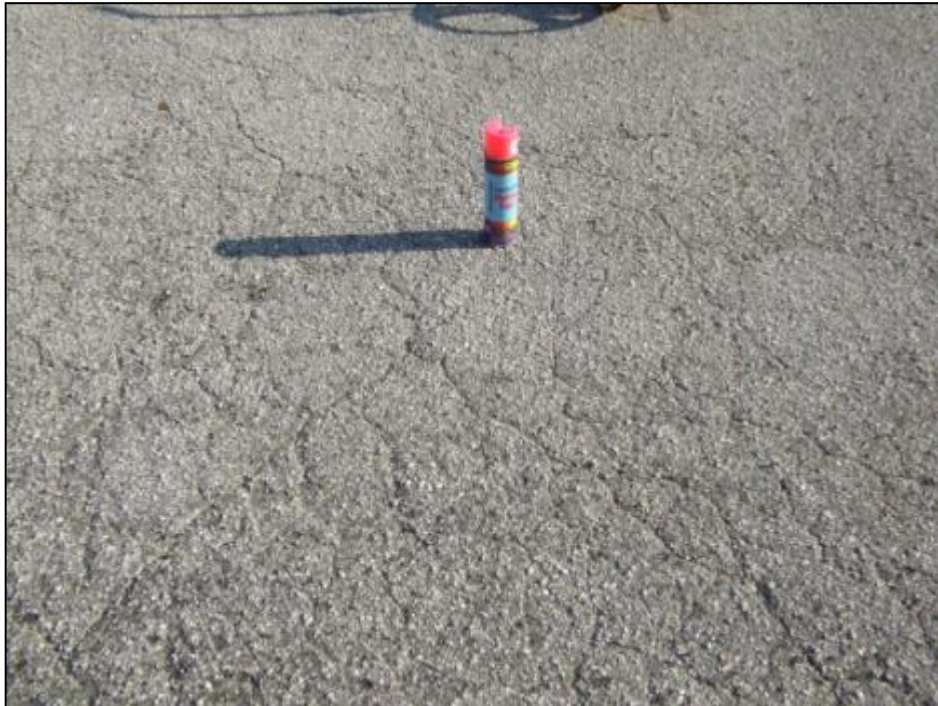
Apron Area, Section 4125, Sample Unit 101 – Medium severity (41) Alligator Cracking, low severity (45) Depression, low severity (48) Longitudinal and Transverse Cracking, low severity (52) Weathering and Raveling, low severity (56) Swelling.

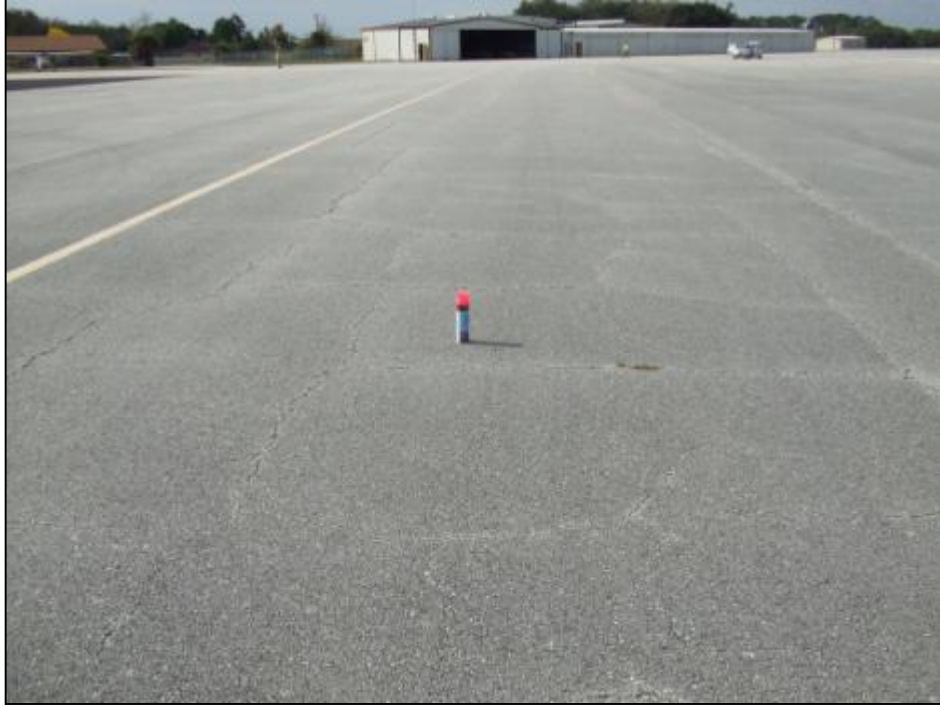
Apron Area, Section 410, Sample Unit 353 – Low and medium severity (43) Block Cracking, low severity (48) Longitudinal and Transverse Cracking, low and medium severity (52) Weathering and Raveling.

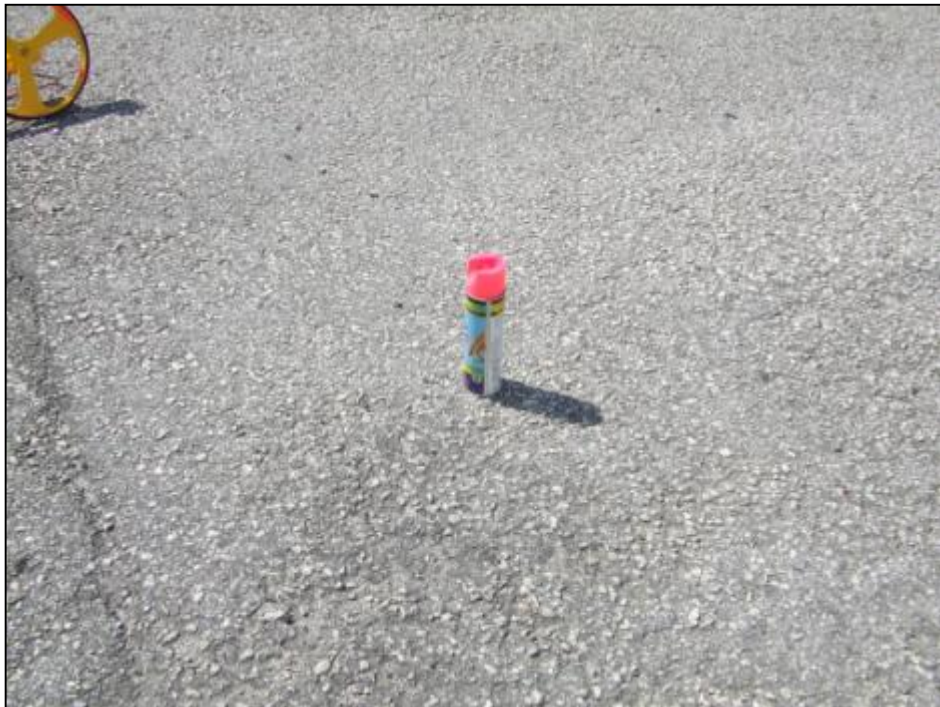
Taxiway Bravo 2, Section 315, Sample Unit 107 – Low severity (48) Longitudinal and Transverse Cracking, low severity (50) Patching, low to high severity (52) Weathering and Raveling.
