**STATE OF FLORIDA
DEPARTMENT OF TRANSPORTATION
AVIATION OFFICE**

**Statewide Airfield Pavement
Management Program**

**Zephyrhills Municipal Airport– ZPH
(General Aviation)
Zephyrhills, Florida
(District 7)**

January 2012

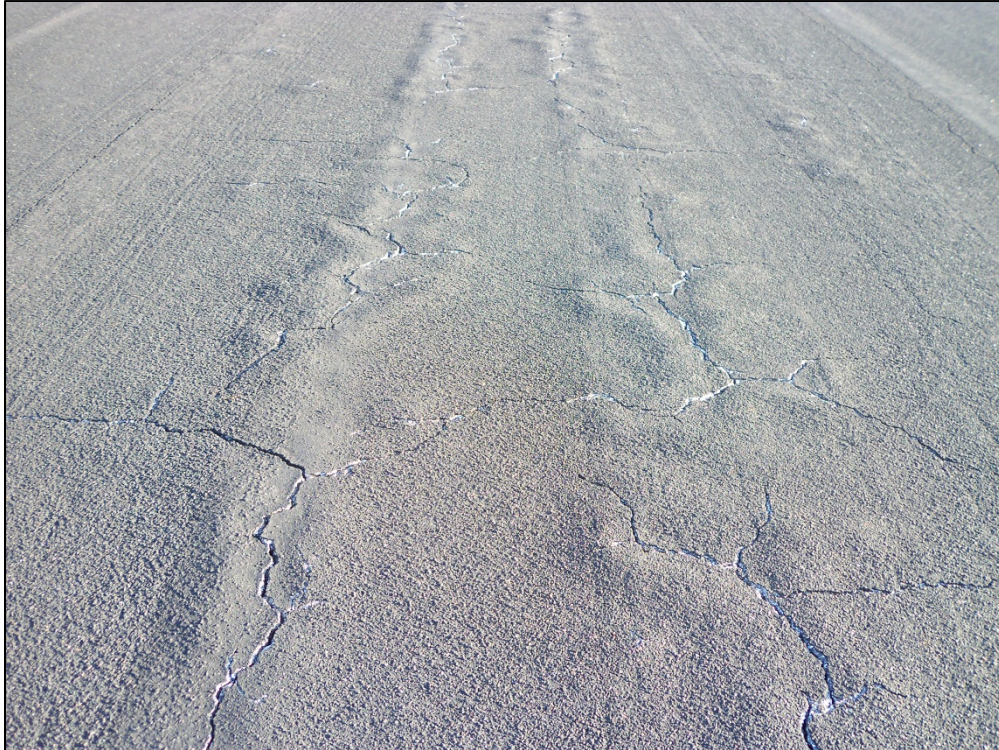
Runway 4-22, Section 6105, Sample Unit 103 – Low severity (43) Block cracking, High severity (48) Longitudinal and Transverse Cracking, Low severity (56) Swell

The asphalt pavement on Runway 4-22 exhibited low, medium and high severity longitudinal/transverse cracking, low severity swelling, low severity block cracking, low severity weathering/raveling, and medium severity alligator cracking. The asphalt overlay on portland cement concrete exhibited high severity joint reflection cracking and medium and high severity longitudinal/transverse cracking. These are prior pavement, climate and age related distresses. Runway 4-22 has a PCI range of 29-52, which is below critical condition.

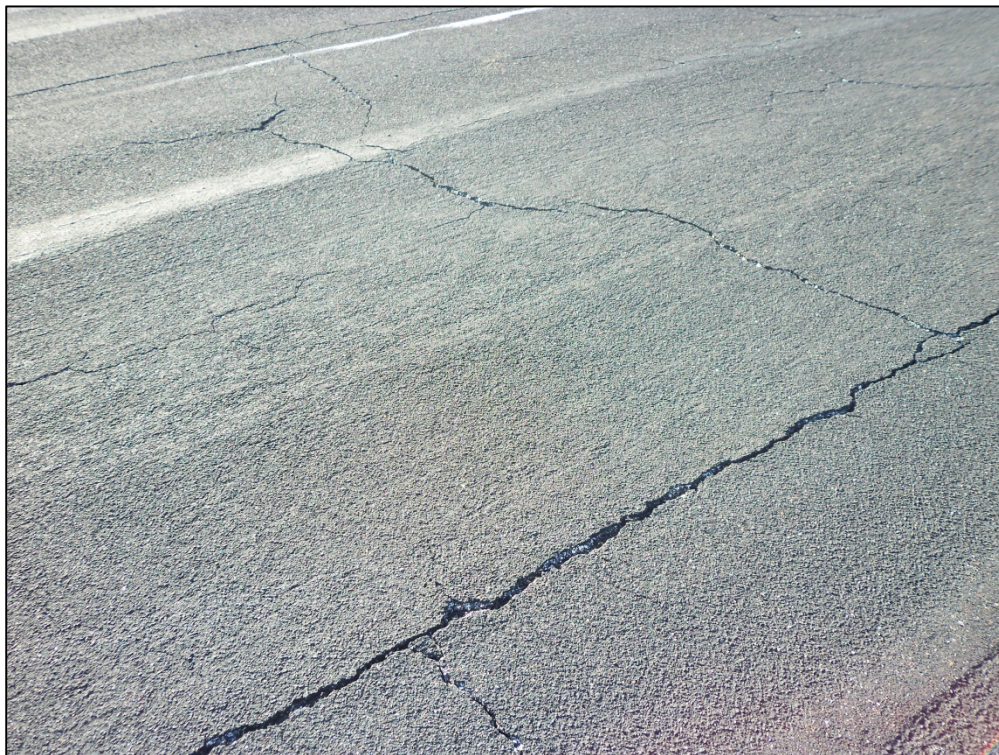
Runway 4-22, Section 6105, Sample Unit 134 –Medium severity (48) Longitudinal and Transverse Cracking, Low severity (52) Raveling and Weathering

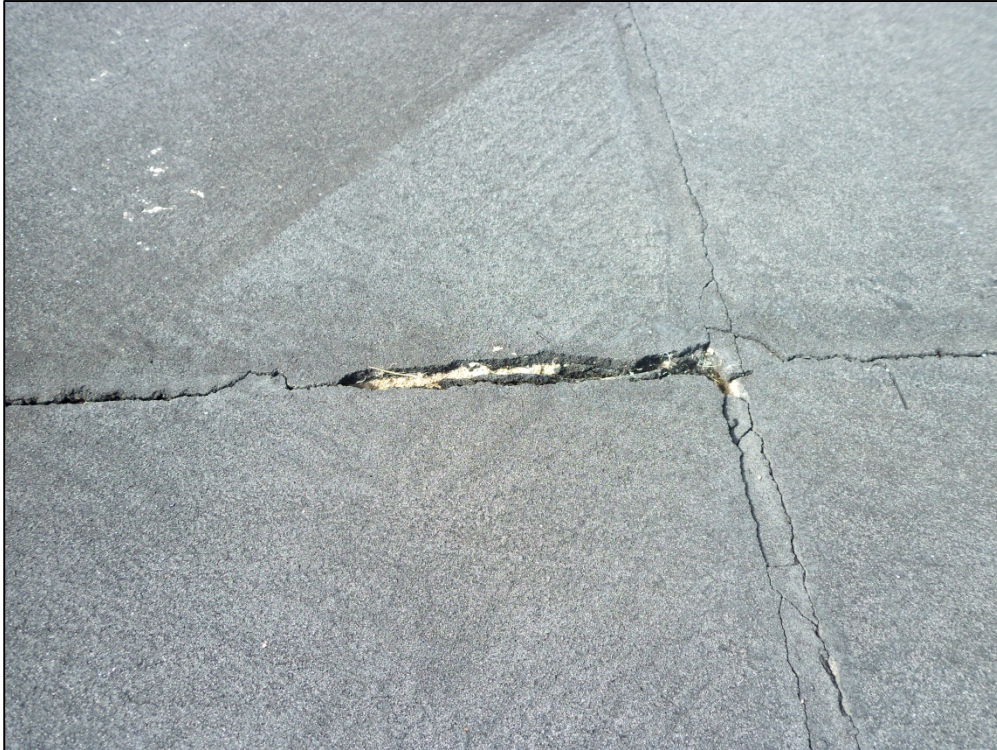
Runway 18-36, Section 6213, Sample Unit 301 –Medium severity (47) Joint Reflection Cracking, Low severity (48) Longitudinal and Transverse Cracking

The asphalt pavement on Runway 18-36 exhibited low severity longitudinal/transverse cracking, low severity weathering/raveling, medium severity joint reflection cracking and low severity swelling. The portland cement concrete pavement exhibited medium and high severity joint seal damage, shrinkage cracking, low severity corner spalling, low and medium severity linear cracking and low severity shattered slab. These are climate, age, load and prior pavement related distresses. Runway 18-36 has a PCI range of 26-69, which is below critical condition.

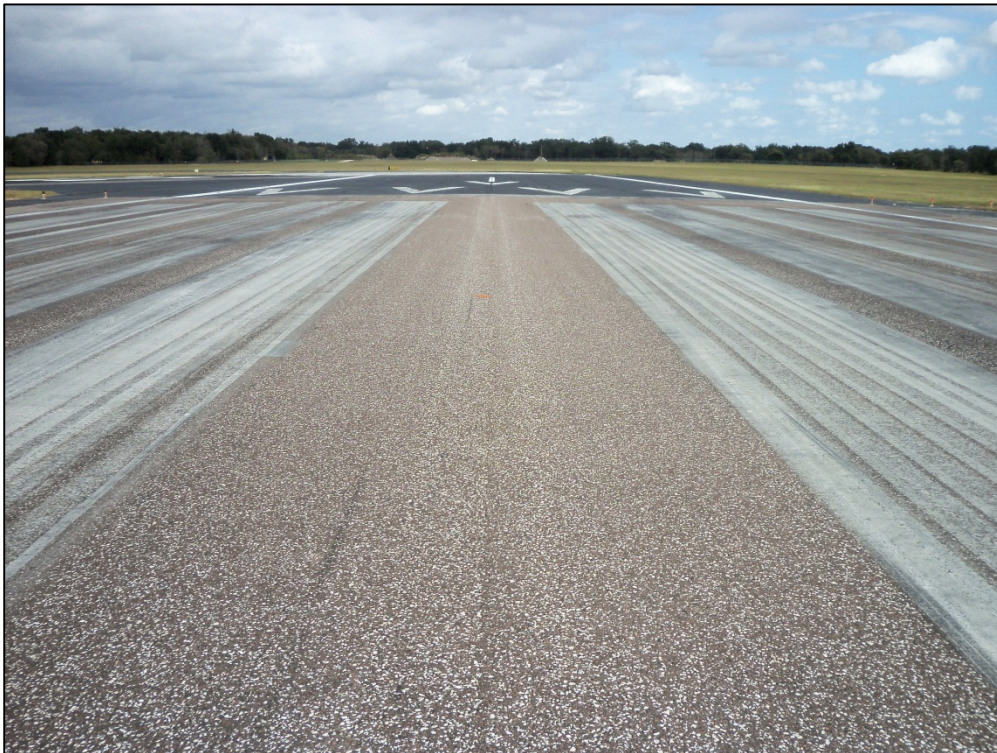
Runway 18-36, Section 6205, Sample Unit 390 –Low severity (52) Raveling and Weathering

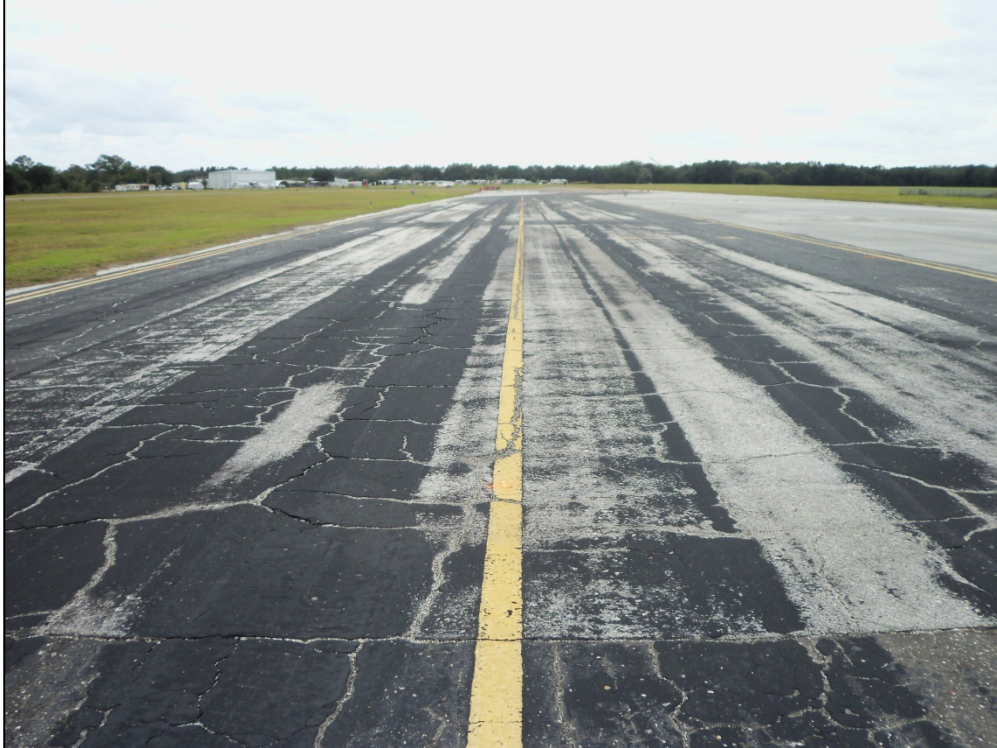
Taxiway Bravo, Section 220, Sample Unit 219 – High severity (43) Block cracking, High severity (52) Raveling and Weathering

Taxiways B pavements exhibited low severity block cracking, low severity longitudinal/transverse cracking, low severity weathering and raveling and low severity depression. These are climate, age and subgrade related distresses. The East Apron and southeast section of Taxiway B exhibit low, medium and high severity shattered slabs, low severity scaling/crazing, medium severity joint seal damage, low and medium severity linear cracking and shrinkage cracking. This area is in a failing condition. Taxiway B has PCI range of 7-79, this wide range is attributed to the variation in construction histories of the pavement sections.

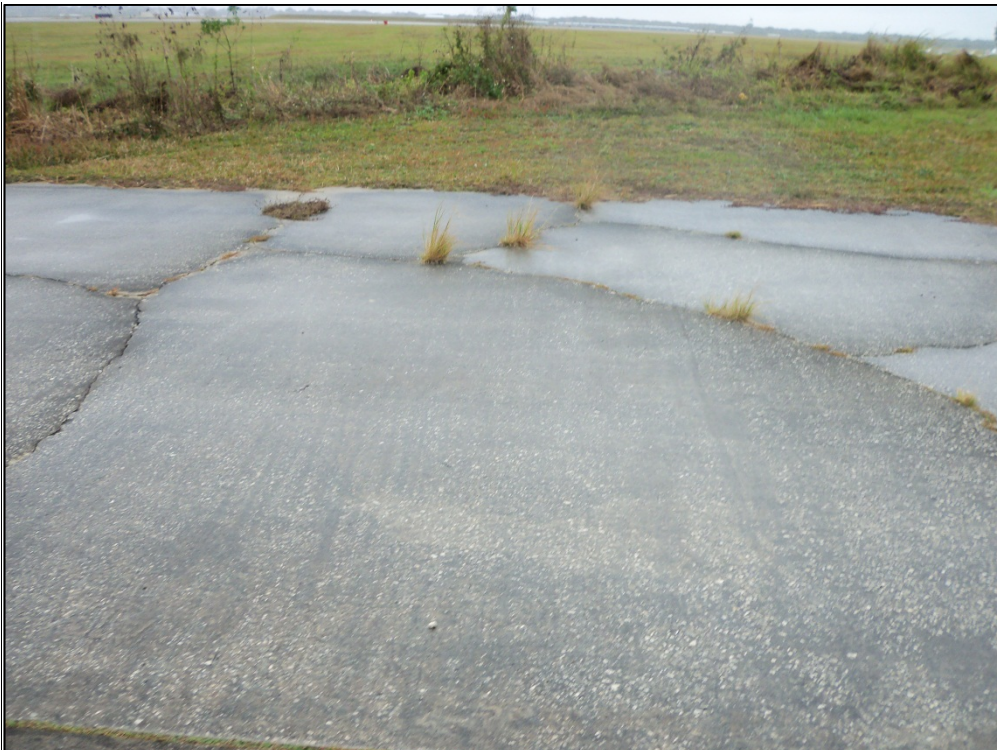
Apron East, Section 5405, Sample Unit 202 – Medium severity (65) Joint Seal Damage, High severity (72) Shattered Slab

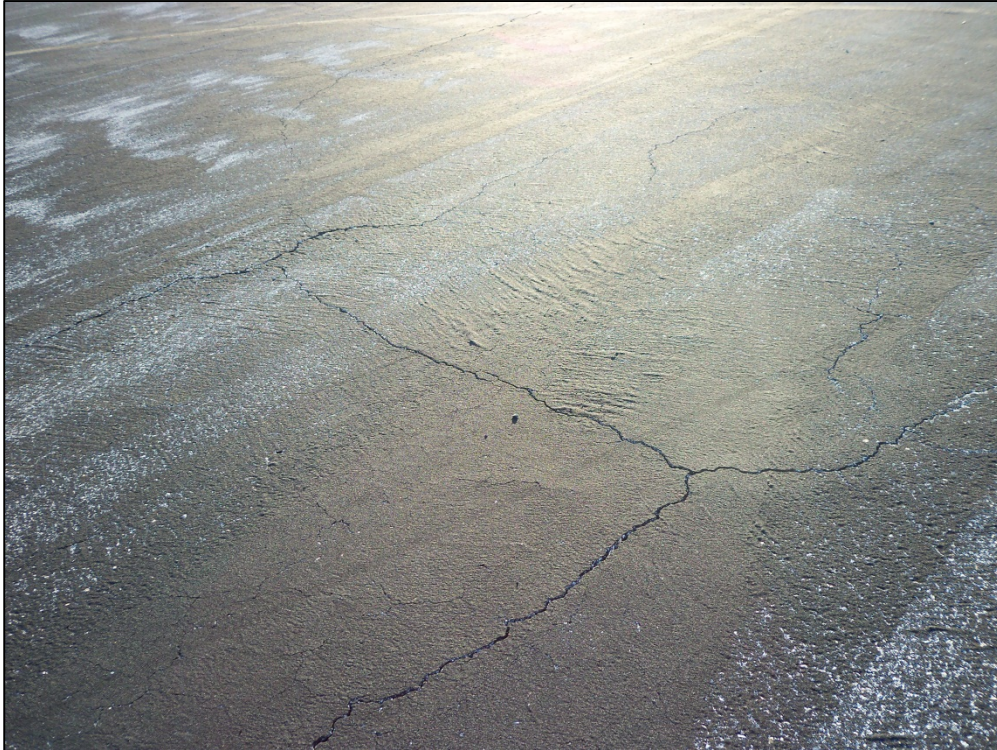
Taxiway Connector A-2, Section 310, Sample Unit 103 – Low severity (48) Longitudinal and Transverse Cracking, (52) Raveling and Weathering

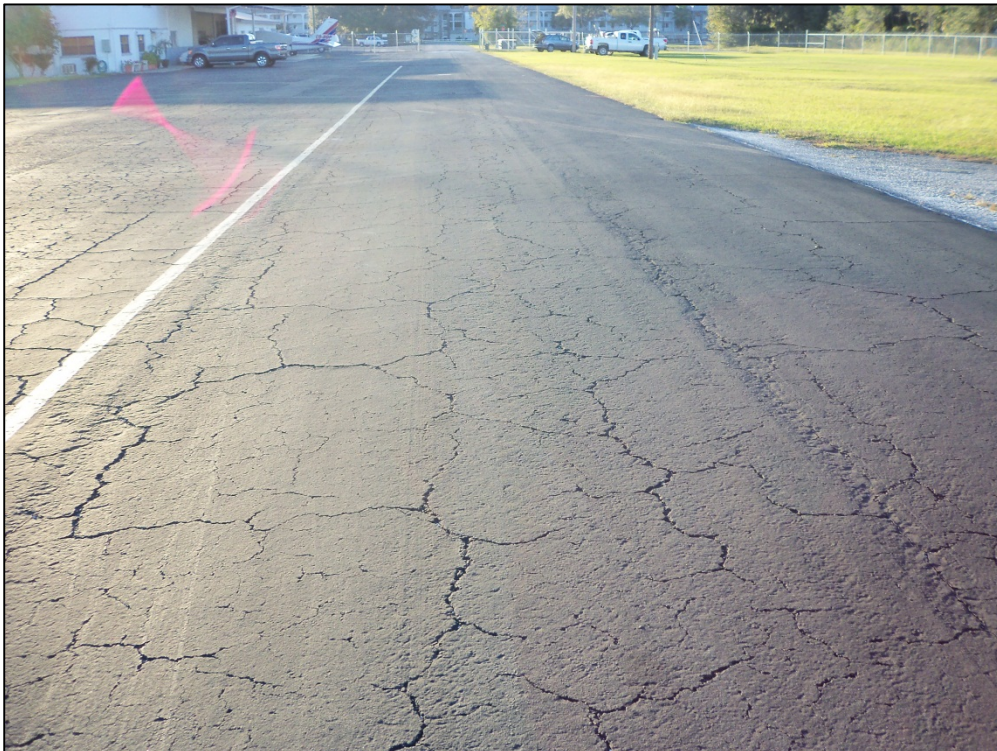
Apron Taxiway Delta, Section 5205, Sample Unit 201 – Low severity (43) Block Cracking
