FLORIDA DEPARTMENT OF TRANSPORTATION  
AVIATION AND SPACEPORT OFFICE

GEORGE T. LEWIS  
CEDAR KEY  
AIRPORT (CDK)

DECEMBER 2013

# STATEWIDE Airfield Pavement Management PROGRAM

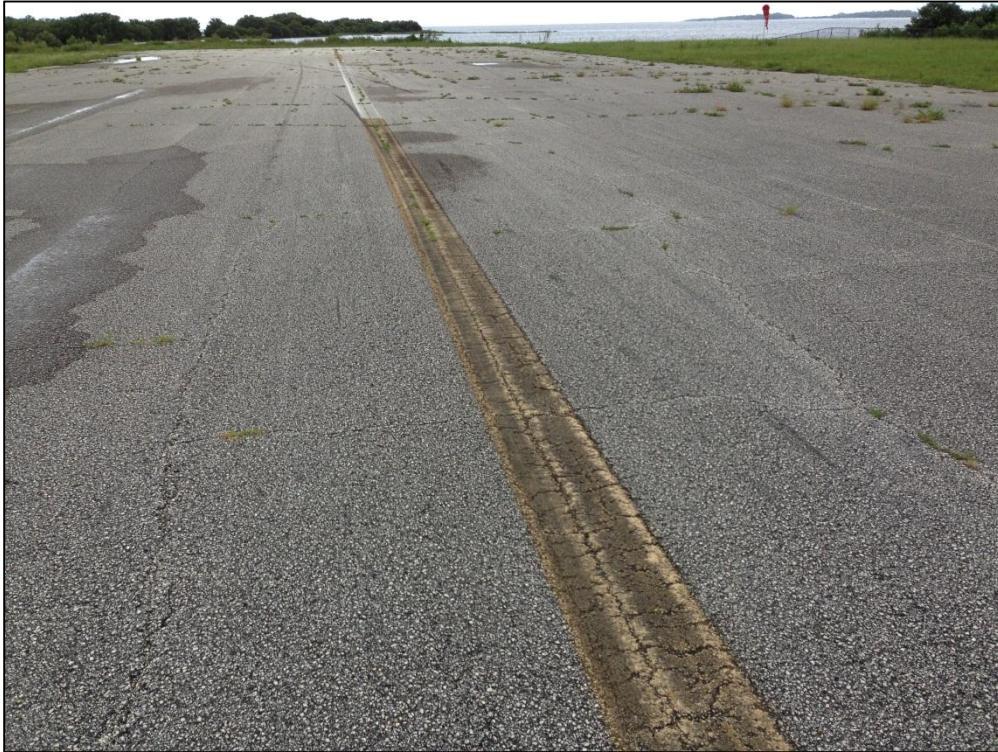
Runway 5-23 exhibited a pavement condition index of 33. Generally, the pavements are in Very Poor condition. Pavements on Runway 5-23 exhibited low severity block cracking; low and medium severity raveling; low severity weathering; and low severity depression. These are climate, age, and subgrade quality based distresses. The severity and quantity of these distresses are indicative of pavements that have little structural capacity left.

Runway 5-23, Section 6105, Sample Unit 105 – Low Severity (43) Block Cracking, Low and Medium Severity (52) Raveling, Low Severity (45) Depression, Low Severity (57) Weathering

- Runway 5-23 – Section 6105
  - Reconstruction attributed to distresses related to subgrade quality, climate, and age of pavement.
- Apron – Section 4105
  - Reconstruction attributed to distresses related to subgrade quality, climate, and age of pavement.
- Taxiway A – Section 105
  - Reconstruction attributed to distresses related to subgrade quality, climate, and age of pavement.

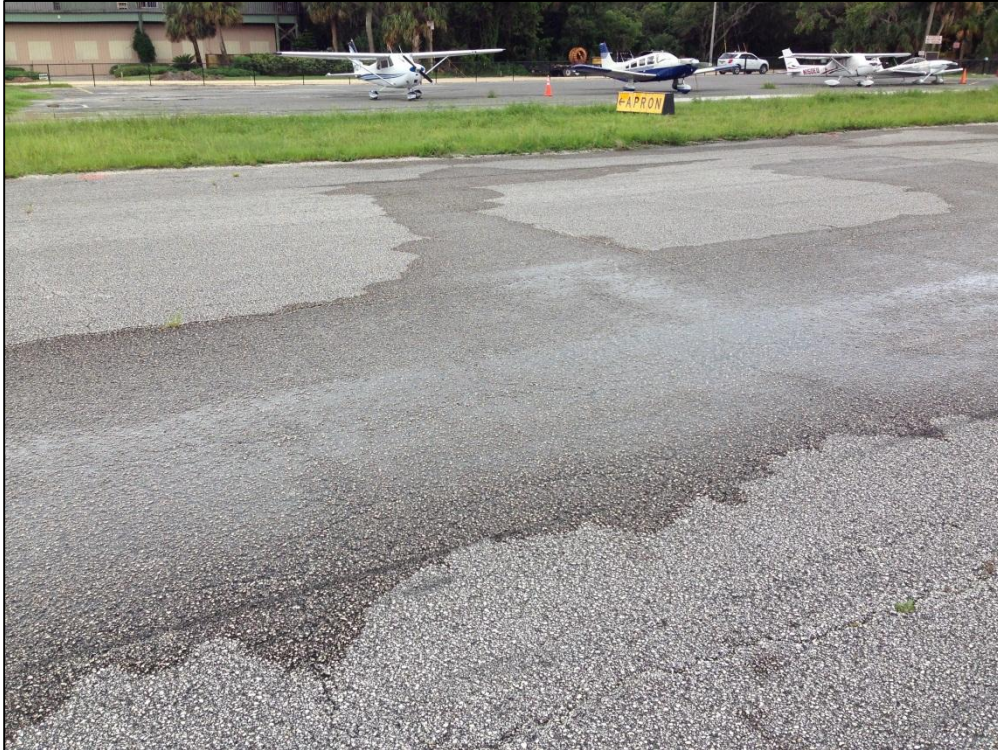
Runway 5-23, Section 6105, Sample Unit 105 – Low and Medium Severity (52) Raveling, Low Severity (45) Depression, Low Severity (43) Block Cracking, Low Severity (57) Weathering

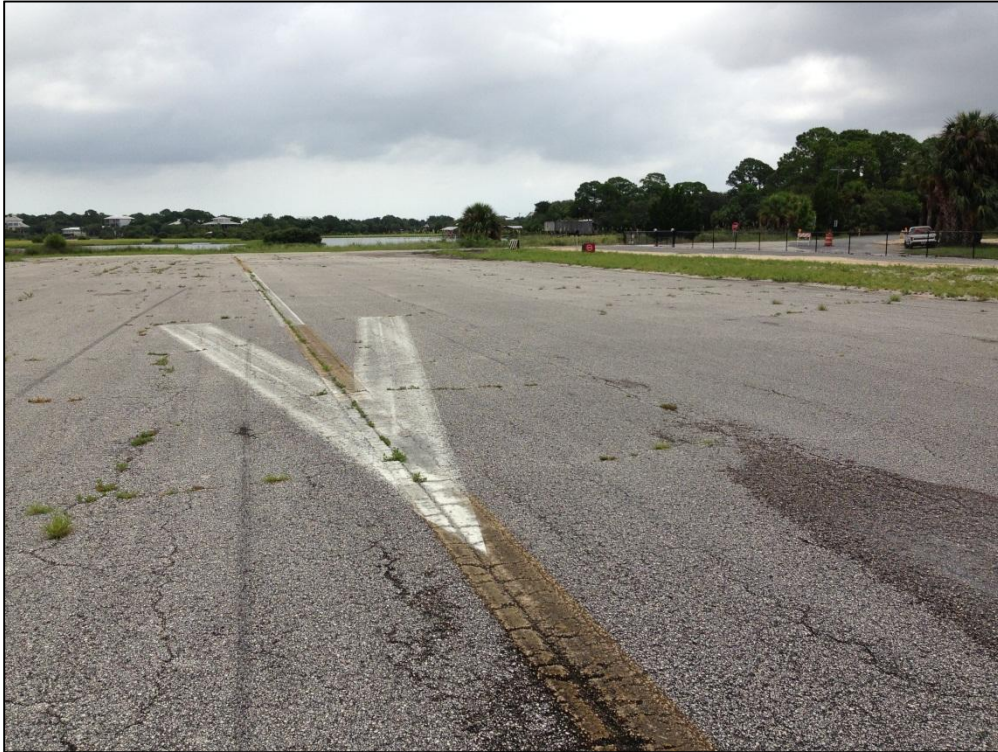
Runway 5-23, Section 6105, Sample Unit 143 – Low Severity (43) Block Cracking, Low and Medium Severity (52) Raveling, Low Severity (57) Weathering

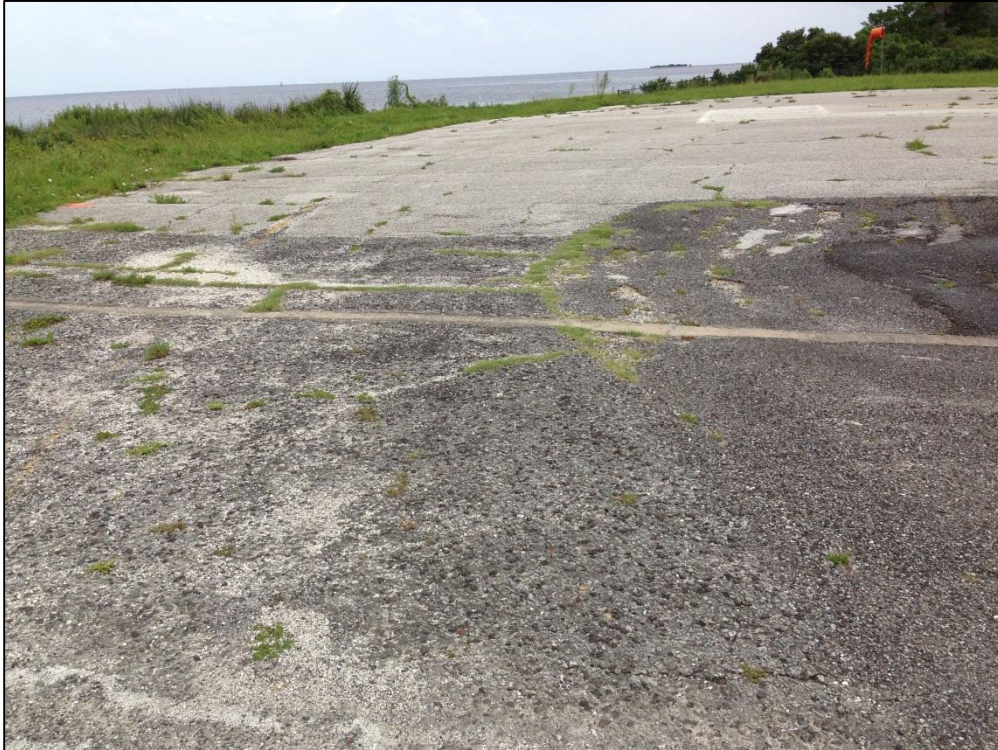
The remaining taxiways and aprons were generally in Failed to Serious condition. The pavements exhibited low and medium severity block cracking; low, medium, and high severity raveling; and low and medium severity depression. The severity and quantity of these distresses are indicative of pavements that have little or no structural capacity left.

Taxiway A, Section 105, Sample Unit 100 – Medium Severity (43) Block Cracking, High Severity (52) Raveling, Medium Severity (50) Patching

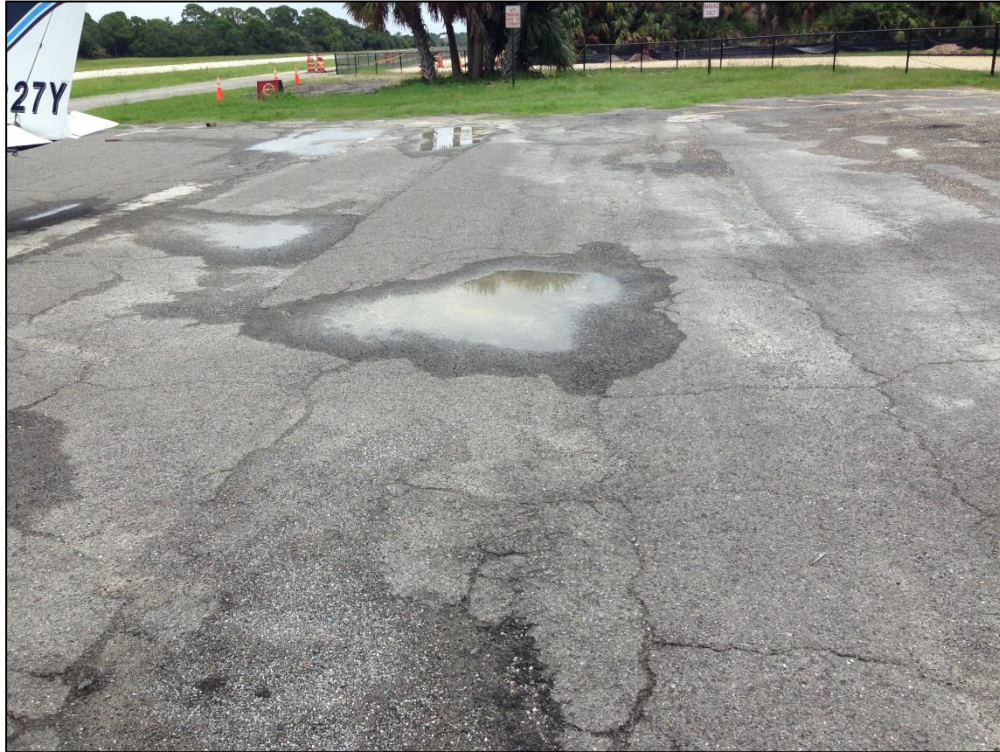
Apron, Section 4105, Sample Unit 100 – Low Severity (43) Block Cracking, Medium and High Severity (52) Raveling, Low and Medium Severity (45) Depression
