**MIAMI EXECUTIVE  
AIRPORT (TMB)**

DISTRICT 6  
REGIONAL RELIEVER  
AIRPORT  
JUNE 2015

STATEWIDE  
**Airfield  
Pavement  
Management**  
PROGRAM

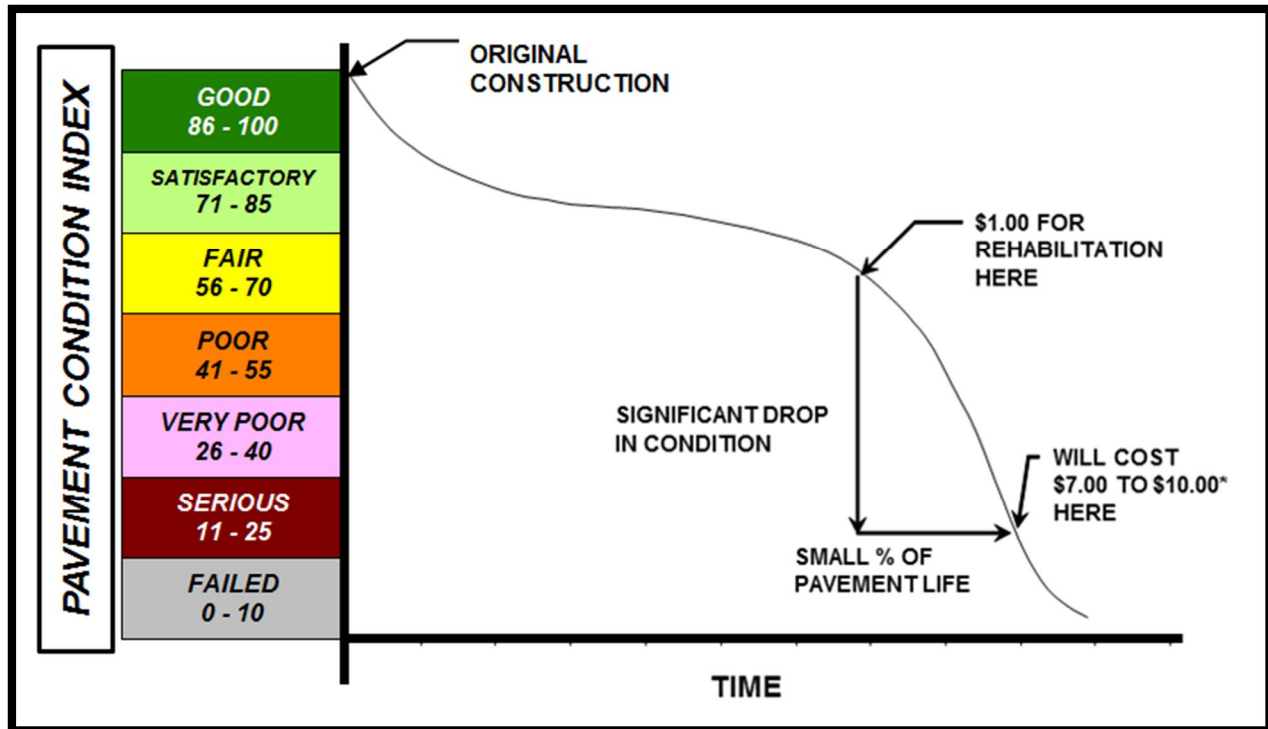
Figure 1-1: Pavement Life Cycle

Note that during approximately the first 75% of a pavement's life, it performs relatively well. After that, however, it begins to deteriorate rapidly. The number of years a pavement stays in 'Good' and 'Satisfactory' conditions depends on how well it is proactively maintained. As the Figure 1-1 demonstrates, the cost of maintaining the pavement above critical condition before rapid deterioration occurs is much less compared to maintaining pavements after substantial deterioration has occurred.

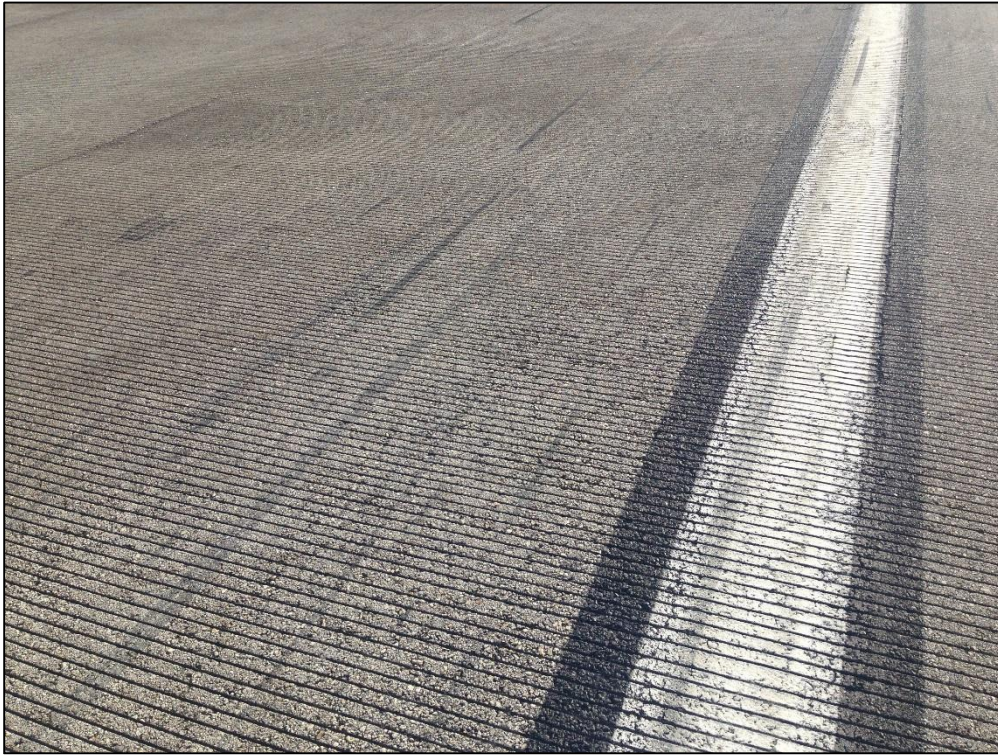
Runway 9L-27R, Section 6105, Sample Unit 383 – Low Severity (48) Longitudinal and Transverse Cracking, Low Severity (57) Weathering, Medium Severity (57) Weathering

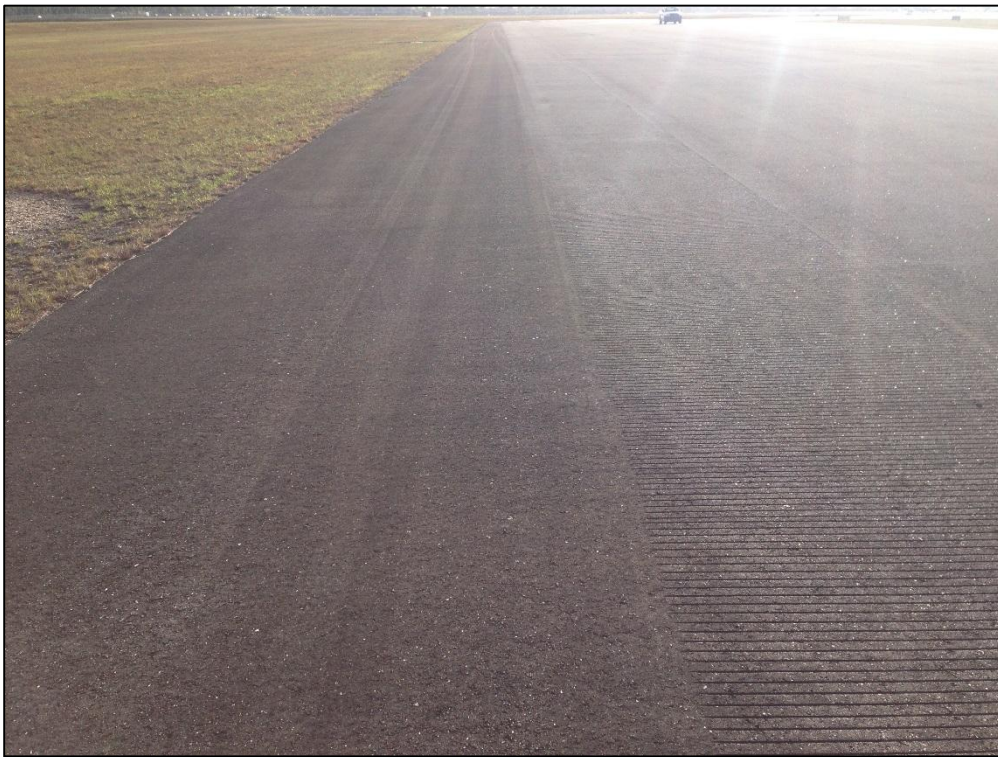
Runway 9L-27R, Section 6110, Sample Unit 184 – Low Severity (57) Weathering, Medium Severity (57) Weathering

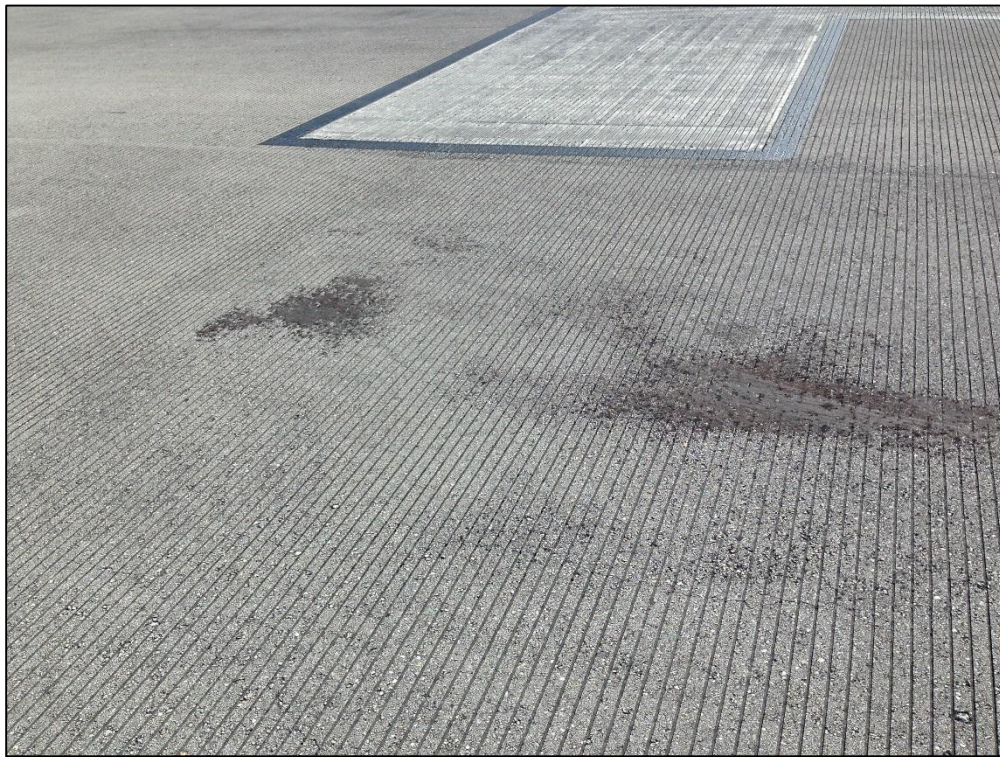
Runway 13-31, Section 6205, Sample Unit 378 – (42) Bleeding, Low Severity (48) Longitudinal and Transverse Cracking, Low Severity (57) Weathering, Medium Severity (57) Weathering

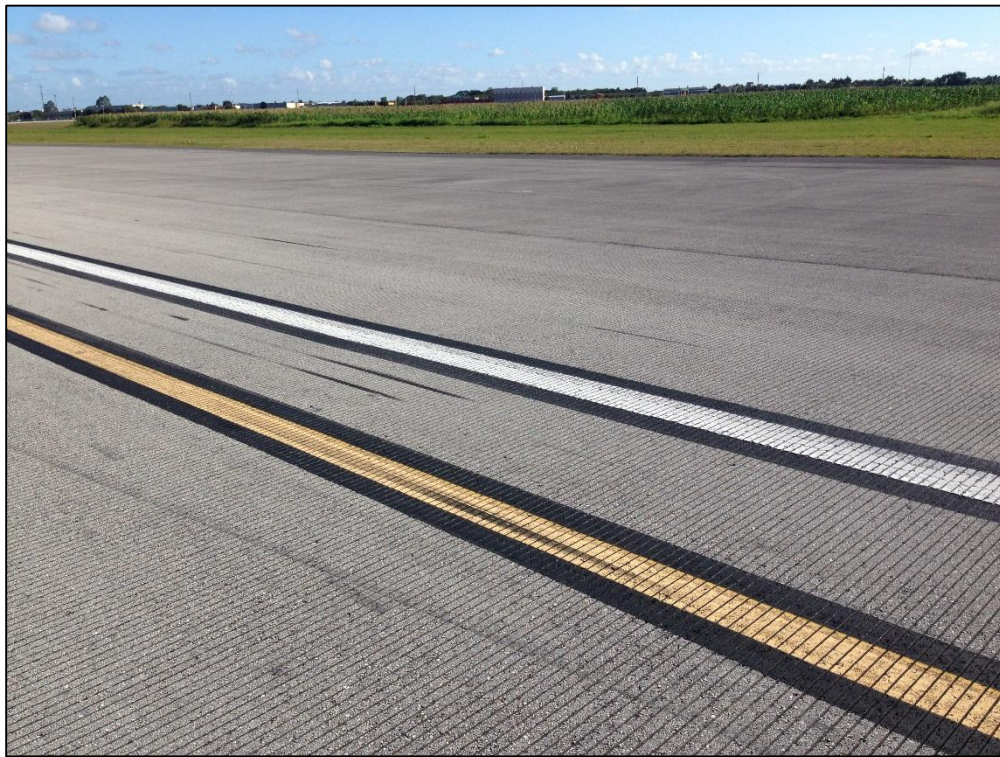
Runway 13-31, Section 6205, Sample Unit 353 – Low Severity (48) Longitudinal and Transverse Cracking, Low Severity (57) Weathering, Medium Severity (57) Weathering

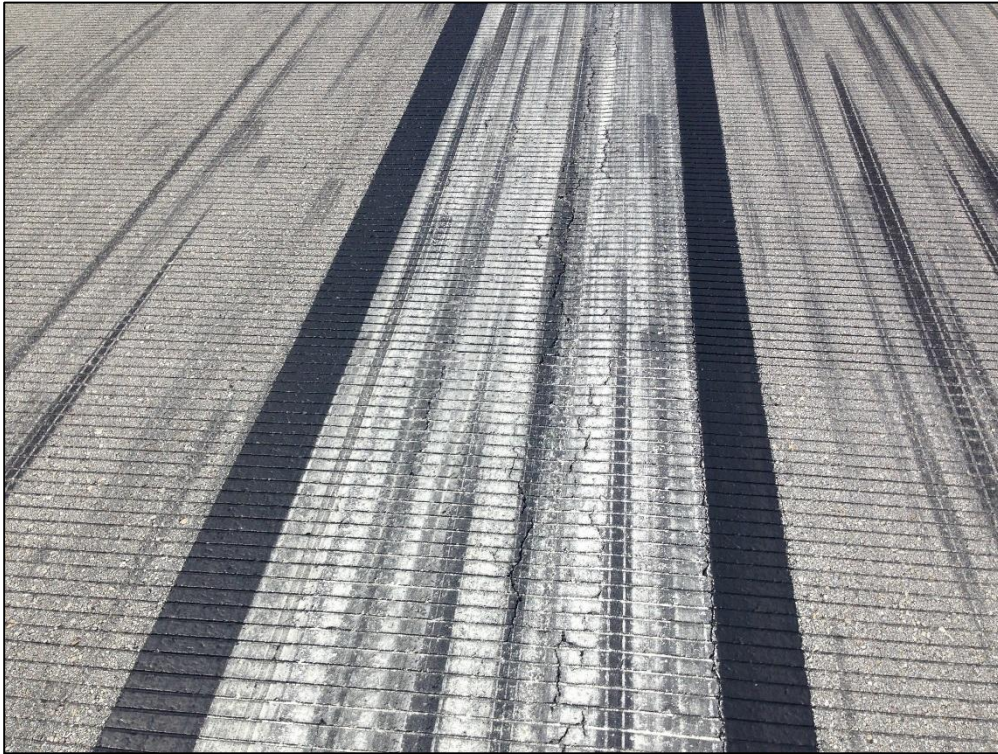
Runway 9R-27L, Section 6305, Sample Unit 342 – Low Severity (48) Longitudinal and Transverse Cracking, Low Severity (52) Raveling, Low Severity (57) Weathering, Medium Severity (57) Weathering

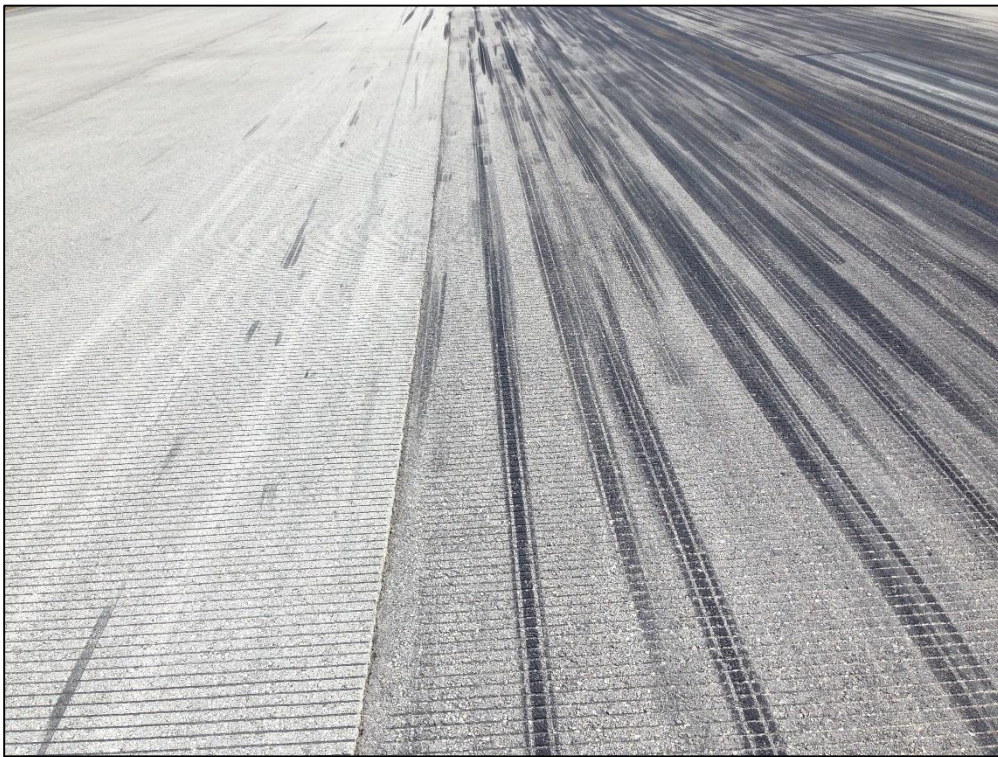
Runway 9R-27L, Section 6305, Sample Unit 325 – Low Severity (48) Longitudinal and Transverse Cracking, Low Severity (57) Weathering, Medium Severity (57) Weathering

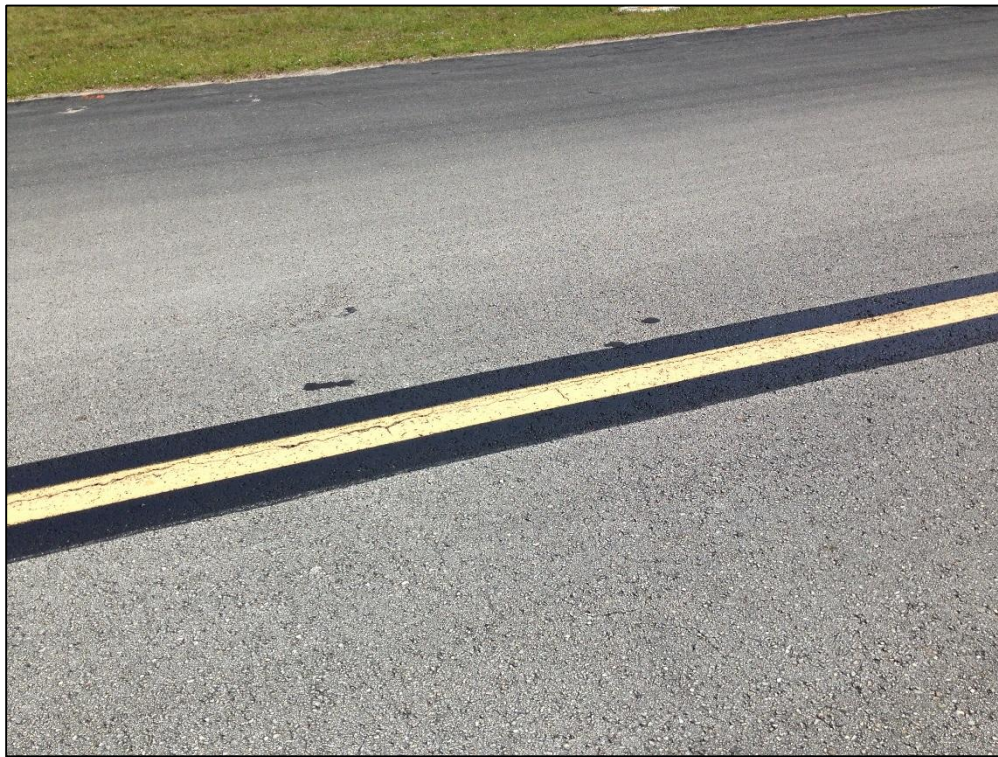
Taxiway Charlie, Section 910, Sample Unit 118 – (42) Bleeding, Low Severity (48) Longitudinal and Transverse Cracking, Low Severity (57) Weathering

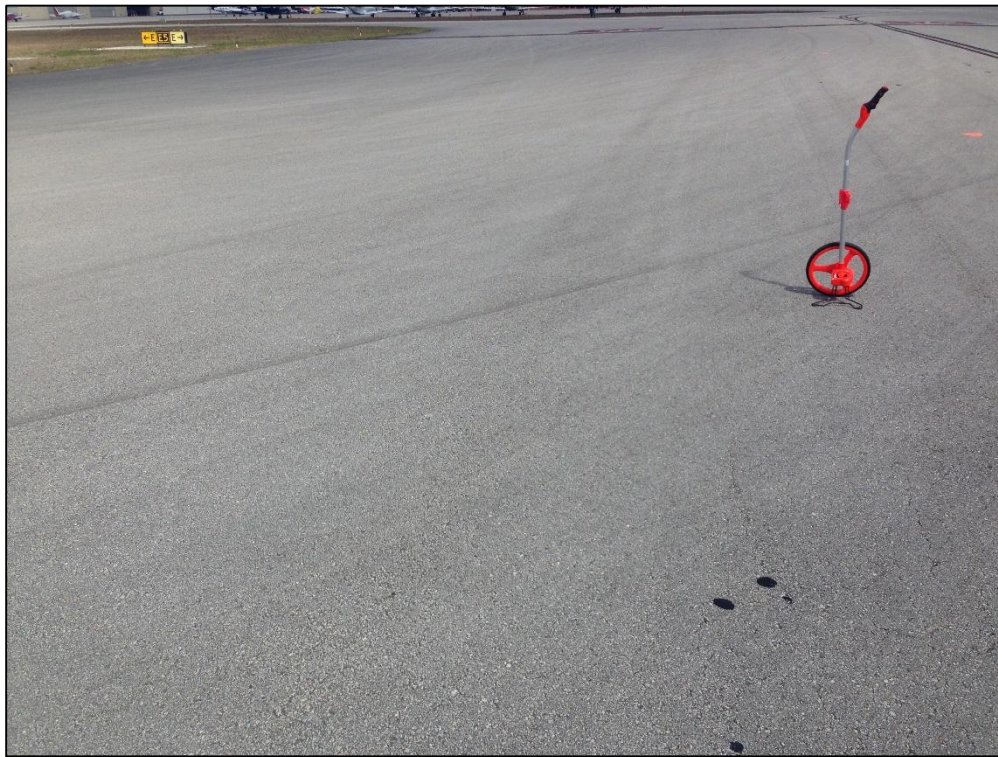
Taxiway E5, Section 529, Sample Unit 100 – Low Severity (48) Longitudinal and Transverse Cracking, Medium Severity (57) Weathering

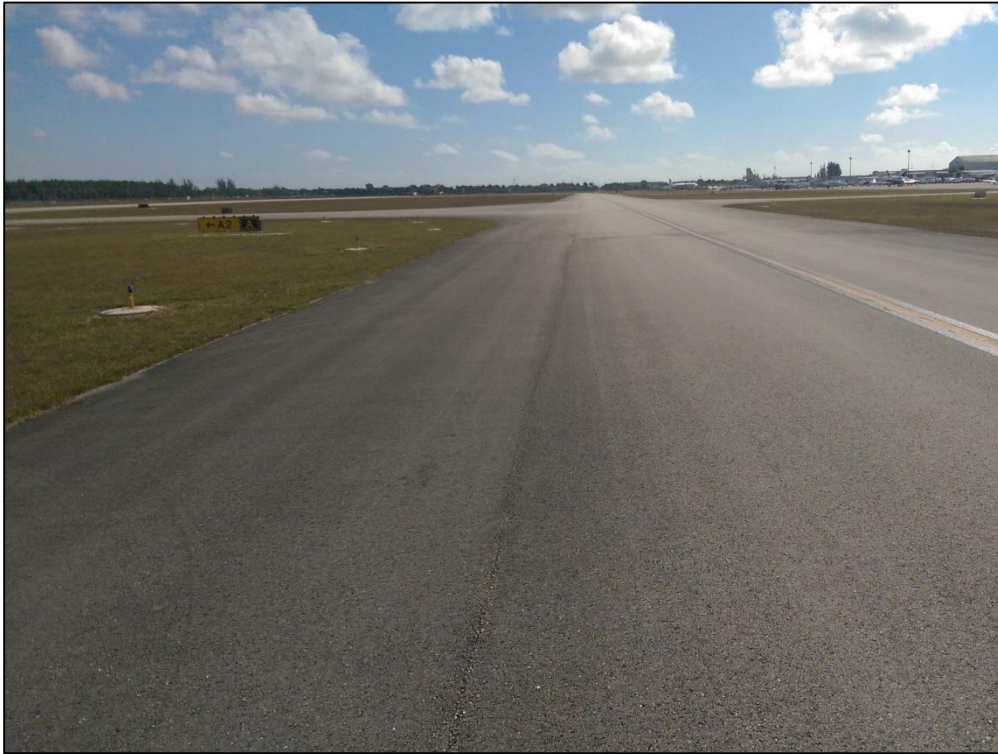
Taxiway Alpha, Section 105, Sample Unit 129 – Low Severity (48) Longitudinal and Transverse Cracking, Low Severity (57) Weathering

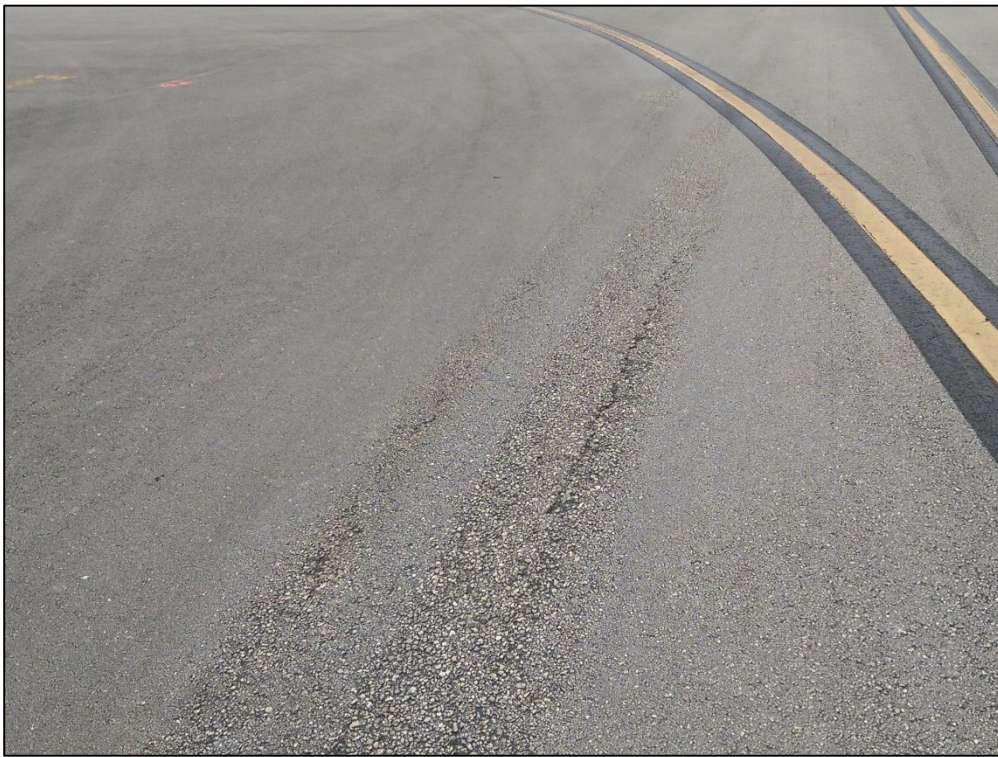
Taxiway Echo, Section 505, Sample Unit 159 – Low Severity (48) Longitudinal and Transverse Cracking, Low Severity (52) Raveling, Medium Severity (52) Raveling

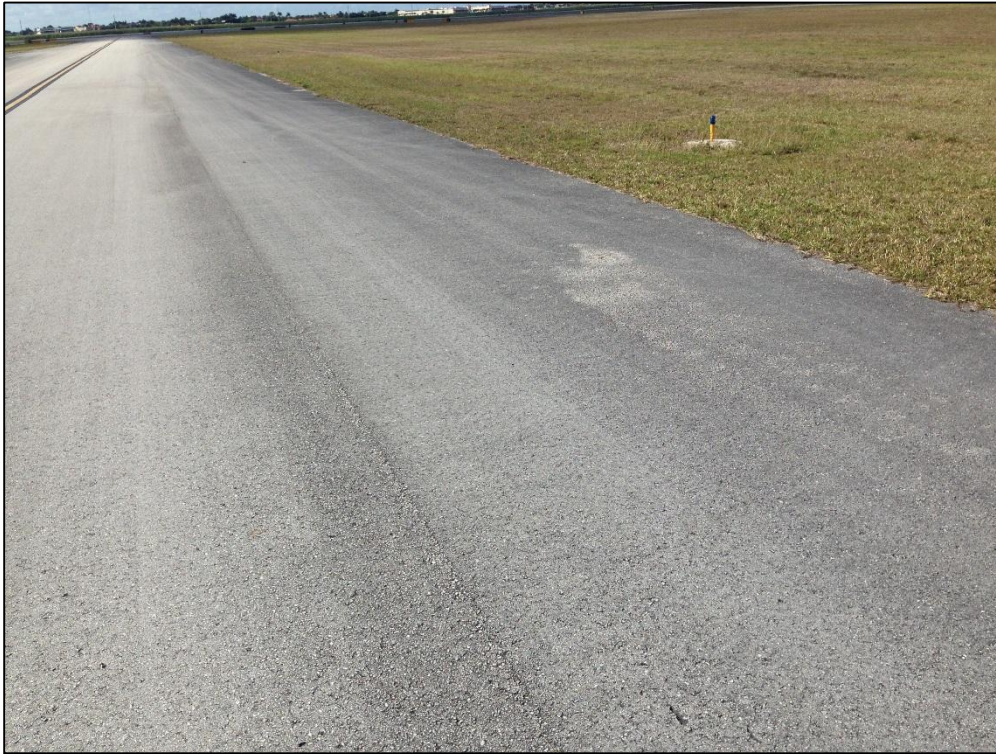
Taxiway Golf, Section 705, Sample Unit 209 – Low Severity (48) Longitudinal and Transverse Cracking, Low Severity (52) Raveling, Low Severity (57) Weathering, Medium Severity (57) Weathering

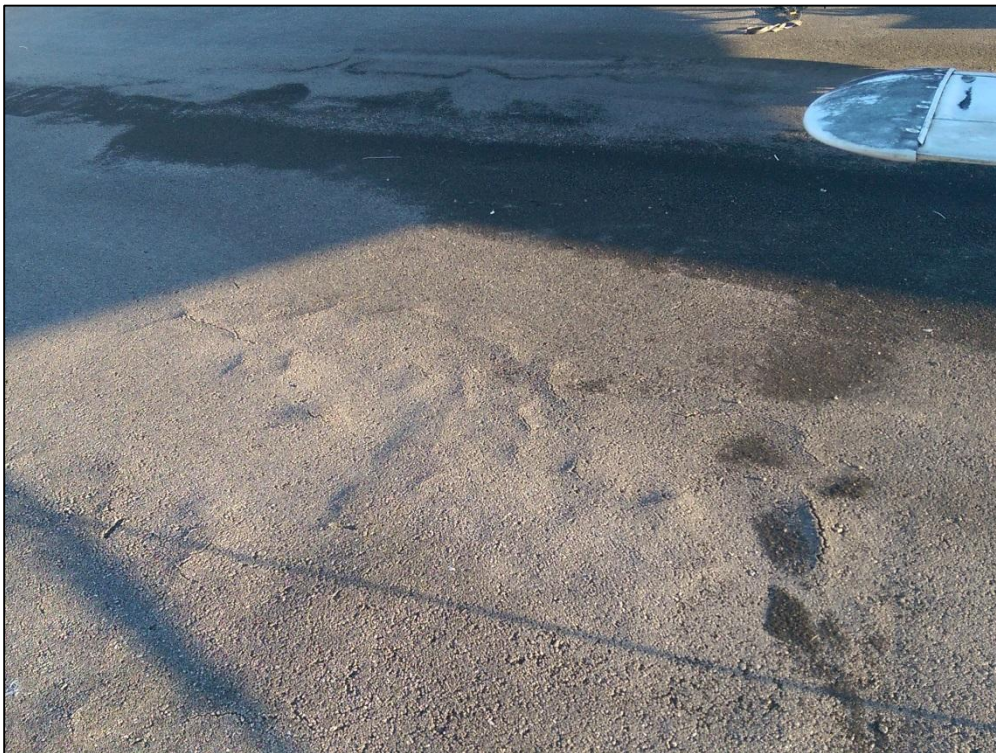
Apron North, Section 4205, Sample Unit 312 – Low Severity (48) Longitudinal and Transverse Cracking, Low Severity (56) Swelling, Low Severity (57) Weathering

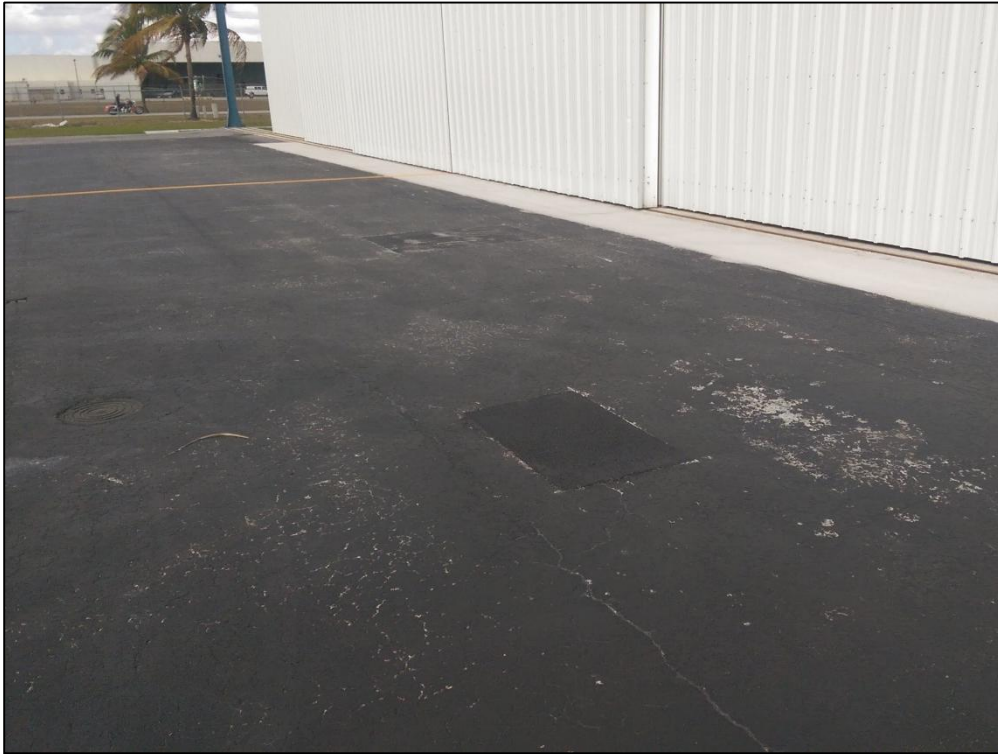
Apron Southeast, Section 4410, Sample Unit 501 – Low Severity (48) Longitudinal and Transverse Cracking, Low Severity (50) Patching, Medium Severity (57) Weathering

- ⦿ Runway 9L-27R – Section 6104
  - Mill and Overlay attributed to climate/age.
- ⦿ Southeast Apron – Section 4410
  - Mill and Overlay attributed to climate/age.
- ⦿ North Apron – Sections 4220, 4225, and 4230
  - Mill and Overlay attributed to climate/age and construction quality.
- ⦿ South Apron – Sections 4125, 4135, and 4140
  - Mill and Overlay attributed to climate/age and construction quality.
- ⦿ South Apron – Section 4130
  - Reconstruction attributed to climate/age and structural.
- ⦿ Taxiway SE Apron – Section 1105
  - Mill and Overlay attributed to climate/age and construction quality.
- ⦿ Taxiway NE Apron – Section 1005
  - Mill and Overlay attributed to climate/age.
- ⦿ Taxiway D2 – Section 420
  - Mill and Overlay attributed to climate/age.
- ⦿ Taxiway D – Section 405

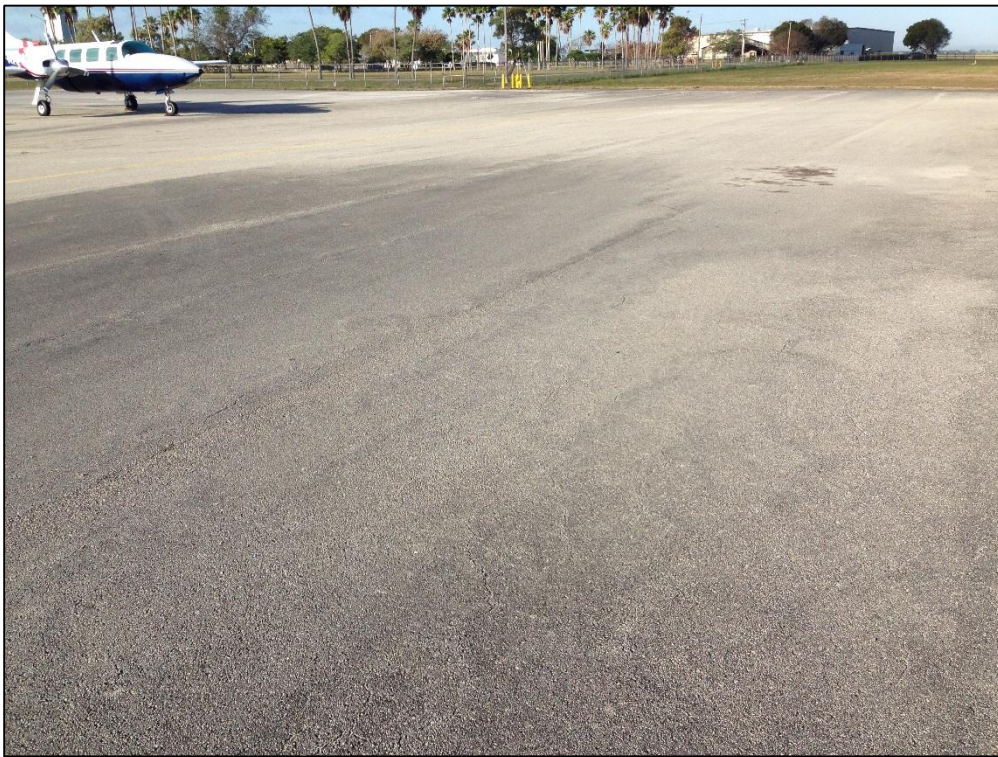
Apron North, Section 4220, Sample Unit 532 – Low Severity (48) Longitudinal and Transverse Cracking, (49) Oil Spillage, Low Severity (52) Raveling, Low Severity (56) Swelling, Medium Severity (57) Weathering
