Statewide Airfield Pavement Management Program

Airport Pavement Evaluation Report September 2017

**Suwannee County
Airport (24J)**
General Aviation Airport
District 2

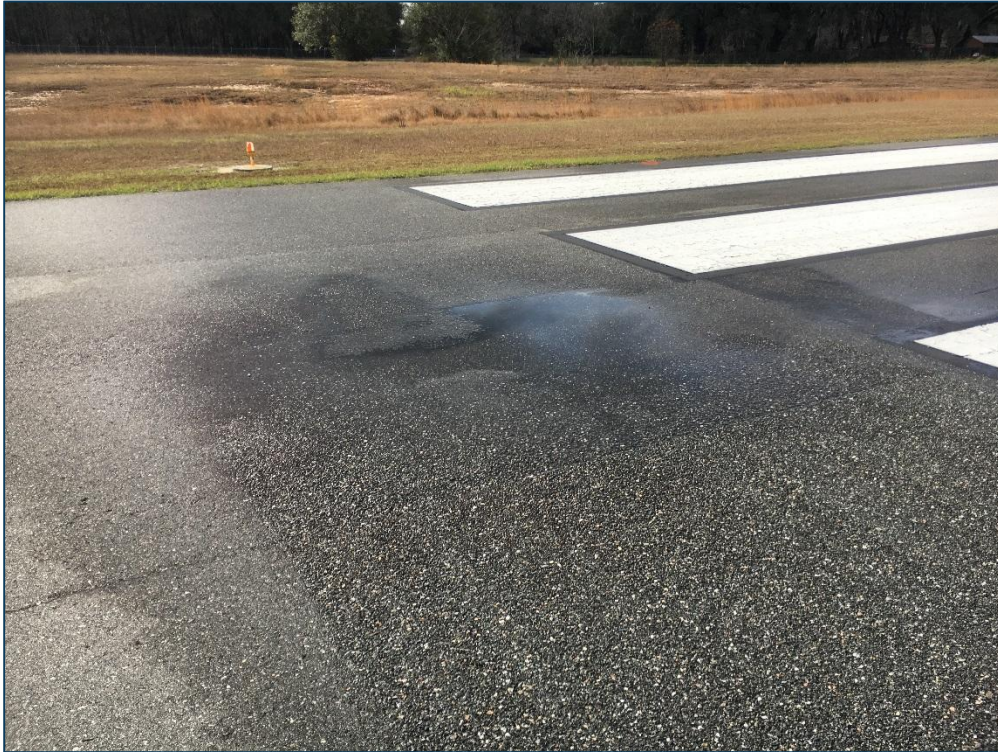
Runway 7-25, Section 6105, Sample Unit 103 – Low Severity (45) Depression, Low Severity (48) Longitudinal and Transverse Cracking, Low Severity (57) Weathering

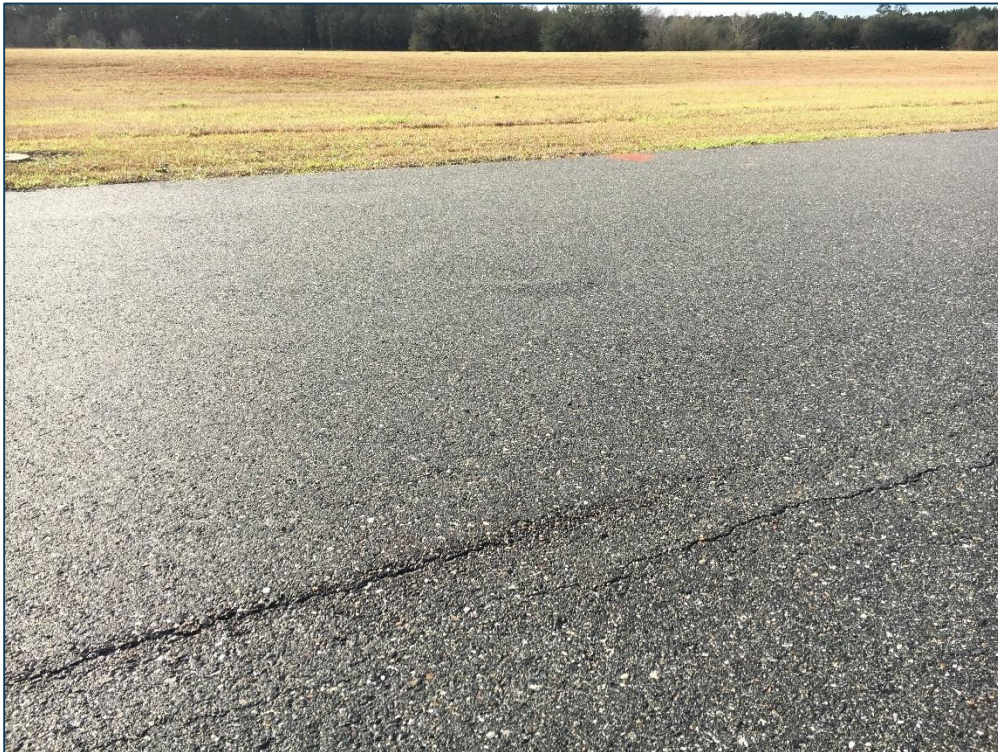
Runway 7-25, Section 6110, Sample Unit 146 – Low Severity (48) Longitudinal and Transverse Cracking, Low Severity (56) Swelling, Low Severity (57) Weathering

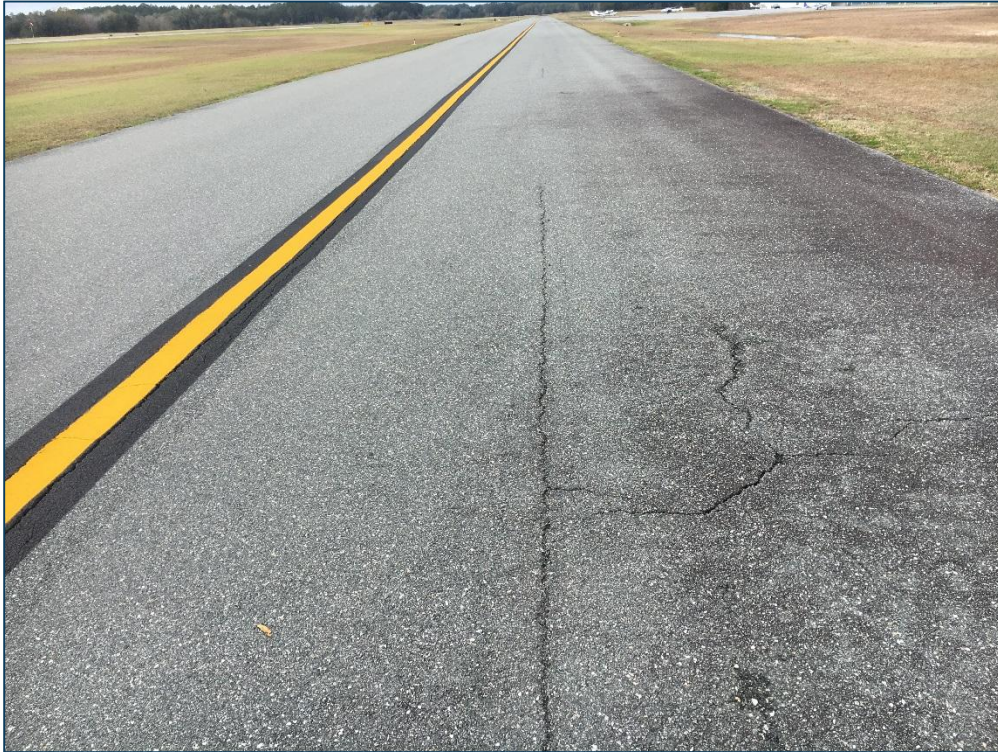
Taxiway A, Section 105, Sample Unit 104 – Low and Medium Severity (48) Longitudinal and Transverse Cracking, Low Severity (57) Weathering

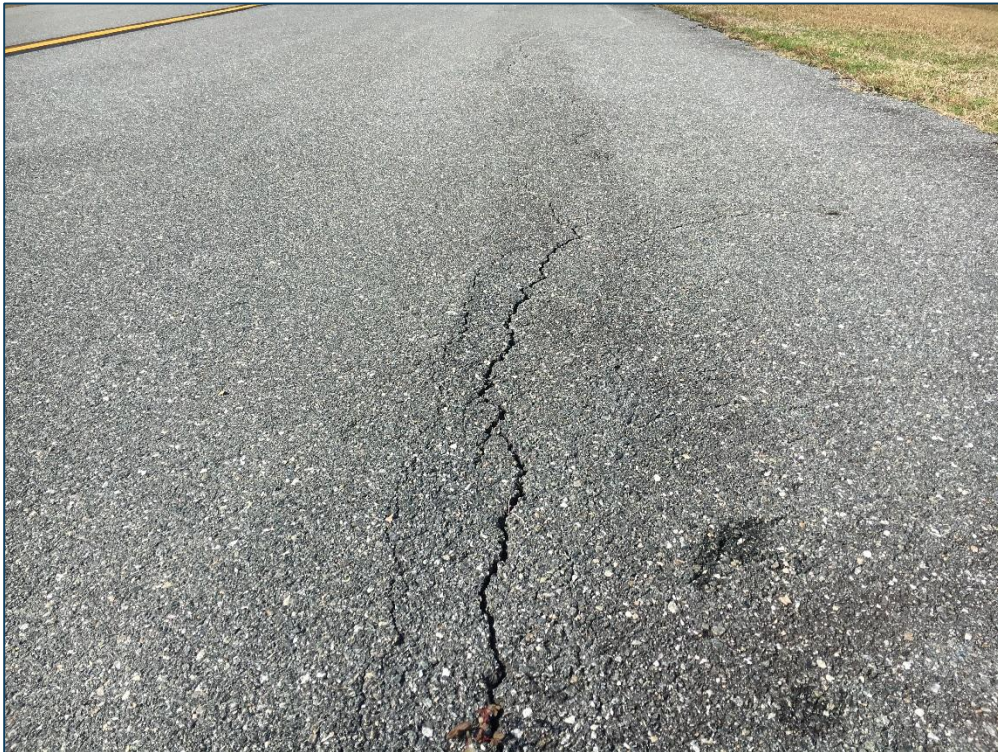
Taxiway A, Section 105, Sample Unit 112 – Low and Medium Severity (48) Longitudinal and Transverse Cracking, Low Severity (56) Swelling, Low Severity (57) Weathering

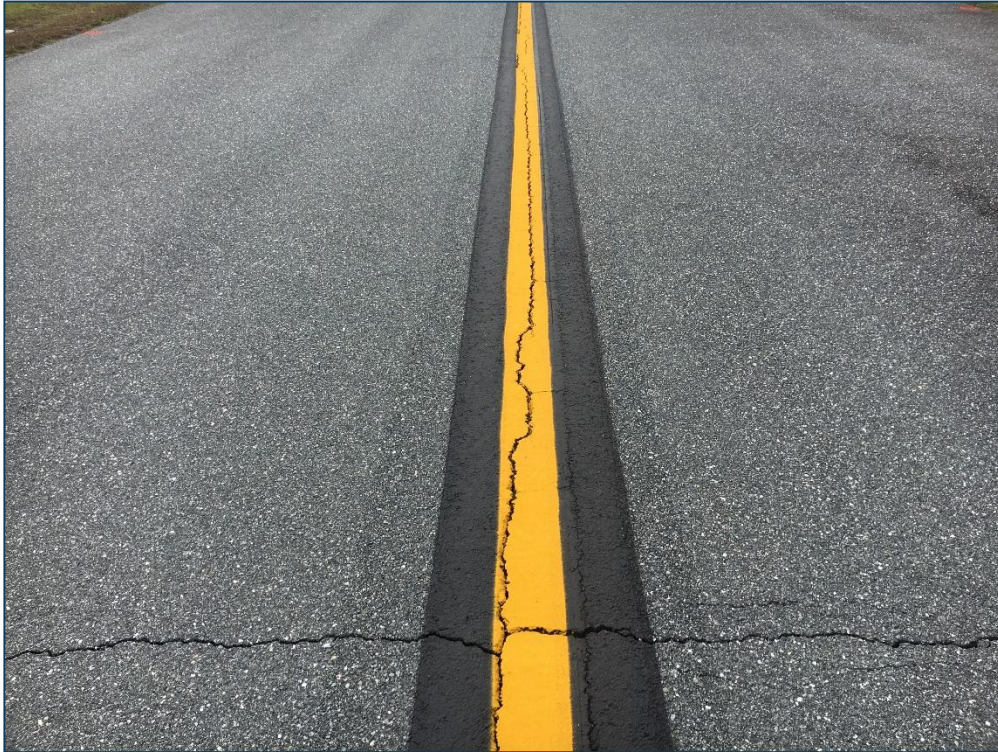
Taxiway A1, Section 115, Sample Unit 101 – Low and Medium Severity (48) Longitudinal and Transverse Cracking, Low Severity (57) Weathering

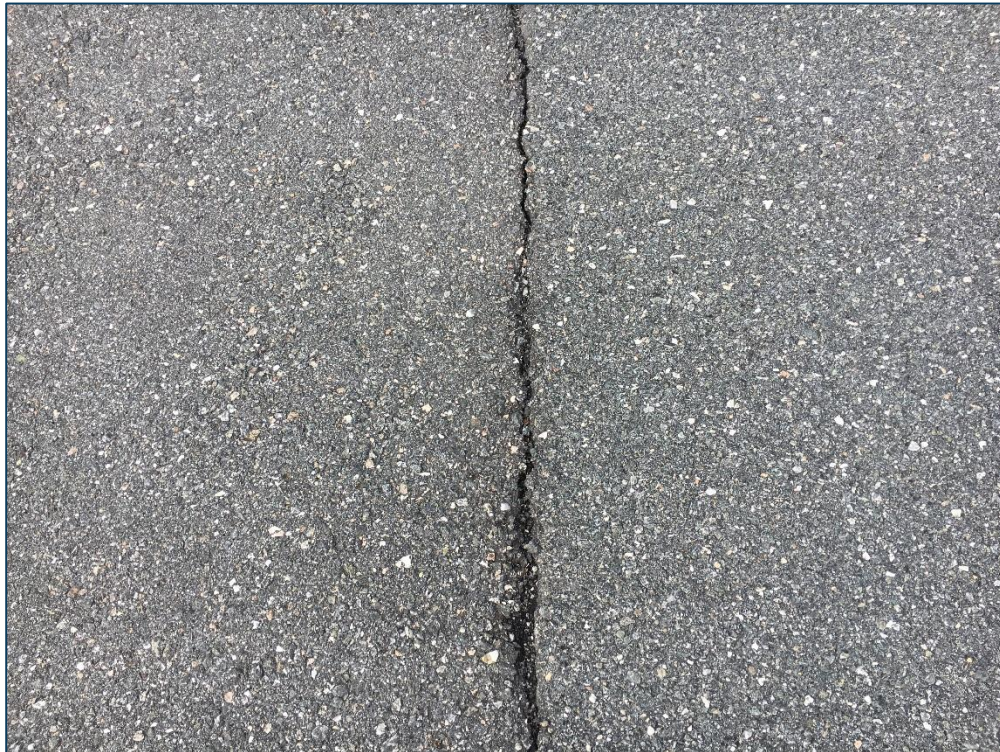
Taxiway A2, Section 125, Sample Unit 100 – Low Severity (48) Longitudinal and Transverse Cracking, Low Severity (52) Raveling, Low Severity (57) Weathering

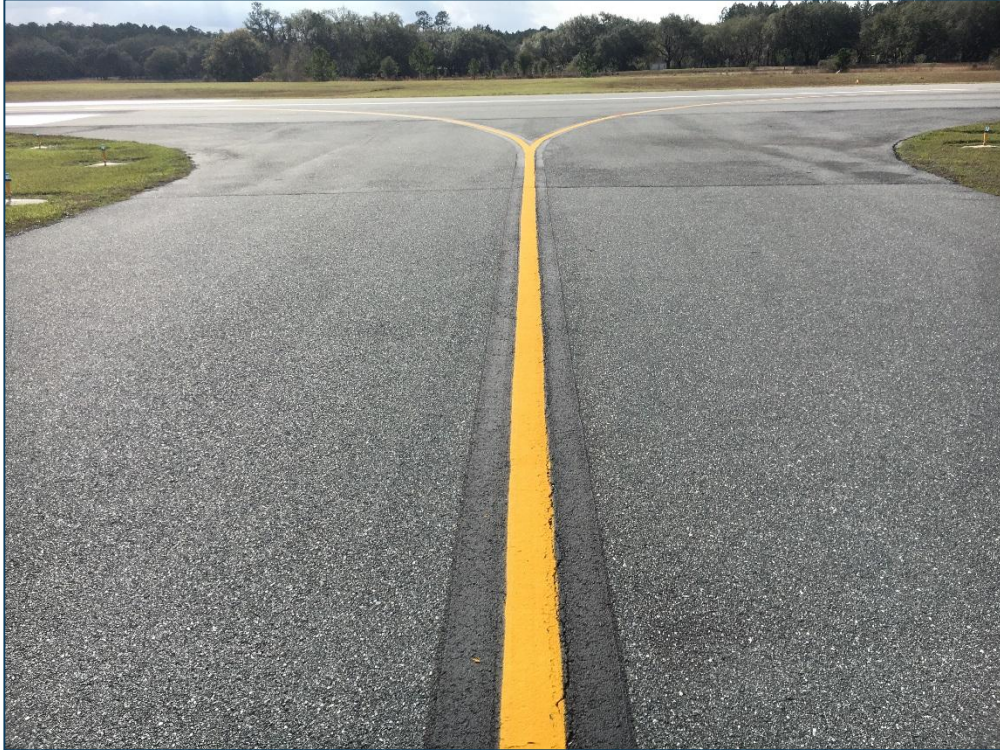
Taxiway A3, Section 135, Sample Unit 100 – Low Severity (48) Longitudinal and Transverse Cracking, Low Severity (57) Weathering

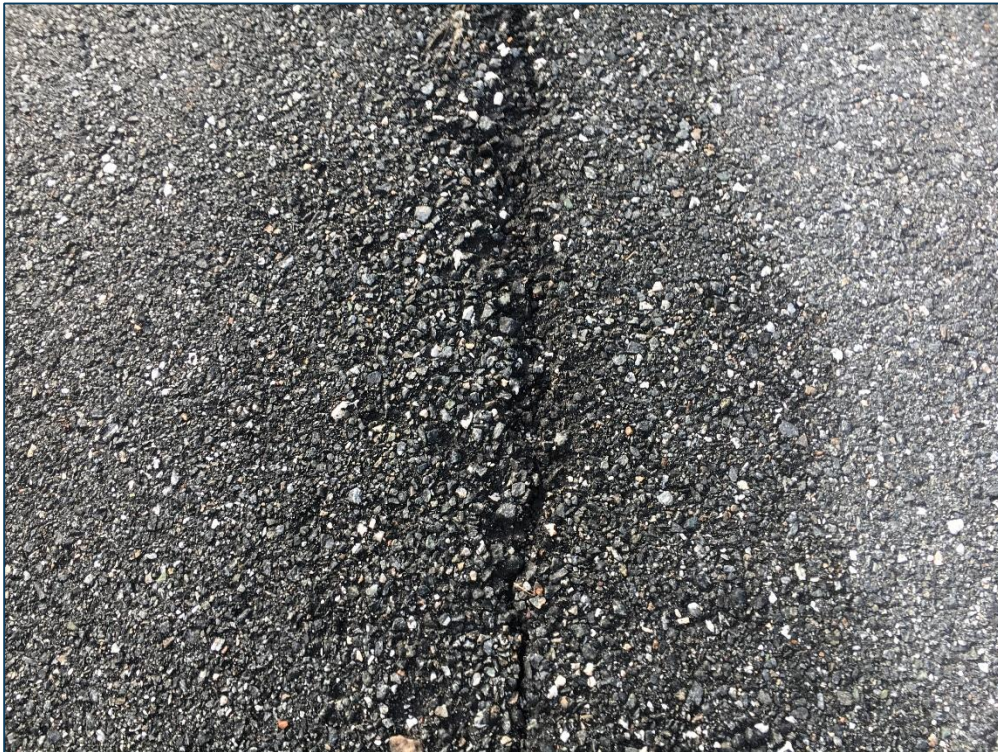
Taxiway C, Section 205, Sample Unit 101 – Low Severity (48) Longitudinal and Transverse Cracking, Low Severity (52) Raveling, Low Severity (57) Weathering

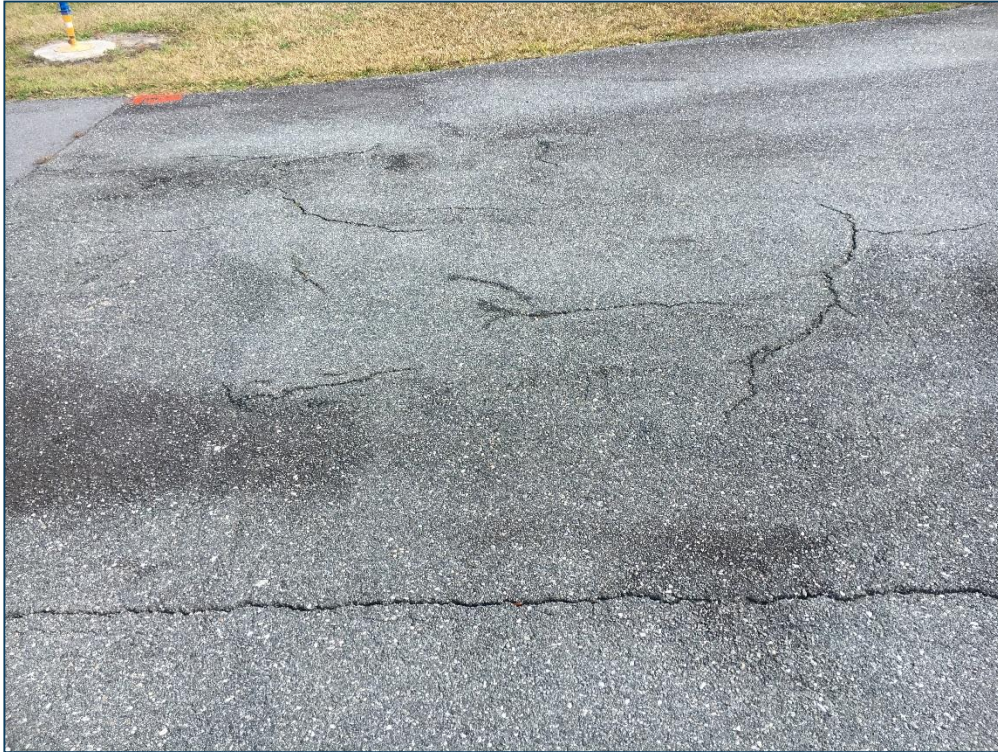
Taxiway to AP, Section 305, Sample Unit 100 – Low and Medium Severity (48) Longitudinal and Transverse Cracking, Low Severity (52) Raveling, Medium Severity (52) Raveling

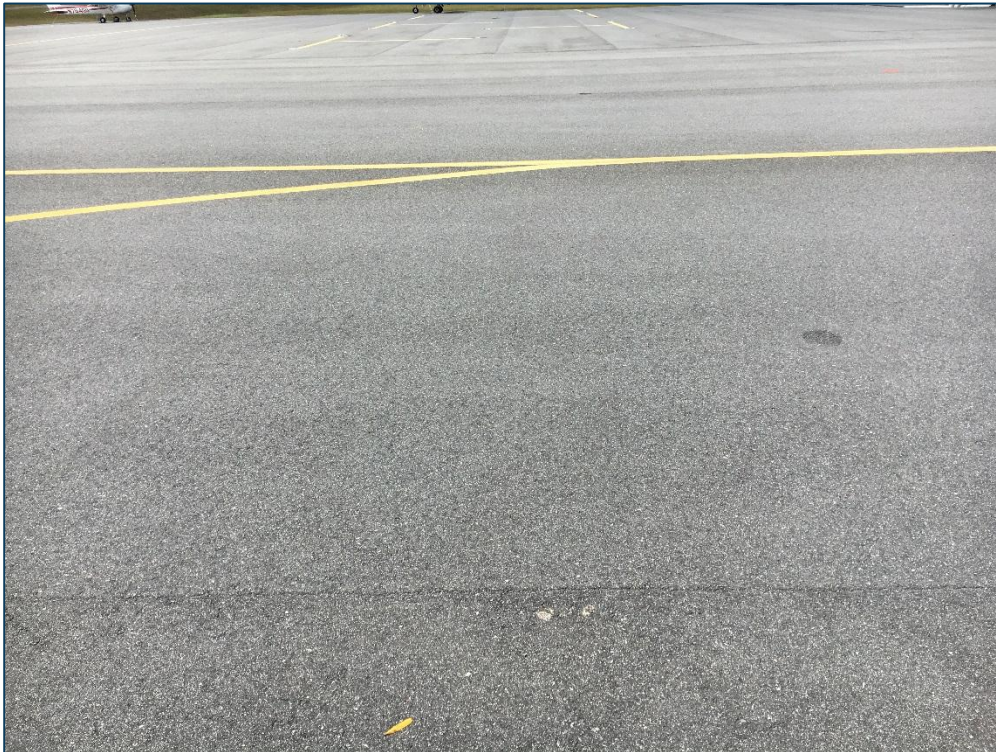
Apron, Section 4105, Sample Unit 202 – Low Severity (48) Longitudinal and Transverse Cracking, Low Severity (57) Weathering

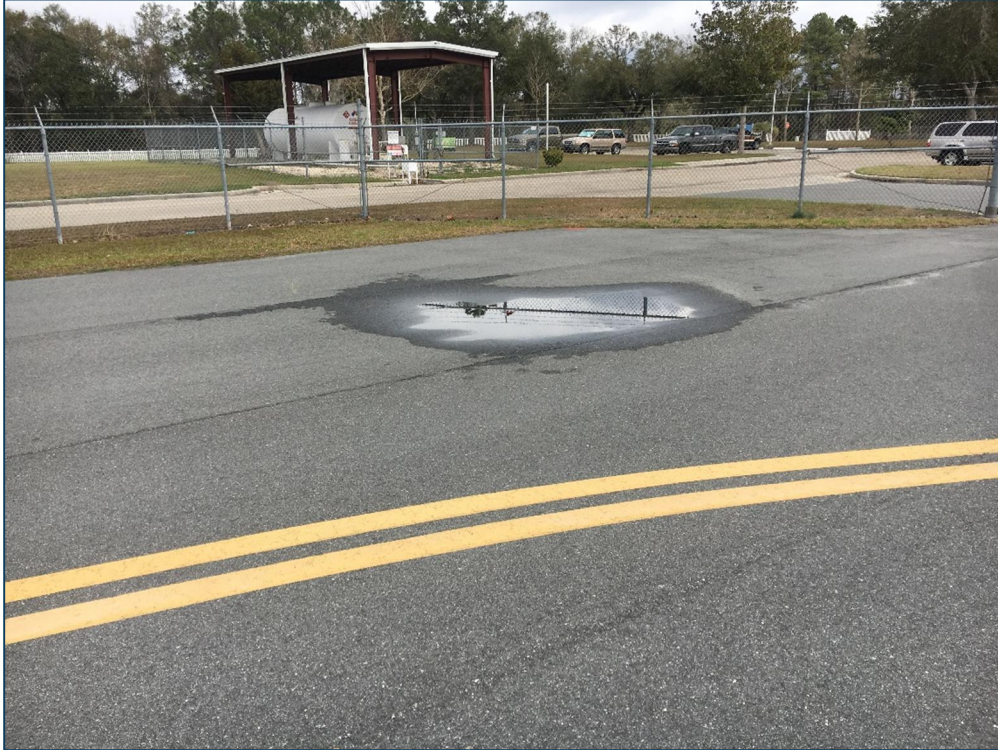
Apron, Section 4105, Sample Unit 454 – Low Severity (45) Depression, Low Severity (57) Weathering

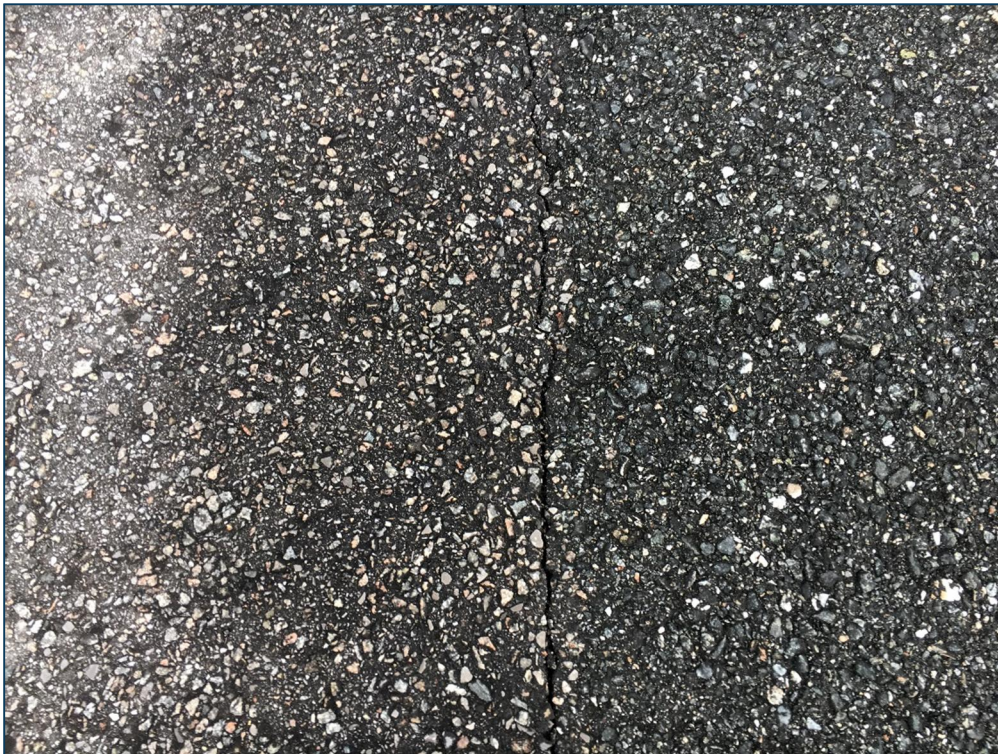
Apron Run-Up, Section 4205, Sample Unit 302 – Low Severity (48) Longitudinal and Transverse Cracking, Low Severity (52) Raveling, Medium Severity (52) Raveling

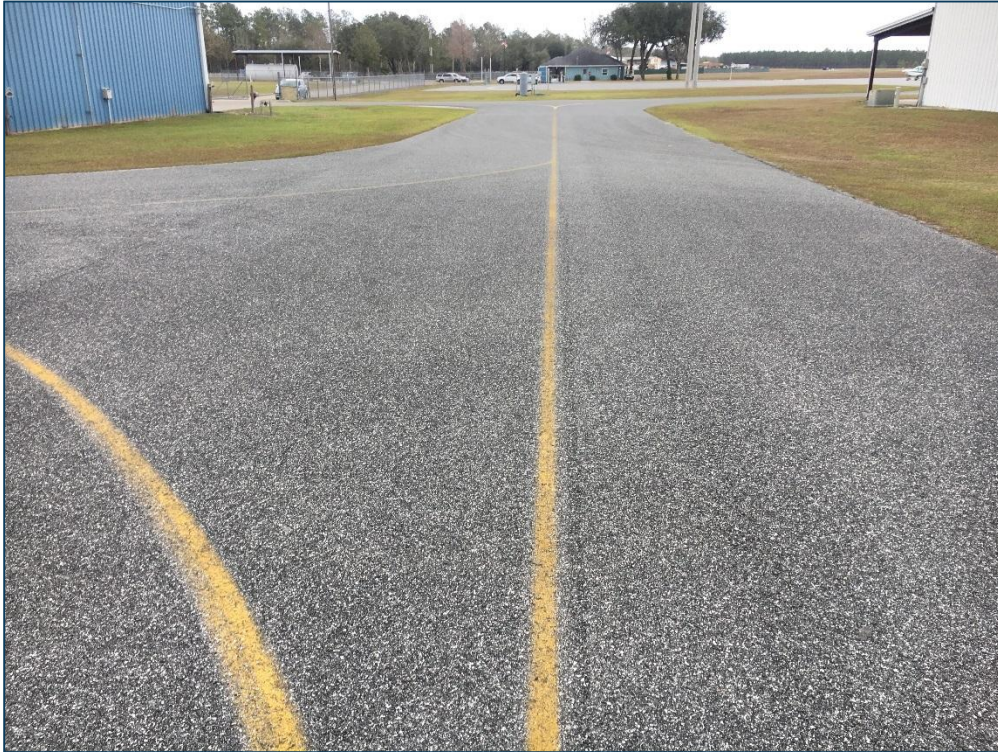
Taxilane to T-Hangar, Section 4115, Sample Unit 100 – Low Severity (52) Raveling

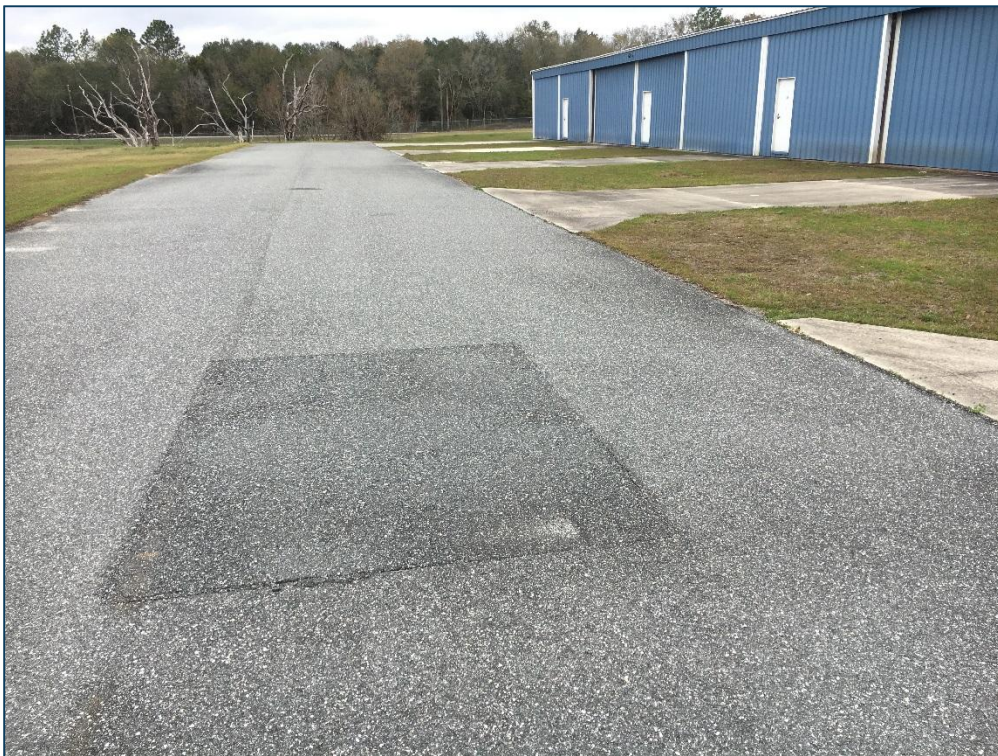
Taxilane to T-Hangar, Section 4125, Sample Unit 401 – Low Severity (50) Patching, Low Severity (52) Raveling, Low Severity (57) Weathering
