Florida Department of Transportation

Statewide Airfield Pavement Management Program

Summary of Wauchula Municipal Airport

Wauchula Municipal Airport was inspected in November 2016 - the overall weighted PCI value was 65, a condition rating of Fair. The results of the maintenance, repair, and major rehabilitation analysis identified \$358,320 in localized M&R needs based on current conditions and a 10-Year major rehabilitation need of \$4,109,000 based on forecasted conditions. The current major rehabilitation needs based on the latest inspection consist of \$4,109,000 for pavements below critical condition.

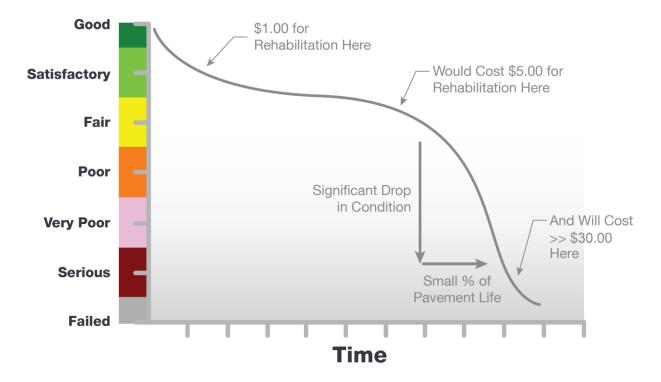
Figure 1.7-1 Typical Pavement Condition Life Cycle

A well-maintained network-level pavement management program may provide airport staff a better understanding of the airfield pavement performance for developing and planning for specific maintenance, repair, and major rehabilitation projects. The understanding of specific distress types and severities will assist the airport in addressing pavement maintenance and repair with the appropriate treatments as defined by the FAA Advisory Circular 150/5380-6C "Guidelines and Procedures for Maintenance of Airport Pavements." The development of projects with an understanding of system inventory, deterioration details, and pavement condition forecasts may assist airport staff in developing practical rehabilitation actions and budgets. Furthermore, the understanding of pavements' past performance and forecasted condition may assist airport staff in addressing pavement rehabilitation in a timely and costeffective manner. Figure 1.7-1 Typical Pavement Condition Life Cycle, which is based on the FAA Advisory Circular 150/5380-7B "Airport Pavement Management Program (PMP)." Figure 1.7-1 Typical Pavement Condition Life Cycle, depicts a general duration of a pavement section and identifies the ideal condition to perform rehabilitative treatments at an optimal cost rather than allowing significant increase in rate of deterioration that would result in increased costs.

Pavement maintenance, repair, and major rehabilitation would be quite anticipatory if all pavements behaved as depicted in Figures 1.7-1 and 1.7-2, however pavement condition performance vary significantly based on several factors. Factors that contribute to a pavement section's condition and deterioration performance may include: functional design life, material type, material construction quality, climatic conditions, aircraft loading type and frequency, nonaircraft loading type and frequency, maintenance history, subgrade conditions, and other infrastructure in the vicinity. The list of factors is not all-inclusive of all factors that may contribute to a pavement's life cycle, it is intended to clarify that unique conditions certainly will affect a pavement's deterioration.

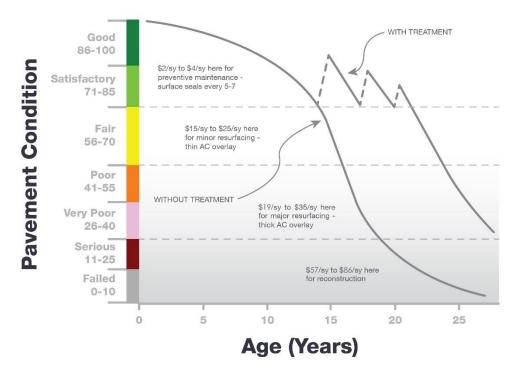
Figure 1.7-2 General Pavement Treatments by Condition Range depicts generic flexible asphalt concrete (AC) pavement treatments that are effective at specific condition ranges. This graphic is a general concept and will vary based on pavement surface type and overall

composition. The intent is to convey various treatment types that would be effective based on the condition of the pavement along the deterioration model.

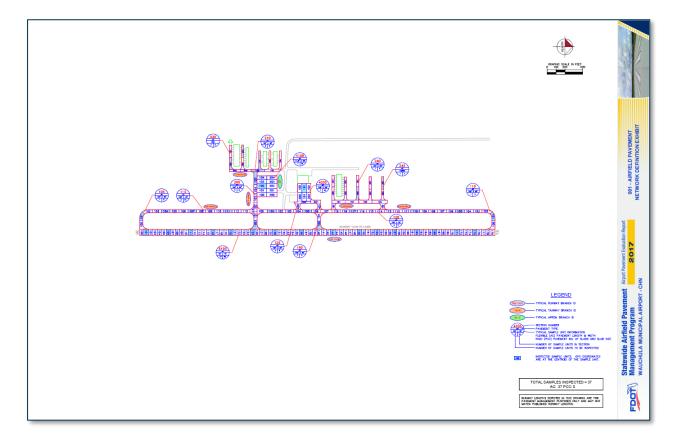
Figure 3.1.1-1 2017 Airfield Pavement Network Definition Exhibit

The Airfield Pavement Network Definition Exhibit provides details to the PCI Survey inspection efforts. The exhibit identifies the pavement facilities, surface type, section definition, and sample unit delineation.

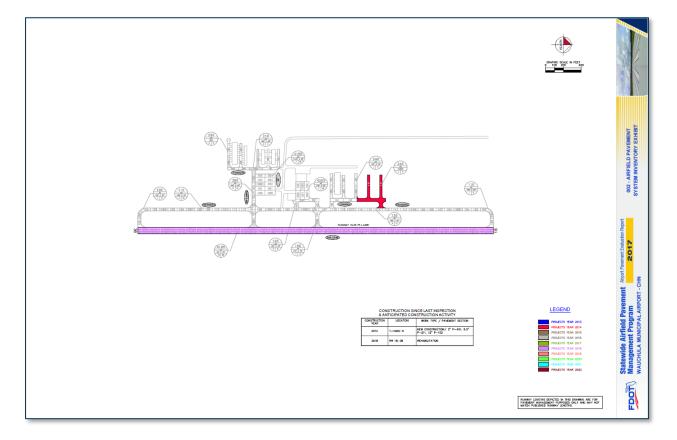
Figure 3.1.1-2 2017 Airfield Pavement System Inventory Exhibit

The Airfield Pavement System Inventory Exhibit provides details to the work history updates communicated by the Airport. The Exhibit provides the approximate limits of recent and/or anticipated construction on the airfield pavement facilities. The limits are based on documentation provided by the Airport and, if constructed, observed in the field.

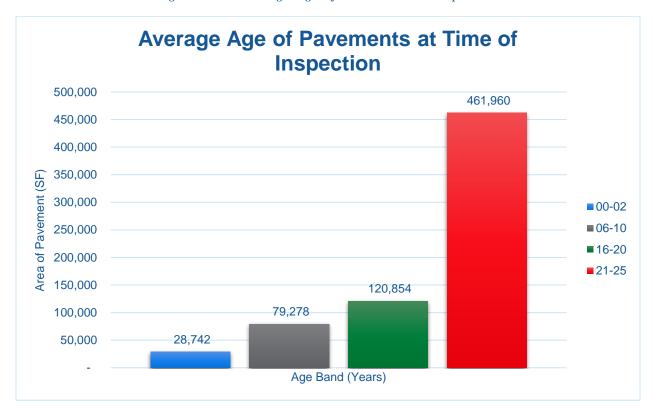
Figure 3.1.2 Average Age of Pavements at Inspection

Standard pavement design practice considers a design life of a 20-year period. Design inputs typically require subgrade soil conditions, pavement section layer material characteristics, and anticipated loading (aircraft fleet mix) for the design-life period. Based on the review of the historic airfield pavement construction, Figure 3.1.2 summarizes the average age of the pavement sections since any major construction activity has occurred during the PCI Survey inspection. This is intended to be a rough estimate based on interpretation of the limited data available at the time of report.

The estimation of the pavement age is based on information requested and provided by participating airports. Additionally, data collected in the prior system updates since 1992 have been relied upon.

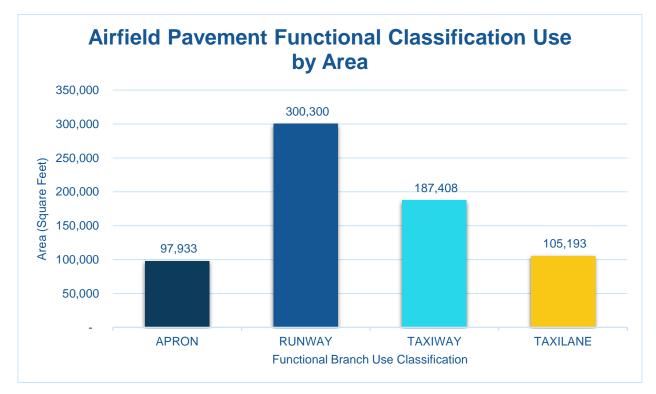
Figure 3.1.3 Airfield Pavement Functional Classification Use by Area

Pavements are subject to varying aircraft loading patterns based on utilization and overall operations. For this SAPMP Update, the following categories of airfield functional use have been identified and associated with the following possible pavement branch facilities: Apron, Runway, Taxiway, and Taxilane. Figure 3.1.3 summarizes the identified pavements' functional use by area in square feet. The pavement areas reviewed exclude shoulder pavement facilities.

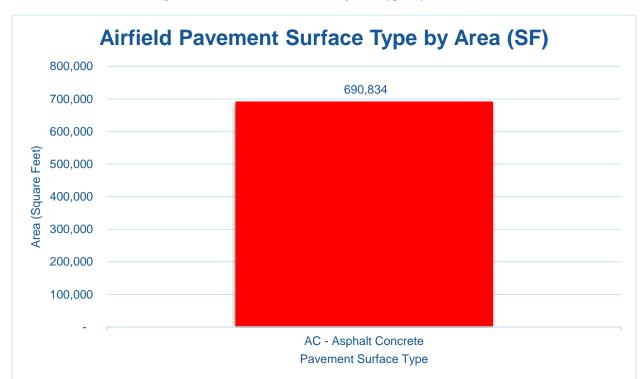
Figure 3.1.4 (a) Pavement Surface Type by Area (SF)

The airfield pavement facility surface types within the SAPMP include four common types of pavement: Portland cement concrete (PCC), asphalt concrete (AC), asphalt concrete overlaid on asphalt concrete (AAC), and asphalt concrete overlaid on Portland cement concrete (APC).

Based on the record documentation incorporated within the SAPMP database throughout the years, the pavement surface types have been assigned to the various pavement sections in accordance to its work history composition. The following Figures 3.1.4 (a) and (b) summarize the applicable pavement types observed at this specific airport's airfield.

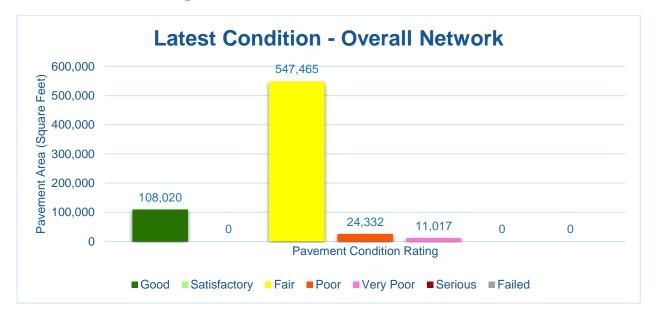
Figure 4.1.1 Latest Condition - Overall Network

The following Figure 4.1.1 summarizes the network-level pavement condition analysis based on the most recent PCI Survey inspection results.

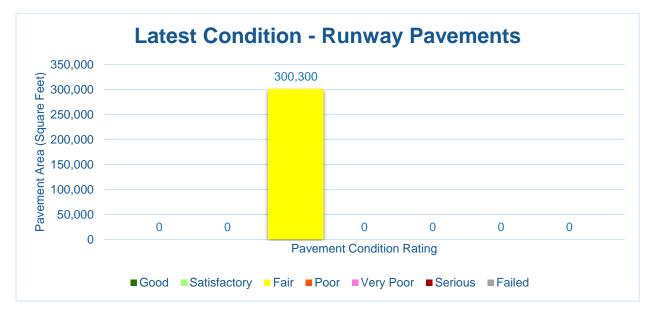
Figure 4.1.2 (a) Latest Condition - Runway Pavements

The following Figures 4.1.2 (a) through (d) summarize the branch-level pavement condition analysis based on the most recent PCI Survey inspection results; the following Figures provide overall branch-level conditions by branch use.

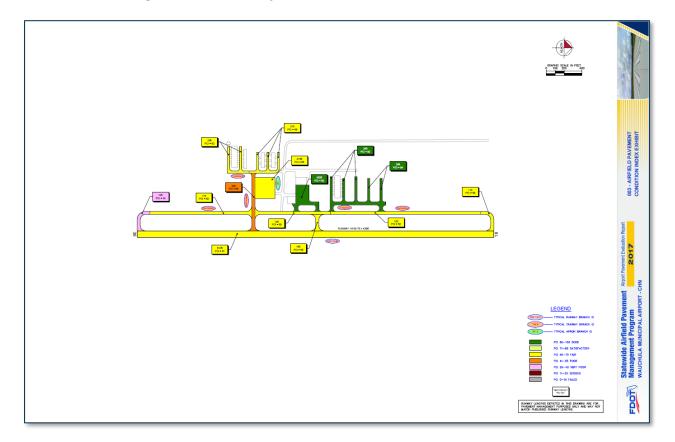
Figure 4.1.3 2017 Airfield Pavement Condition Index Exhibit

Figure 4.1.3 is an inset view of the 2017 Airfield Pavement Condition Index Exhibit that visually represents the results of the latest PCI Survey inspection. A large format exhibit is located in **Appendix C Technical Exhibits.**

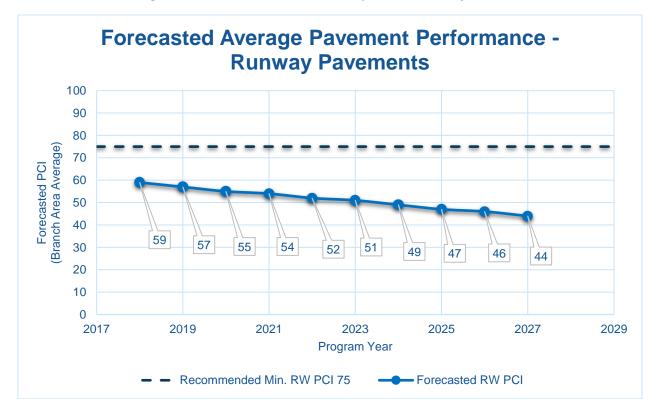
Figure 4.3.2 (a) Forecasted Runway Pavement Performance

The following Figures 4.3.2 (a) through (c) depict the branch-level pavement condition forecast by Branch Use (Runway, Taxiway, and/or Apron). The forecasted conditions are for a 10-year duration starting in January 2018 through January 2027.

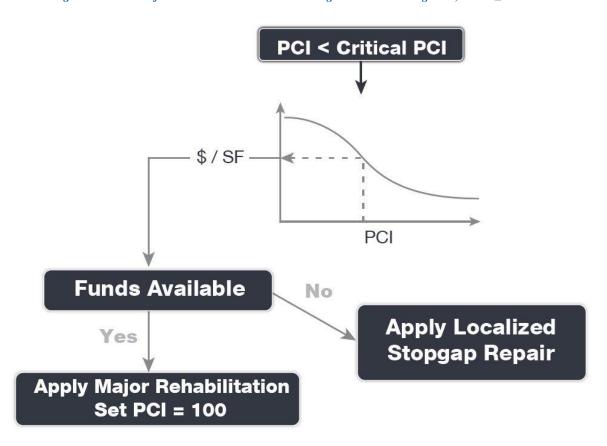
Figure 6.1-1 Major Rehabilitation Planning Decision Diagram, PCI ≤ Critical PCI

Major rehabilitation is recommended to correct or improve structural deficiencies and/or functional deterioration for pavement sections within a network. Often, when pavements are subject to significant changes in the aircraft fleet mix (frequency and type), major rehabilitation is required to provide a pavement section to meet the traffic demand. Major rehabilitation is recommended when a pavement section falls below the Critical PCI value that is defined during the system customization or if a pavement section has a significant observation of load-related distress. Observation of any load-related distress potentially indicates that the section may be structurally deficient or that the aircraft loads being applied to the pavement section are different than what the section was designed for. Figures 6.1-1 and 6.1-2 depict the decision process for major rehabilitation project identification with the assumption of available funds. Should funding be unavailable for pavement sections in need of major rehabilitation, the airport may elect to apply the appropriate localized stopgap repair.

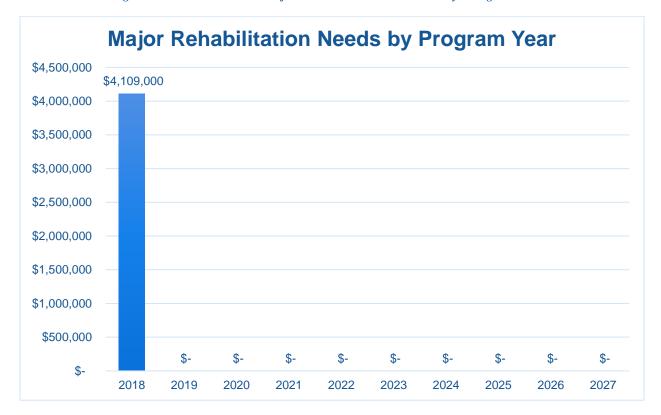
Figure 6.3.1-1 10-Year Major Rehabilitation Needs by Program Year

The following Figure 6.3.1-1 summarizes the section-level major rehabilitation needs for a 10year period between 2018 and 2027. Figure 6.3.1-2 provides an inset view of Airfield Pavement Major Rehabilitation Exhibit, a large format exhibit is located in Appendix C Technical **Exhibits**. The exhibit graphically depicts the Major Rehabilitation Needs with rounded costs.

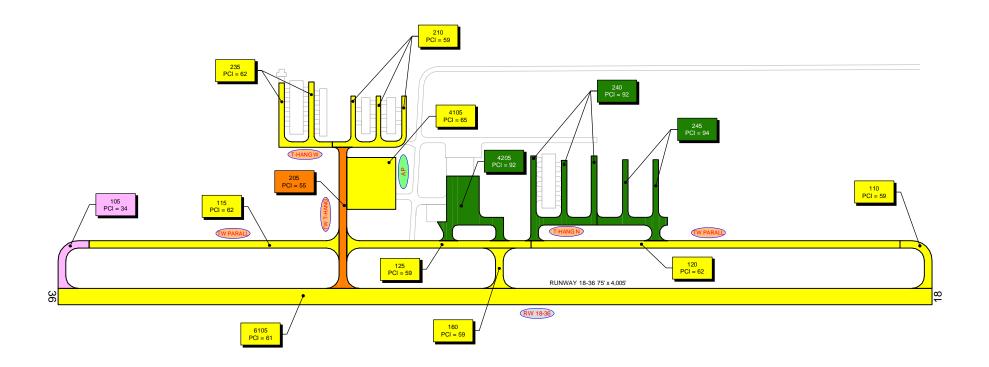
CONSTRUCTION SINCE LAST INSPECTION & ANTICIPATED CONSTRUCTION ACTIVITY

WALLES CONCINCOTIONALE								
CONSTRUCTION YEAR	LOCATION	WORK TYPE / PAVEMENT SECTION						
2014	T-HANG N	NEW CONSTRUCTION/ 2" P-401, 6.5" P-211, 12" P-152						
2018	RW 18-36	REHABILITATION

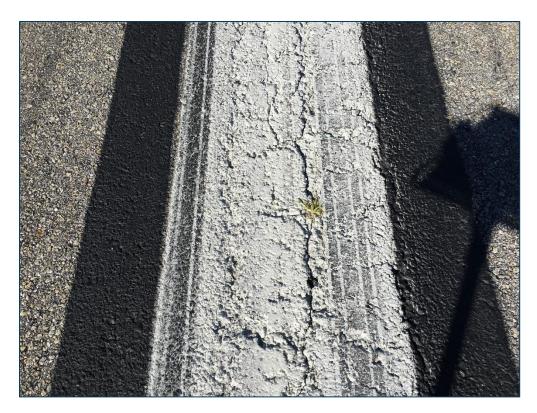
Runway 18-36, Section 6105, Sample Unit 111 – Low Severity (48) Longitudinal and Transverse Cracking, Low Severity (52) Raveling, Low Severity (57) Weathering

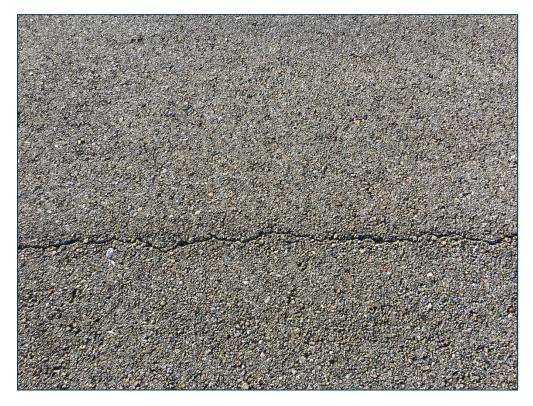
Runway 18-36, Section 6105, Sample Unit 171 - Low Severity (48) Longitudinal and Transverse Cracking, Low Severity (57) Weathering

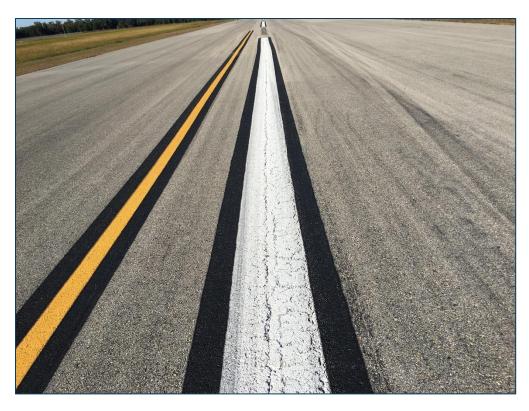
Runway 18-36, Section 6105, Sample Unit 143 - Low Severity (48) Longitudinal and Transverse Cracking, Low Severity (52)

Raveling

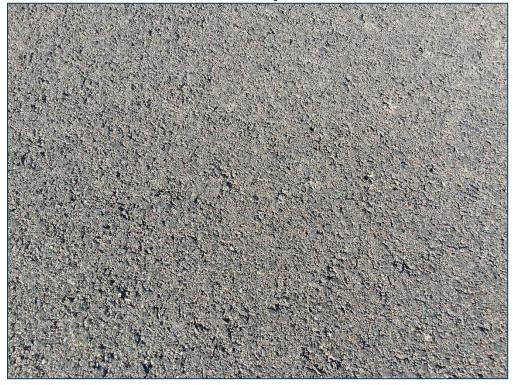
Taxilane to North Hangars, Section 245, Sample Unit 601 – Low Severity (57) Weathering

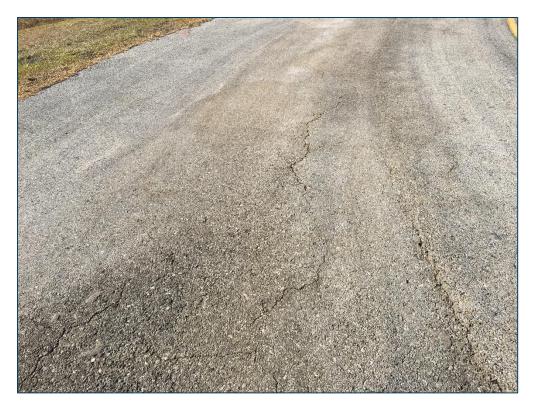
Parallel Taxiway, Section 105, Sample Unit 101 – Low Severity (45) Depression, Low and Medium Severity (48) Longitudinal and Transverse Cracking, Low Severity (52) Raveling, Medium Severity (52) Raveling

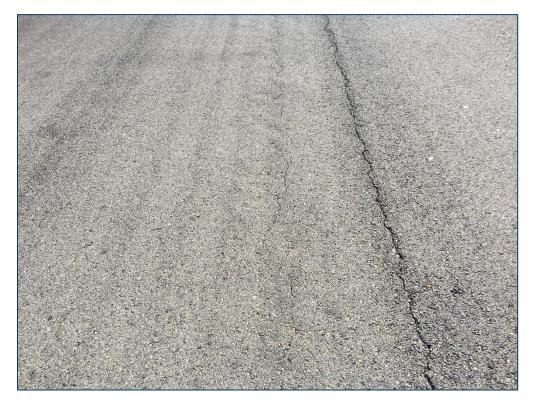
Parallel Taxiway, Section 115, Sample Unit 111 - Low and Medium Severity (48) Longitudinal and Transverse Cracking, Low Severity (52) Raveling, Low Severity (56) Swelling

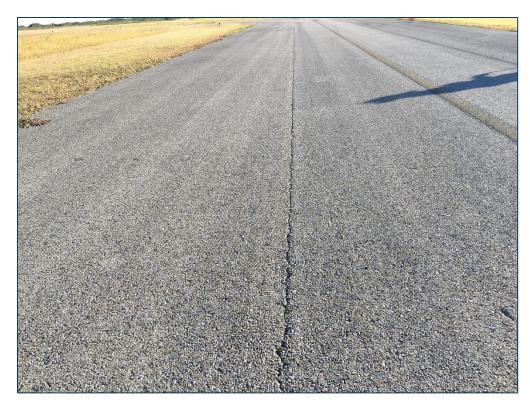
Parallel Taxiway, Section 125, Sample Unit 101 - Low Severity (48) Longitudinal and Transverse Cracking, Medium Severity (48) Longitudinal and Transverse Cracking, Low Severity (52) Raveling, Medium Severity (52) Raveling

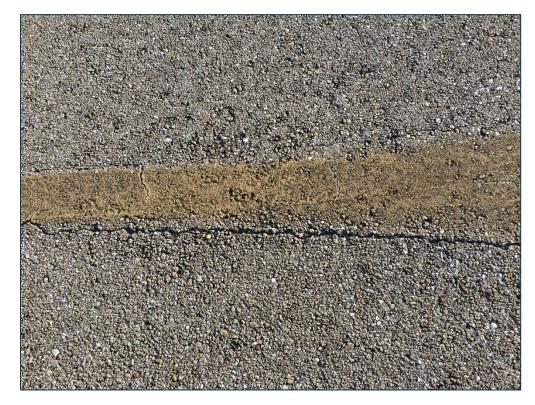
Taxilane To Hangars, Section 205, Sample Unit 105 - Low and Medium Severity (48) Longitudinal and Transverse Cracking, Low Severity (52) Raveling

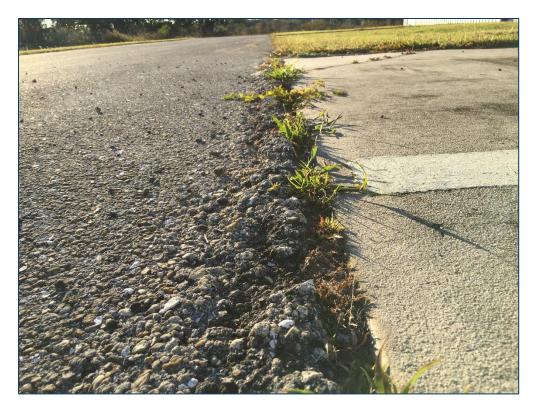
Taxilane To West Hangars, Section 210, Sample Unit 102 - Low Severity (52) Raveling, Low Severity (54) Shoving

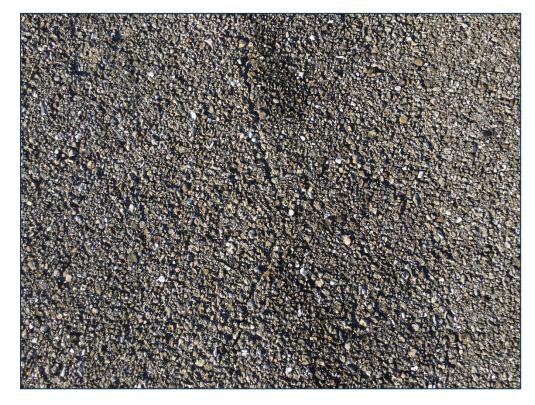
Apron AP, Section 4105, Sample Unit 102 – Low Severity (48) Longitudinal and Transverse Cracking, Low Severity (52) Raveling, Low Severity (56) Swelling
