# Statewide Airfield Pavement Management Program

Sebring Regional Airport was inspected in April 2017 - the overall weighted PCI value was 62, a condition rating of Fair. The results of the maintenance, repair, and major rehabilitation analysis identified \$2,140,550 in localized M&R needs based on current conditions and a 10-Year major rehabilitation need of \$19,659,000 based on forecasted conditions. The current major rehabilitation needs based on the latest inspection consist of \$14,635,000 for pavements below critical condition.

Inspection Photograph Documentation

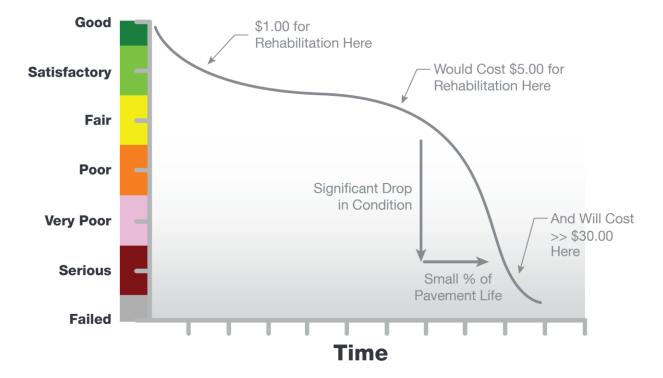
Figure 1.7-1 Typical Pavement Condition Life Cycle

\*Figure is for conceptual purposes only – unit costs are not specific to airfield pavements (AC vs PCC).

Pavement maintenance, repair, and major rehabilitation would be quite anticipatory if all pavements behaved as depicted in Figures 1.7-1 and 1.7-2, however pavement condition performance vary significantly based on several factors. Factors that contribute to a pavement section's condition and deterioration performance may include: functional design life, material type, material construction quality, climatic conditions, aircraft loading type and frequency, nonaircraft loading type and frequency, maintenance history, subgrade conditions, and other infrastructure in the vicinity. The list of factors is not all-inclusive of all factors that may contribute to a pavement's life cycle, it is intended to clarify that unique conditions certainly will affect a pavement's deterioration.

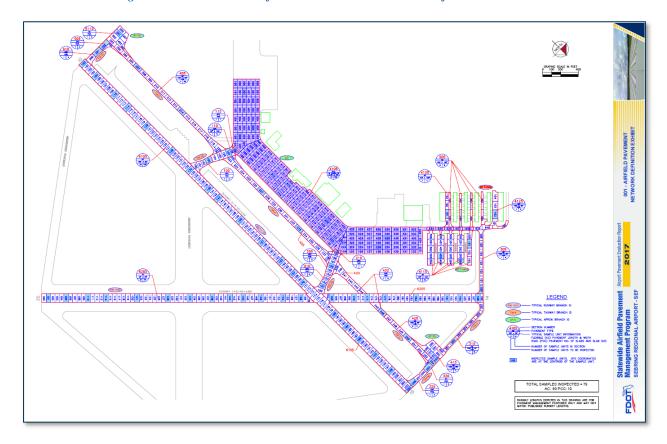
Figure 3.1.1-1 2017 Airfield Pavement Network Definition Exhibit

The Airfield Pavement Network Definition Exhibit provides details to the PCI Survey inspection efforts. The exhibit identifies the pavement facilities, surface type, section definition, and sample unit delineation.

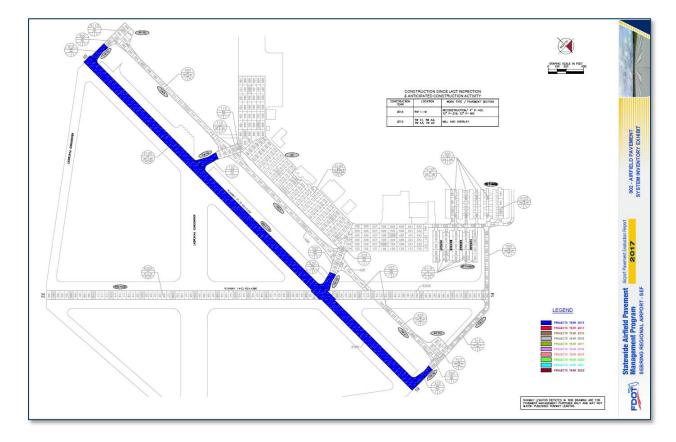
Figure 3.1.1-2 2017 Airfield Pavement System Inventory Exhibit

The Airfield Pavement System Inventory Exhibit provides details to the work history updates communicated by the Airport. The Exhibit provides the approximate limits of recent and/or anticipated construction on the airfield pavement facilities. The limits are based on documentation provided by the Airport and, if constructed, observed in the field.

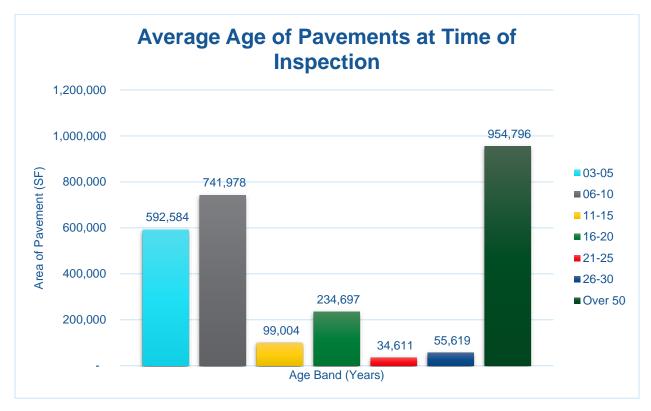
Figure 3.1.2 Average Age of Pavements at Inspection

The estimation of the pavement age is based on information requested and provided by participating airports. Additionally, data collected in the prior system updates since 1992 have been relied upon.

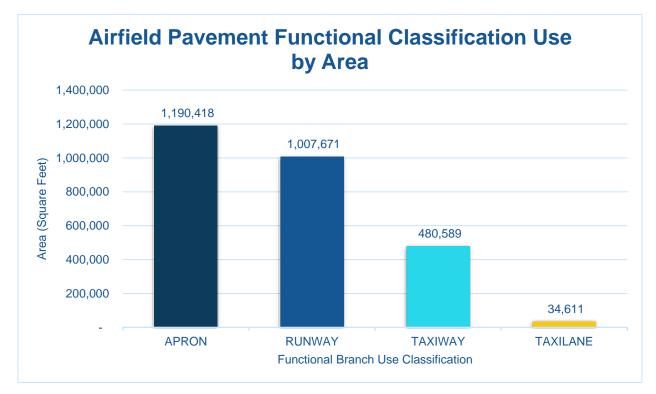
Figure 3.1.3 Airfield Pavement Functional Classification Use by Area

Pavements are subject to varying aircraft loading patterns based on utilization and overall operations. For this SAPMP Update, the following categories of airfield functional use have been identified and associated with the following possible pavement branch facilities: Apron, Runway, Taxiway, and Taxilane. Figure 3.1.3 summarizes the identified pavements' functional use by area in square feet. The pavement areas reviewed exclude shoulder pavement facilities.

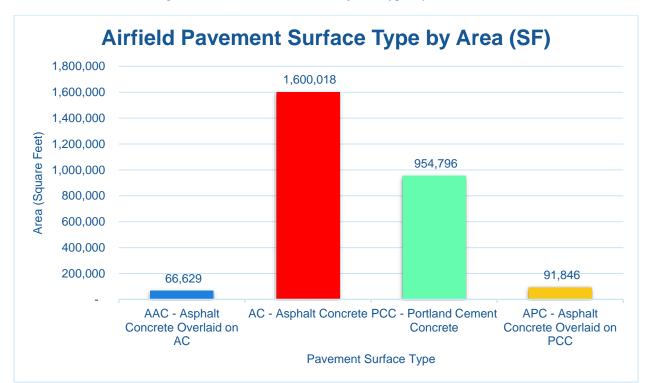
Figure 3.1.4 (a) Pavement Surface Type by Area (SF)

Based on the record documentation incorporated within the SAPMP database throughout the years, the pavement surface types have been assigned to the various pavement sections in accordance to its work history composition. The following Figures 3.1.4 (a) and (b) summarize the applicable pavement types observed at this specific airport's airfield.

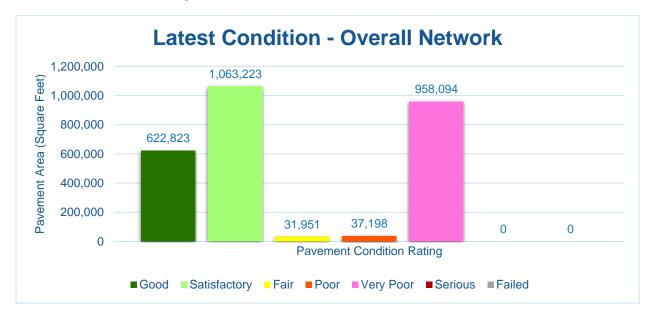
Figure 4.1.1 Latest Condition - Overall Network

The following Figure 4.1.1 summarizes the network-level pavement condition analysis based on the most recent PCI Survey inspection results.

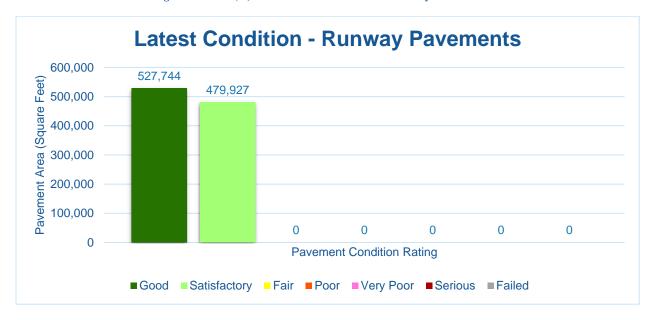
Figure 4.1.2 (a) Latest Condition - Runway Pavements

The following Figures 4.1.2 (a) through (d) summarize the branch-level pavement condition analysis based on the most recent PCI Survey inspection results; the following Figures provide overall branch-level conditions by branch use.

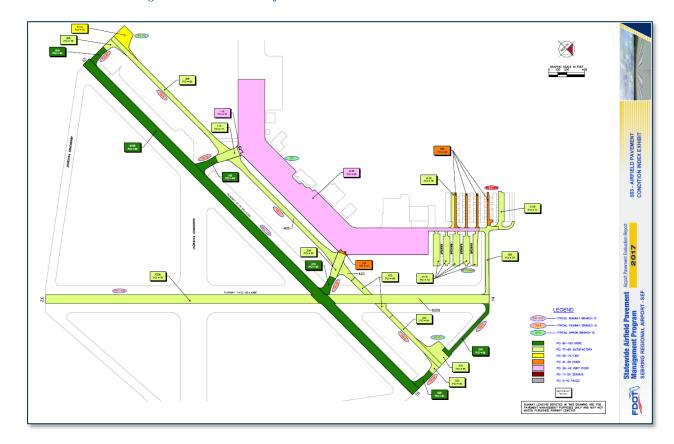
Figure 4.1.3 2017 Airfield Pavement Condition Index Exhibit

Figure 4.1.3 is an inset view of the 2017 Airfield Pavement Condition Index Exhibit that visually represents the results of the latest PCI Survey inspection. A large format exhibit is located in **Appendix C Technical Exhibits.**

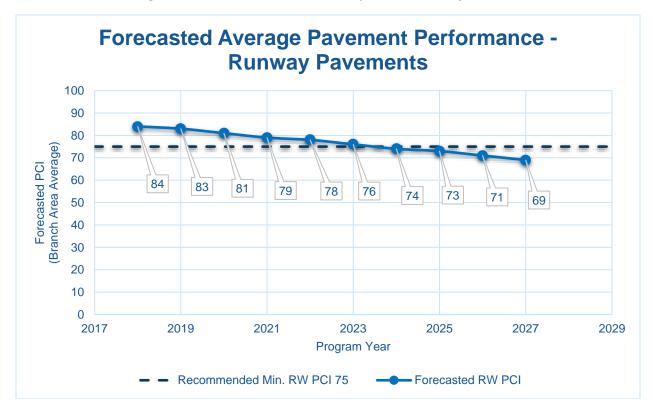
Figure 4.3.2 (a) Forecasted Runway Pavement Performance

The following Figures 4.3.2 (a) through (c) depict the branch-level pavement condition forecast by Branch Use (Runway, Taxiway, and/or Apron). The forecasted conditions are for a 10-year duration starting in January 2018 through January 2027.

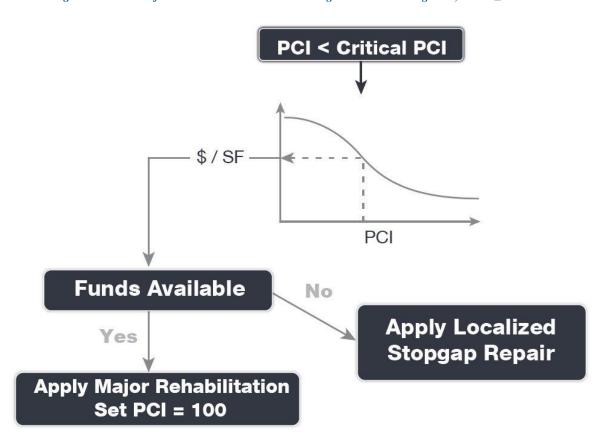
Figure 6.1-1 Major Rehabilitation Planning Decision Diagram, PCI ≤ Critical PCI

Major rehabilitation is recommended to correct or improve structural deficiencies and/or functional deterioration for pavement sections within a network. Often, when pavements are subject to significant changes in the aircraft fleet mix (frequency and type), major rehabilitation is required to provide a pavement section to meet the traffic demand. Major rehabilitation is recommended when a pavement section falls below the Critical PCI value that is defined during the system customization or if a pavement section has a significant observation of load-related distress. Observation of any load-related distress potentially indicates that the section may be structurally deficient or that the aircraft loads being applied to the pavement section are different than what the section was designed for. Figures 6.1-1 and 6.1-2 depict the decision process for major rehabilitation project identification with the assumption of available funds. Should funding be unavailable for pavement sections in need of major rehabilitation, the airport may elect to apply the appropriate localized stopgap repair.

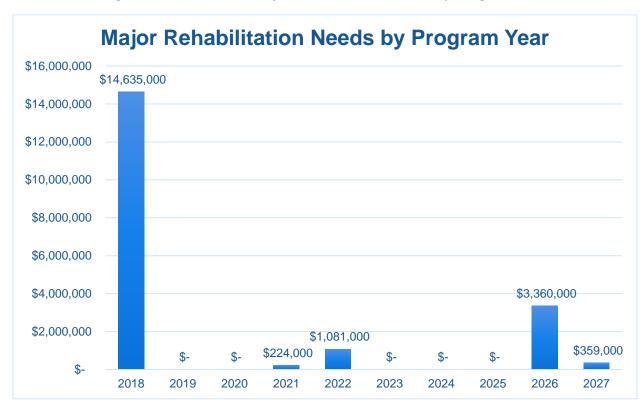
Figure 6.3.1-1 10-Year Major Rehabilitation Needs by Program Year

The following Figure 6.3.1-1 summarizes the section-level major rehabilitation needs for a 10year period between 2018 and 2027. Figure 6.3.1-2 provides an inset view of Airfield Pavement Major Rehabilitation Exhibit, a large format exhibit is located in Appendix C Technical **Exhibits**. The exhibit graphically depicts the Major Rehabilitation Needs with rounded costs.

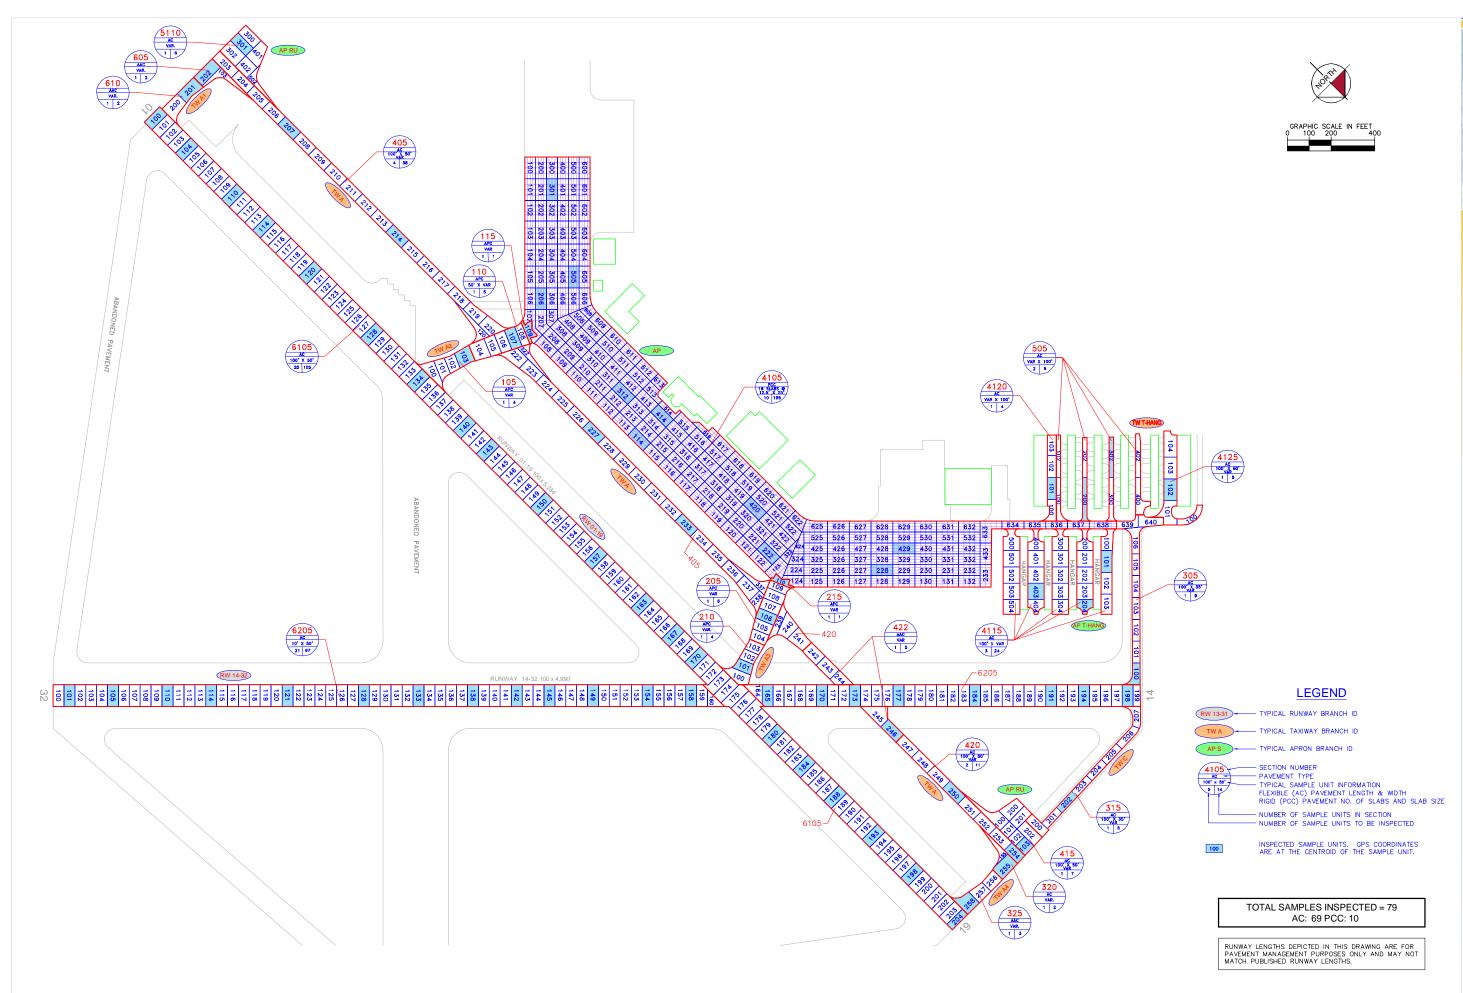
### CONSTRUCTION SINCE LAST INSPECTION & ANTICIPATED CONSTRUCTION ACTIVITY

& ANTICIPATED CONSTRUCTION ACTIVITY											
CONSTRUCTION YEAR	LOCATION	WORK TYPE / PAVEMENT SECTION									
2013	RW 1-19	RECONSTRUCTION/ 4" P-401, 12" P-219, 12" P-160									
2013	TW A1, TW A2, TW A3, TW A4	MILL AND OVERLAY

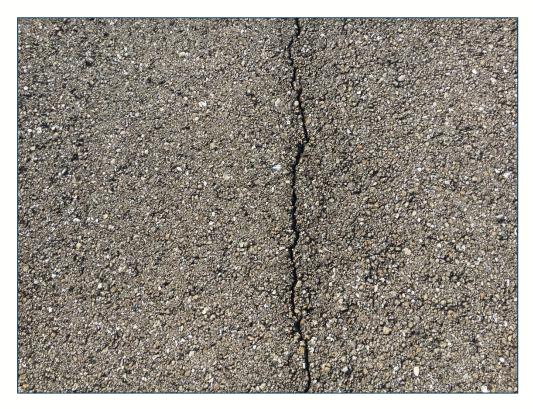
Runway 14-32, Section 6205, Sample Unit 101 – Low Severity (48) Longitudinal and Transverse Cracking, Low Severity (57) Weathering

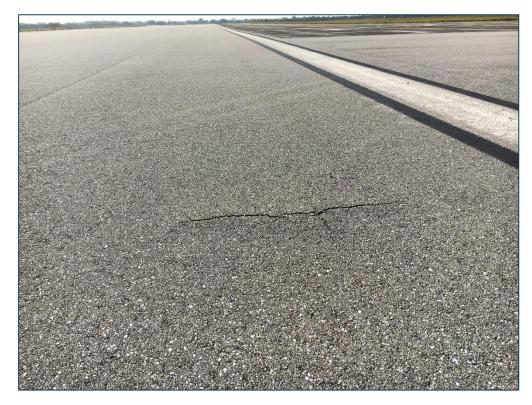
Runway 14-32, Section 6205, Sample Unit 133 – Low Severity (48) Longitudinal and Transverse Cracking, Low Severity (56) Swelling, Low Severity (57) Weathering

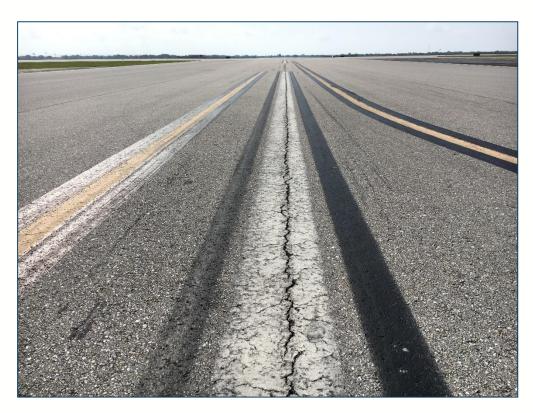
Runway 14-32, Section 6205, Sample Unit 170 - Low Severity (48) Longitudinal and Transverse Cracking, Low Severity (57) Weathering

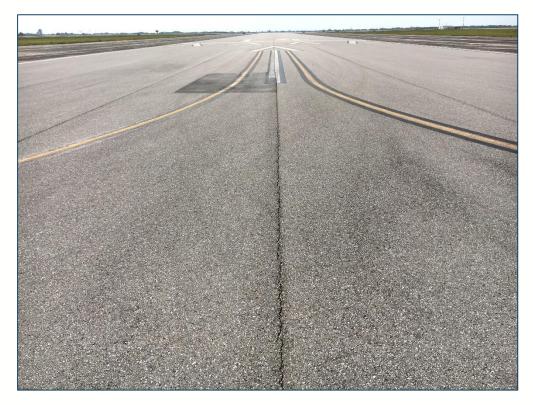
Runway 14-32, Section 6205, Sample Unit 198 – Low Severity (48) Longitudinal and Transverse Cracking, Low Severity (50) Patching, Low Severity (57) Weathering

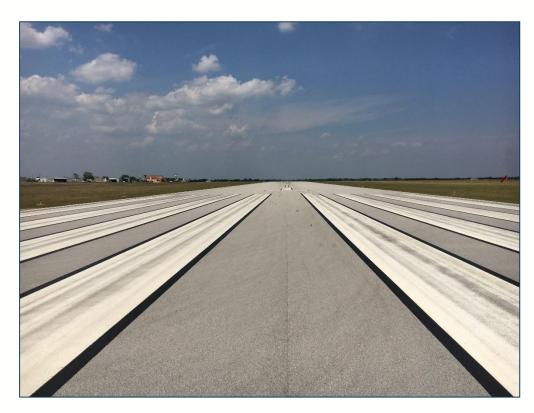
Runway 01-19, Section 6105, Sample Unit 100 - Low Severity (57) Weathering

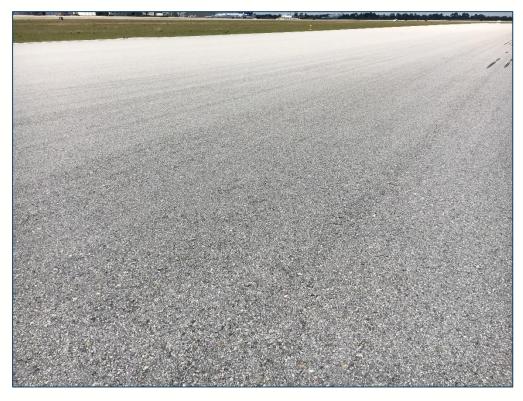
Runway 01-19, Section 6105, Sample Unit 157 - Low Severity (57) Weathering

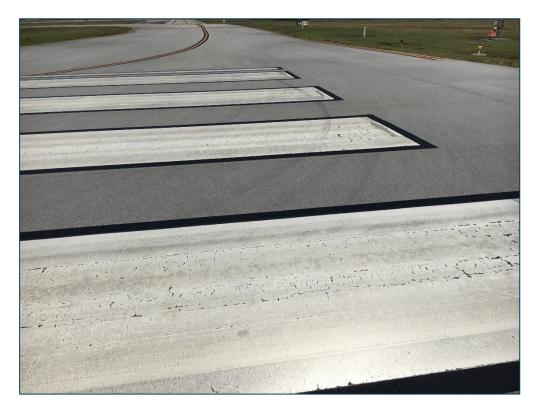
Runway 01-19, Section 6105, Sample Unit 204 – Low Severity (57) Weathering

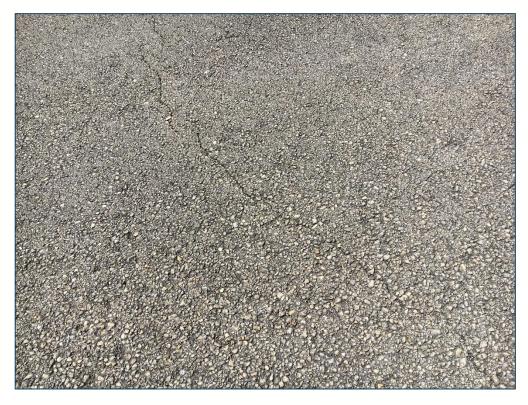
Taxiway A, Section 405, Sample Unit 207 - Low Severity (48) Longitudinal and Transverse Cracking, Low Severity (52) Raveling, Low Severity (57) Weathering

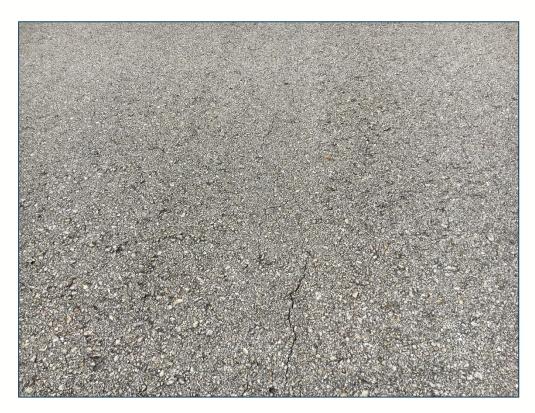
Taxiway A, Section 405, Sample Unit 233 - Low Severity (48) Longitudinal and Transverse Cracking, Low Severity (57) Weathering

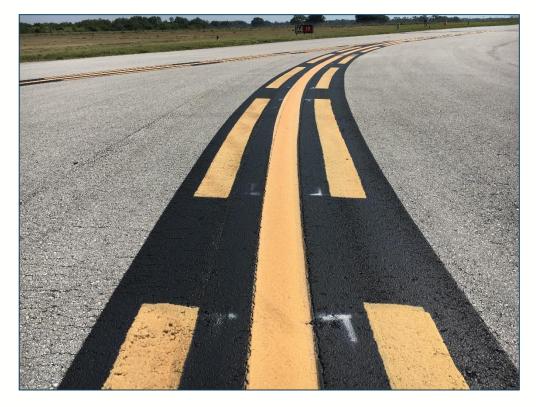
Taxiway A, Section 420, Sample Unit 254 - Low Severity (48) Longitudinal and Transverse Cracking, Low Severity (52) Raveling, Low Severity (57) Weathering

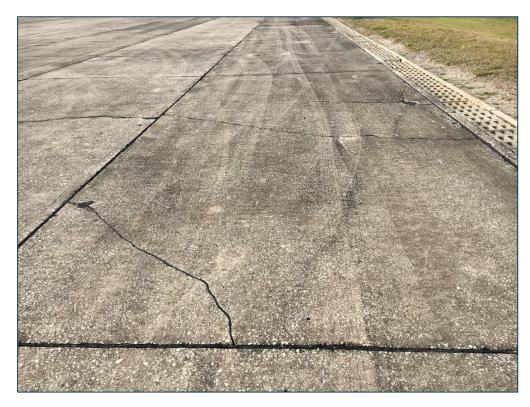
Apron, Section 4105, Sample Unit 114 - Medium Severity (72) Shattered Slab

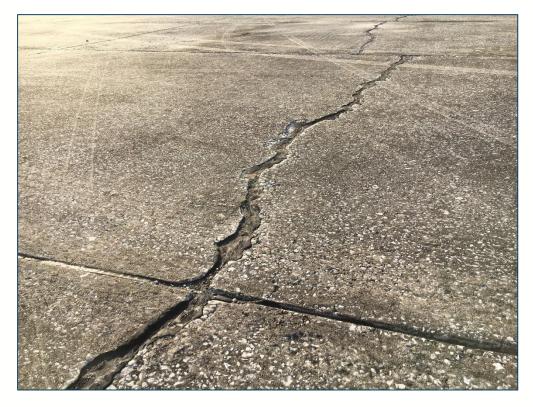
Apron, Section 4105, Sample Unit 301 – Medium Severity (63) Longitudinal, Transverse, and Diagonal Cracking, Medium Severity (65) Joint Seal Damage

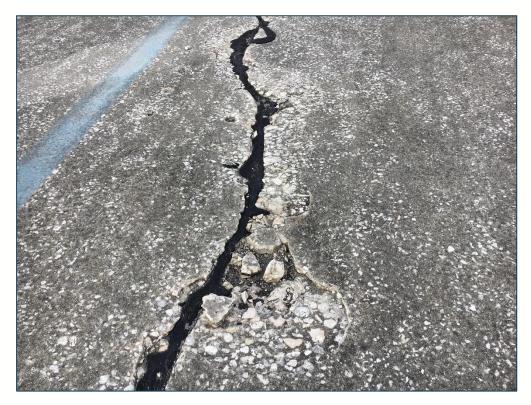
Apron, Section 4105, Sample Unit 429 - High Severity (63) Longitudinal, Transverse, and Diagonal Cracking

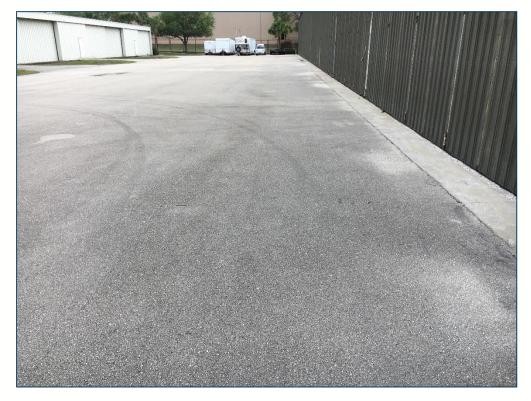
T-Hangar Apron, Section 4125, Sample Unit 102 – Low Severity (52) Raveling, Low Severity (57) Weathering
