Statewide Airfield Pavement Management Program

Airport Pavement Evaluation Report

September 2017

DeFuniak Springs Airport (54J)
General Aviation Airport
District 3

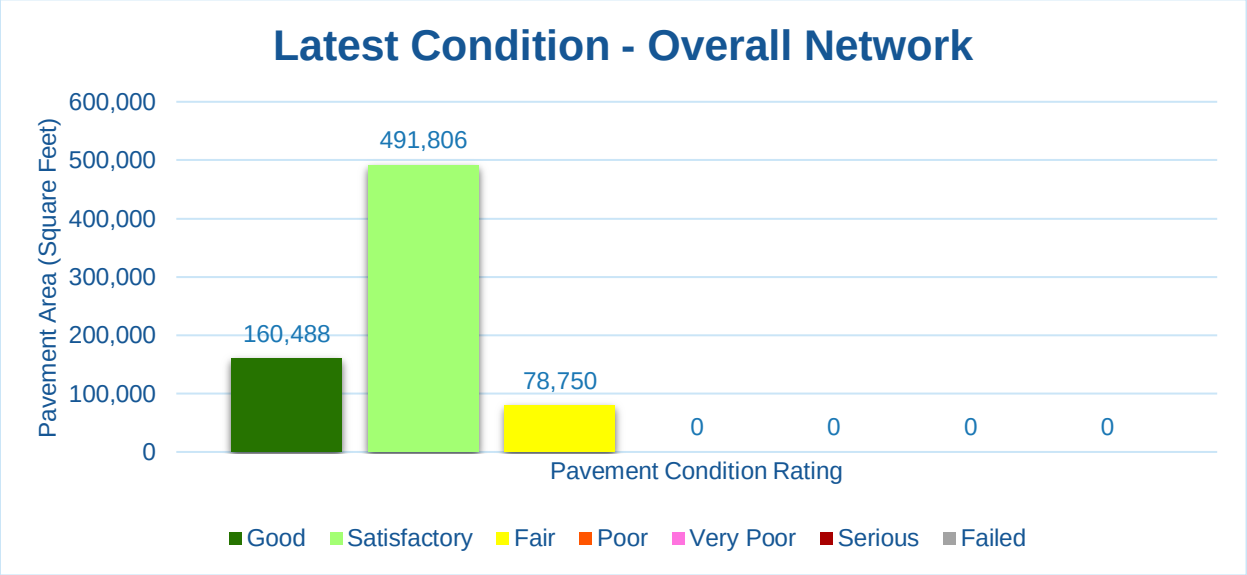
Figure 4.1.1 Latest Condition – Overall Network

DeFuniak Springs Airport was inspected in February 2017 – the overall weighted PCI value was 81, a condition rating of Satisfactory. The results of the maintenance, repair, and major rehabilitation analysis identified $57,100 in localized M&R needs based on current conditions and a 10-Year major rehabilitation need of $2,806,000 based on forecasted conditions. The current major rehabilitation needs based on the latest inspection consist of $173,000 for pavements below critical condition.

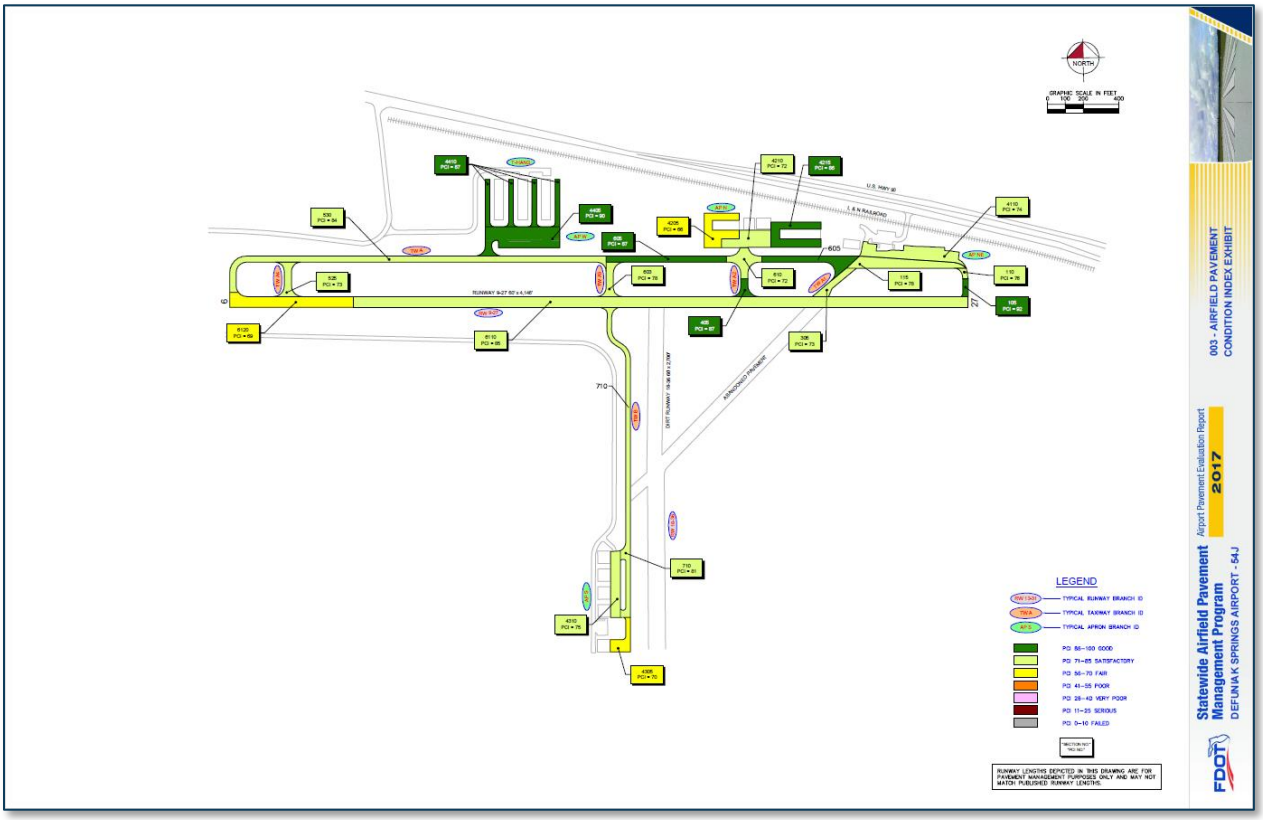
Figure 4.1.3 2017 Airfield Pavement Condition Index Exhibit

Figure 4.1.3 is an inset view of the 2017 Airfield Pavement Condition Index Exhibit that visually represents the results of the latest PCI Survey inspection. A large format exhibit is located in **Appendix C Technical Exhibits.**

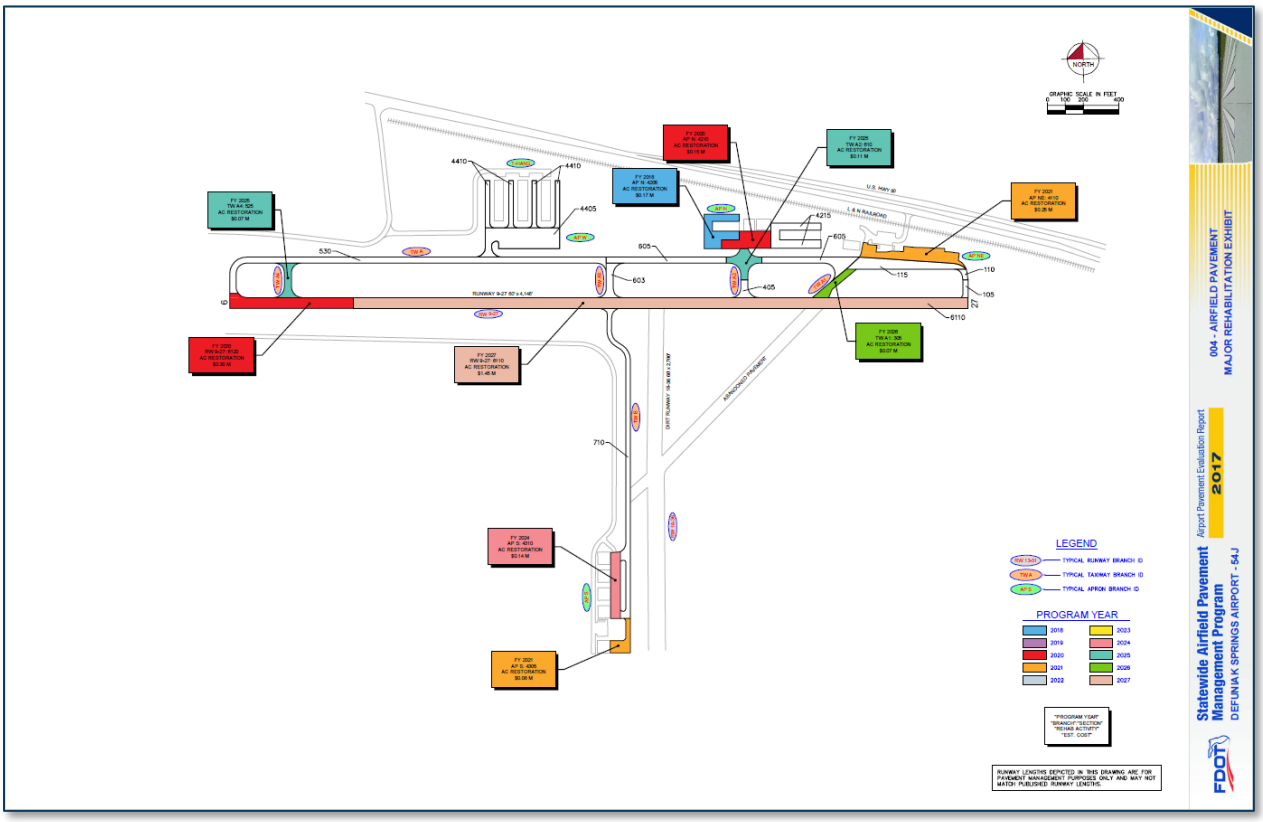
Figure 6.3.1-2 10-Year Major Rehabilitation Needs by Program Year Exhibit

The following **Figure 6.3.1-1** summarizes the section-level major rehabilitation needs for a 10-year period between 2018 and 2027. **Figure 6.3.1-2** provides an inset view of Airfield Pavement Major Rehabilitation Exhibit, a large format exhibit is located in **Appendix C Technical Exhibits**. The exhibit graphically depicts the Major Rehabilitation Needs with rounded costs.
