FLORIDA DEPARTMENT OF TRANSPORTATION
AVIATION AND SPACEPORTS OFFICE

Statewide Airfield Pavement Management Program

Airport Pavement Evaluation Report

Bartow Municipal Airport (BOW)
General Aviation Airport
District 1

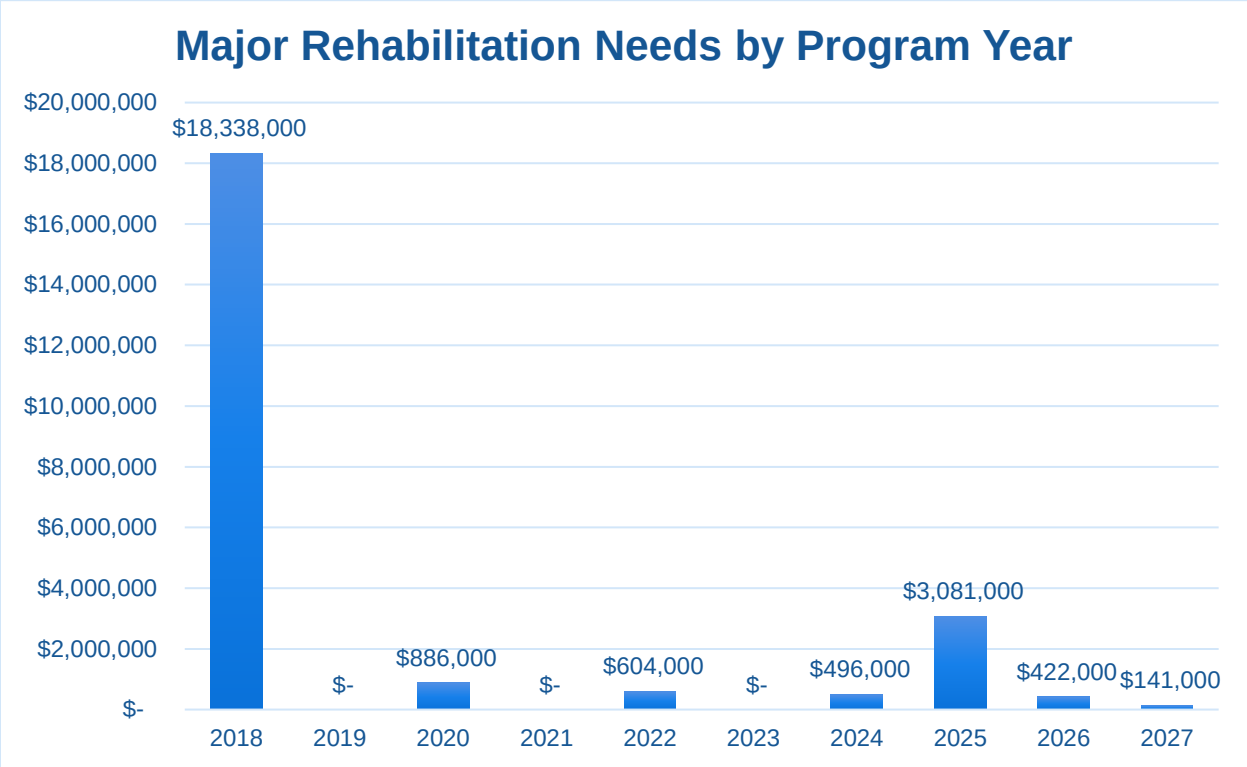
Figure 6.3.1-1 10-Year Major Rehabilitation Needs by Program Year

The following **Figure 6.3.1-1** summarizes the section-level major rehabilitation needs for a 10-year period between 2018 and 2027. **Figure 6.3.1-2** provides an inset view of Airfield Pavement Major Rehabilitation Exhibit, a large format exhibit is located in **Appendix C Technical Exhibits**. The exhibit graphically depicts the Major Rehabilitation Needs with rounded costs.

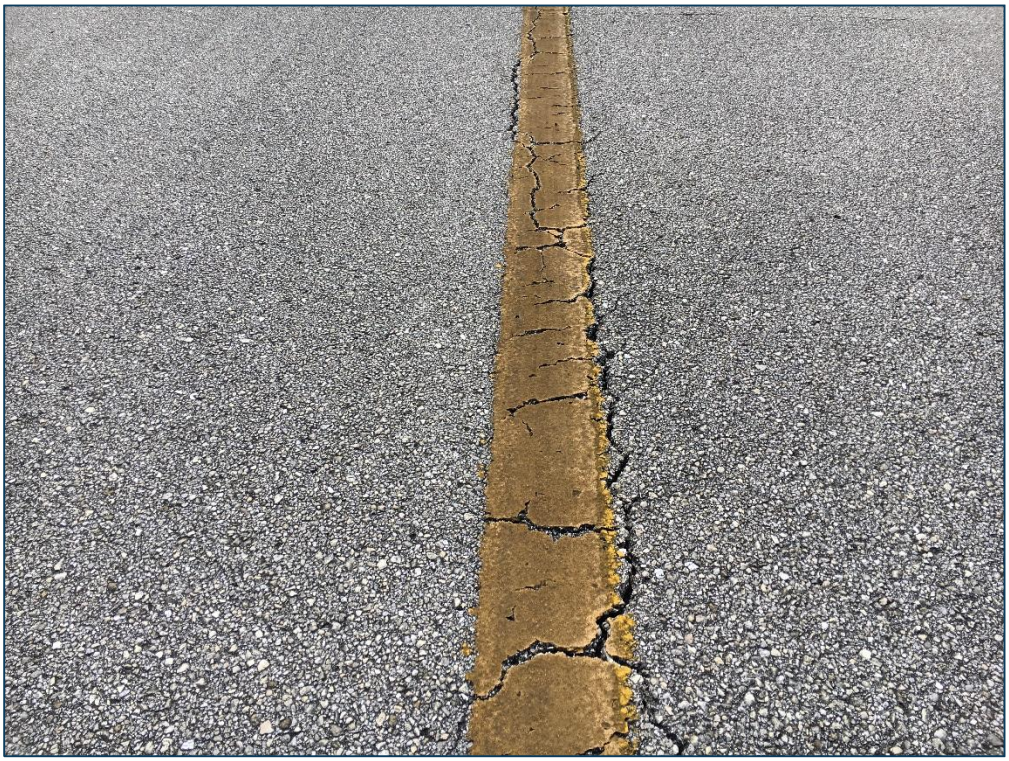
Taxiway C1, Section 305, Sample Unit 102 – Low Severity (48) Longitudinal and Transverse Cracking, Low Severity (52) Raveling,Low Severity (57) Weathering
